ADDENDUM NUMBER TWO

REBID - Taylor House Phase II Renovations

Project No.: U-899-18

DATE OF ISSUE: May 7, 2019

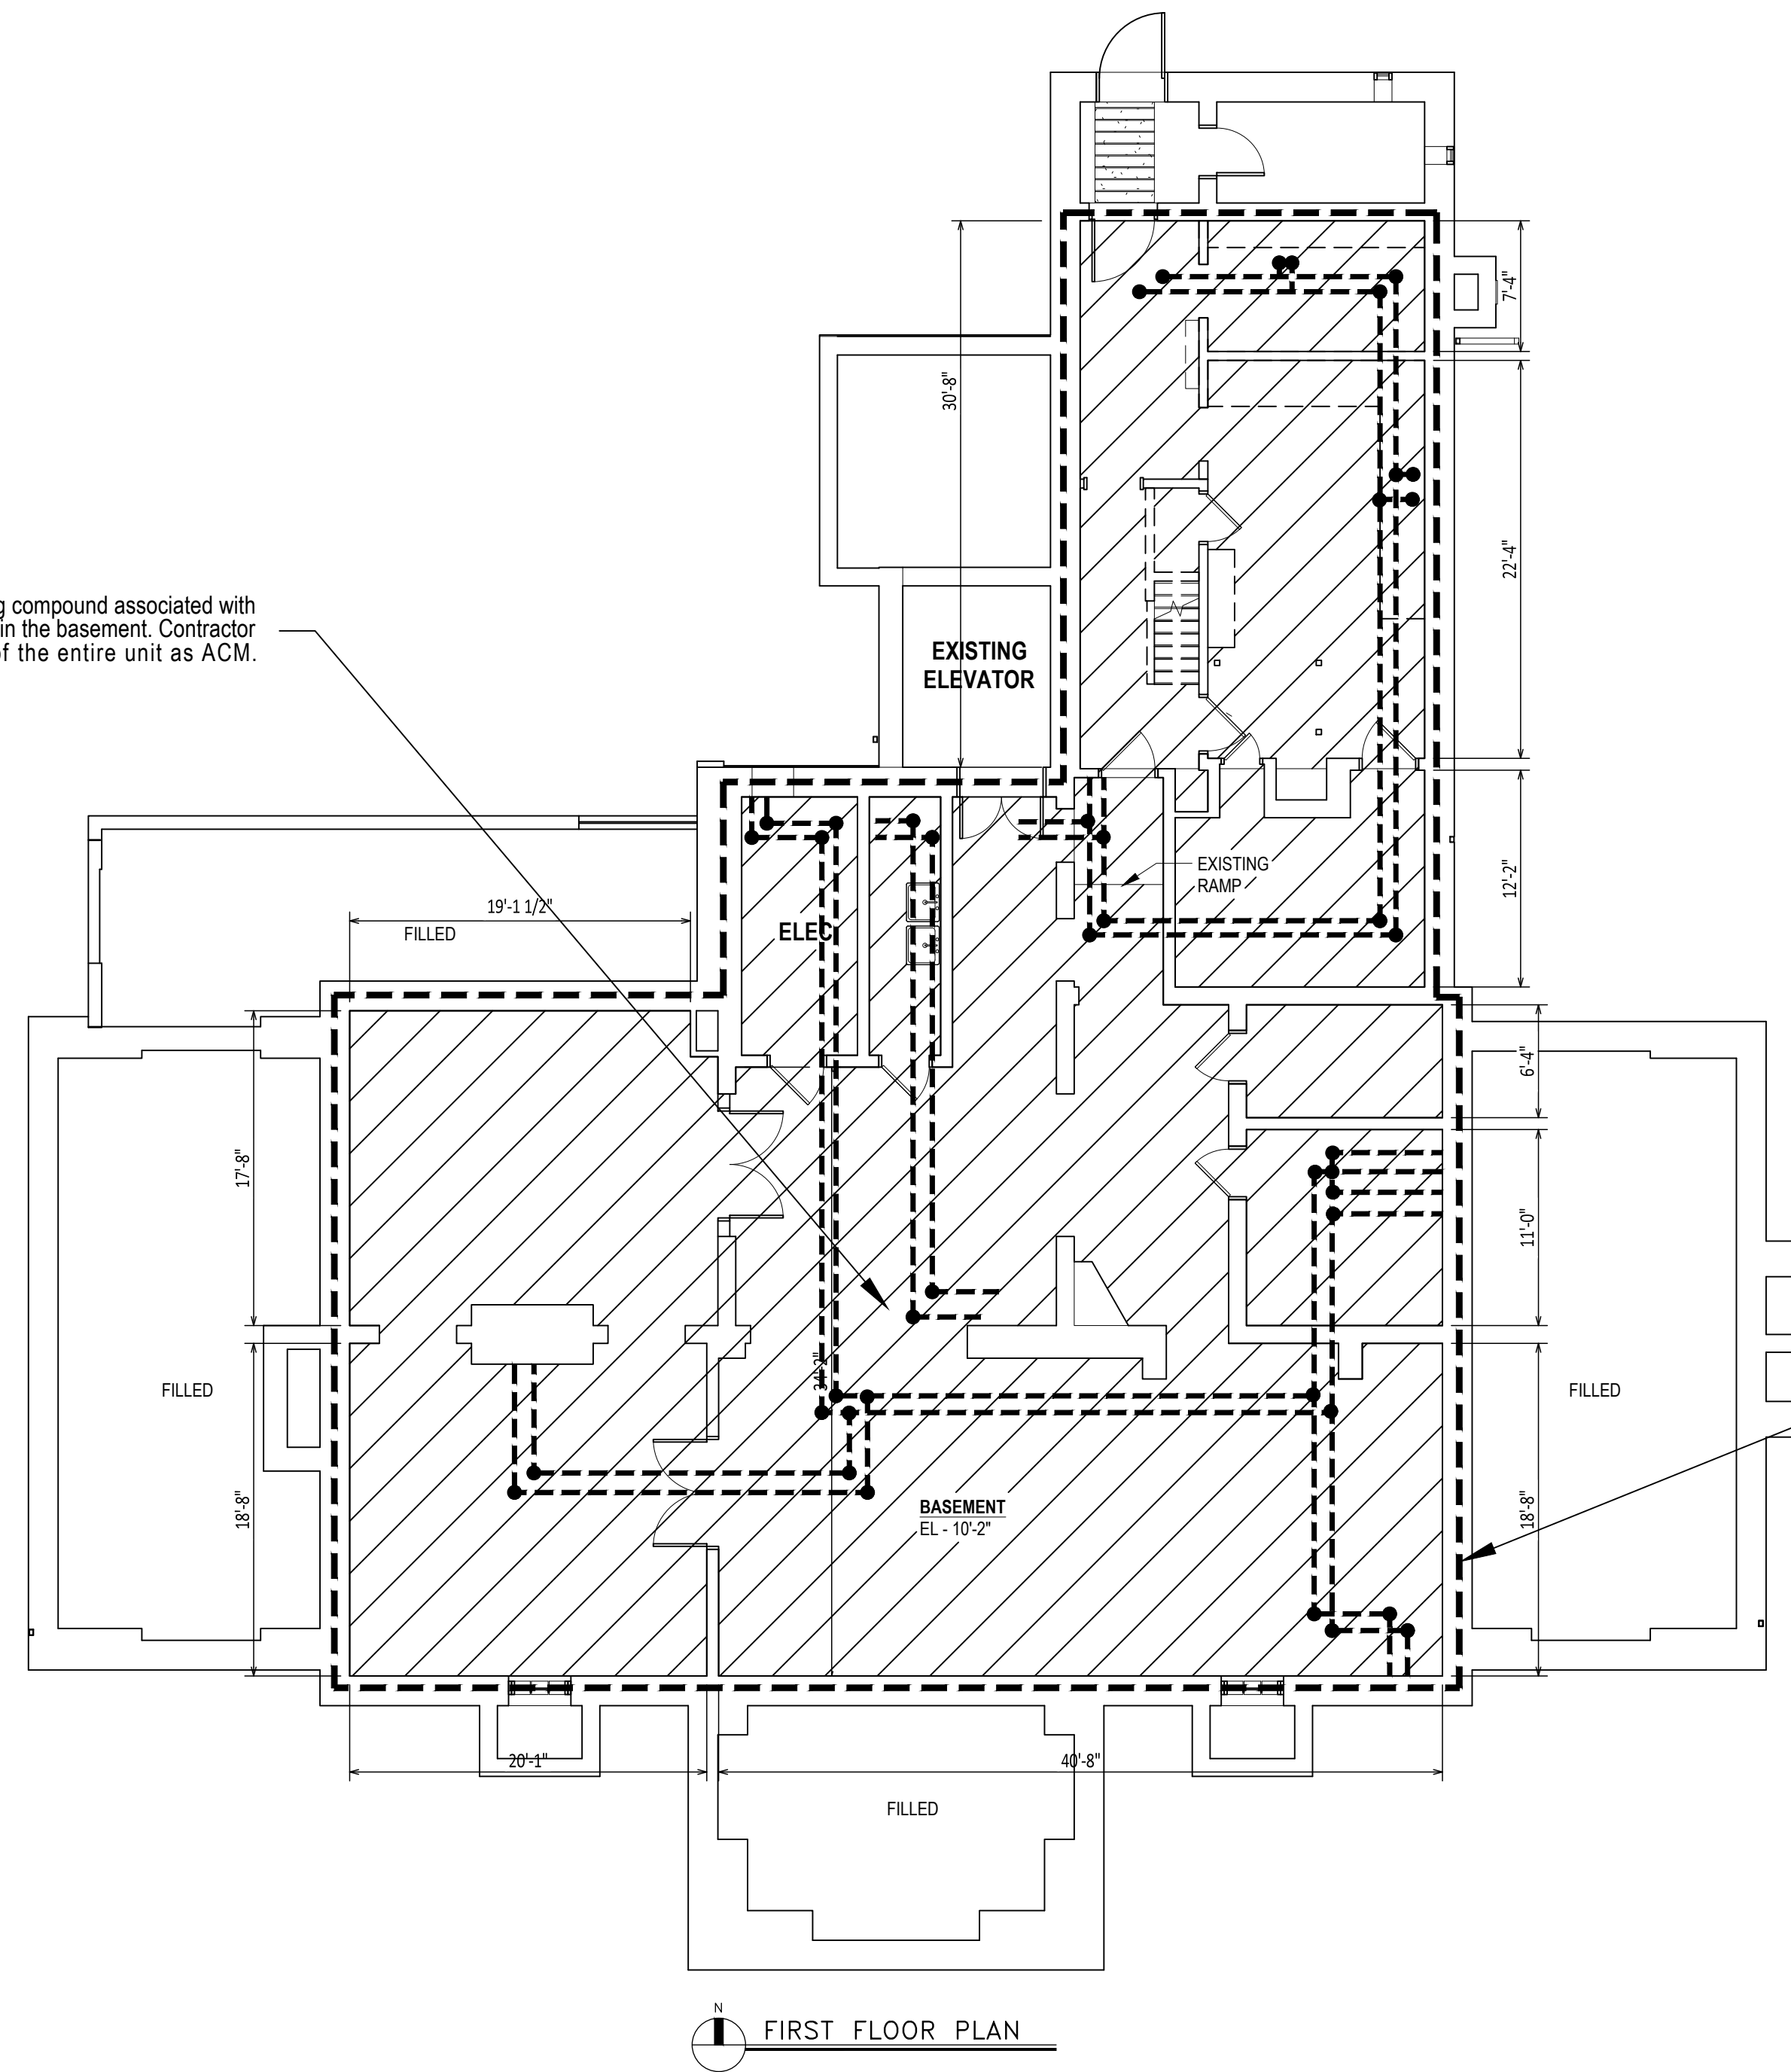
Contractor shall clean all vertical and horizontal surfaces throughout basement areas included in limits of abatement.

Contractor to remove all TSI pipe insulation and mudded fittings associated with mechanical lines throughout the limits of abatement.

Contractor shall abate the ACM mudding compound associated with the interior of the existing boiler located in the basement. Contractor shall have the option of disposing of the entire unit as ACM.

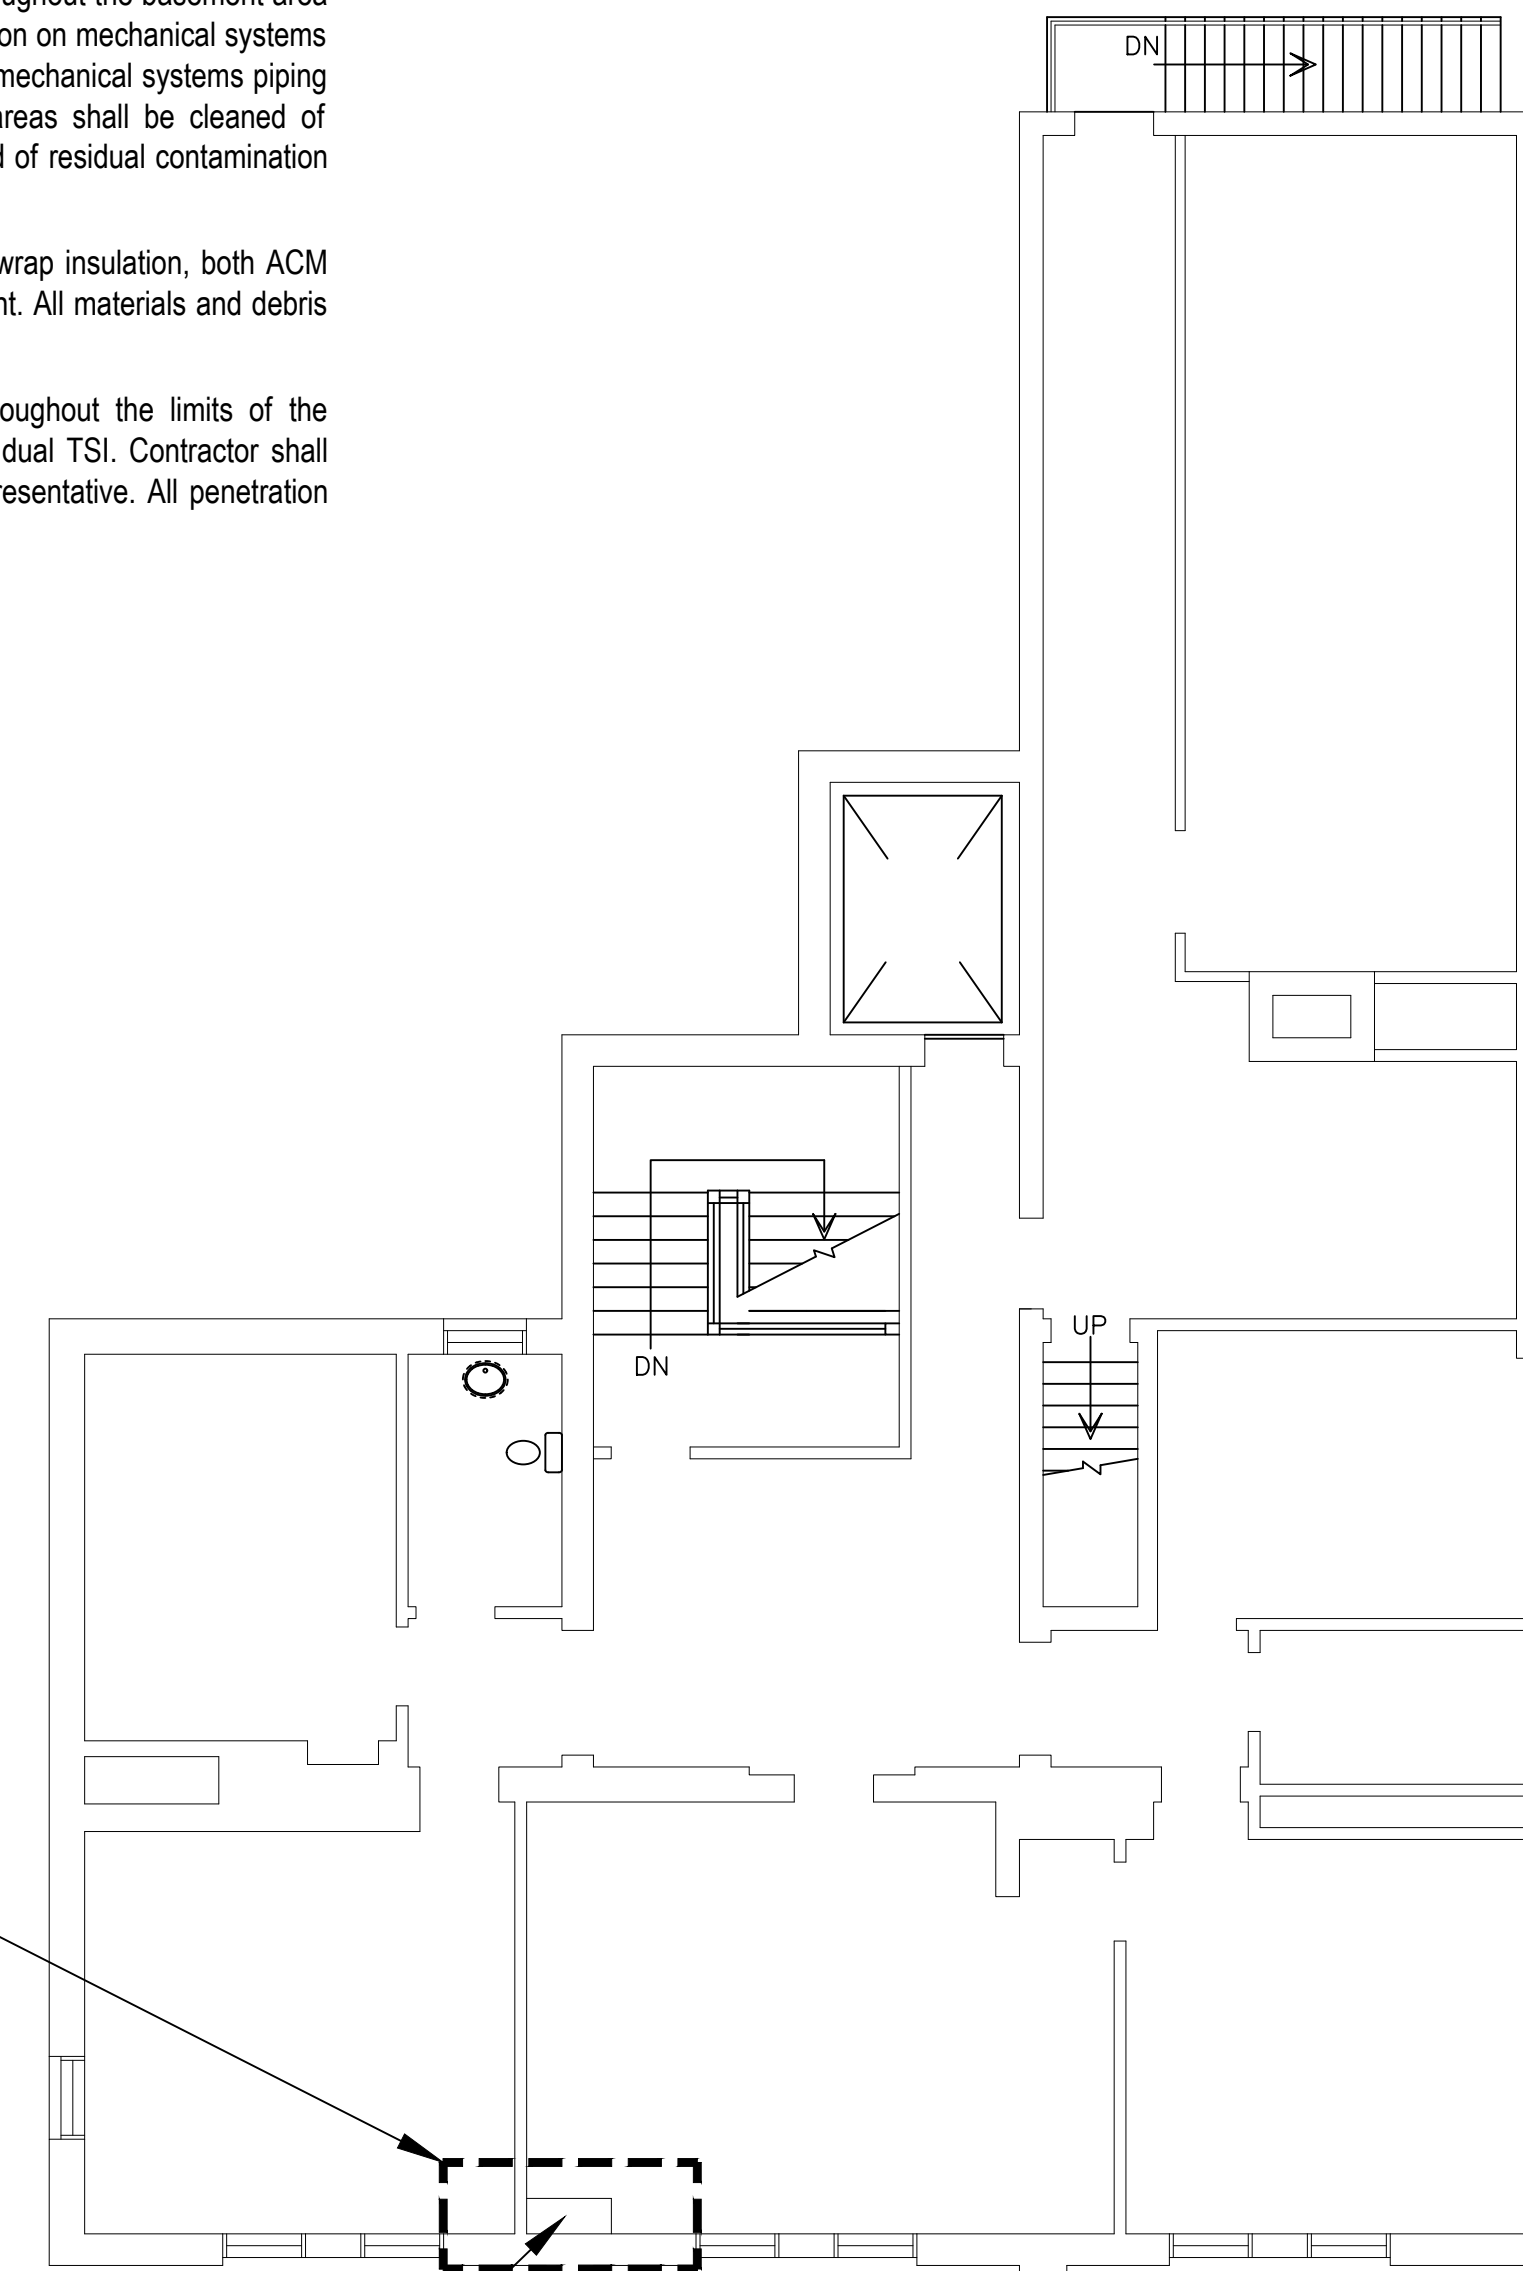
SECOND FLOOR PLAN

Contractor shall abate ACM duct wrap/tape on the metal HVAC duct within the interior of wood bench. Existing metal duct to remain. Contractor to coordinate the limits of the removal so that the demo contractor will not come in contact with ACM to during removal of existing hardwood floor

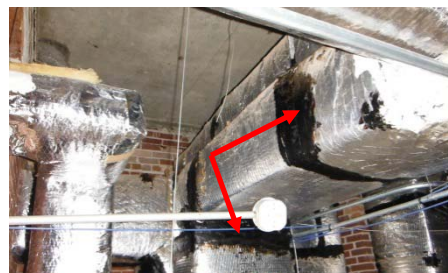
Metal HVAC ductwork with fiberglass duct wrap insulation was observed in the east and west wings. Asbestos-containing black mastic was used to seal the seams of the fiberglass duct wrap in hallways H102, H104, H105 of the west wing and in room 133 of the east wing. This material appears to be intact and is in a non-friable condition. Prior to demolition of the building, this material must be removed and disposed of as ACM by a licensed abatement contractor.

Photo 1. Asbestos-containing black mastic was found on HVAC duct wrap in the east and west wings.

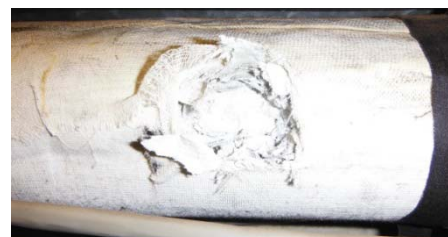
The Aircell TSI insulation is located at the south wall of room 125 on the first floor below the existing ceiling and in the basement of the original portion of the building structure. Due to limited access to the wall cavities and lack of original construction drawings, it is difficult to clearly delineate the exact location and estimated quantity of this material. Therefore, unless otherwise determined, it is assumed that this material

Photo 2. Asbestos-containing Aircell pipe insulation

exists throughout the exterior wall cavities, above hard ceilings and within pipe chases. This material was observed to be in an intact but friable condition. Some evidence of deterioration was noted due to the age of the material. Prior to demolition activities, this material must be removed and disposed of as ACM by a licensed abatement contractor.

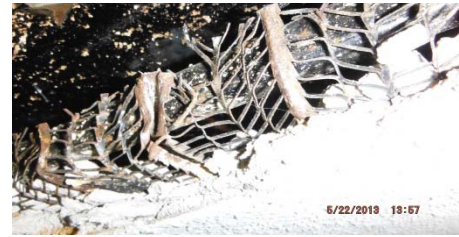
Asbestos-containing plaster ceilings are located above the existing suspended ceiling grid in rooms 135, 137 and 138 of the east wing. The exposed surfaces are also coated in an asbestos-containing spray-applied ceiling texture. Both materials appear to be intact and however the texturing is in a friable condition. Some localized damage was noted. Prior to demolition activities, these materials must be removed and disposed of as friable ACM by a licensed abatement contractor.

Photo 3. The asbestos-containing plaster ceilings were found above the ceiling grid in rooms 135, 137 and 138 of the east wing.

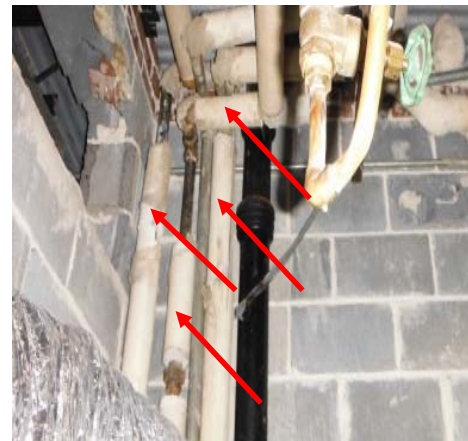
Asbestos-containing block TSI pipe insulation was noted in the area of the basement associated with the original house and above the ceiling in room 139 of the east wing. Due to limited access to the wall cavities and lack of original construction drawings for both the original house and the east wing, it is difficult to clearly delineate the exact location and to estimate the quantity of this ACM. During demolition and/ or renovation activities, there is potential for asbestos-containing TSI to be uncovered in exterior wall cavities, above hard ceilings and within pipe chases. This material appears to be intact and is in a friable condition. This material must be removed and disposed of as ACM by a licensed abatement contractor prior to demolition of the building.

Photo 4. Asbestos-containing block TSI was observed in the basement level of the original house and above the ceiling in room 139 of the east wing.

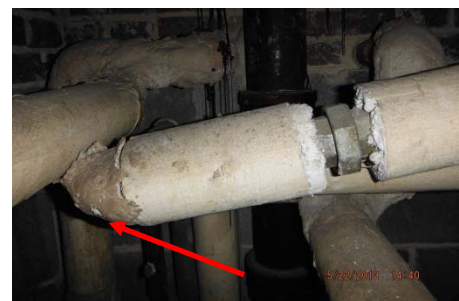
Mudded elbows were found on the joints of all three (3) types of pipe insulation in the basement of the original structure and above the ceiling in room 139 of the east wing. Mudded elbows associated with the Aircell, asbestos-containing block and non-ACM fiberglass insulations were sampled independently of each other. Laboratory results indicate that the mudded elbows associated with the Aircell- and ACM block-insulated lines are also ACM, while the elbows associated with the non-ACM fiberglass-insulated pipe lines were

Photo 5. Asbestos-containing mudded elbows were found on pipe lines insulated with Aircell and block insulation.

found to be non-ACM. However, because of the potential for variability in the types of materials used for the mudded elbows, it is prudent to handle all mudded elbows as ACM. This material appears to be intact and is in a friable condition. This material must be removed and disposed of as ACM by a licensed abatement contractor prior to demolition of the building.

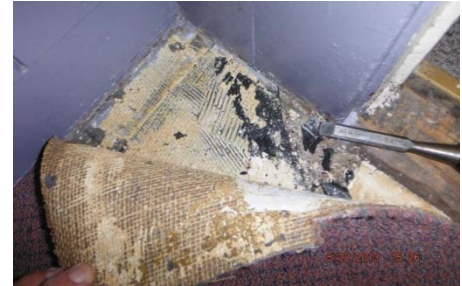
Asbestos-containing 9” x 9” black floor tiles were identified under the existing carpet in room 205 of the carriage house. During bulk sample collection of the floor tiles and associated mastic, a layer of felt paper was also identified. Both the black floor tile mastic and the underlying felt paper were found to be negative for asbestos. The asbestos-containing floor tiles are intact but show evidence of a significant amount of deterioration due to its age. It is difficult to assess the overall condition due to the carpeting. Furthermore, the tiles were noted to be very brittle during bulk sample collection, indicating that removal of the overlying non-ACM carpet which is glued down will need to be performed under full containment due to the high potential for breakage of the tiles. These materials must be removed and disposed of as ACM by a licensed abatement contractor prior to demolition of the building.

Photo 6. Asbestos-containing 9” x 9” floor tiles were found beneath non-ACM carpeting. Non-ACM felt paper was also identified in this location beneath the ACM floor tiles.

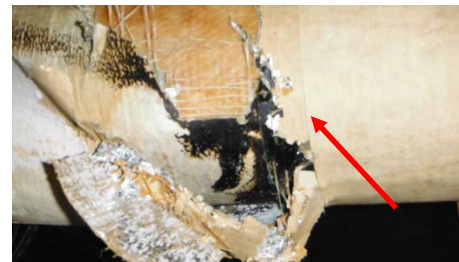
The majority of fiberglass pipe insulation observed in the subject structure was considered to be a non-suspect material. However, fiberglass pipe insulation found in the basement of the original building structure had a wrap that was found to contain a layer of asbestos-containing black mastic. This ACM is on a section of pipe located on the south end of the basement and appears to be intact and in a non-friable condition. Prior to demolition of the building, this material must be removed and disposed of as ACM by a licensed abatement contractor.

Photo 7. Asbestos-containing fiberglass pipe insulation was found in the south end of the basement level.

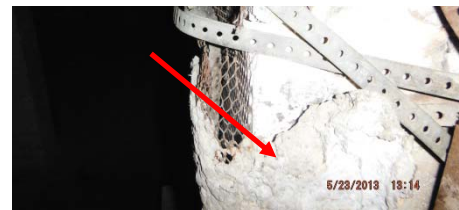
The investigation identified an abandoned kiln located in the basement of the east wing (Room 014) which is in the former Carriage House of the original structure. The kiln was insulated with an asbestos-containing jacketing on the exterior and also has asbestos-insulated wiring. The asbestos-containing electrical wiring was found on the rear of the kiln. The TSI is severely damaged, with visible debris observed on the ground,

Photo 8. Remnants of asbestos-containing TSI jacketing were found to be severely damaged.

while the electrical wiring insulation appears to be intact but in poor condition. Both are in friable condition. These materials must be removed and disposed of as friable ACM by a licensed abatement contractor prior to demolition of the building. Additionally, the associated bricks and surrounding surface soils may need to be abated due to contamination.

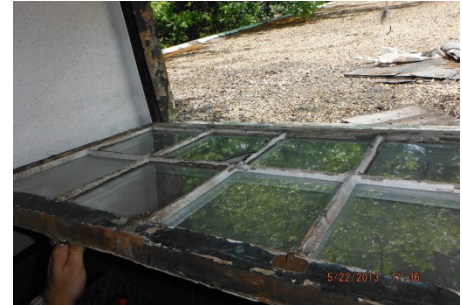
Asbestos-containing window glazing was found on forty-one (41) exterior windows associated with the subject structure. This material was observed to be damaged with obvious deterioration due to weathering, which has rendered it friable in some areas. Furthermore, evidence of delamination was observed, as window glazing debris has accumulated on some of the window sills. The window units vary in size and are located around the perimeter of the original house on the first through third floors, on the second floor of the carriage house, on the north side of the east wing and on the east side of the west wing. Prior to demolition activities, this material and associated debris must be removed and disposed of as ACM by a licensed abatement contractor.

Photo 9. Asbestos-containing exterior window glazing was found on all exterior windows of the subject structure

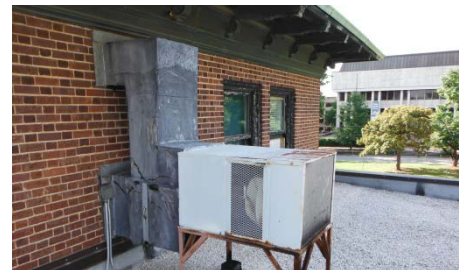
Exterior HVAC ductwork was found on the roof of the west wing. This ductwork supplies the second floor of the original house and is insulated with fiberglass. Asbestos-containing HVAC mastic was used to seal the seams of the duct insulation. This material appears to be in an intact non-friable condition but shows evidence of deterioration from exposure to the elements. Prior to demolition of the building, this material must be removed and disposed of as ACM by a licensed abatement contractor.

Photo 10. Asbestos-containing black HVAC mastic was found on ductwork insulation located on the roof of the west wing.

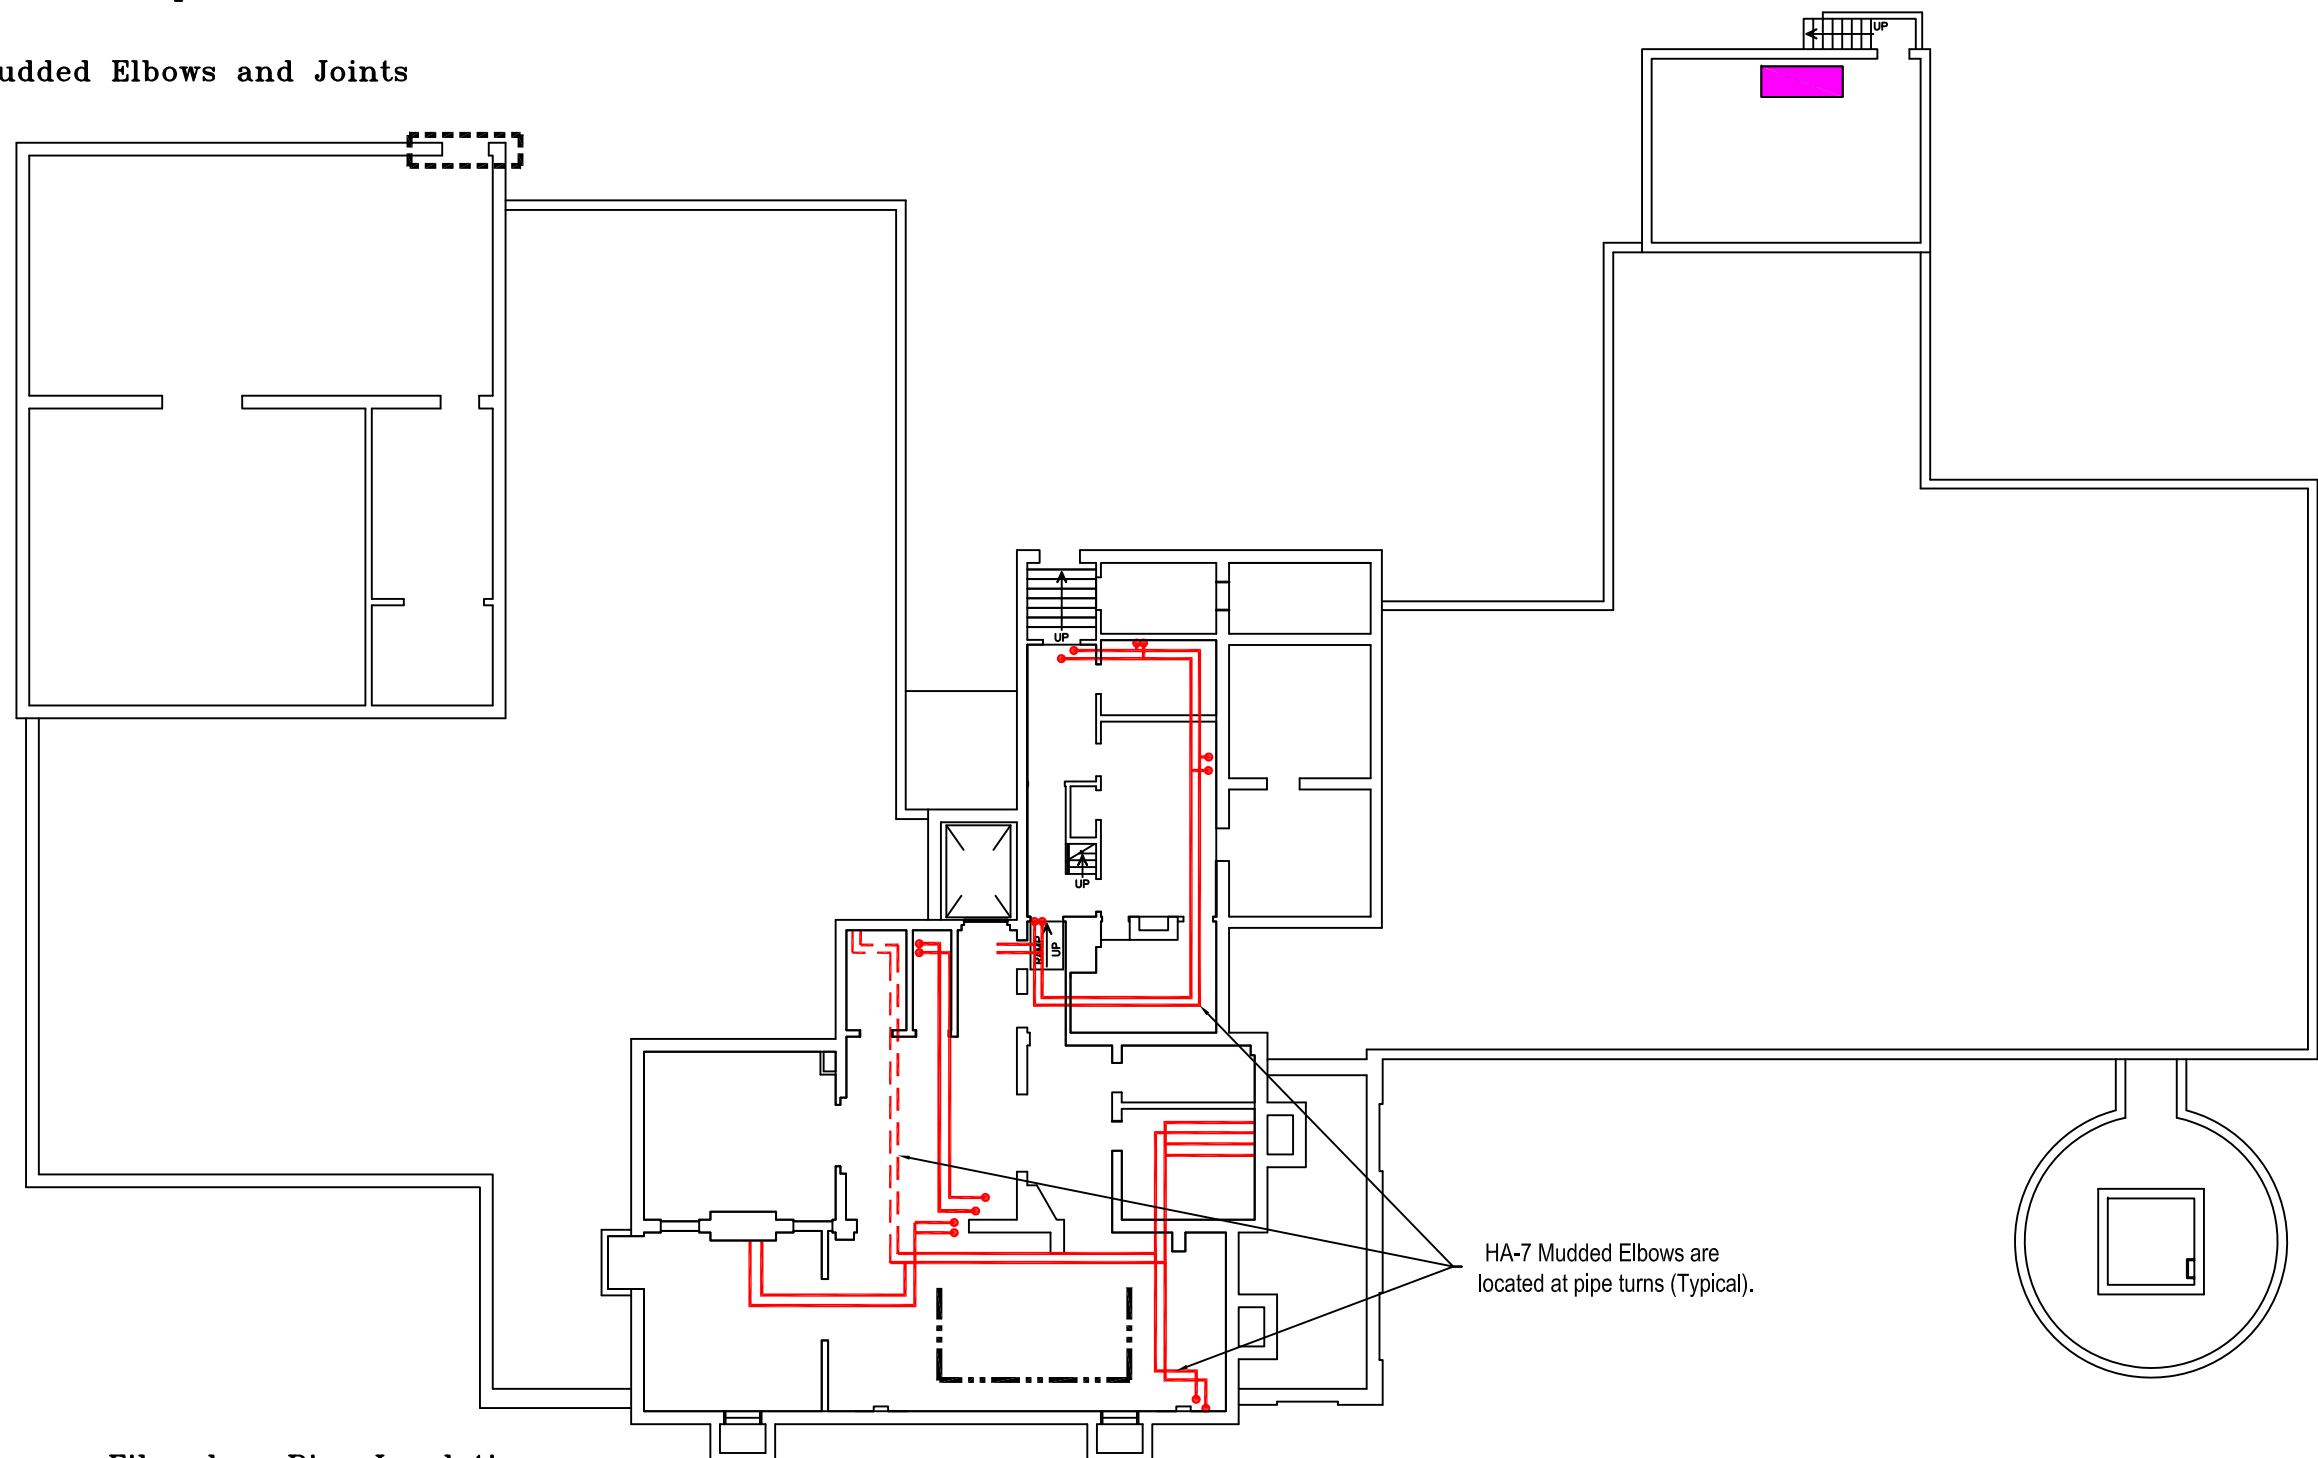
HA-7 Mudded Elbows are located at pipe turns (Typical).

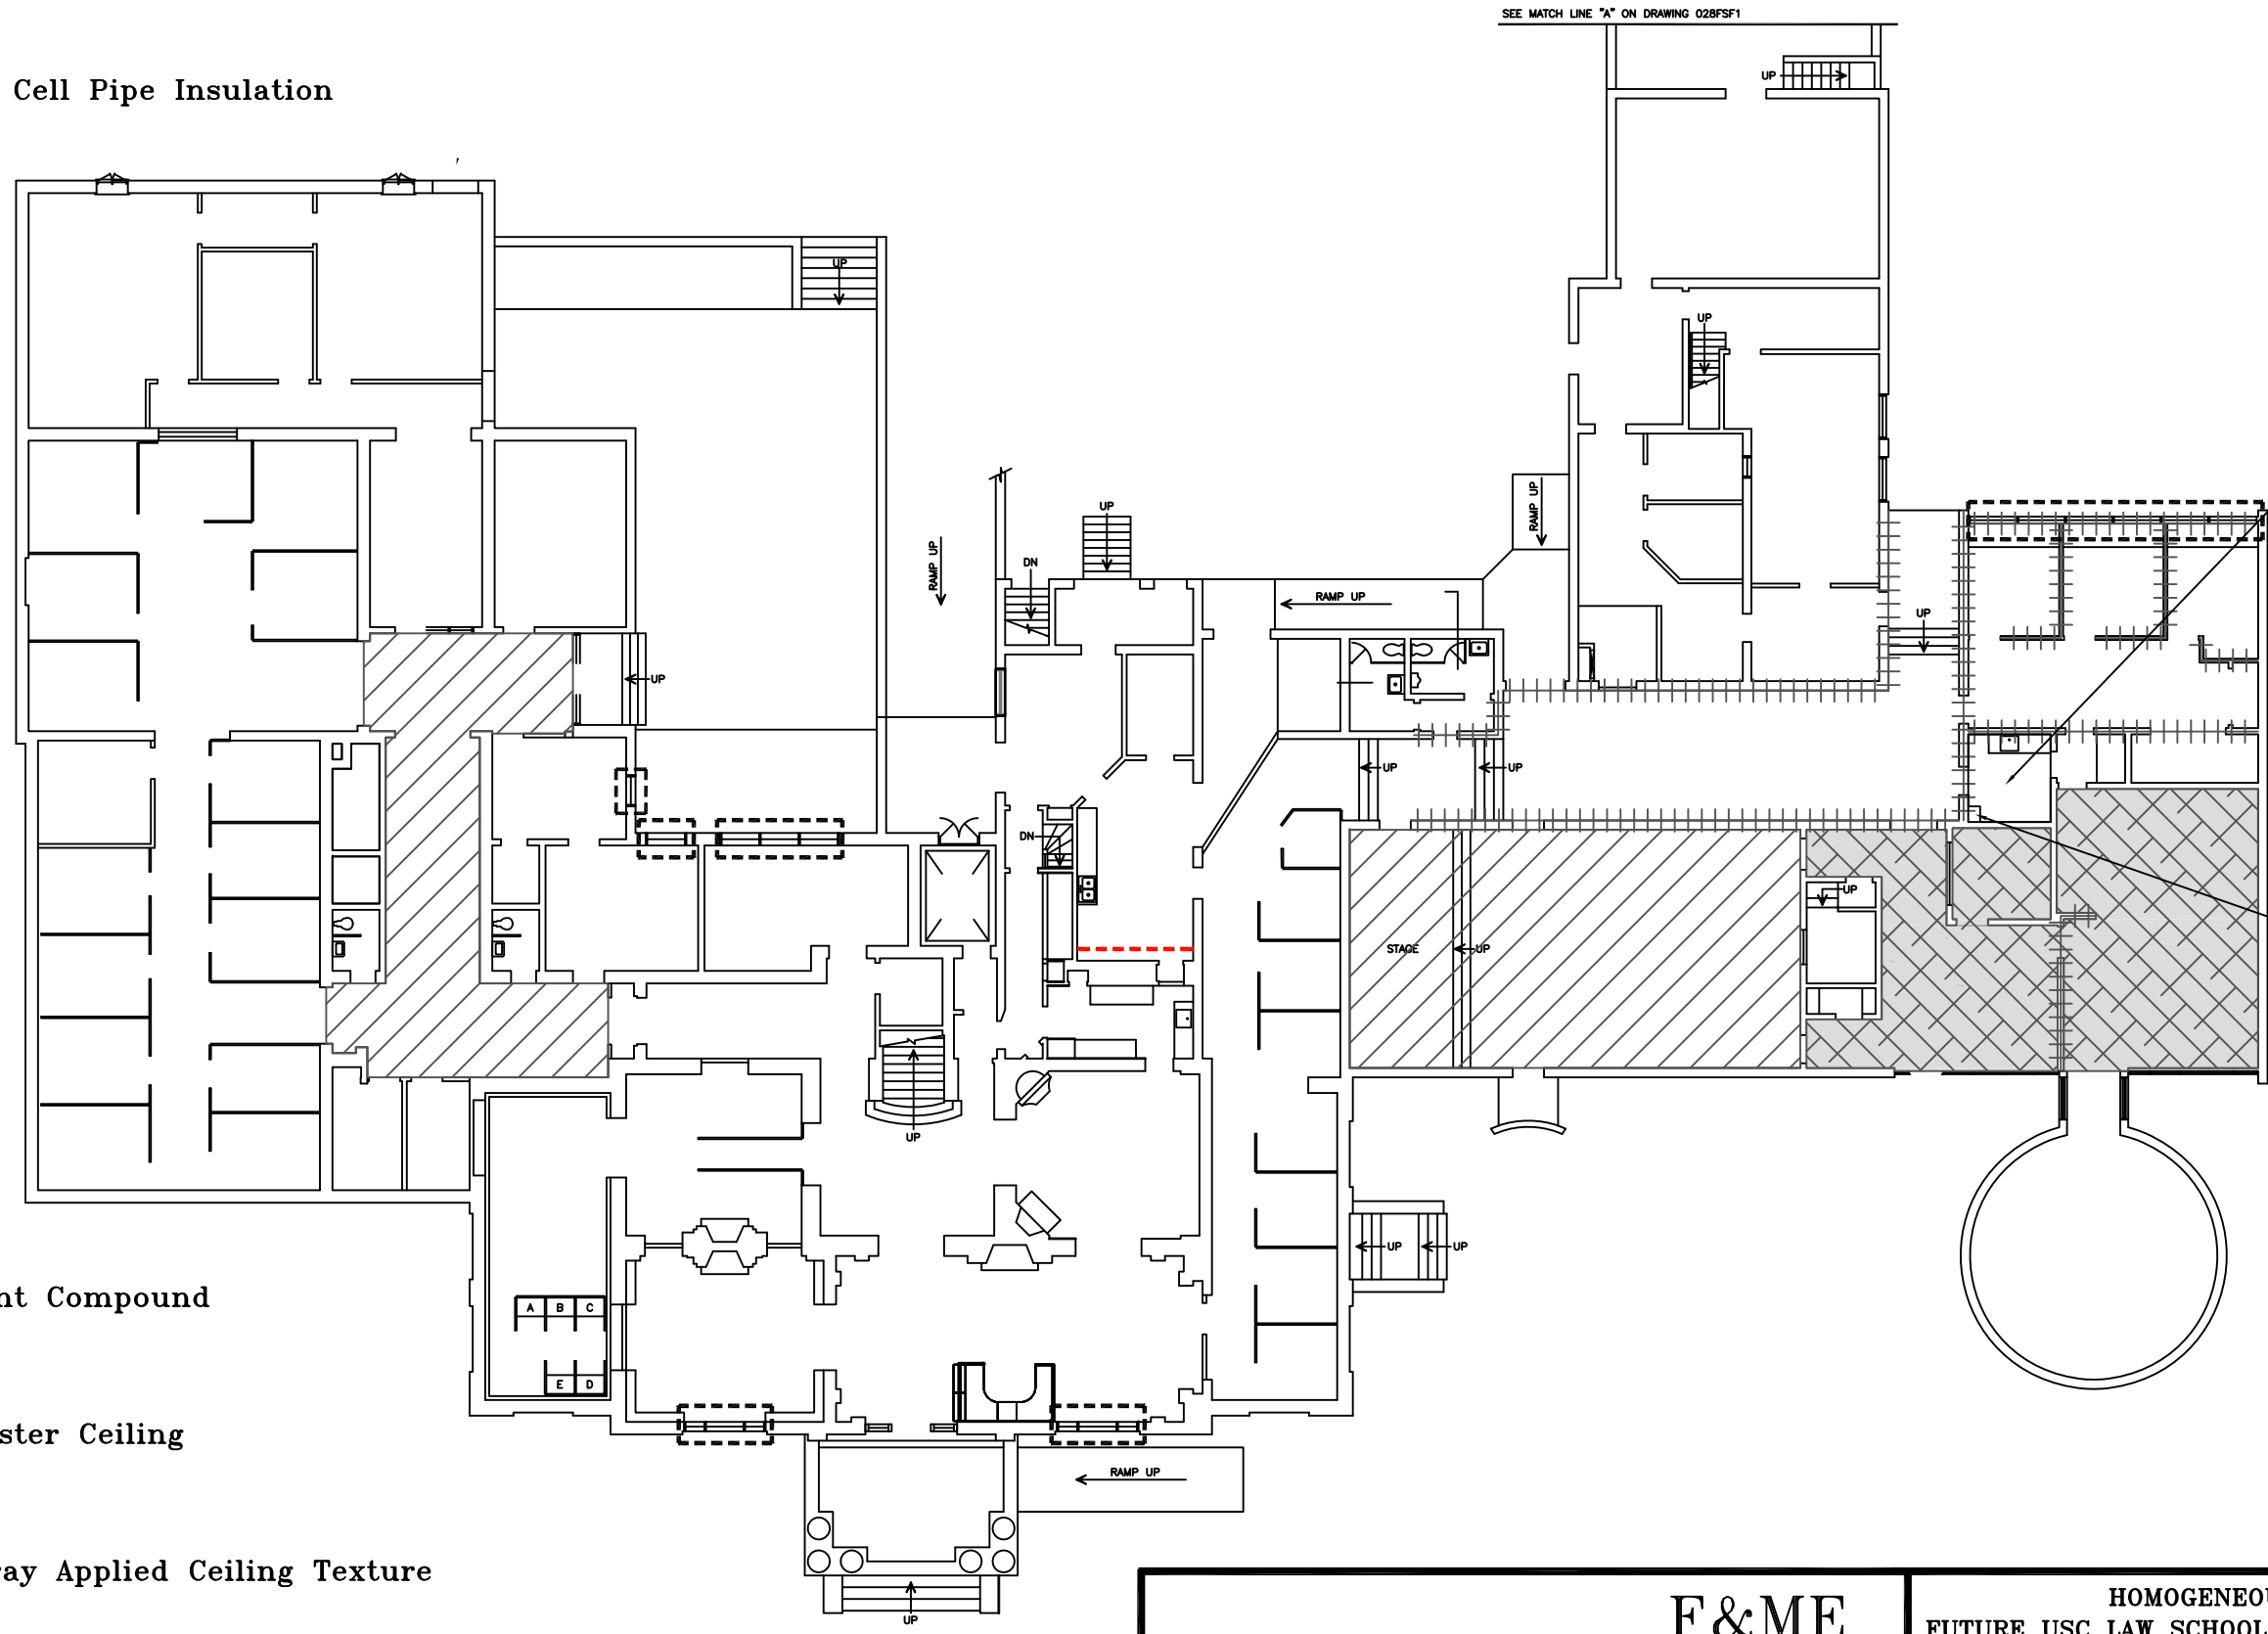
HA-6 Block TSI Pipe Insulation & HA-7 Mudded Elbows are located above ceiling in this room.

HA-6 Block TSI Pipe Insulation & HA-7 Mudded Elbows are located in chase.
