ADDENDUM NUMBER 2
Thursday, May 30, 2019

PROJECT: **UPSTATE-LED Lighting-Palmetto Villas-Unit 6**
UNIVERSITY OF SOUTH CAROLINA
PROJECT NO. FP00000251
LEA PROJECT NO. USC-2019-08

LIMITED ASBESTOS INSPECTION REPORT

LOCATION
Villas Building #6
800 University Way
Spartanburg, SC 29303

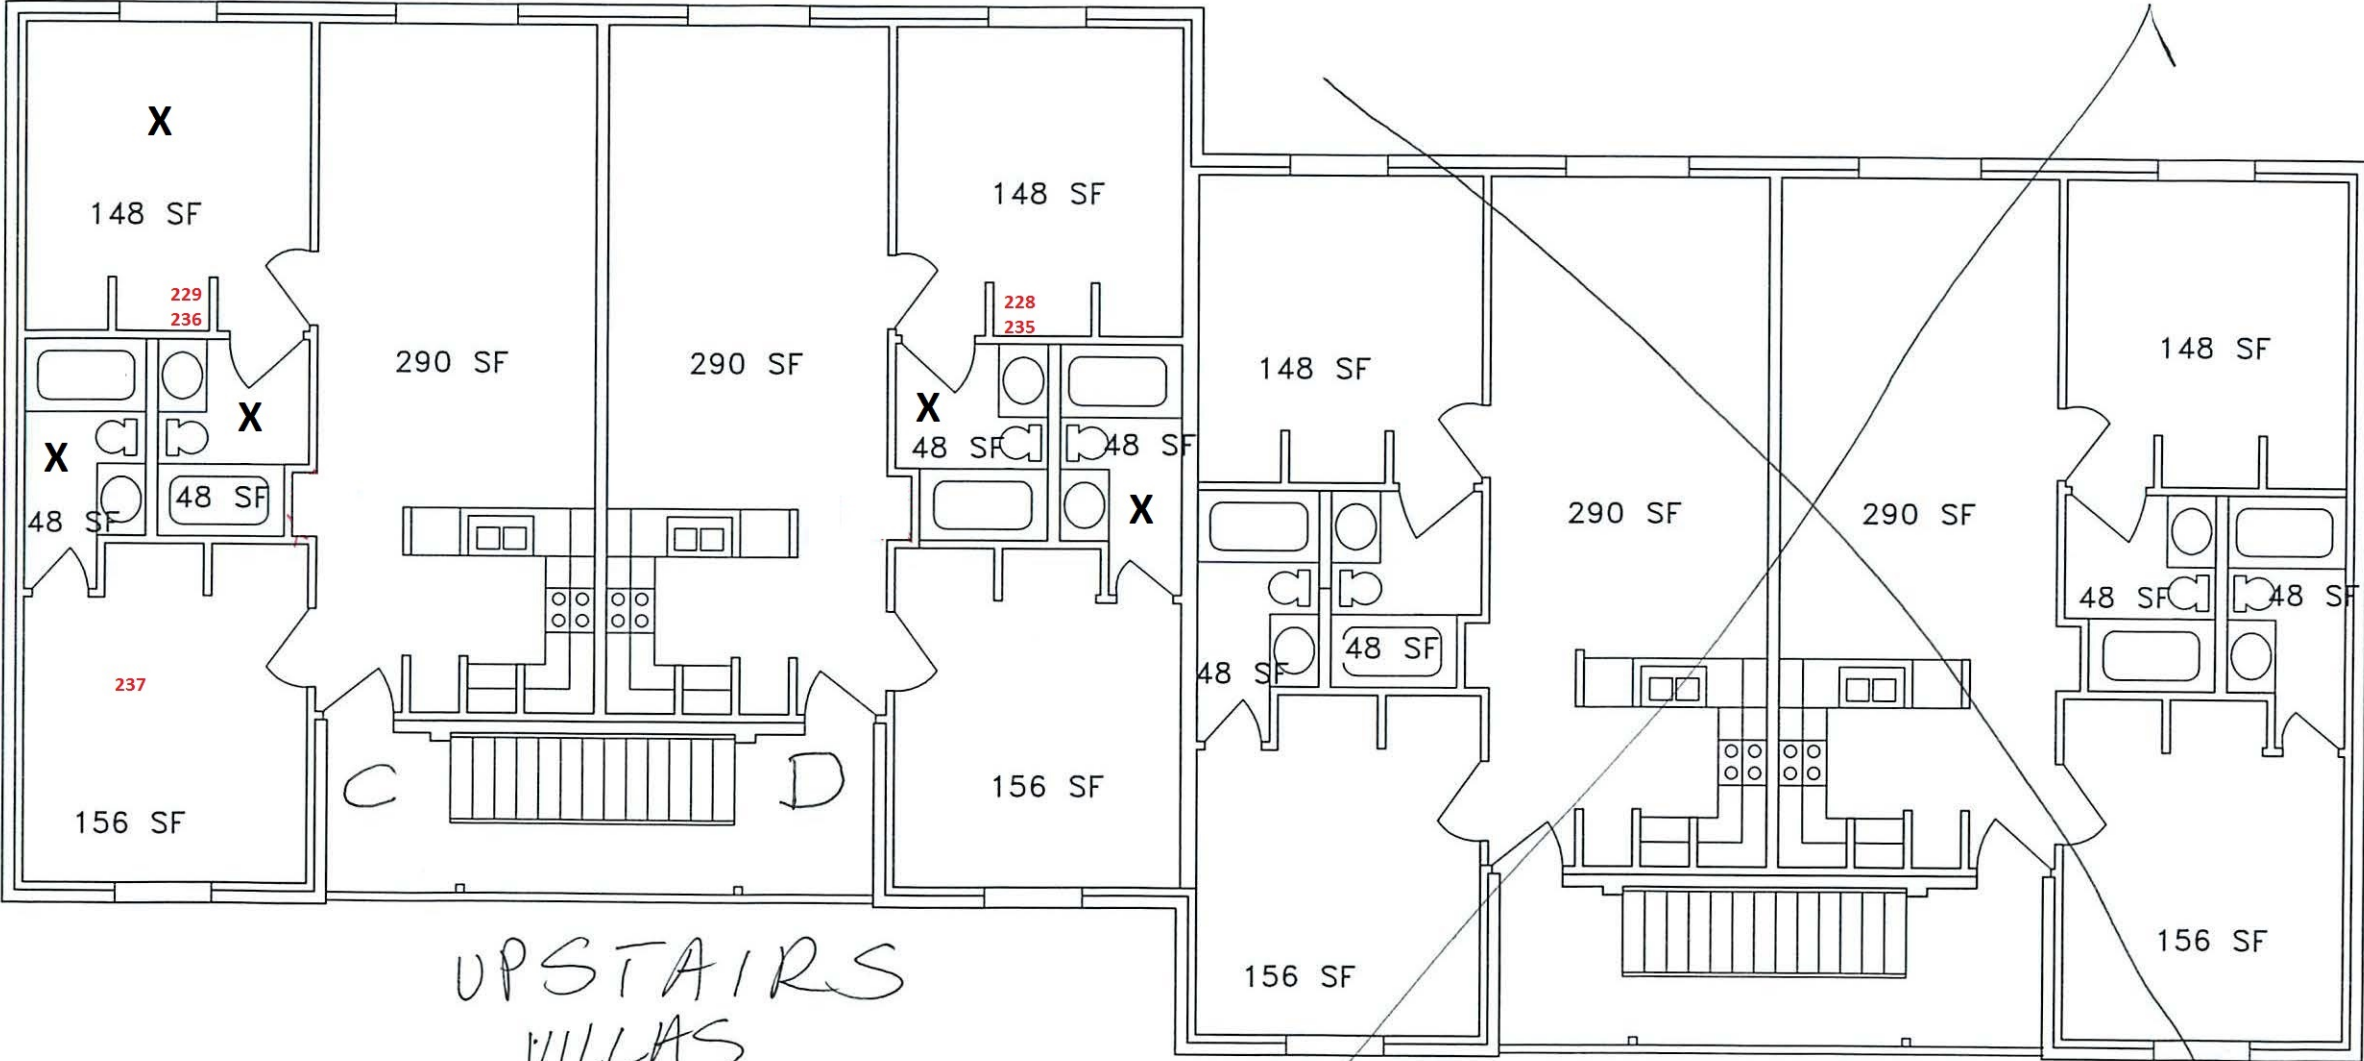
UPSTAIRS
VILLAS
BLDG 6

X= No Ceiling Texture
