March 28, 2019

Re: Asbestos Containing Materials Re-inspection/Report Update
Bates West Residence Hall
1405 Whaley Street
Columbia, South Carolina 29208
F&ME Project No.: E6200.010

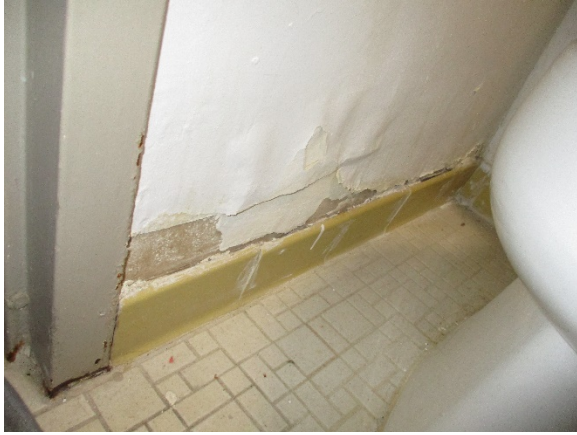
Assessment - During the field investigation, areas were noted with damage to the existing drywall walls in bathrooms found in the dorm rooms. The joint compound associated with the drywall in the building is an ACM and was found in a friable condition in these damaged areas. The drywall damage was found during the walk through in bathrooms 1008, 1101, and 1202. Also, water damage was noted to the ACM spray-applied ceiling texturing in room 1404, which was also noted to be in a friable condition. Additionally, abatement of the spray-applied ceiling texturing was recently completed in room 208 due to a ruptured water line. No other damage to ACM materials were found during this re-inspection.

Photo 1. Damaged ACM Drywall in Room 1008.

Conclusion/Recommendations - Except where noted, all other ACM materials previously listed and identified in the October 2015 investigation appear to remain in the building in the same conditions as previously noted. With the exception of the localized damage to the drywall found in the dorm room bathrooms and the spray-applied ceiling texturing noted in room 1404, no other damage was noted during the field investigation. It is important to note that access to the residence hall rooms was limited to one (1) room per floor and there is a probability that additional damage in other areas may be found where ACM is present. Therefore, it is recommended that USC Facilities, Housing and Hazmat Staff conduct an inventory of bathrooms with damaged drywall and implement an operations and maintenance program (OEM) to clean-up and repair the damaged drywall and texture ceiling materials in locations where damage is found.

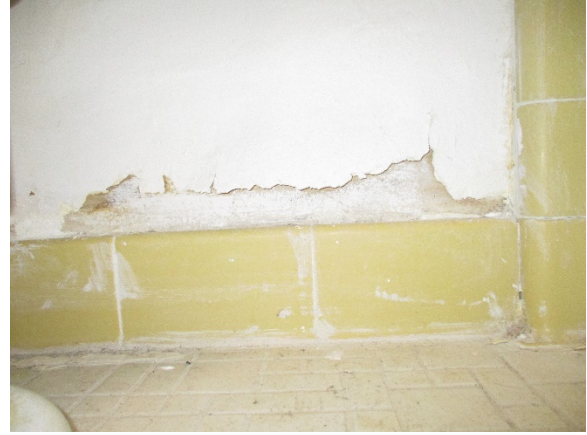
Photo 2. Damaged ACM Drywall in Room 1101.

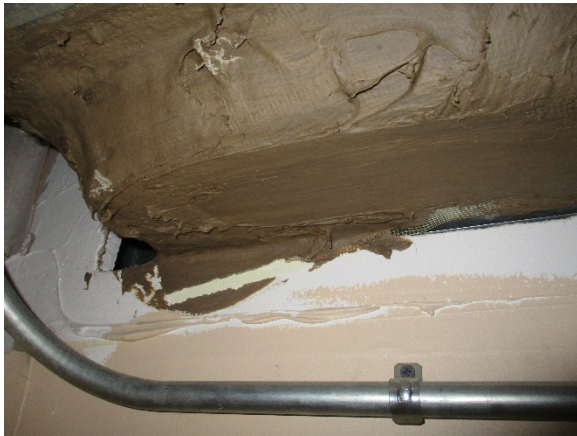
Photo 3. Non-ACM Brown Mastic on Metal Duct.

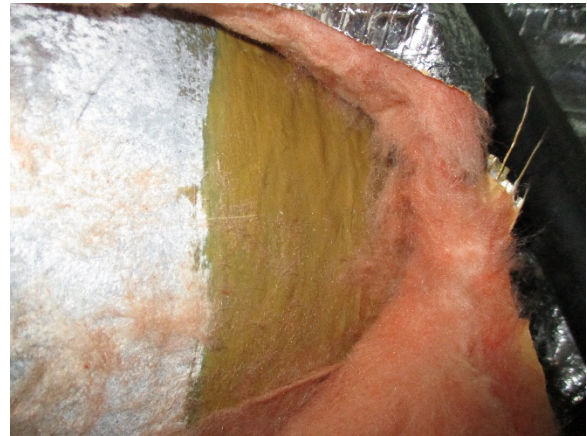
HA-20 – Olive Mastic on Metal Duct (20 SF). Asbestos-containing olive mastic found on the seams of a metal duct in mechanical room 124 under non-ACM fiberglass wrap insulation. This material was found in a good, intact non-friable condition.

Photo 4. ACM Olive Duct Mastic under Fiberglass Insulation in 1st Floor Mechanical Room.

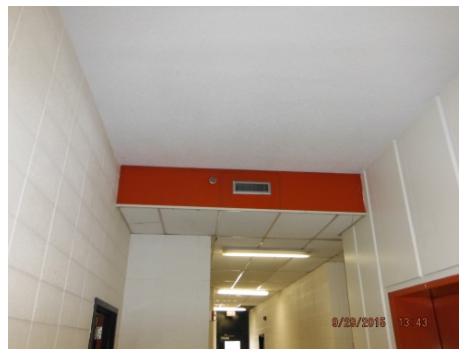
Asbestos-containing spray-applied ceiling texture is located on the ceilings in multiple areas throughout the building. Overall this material is intact with little damage being noted. Overspray was noted above suspended ceilings in the main lobby and office on the second floor. It appeared that an original drywall ceiling in this area was removed and replaced with suspended ceilings during a past renovation. It should be noted that this occurrence would indicate that overspray will be found in all area where textured ceilings are present above hard ceilings, within closed chases and within the interior of wall cavities. During development of abatement design efforts should be taken to identify and address removal of overspray in hidden areas. Prior to demolition activities, this material must be removed and disposed of as ACM by a licensed abatement contractor.

Photo 1. Asbestos-containing spray-applied ceiling texture located in various rooms of the structure.

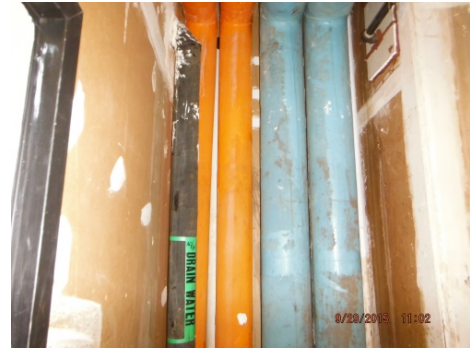
ACM joint compound associated with drywall walls and ceilings is found throughout the building on all floors (see Homogeneous Area Plan). Both the drywall and the ACM joint compound are in an intact and good condition with little damage being noted. Prior to demolition activities, all drywall wall and ceiling systems throughout the building must be removed and disposed of as ACM by a licensed abatement contractor.

Photo 3. Asbestos-containing joint compound associated with drywall ceilings and walls are located in various rooms of the structure.

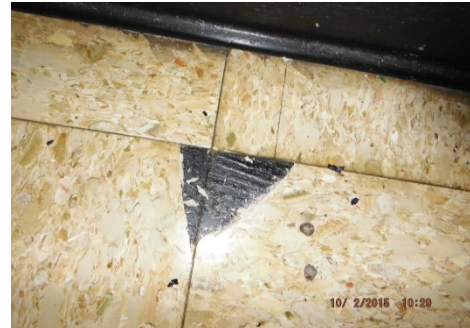
Asbestos-containing ACM tan streaked 12” x 12” floor tile was observed in several locations in the building (see Homogeneous Area Plan). Where observed these materials were noted to be intact and in a good non-friable condition. Prior to demolition activities, this material must be removed and disposed of as ACM by a licensed abatement contractor.

Photo 4. Asbestos-containing tan streaked 12” x 12” floor tile and associated mastic was observed in numerous locations throughout the building.

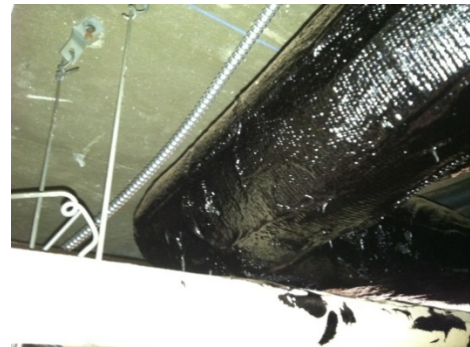
Asbestos-containing black mastic associated with cellular foam glass pipe insulation was observed throughout the building (see Homogeneous Area Plan). Where observed this material was noted to be in good condition. Prior to demolition activities, this material must be removed and disposed of as ACM by a licensed abatement contractor. It should be noted that abatement of ACM black mastic will require disposal of foam glass as ACM. Residual black mastic on piping should be anticipated.

Photo 5. Asbestos-containing black mastic associated with black foam glass pipe insulation was observed in various locations throughout the building.

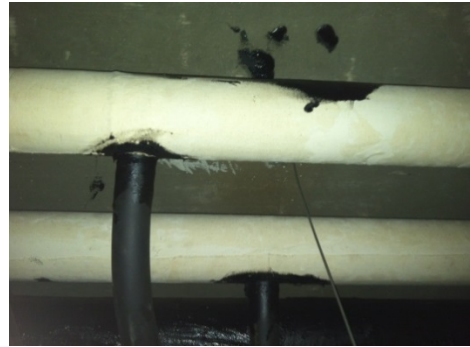
ACM white block pipe insulation was observed in numerous locations throughout the building (see Homogeneous Area Plan). This material was found in wall and floor penetrations in all mechanical rooms on all floors. This material will be found and anticipated in closed chases and wall cavities throughout the building. Where observed this material was noted to be mostly in an intact condition. However, exposed unwrapped ends with some localized damage were noted in mechanical rooms where previous abatement had terminated and was friable. Prior to demolition activities, this material must be removed and disposed of as ACM by a licensed abatement contractor.

Photo 6. Asbestos-containing white block pipe insulation was observed in various locations throughout the building.

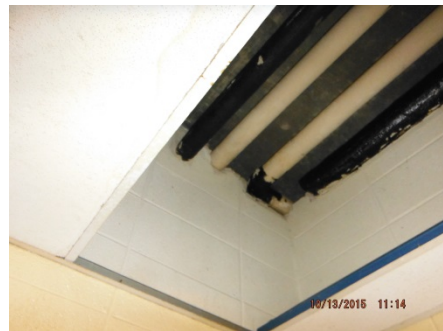
Asbestos-containing black mastic on fittings associated with fiberglass pipe insulation was observed throughout the building (see Homogeneous Area Plan). Where observed this material was noted to be in good non-friable condition. Prior to demolition activities, this material must be removed and disposed of as ACM by a licensed abatement contractor.

Photo 7. Asbestos-containing black mastic on fiberglass elbows was observed throughout the building.

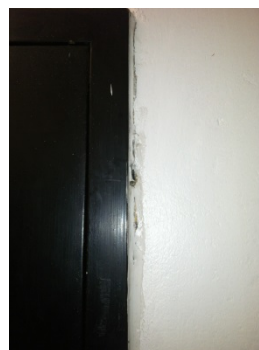
ACM door caulking was noted on all stairwell doors on all floors of the building (see Homogeneous Area Plan). Where observed this material was noted to be in good non-friable condition. Prior to demolition activities, this material must be removed and disposed of as ACM by a licensed abatement contractor.

Photo 8. Asbestos-containing interior door caulking. All stairwell doors throughout the building.

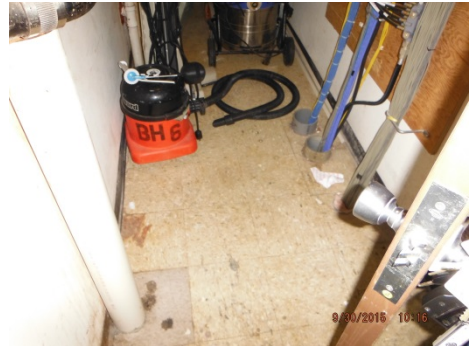
Asbestos-containing tan with brown streaks 12” x 12” floor tiles and associated mastic was observed in numerous locations throughout the building (see Homogeneous Area Plan). Where observed these materials were noted to be in good non-friable condition. Prior to demolition activities, this material must be removed and disposed of as ACM by a licensed abatement contractor.

Photo 10. . Asbestos-containing tan with brown streaks 12” x 12” floor tile and associated mastic were observed in numerous locations throughout the building.

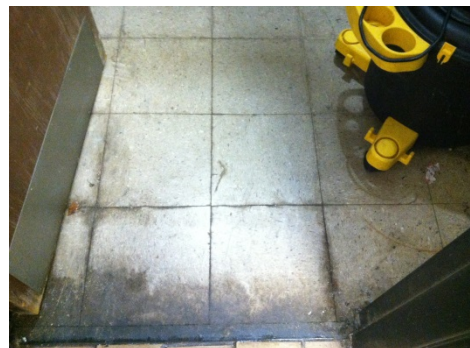
Asbestos-containing light tan streaked 12” x12” floor tile and associated mastic were observed in numerous locations throughout the building (see Homogeneous Area Plan). Overall, this material was in an intact non-friable condition, but showed evidence of wear and deterioration from age. Prior to demolition activities, this material must be removed and disposed of as ACM by a licensed abatement contractor.

Photo 11. ACM light tan 12” x12” floor tile and associated mastic was observed in numerous locations throughout the building.

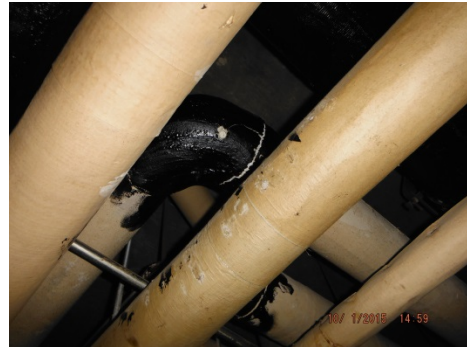
Asbestos-containing black mastic on cementitious elbows was observed throughout the building (see Homogeneous Area Plans). Where observed this material was noted to be in a good non-friable condition. It should be noted that removal of this black mastic along with the cementitious mudded elbows will require friable abatement methods. Prior to demolition activities, this material must be removed and disposed of as ACM by a licensed abatement contractor.

Photo 12. Asbestos-containing black mastic associated with the seams of foam glass TSI was observed throughout the building.

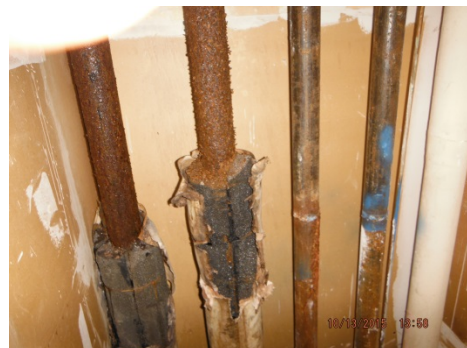
ACM black mastic was noted on seams of cellular foam glass pipe insulation. This material was utilized to hold foam glass form fitted sections together during the insulation of hot and chilled water lines. This material was observed above suspended ceilings and in mechanical rooms throughout the building (see Homogeneous Area Plan). It should be noted that separation of this material from the foam glass may not be cost effective. Therefore, removal and disposal of the foam glass as ACM should be anticipated in the abatement design. Where observed this material was in an intact non-friable condition. Prior to demolition activities, this material must be removed and disposed of as ACM by a licensed abatement contractor.

Photo 13. Asbestos-containing black mastic associated with the seams of foam glass TSI was observed throughout the building.

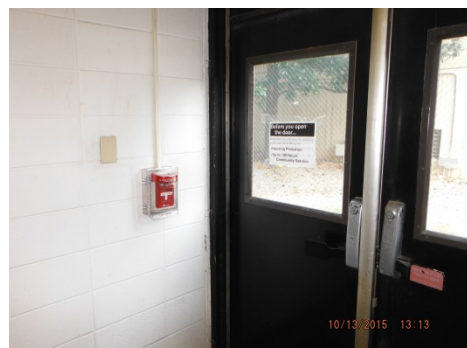
Asbestos-containing interior door caulking was observed on the first floor level associated with the side exit doors (see Homogeneous Area Plans). Where observed this material was noted to be in good intact non-friable condition. Prior to demolition activities, this material must be removed and disposed of as ACM by a licensed abatement contractor.

Photo 14. Asbestos-containing white interior door caulking was observed to be associated with the first floor exit doors.

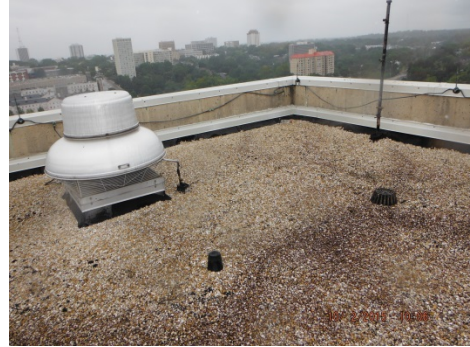
Built-up roofing materials associated with the main roof and penthouse structure were not sampled during this investigation due to the schedule. Therefore, for the purposes of this report all roofing materials are assumed positive for asbestos content. Samples of roofing materials should be collect during additional investigations or during design development phases of the project. Where observed this material was noted to be in good intact non-friable condition. Prior to demolition activities, this material must be sampled for asbestos content.

Photo 15. Black built-up roofing felt was observed on the main roof level as well as the elevator machine rooftop level.

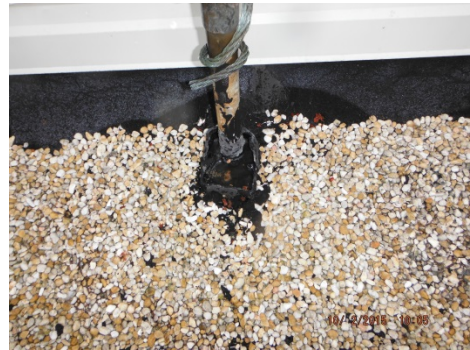
Black rolled-on roof flashing was observed along the perimeter and along the base of the elevator machine room on the main roof level. (see Homogeneous Area Plans). Where observed this material was noted to be in good intact non-friable condition. For the purposes of this report this material is assumed positive for asbestos content. Prior to demolition activities, this material must be sampled for asbestos content.

Photo 16 Black rolled-on roof flashing was observed along the perimeter and along the base of the elevator machine room on the main roof level.

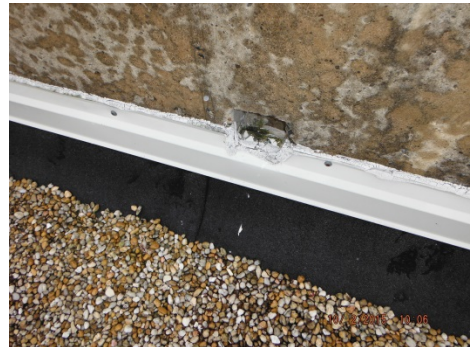
White caulking was observed to be associated with the perimeter counterflashing at top of all flashing found on both the main roof and the penthouse roof (see Homogeneous Area Plans). Where observed this material was noted to be in an intact non-friable condition. For the purposes of this report this material is assumed positive for asbestos content. Prior to demolition activities, this material must be sampled for asbestos content.

Photo 17. White roof cap caulking was observed to be associated with the perimeter of all roof levels.

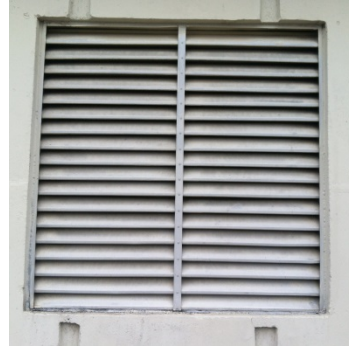
- HA-17 – Gray Louver Caulking (Assumed) (~25 L.F.)
Gray louver window caulking was observed on the side of the elevator machine room on the main roof level (see Homogeneous Area Plans). Where observed this material was noted to be in good intact non-friable condition. For the purposes of this report this material is assumed positive for asbestos content. Prior to demolition activities, this material must be sampled for asbestos content.

Photo 18. Gray louver caulking was observed on the side of the elevator machine room on the main roof level.

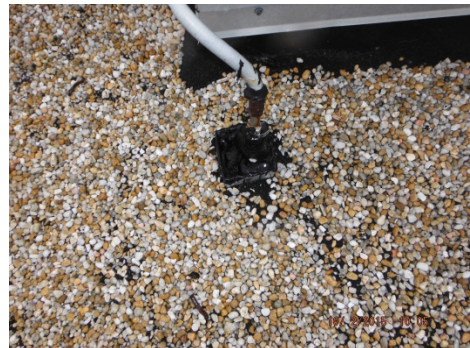
- HA-18 – Black Roof Mastic Associated with Roof Penetrations (Assumed) (~250 S.F.)
Black roof mastic associated with all roof penetrations was observed on the main roof level. (see Homogeneous Area Plans). Where observed this material was noted to be in good intact non-friable condition. For the purposes of this report this material is assumed positive for asbestos content. Prior to demolition activities, this material must be sampled for asbestos content.

Photo 20. Black roof mastic associated with all roof penetrations on main roof level.

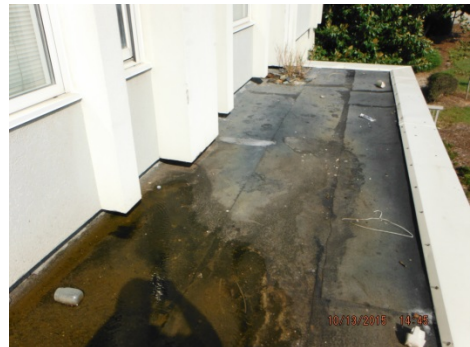
- HA-19 – Black Rolled-on Roofing Felt (Assumed) (~300 S.F.)
Black rolled-on roofing felt was observed to be associated with the front overhang roofing system (see Homogeneous Area Plan). Where observed this material was observed to be in good condition. For the purposes of this report this material is assumed positive for asbestos content. Prior to demolition activities, this material must be sampled for asbestos content.

Photo 21. Black rolled-On roofing felt was observed to be associated with the front overhang roofing system.
