Report of Eddy Current Inspection

Manufacturer: McQuay

Model: WMC145SB

Location: UNIVERSITY OF SOUTH CAROLINA
CAMPUS LIFE BUILDING
SPARTANBURG, SC 29301

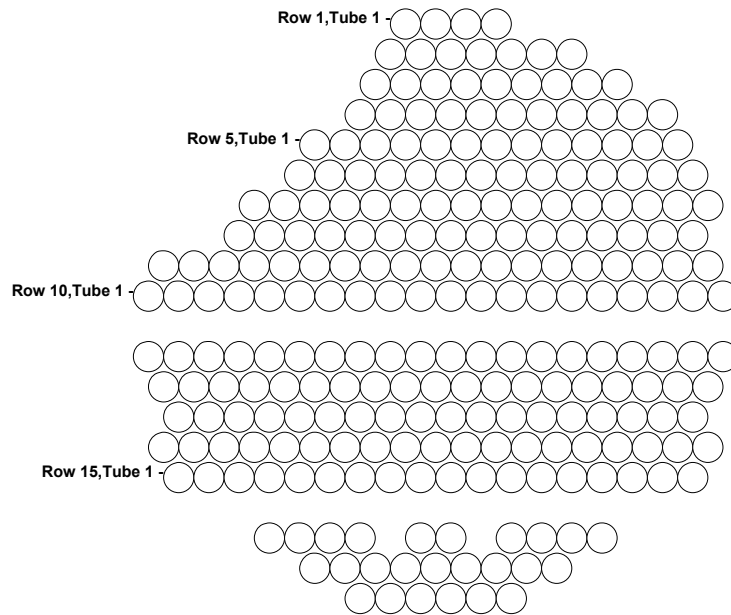
Condenser Section

No Significant defects were found.

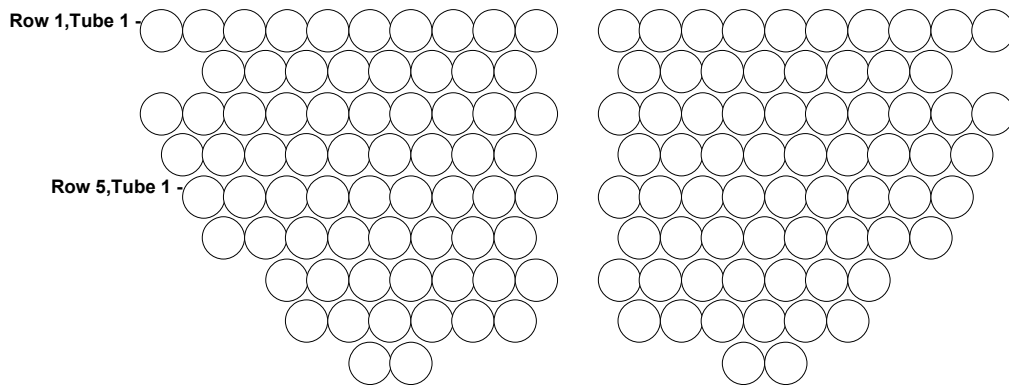
Evaporator Section

No Significant defects were found.

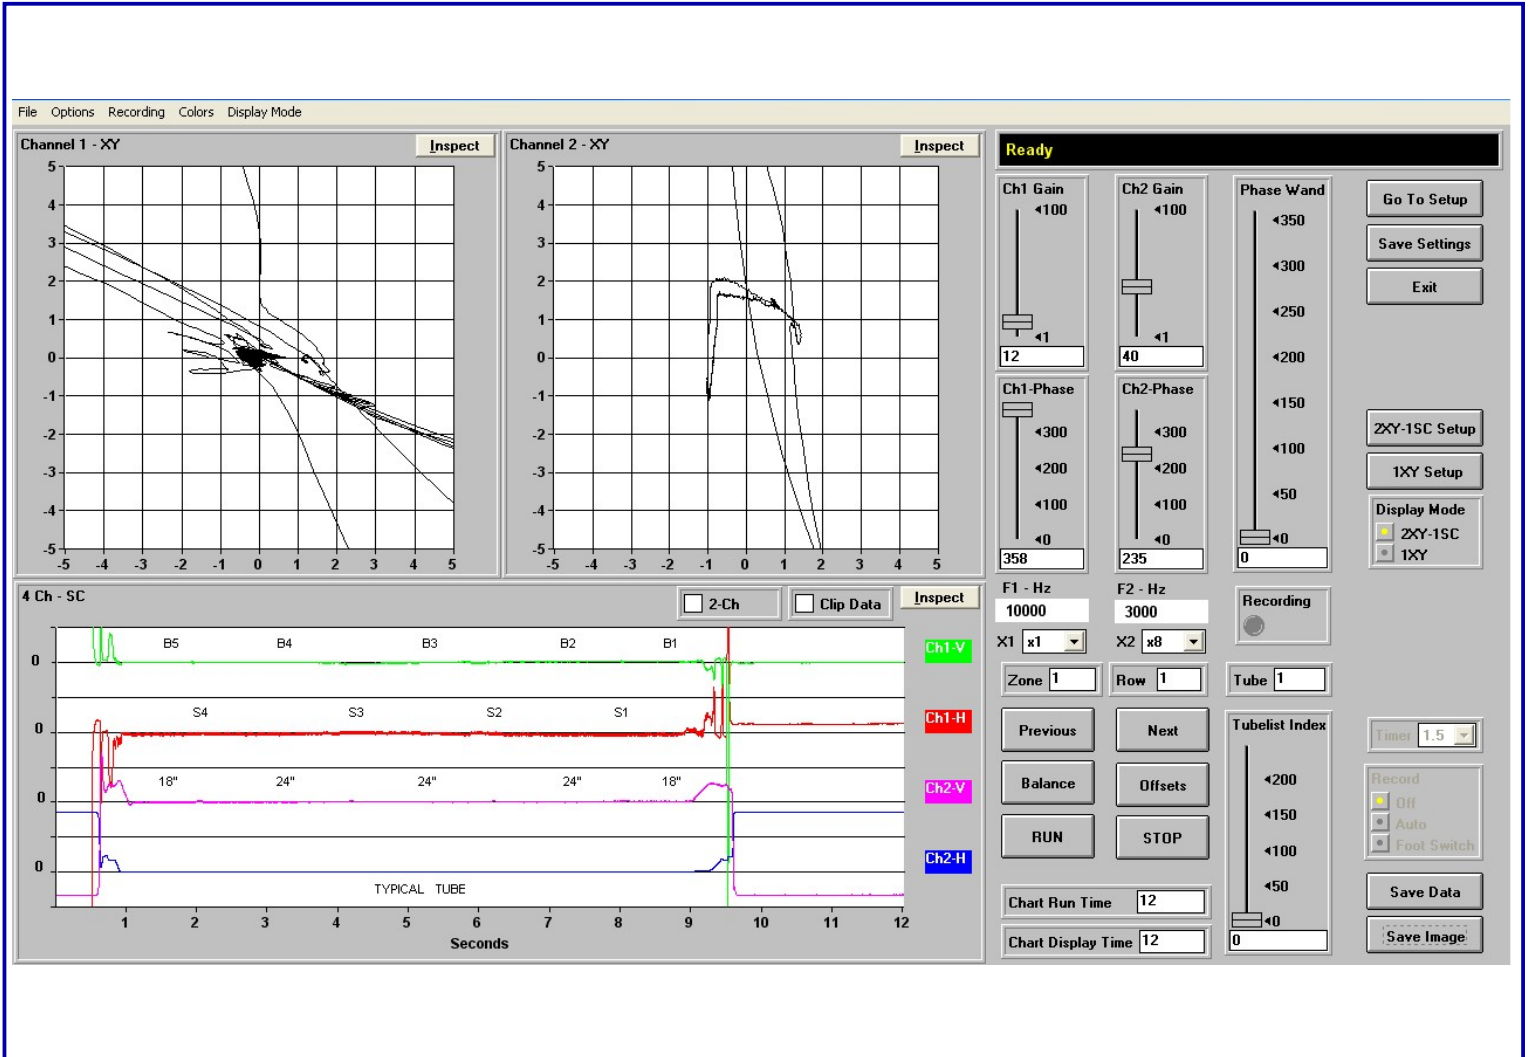
Condenser Section

NO SIGNIFICANT DEFECTS (Row 1 Tube 1)

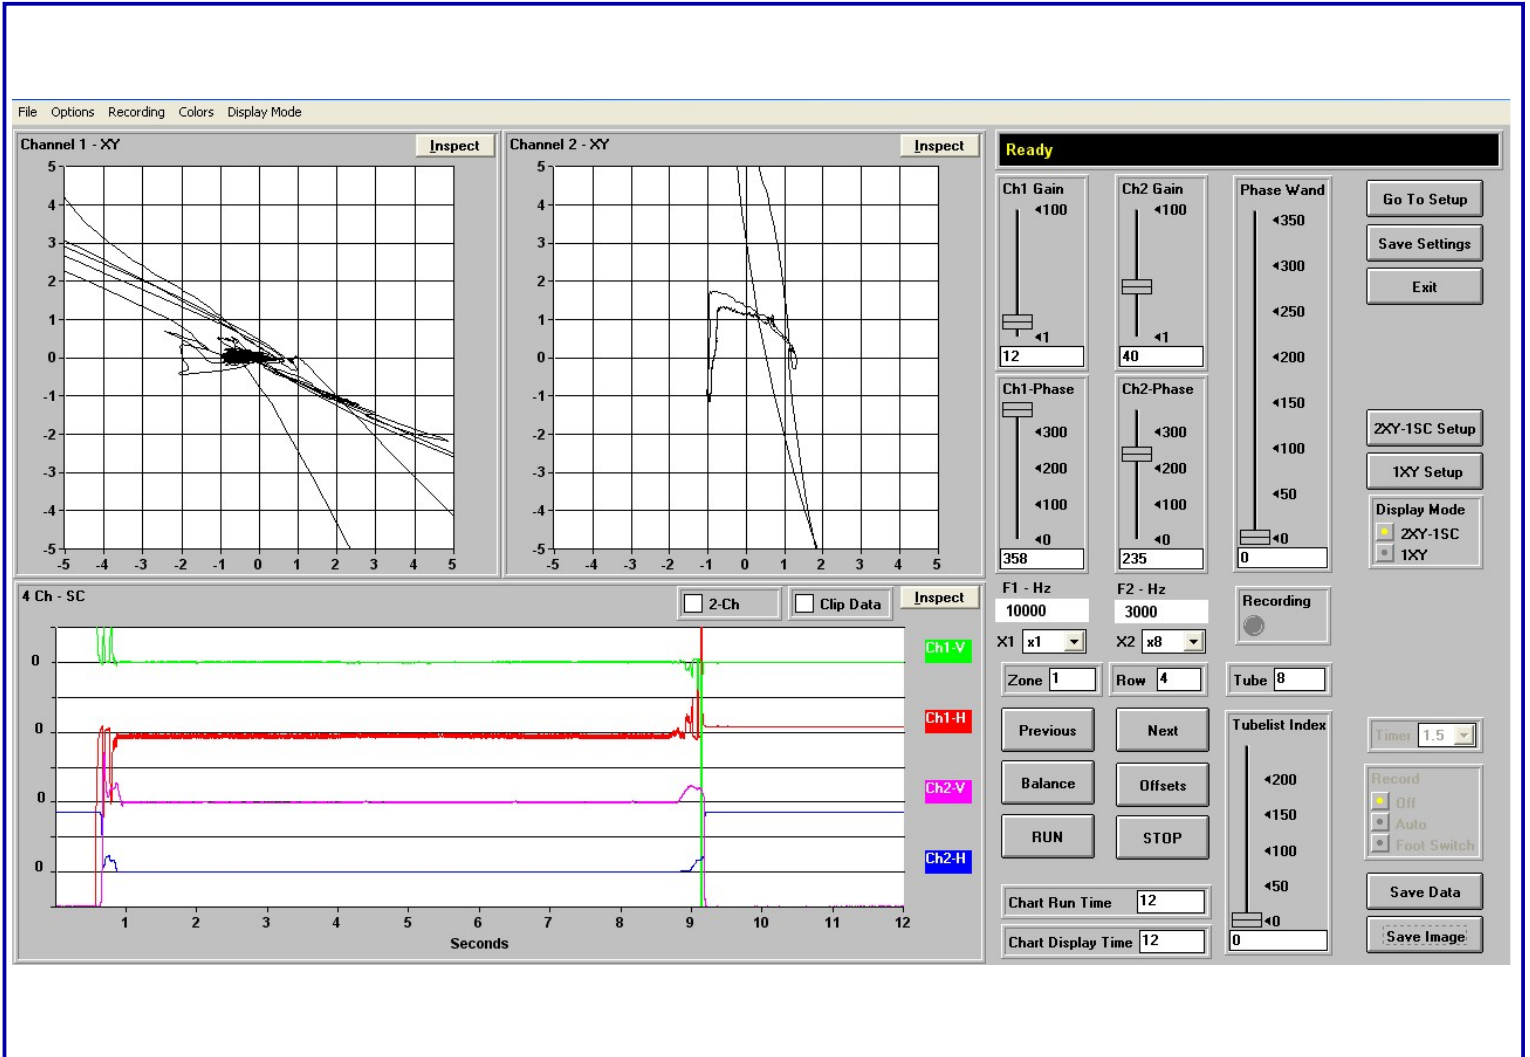
Condenser Section

NO SIGNIFICANT DEFECTS (Row 4 Tube 8)

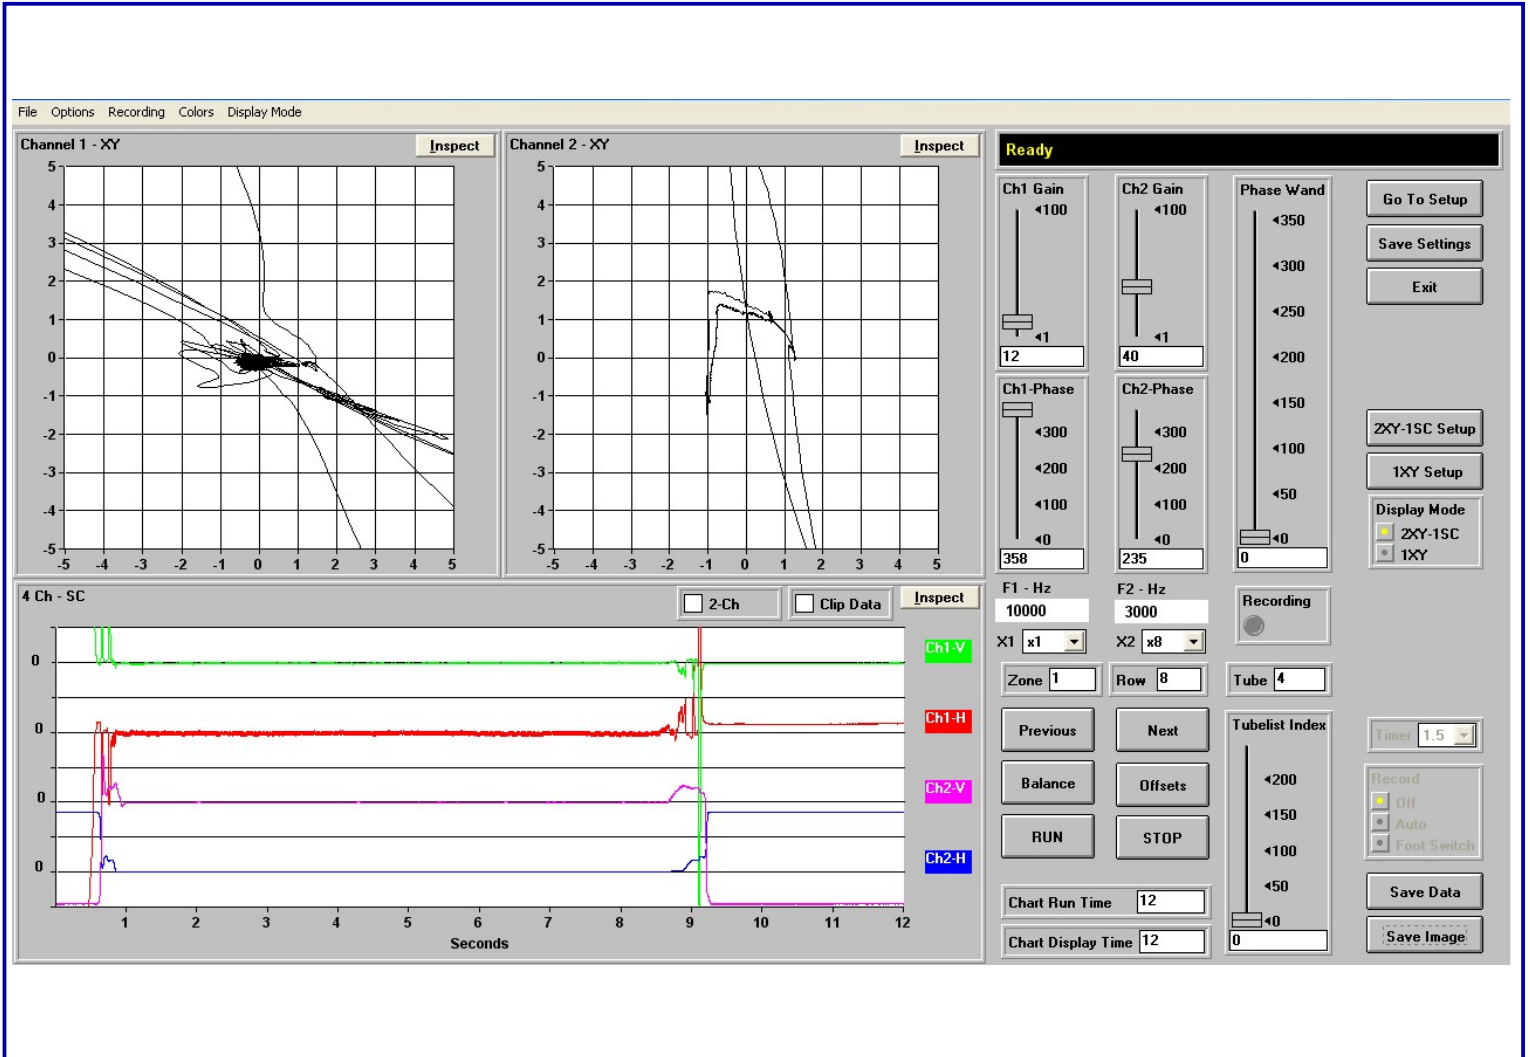
Condenser Section

NO SIGNIFICANT DEFECTS (Row 8 Tube 4)

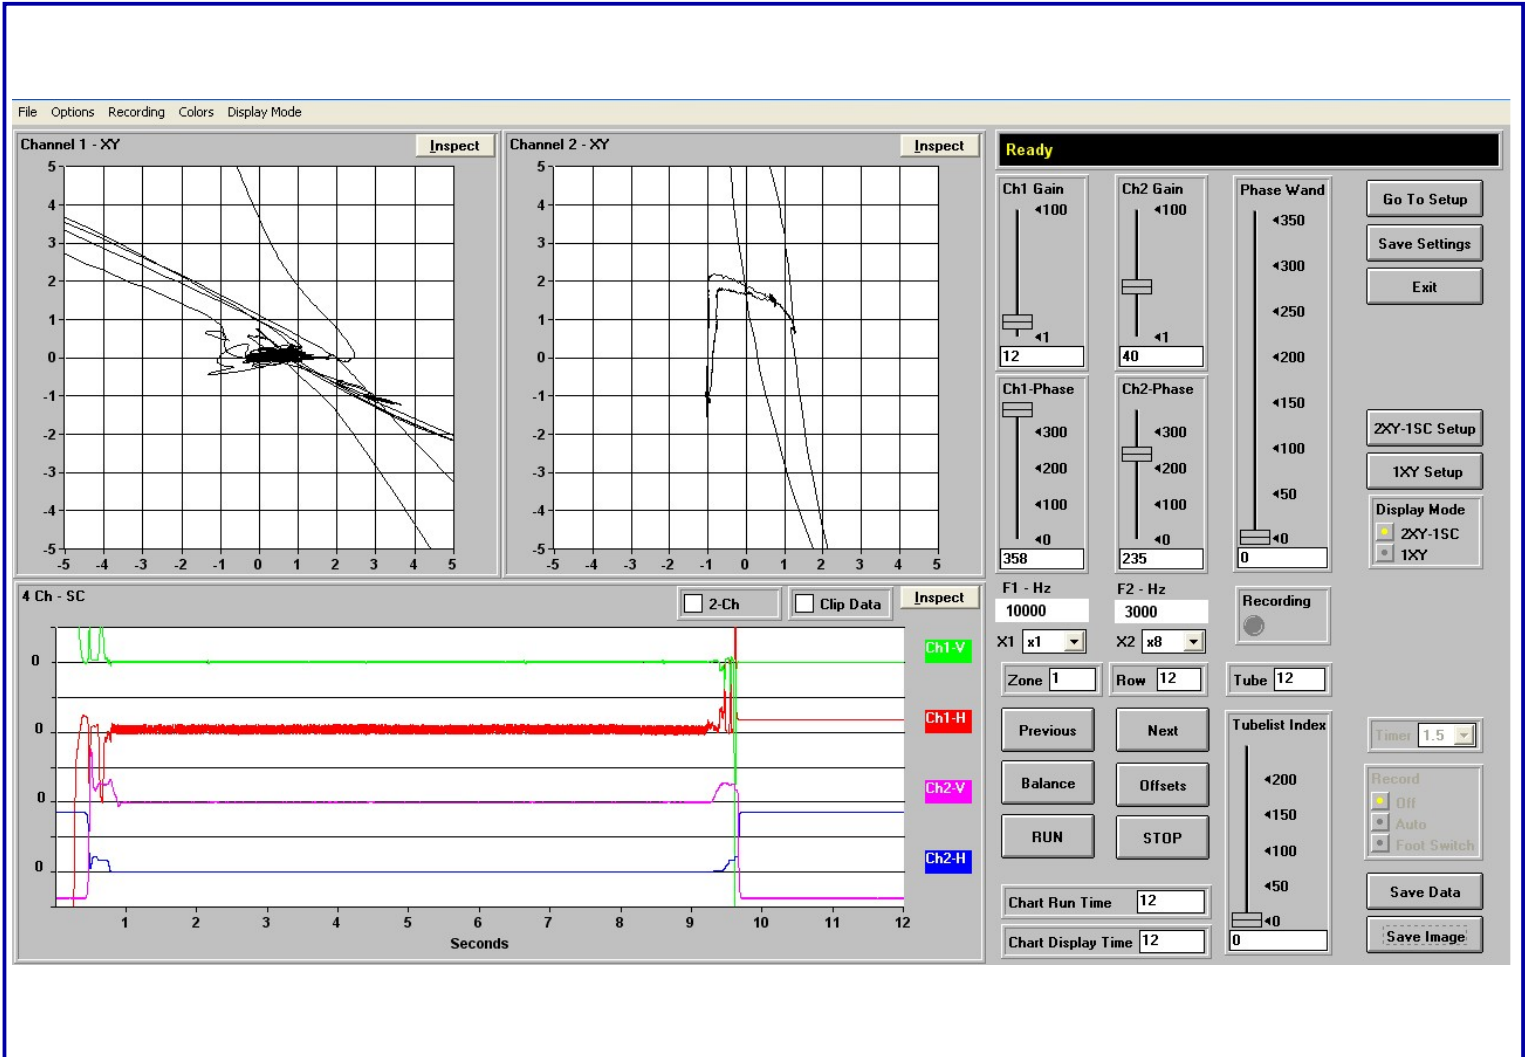
Condenser Section

NO SIGNIFICANT DEFECTS (Row 12 Tube 12)

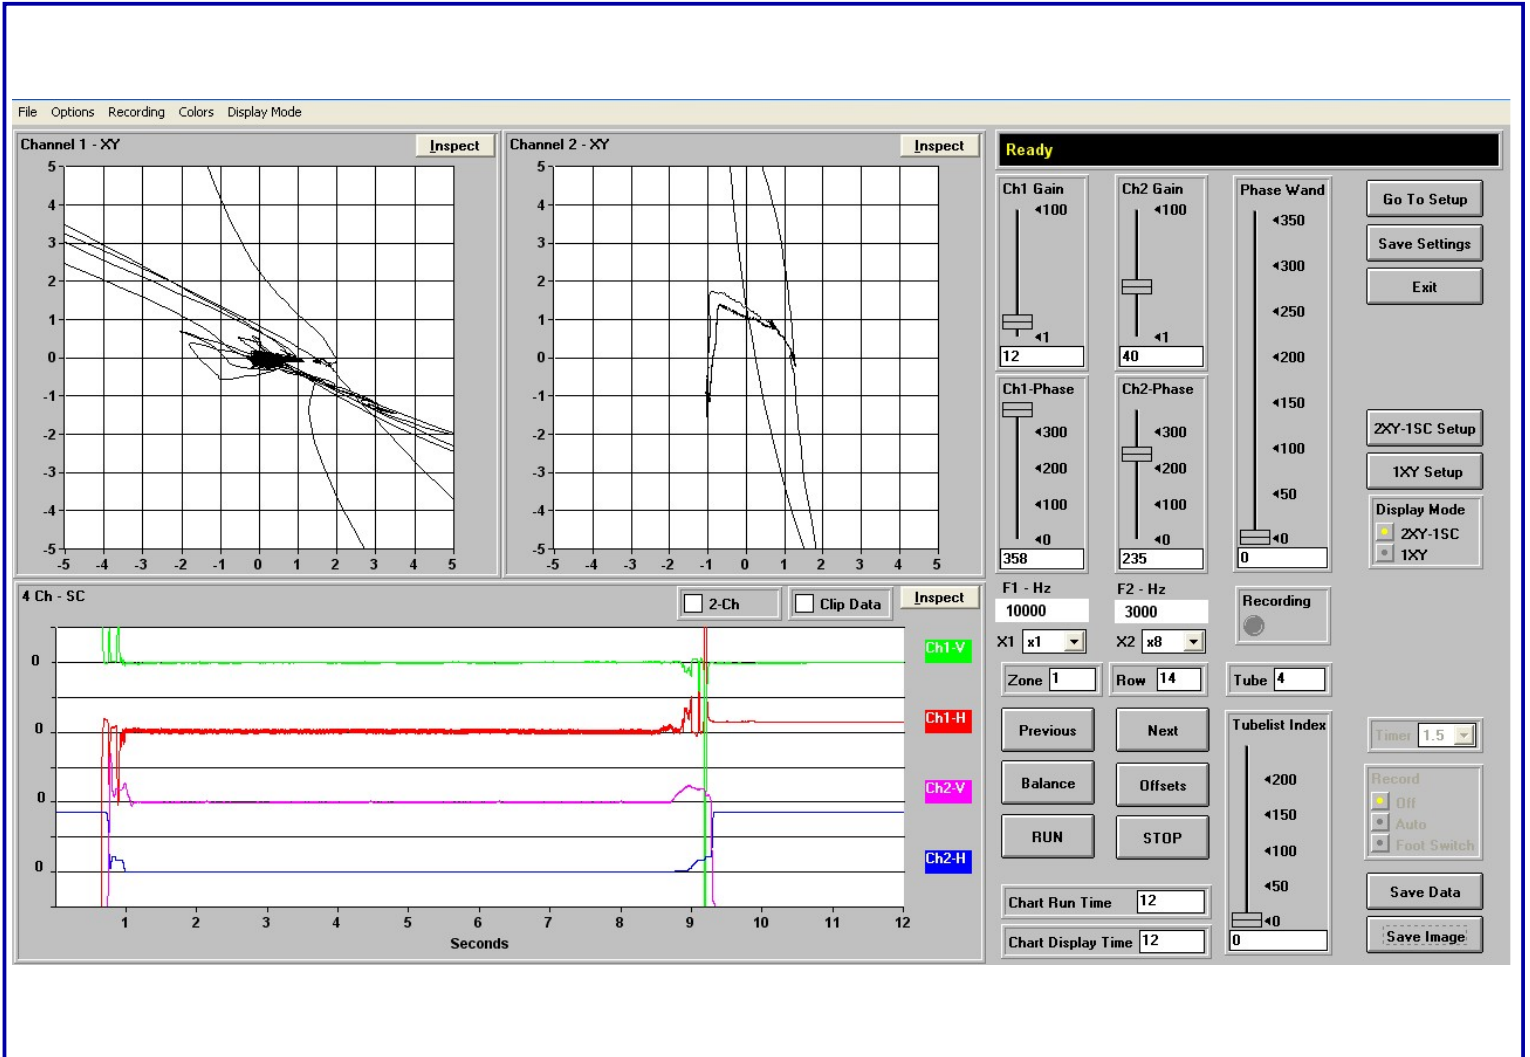
Condenser Section

NO SIGNIFICANT DEFECTS (Row 14 Tube 4)

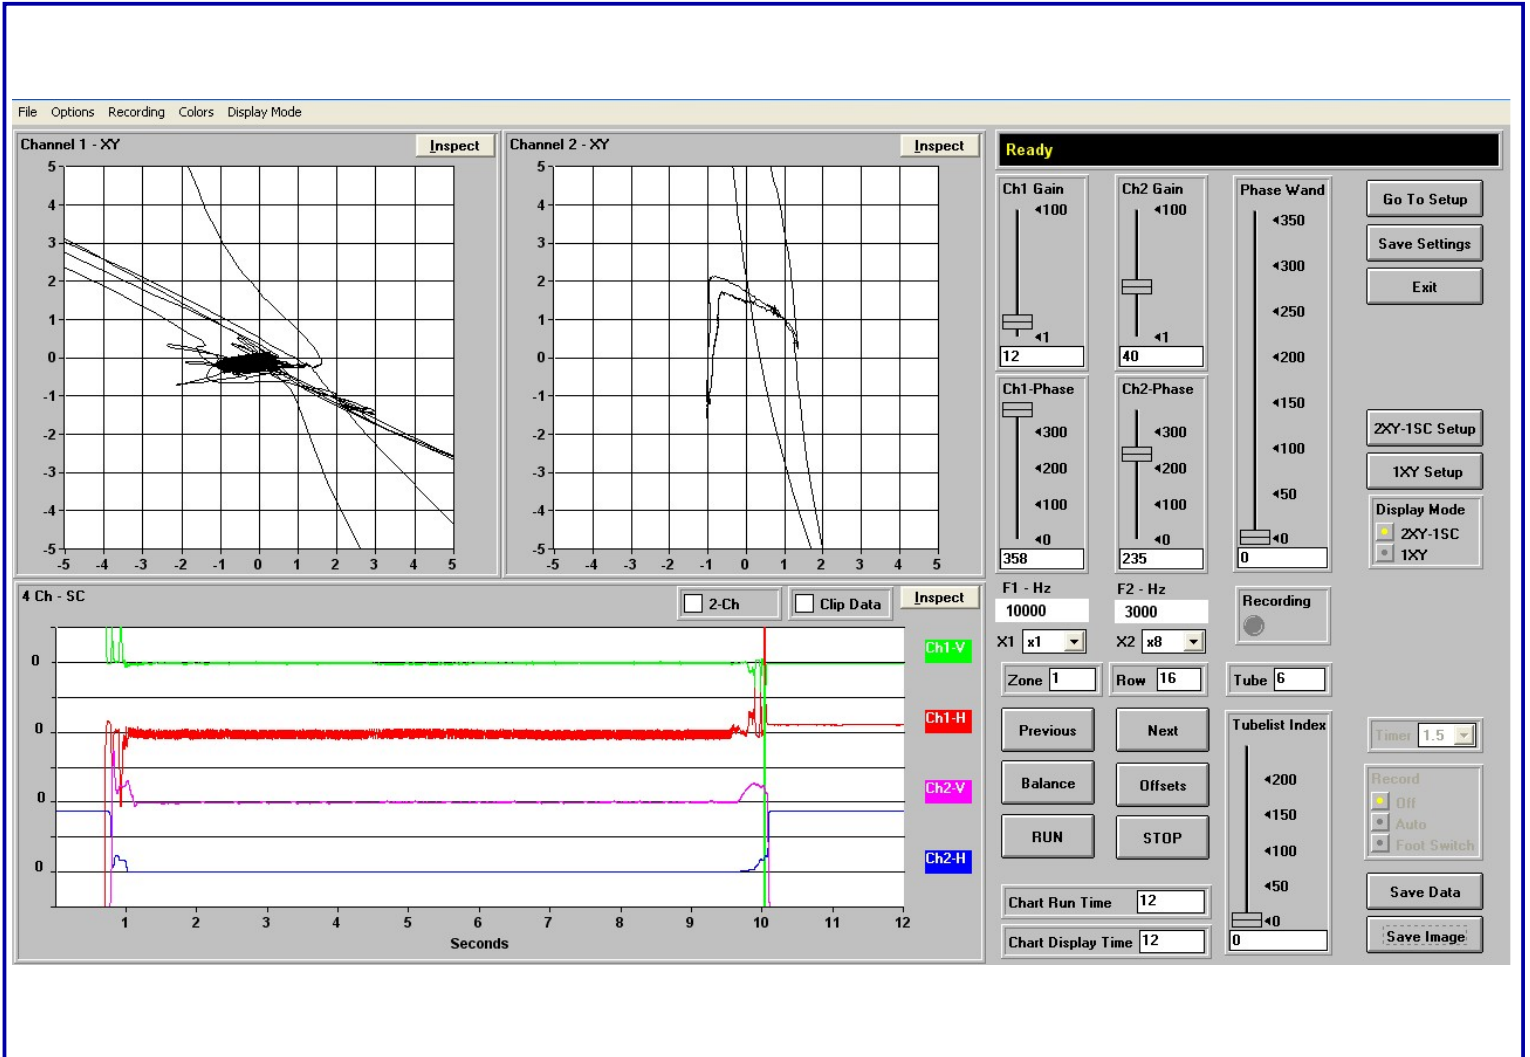
Condenser Section

NO SIGNIFICANT DEFECTS (Row 16 Tube 6)

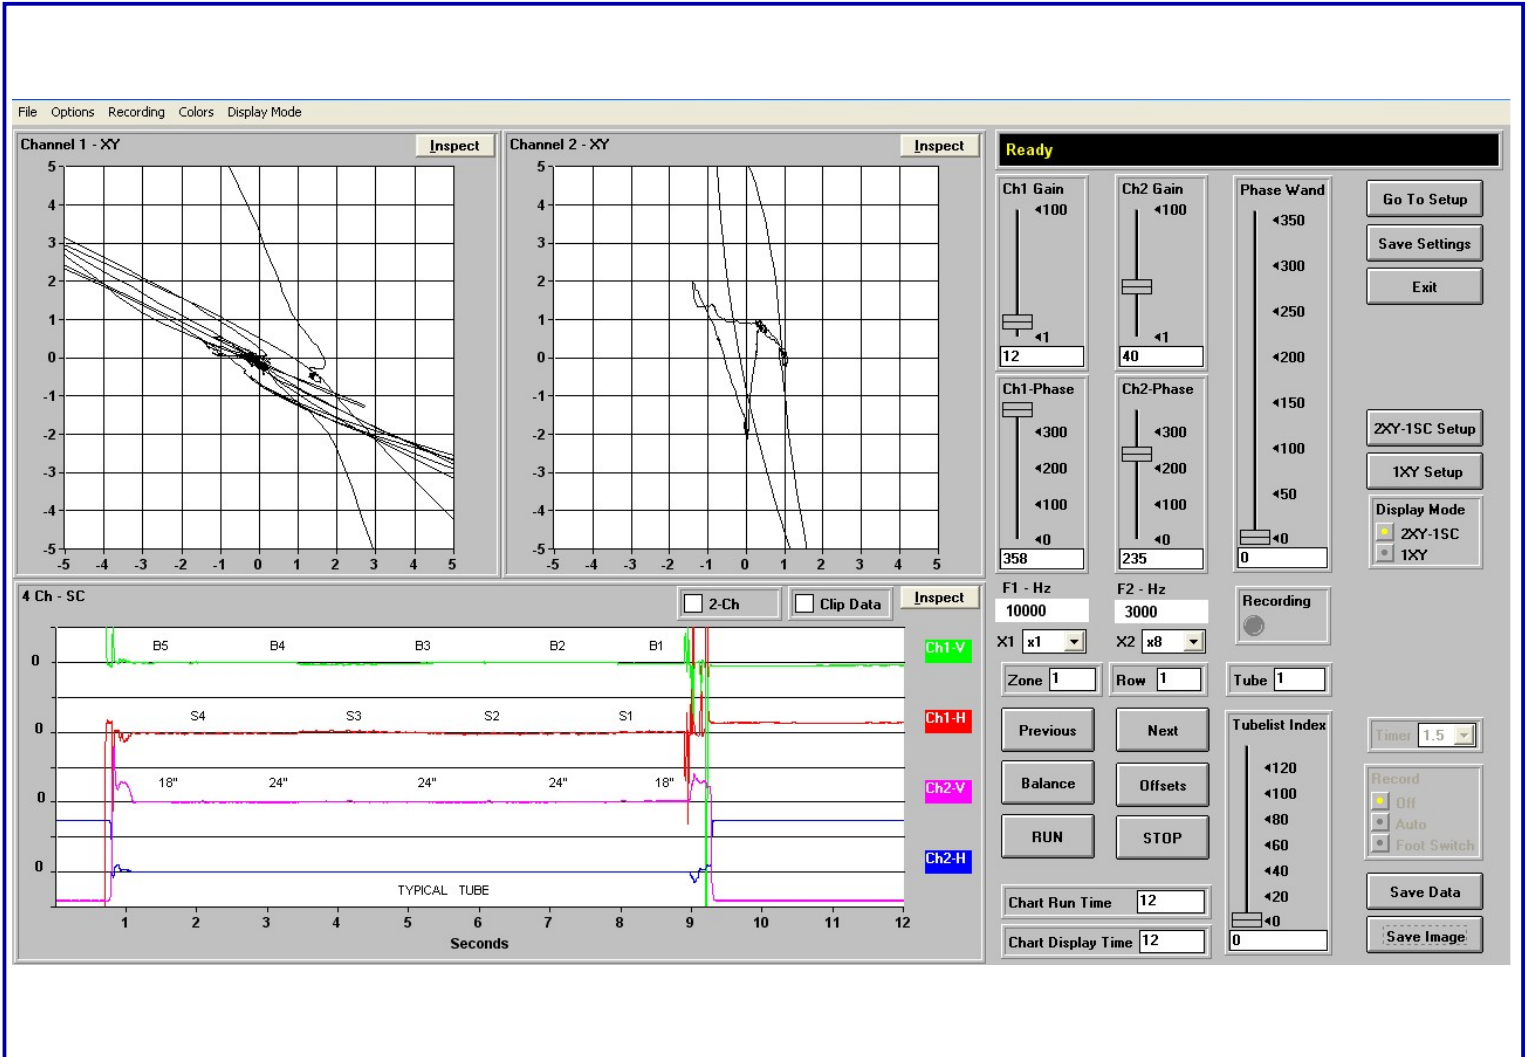
Evaporator Section

NO SIGNIFICANT DEFECTS (Row 1 Tube 1)

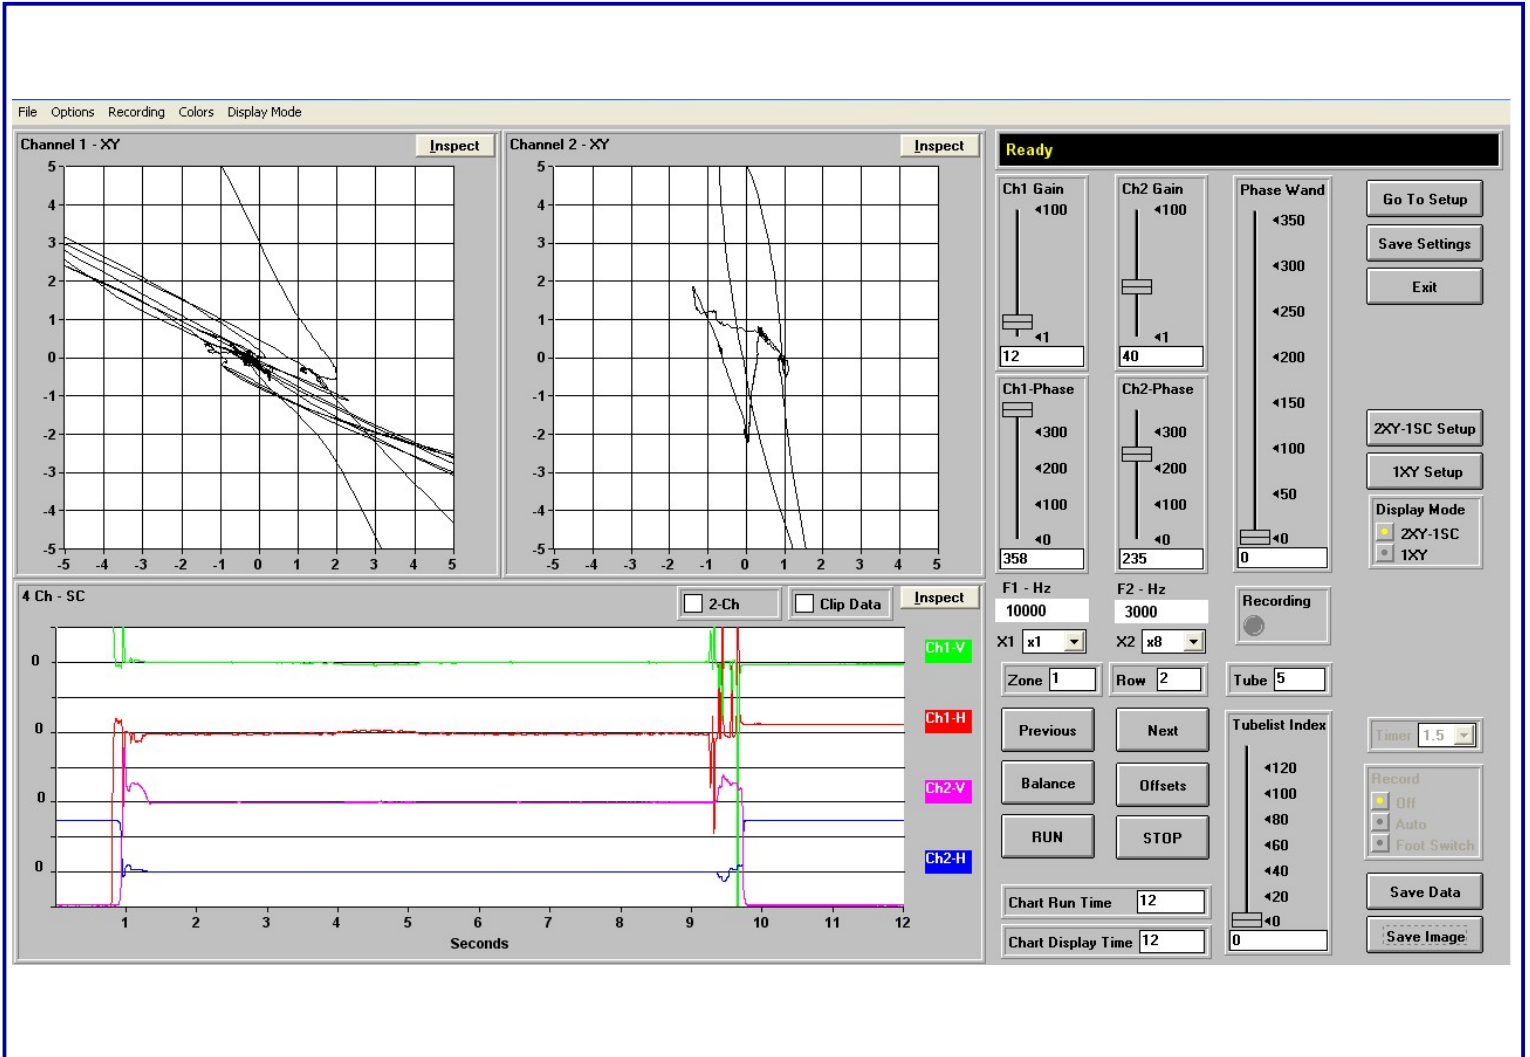
Evaporator Section

NO SIGNIFICANT DEFECTS (Row 2 Tube 5)

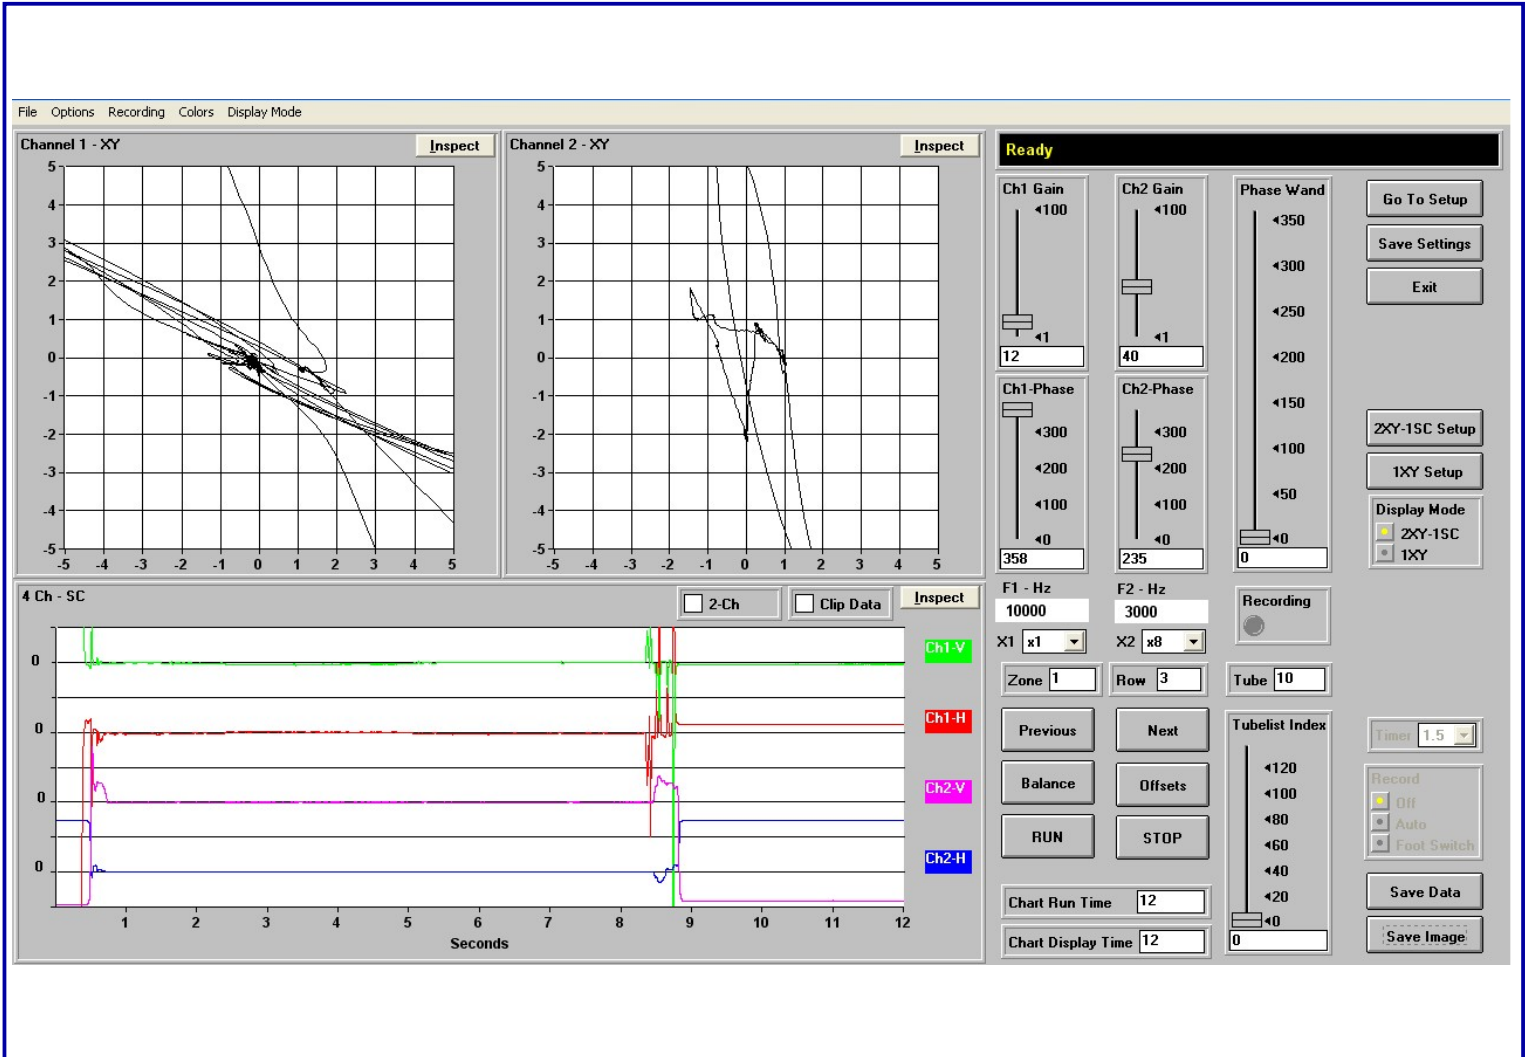
Evaporator Section

NO SIGNIFICANT DEFECTS (Row 3 Tube 10)

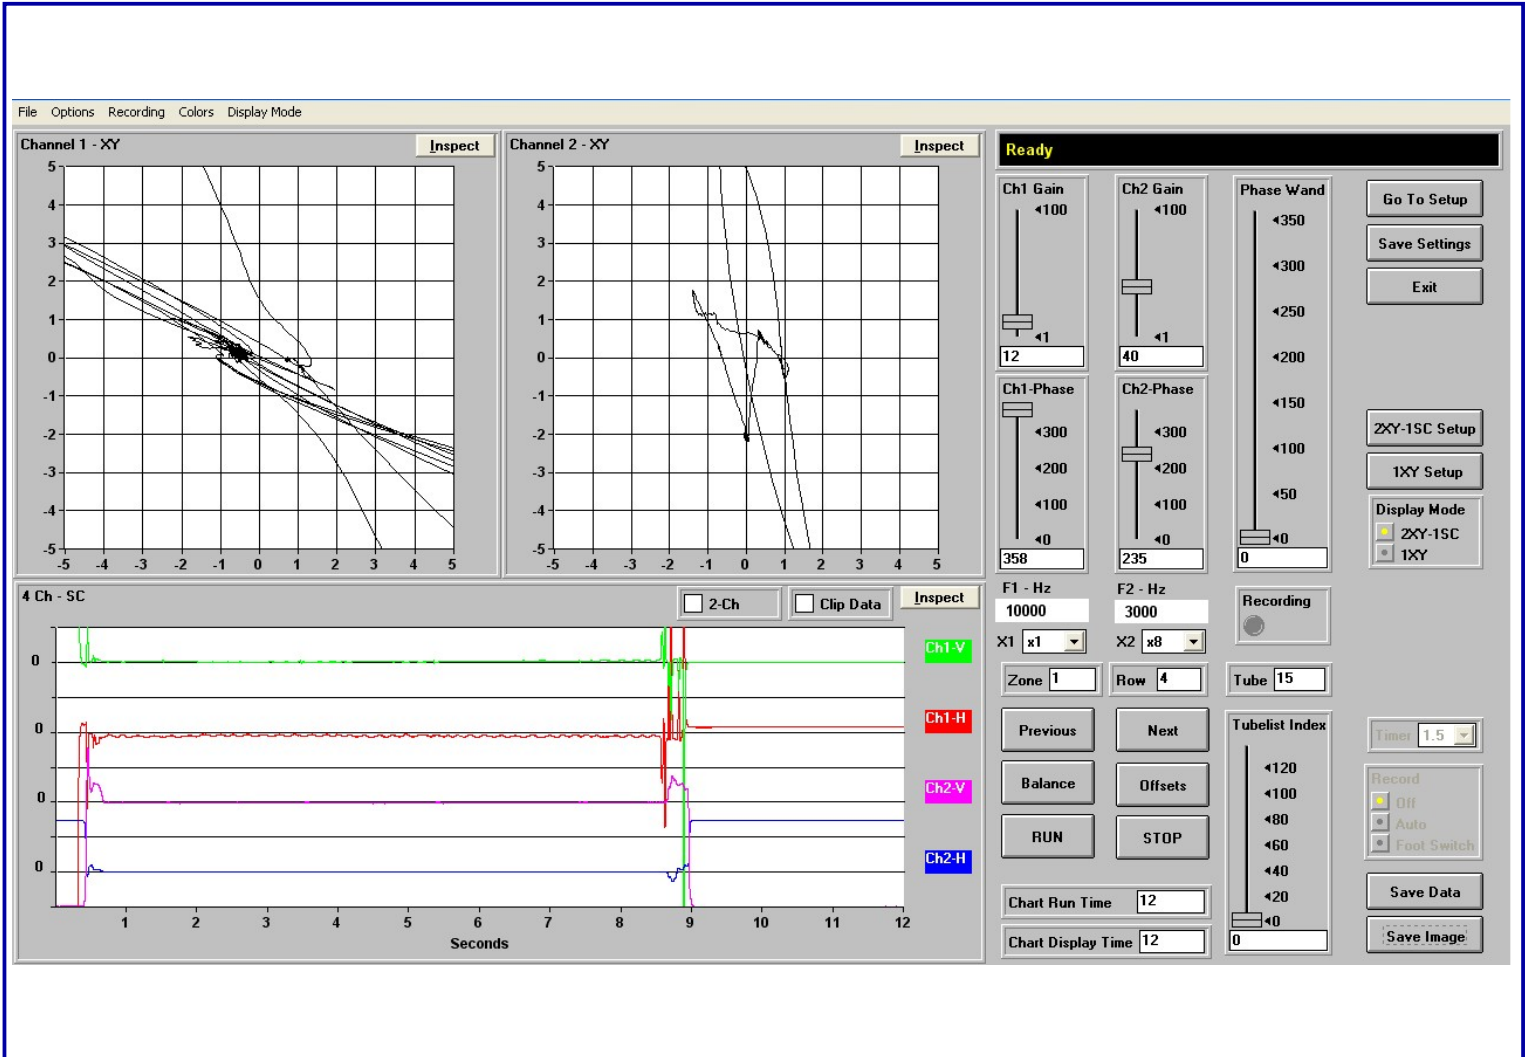
Evaporator Section

NO SIGNIFICANT DEFECTS (Row 4 Tube 15)

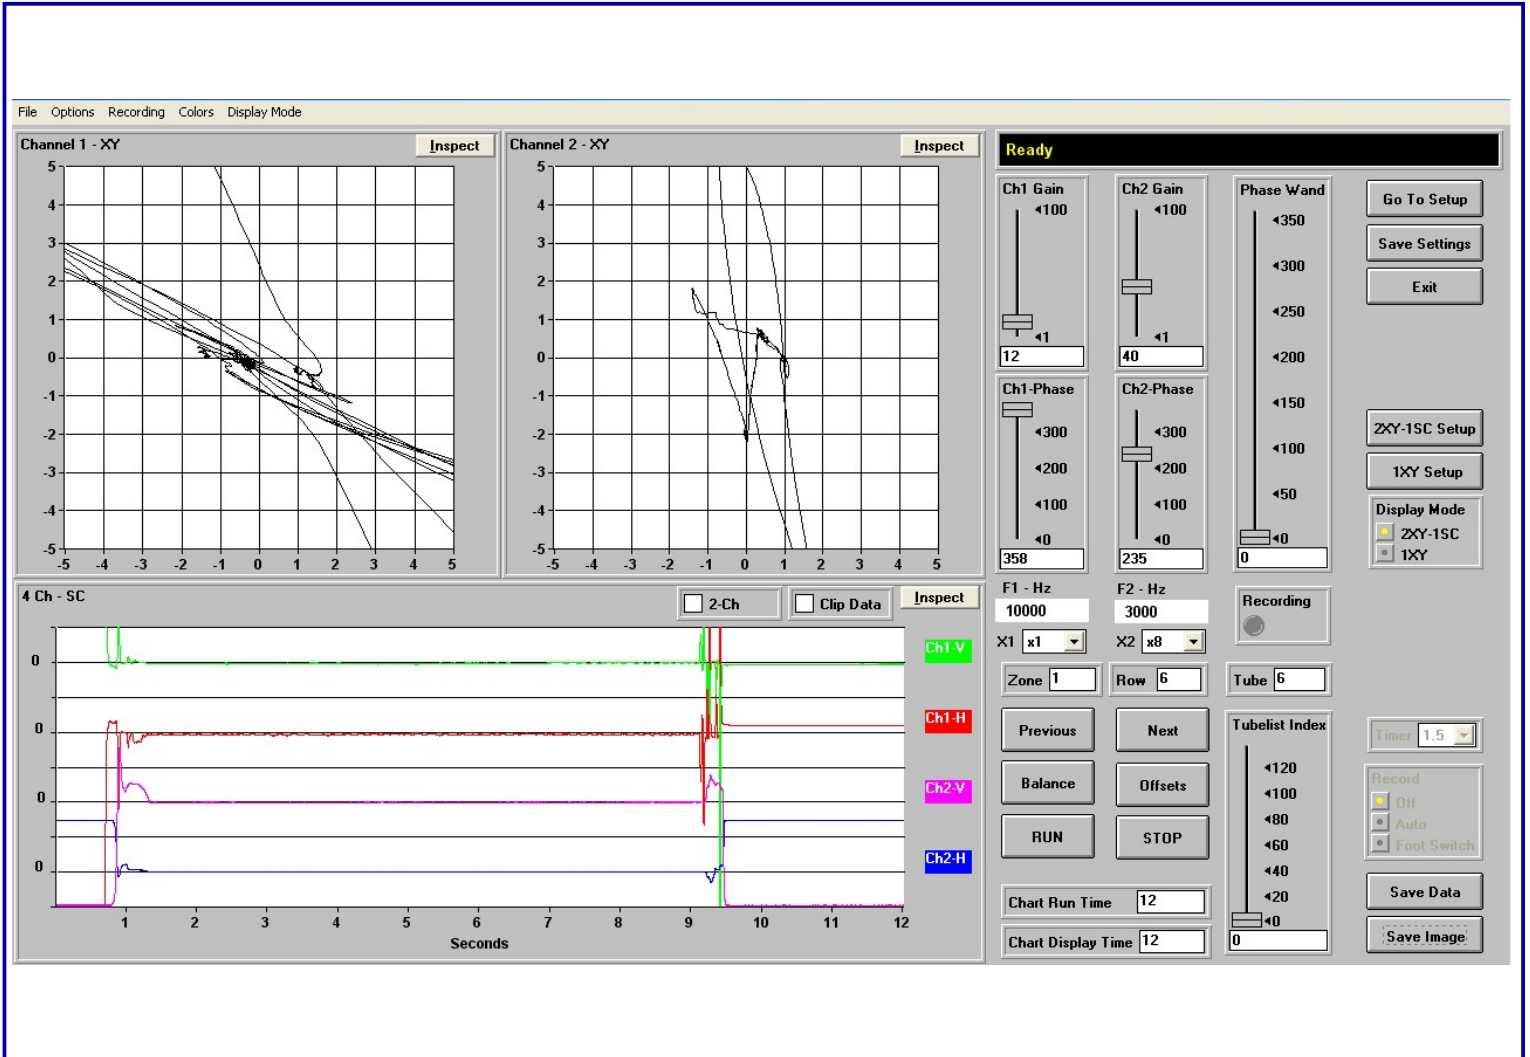
Evaporator Section

NO SIGNIFICANT DEFECTS (Row 6 Tube 6)

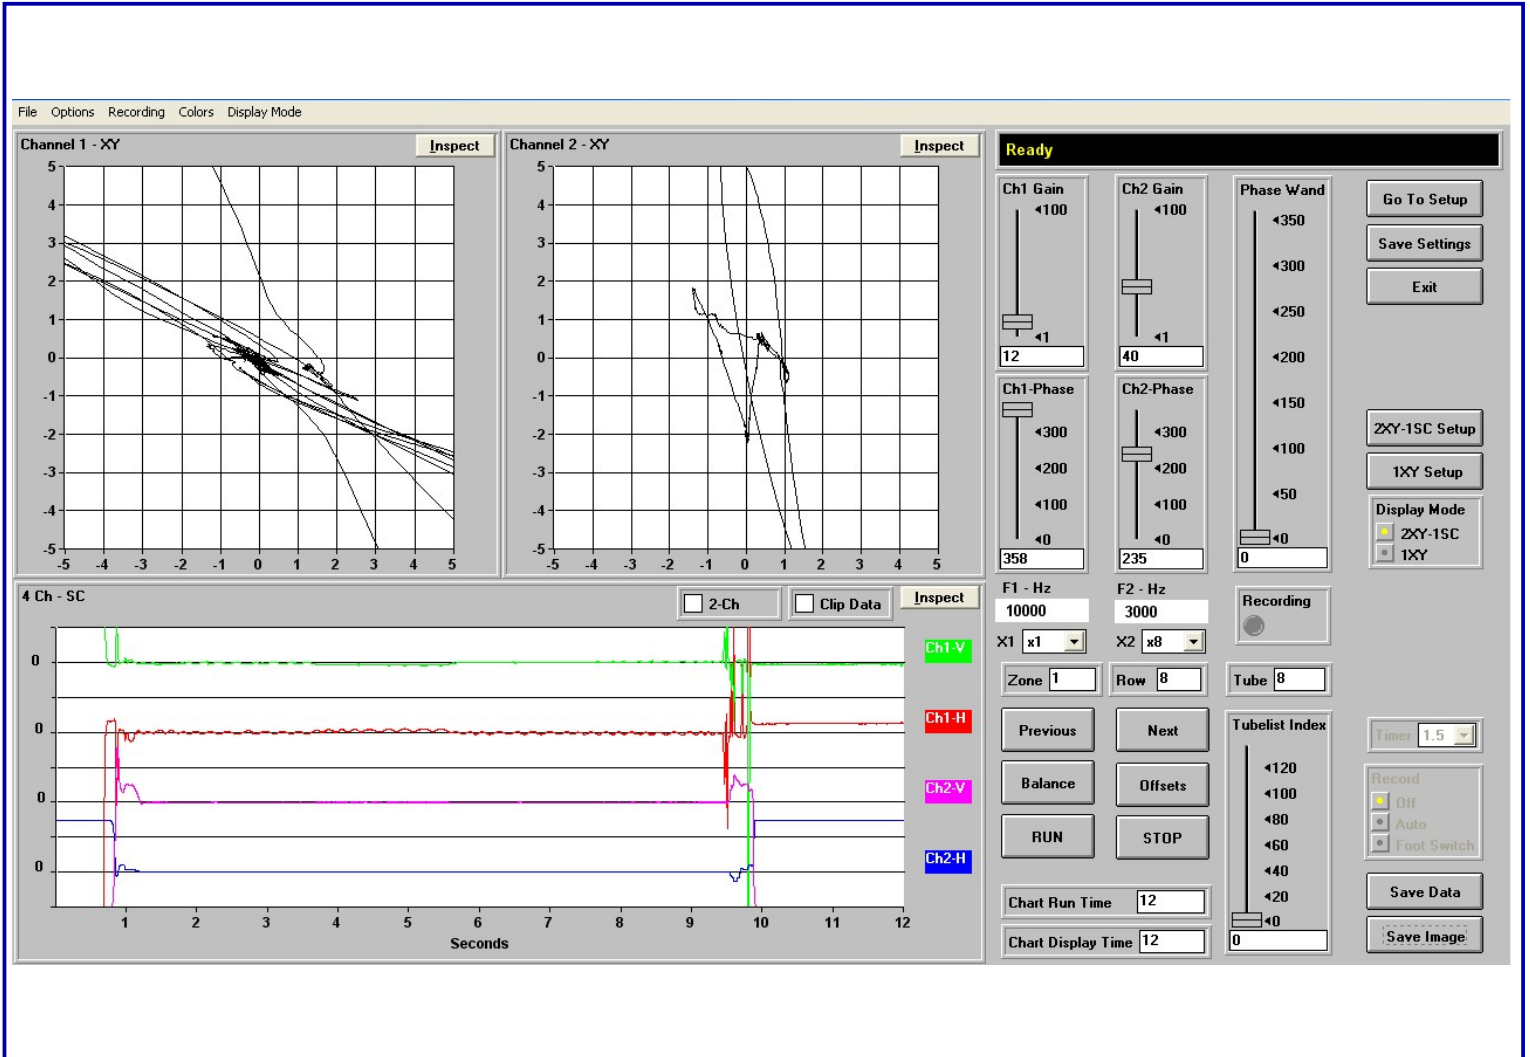
Evaporator Section

NO SIGNIFICANT DEFECTS (Row 8 Tube 8)
