**LEAD-BASED PAINT INVESTIGATION
REPORT**

**USC SOUTH TOWER RESIDENCE
HALL
COLUMBIA, SOUTH CAROLINA 29201**

**UNIVERSITY OF
SOUTH CAROLINA**

January 27, 2012

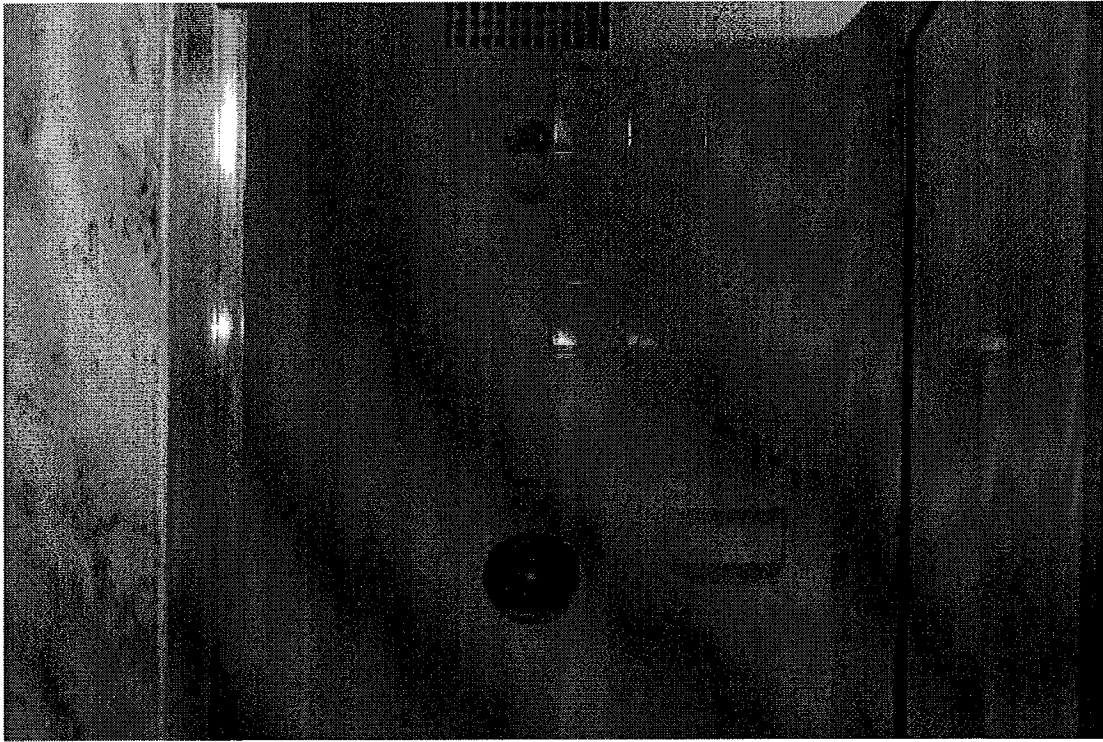
White ceramic tile in shower stalls in community bathrooms

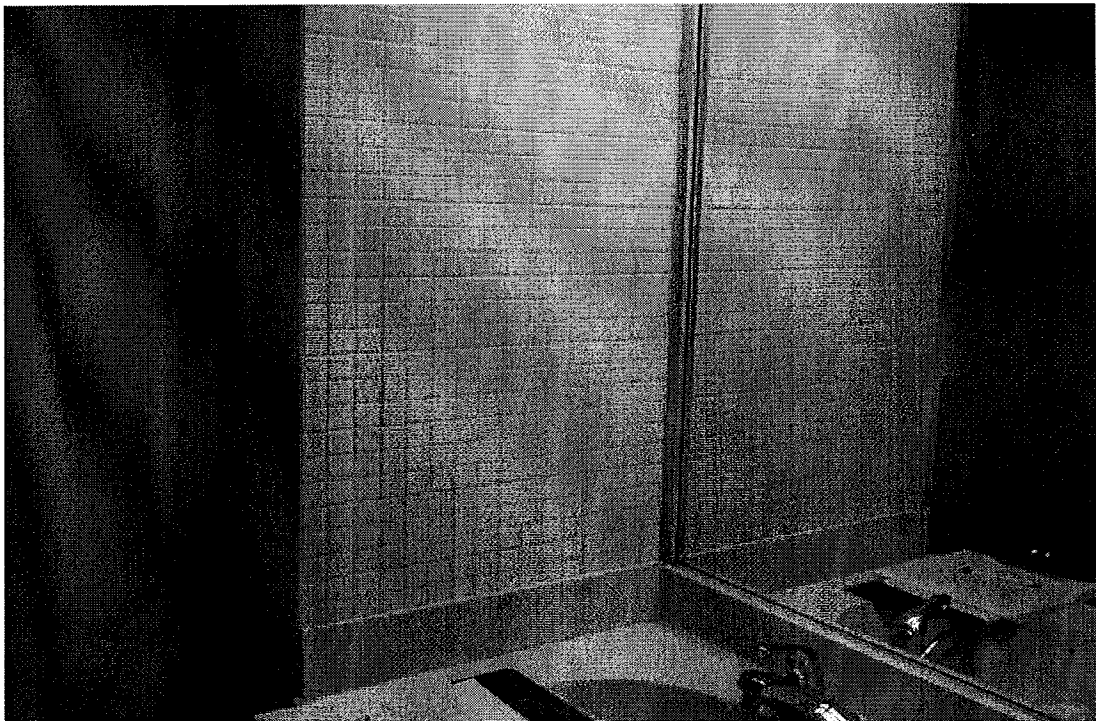
White wall tiles in bathrooms throughout the building

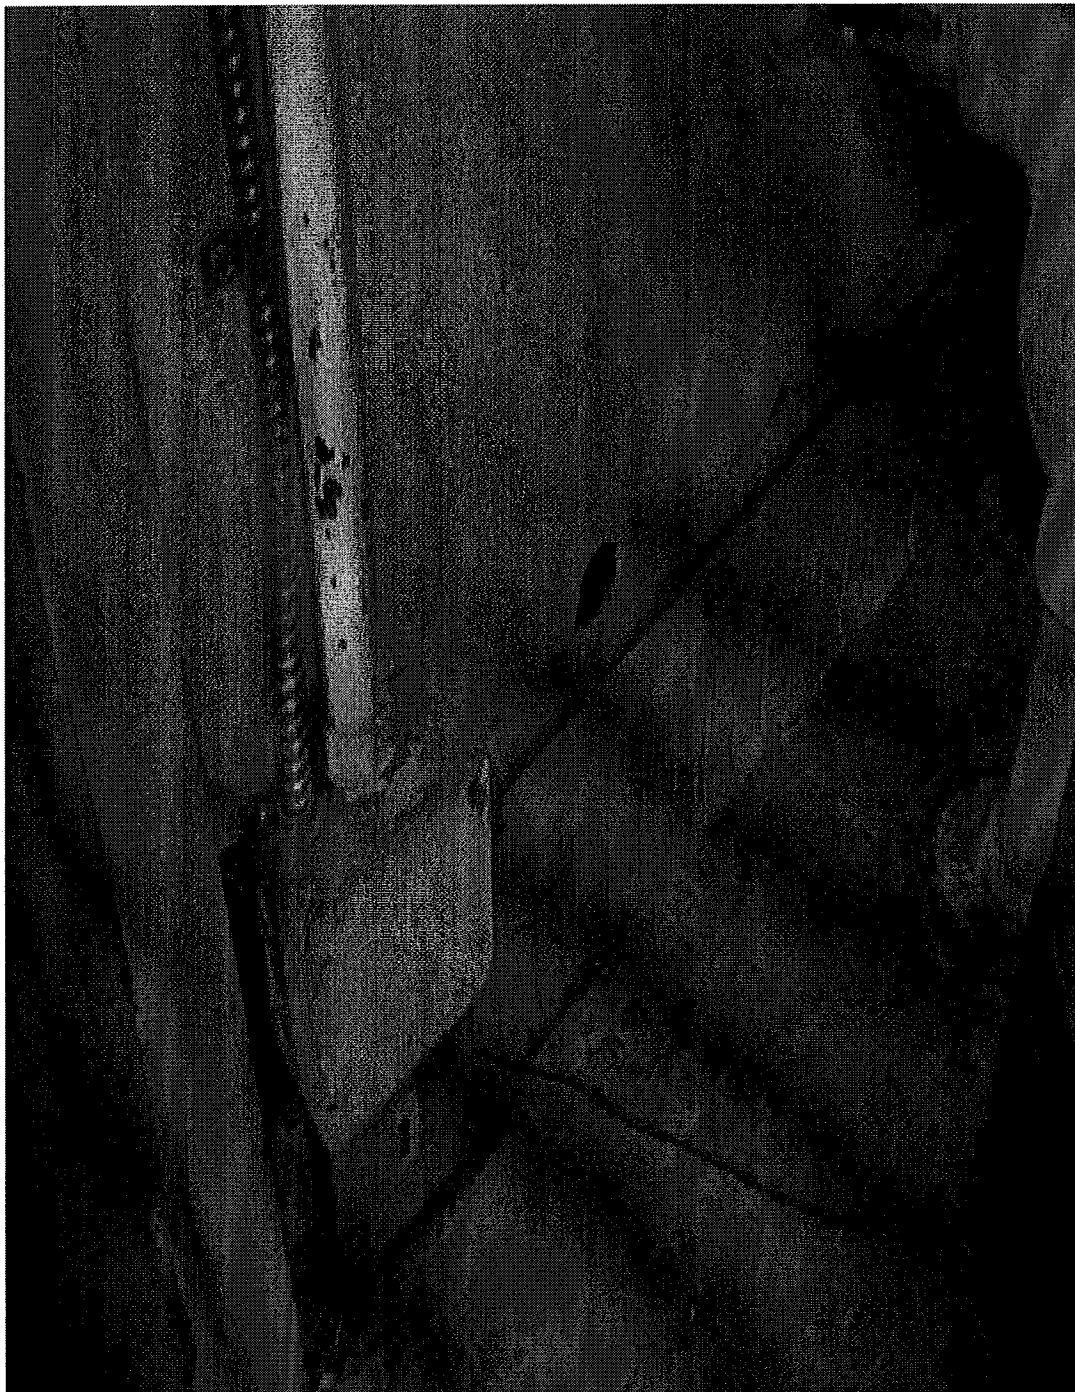
Ceramic tile baseboard in custodial closets throughout the building

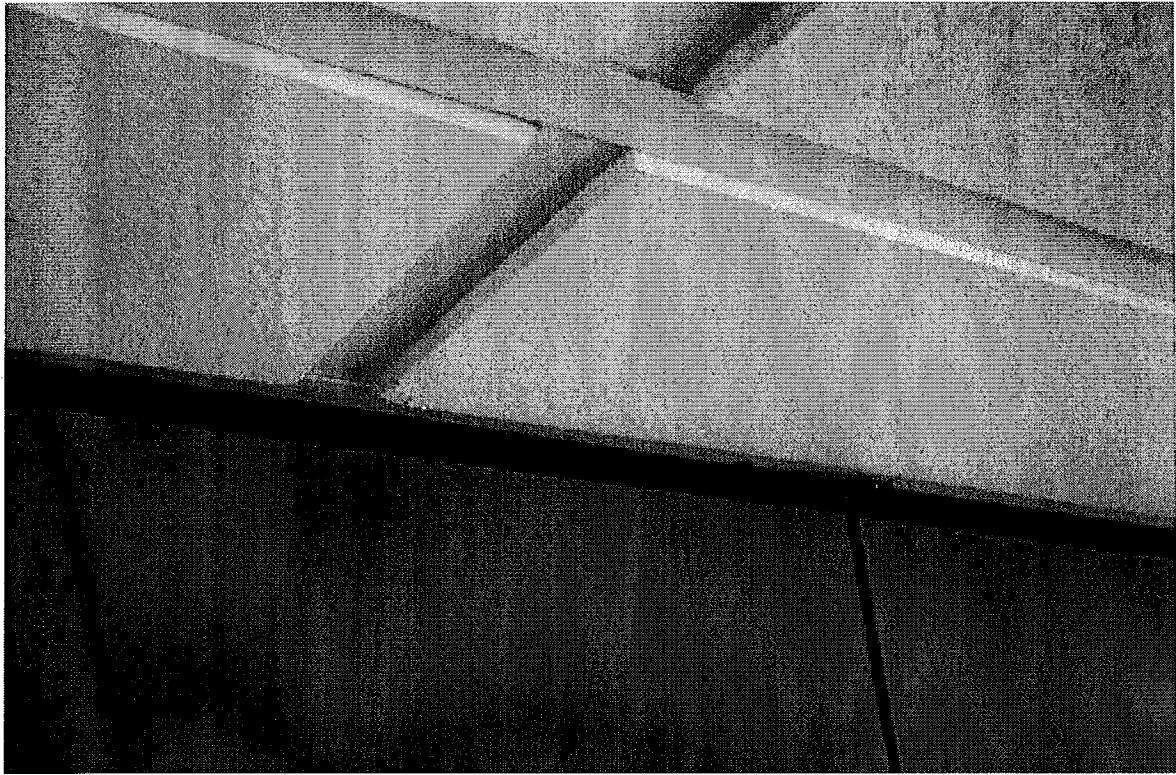
Black decorative trim strips on top of walls and around doors throughout the first floor lobby
