## Report of Eddy Current Inspection

Manufacturer: Carrier

Model: 30HXC261RZ

Location: UNIVERSITY OF SOUTH CAROLINA  
HEALTH ED CENTER  
SPARTANBURG, SC 29301

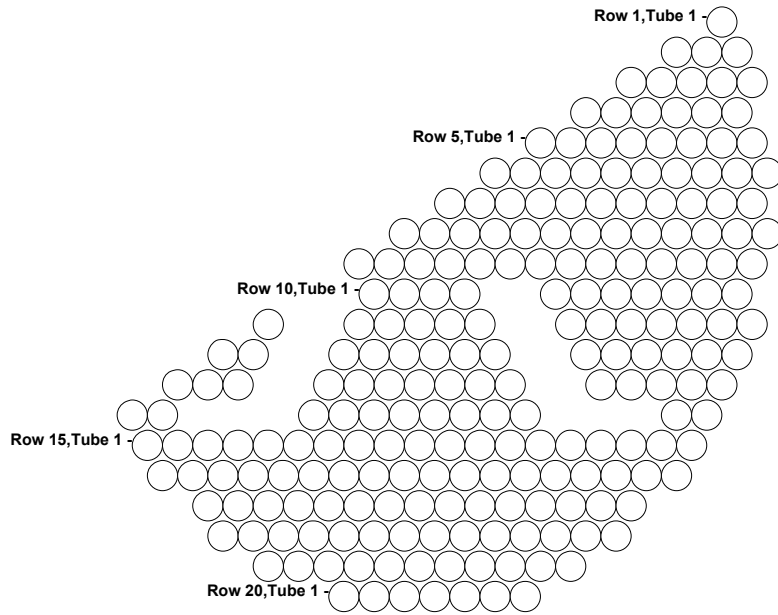
# Condenser Section

No Significant defects were found.

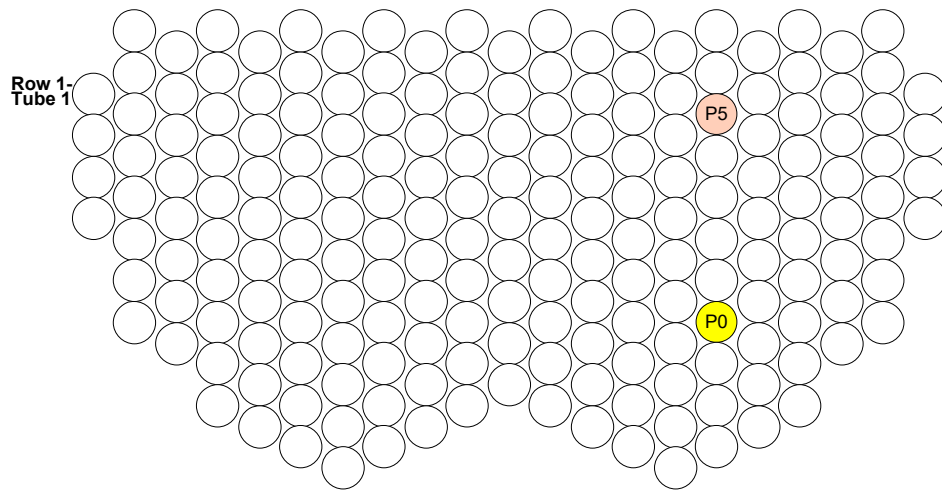
# Evaporator Section

Evaporator: 195 Tubes		
Tubes Tested: 195 Tubes		
Significant/Measurable Indications	Tubes Marked	Percent of Bundle
ID PIT < 20%	1	.51
OD PIT < 20%	1	.51
<b>Totals</b>	<b>2</b>	<b>1.02</b>

= ID PIT < 20%

= OD PIT < 20%

Tubes indicating ID Pits require no immediate corrective action. However, this type damage is usually progressive and should be monitored.

The OD Pits detected are considered minor and require no immediate corrective action, but should be monitored for defect growth.

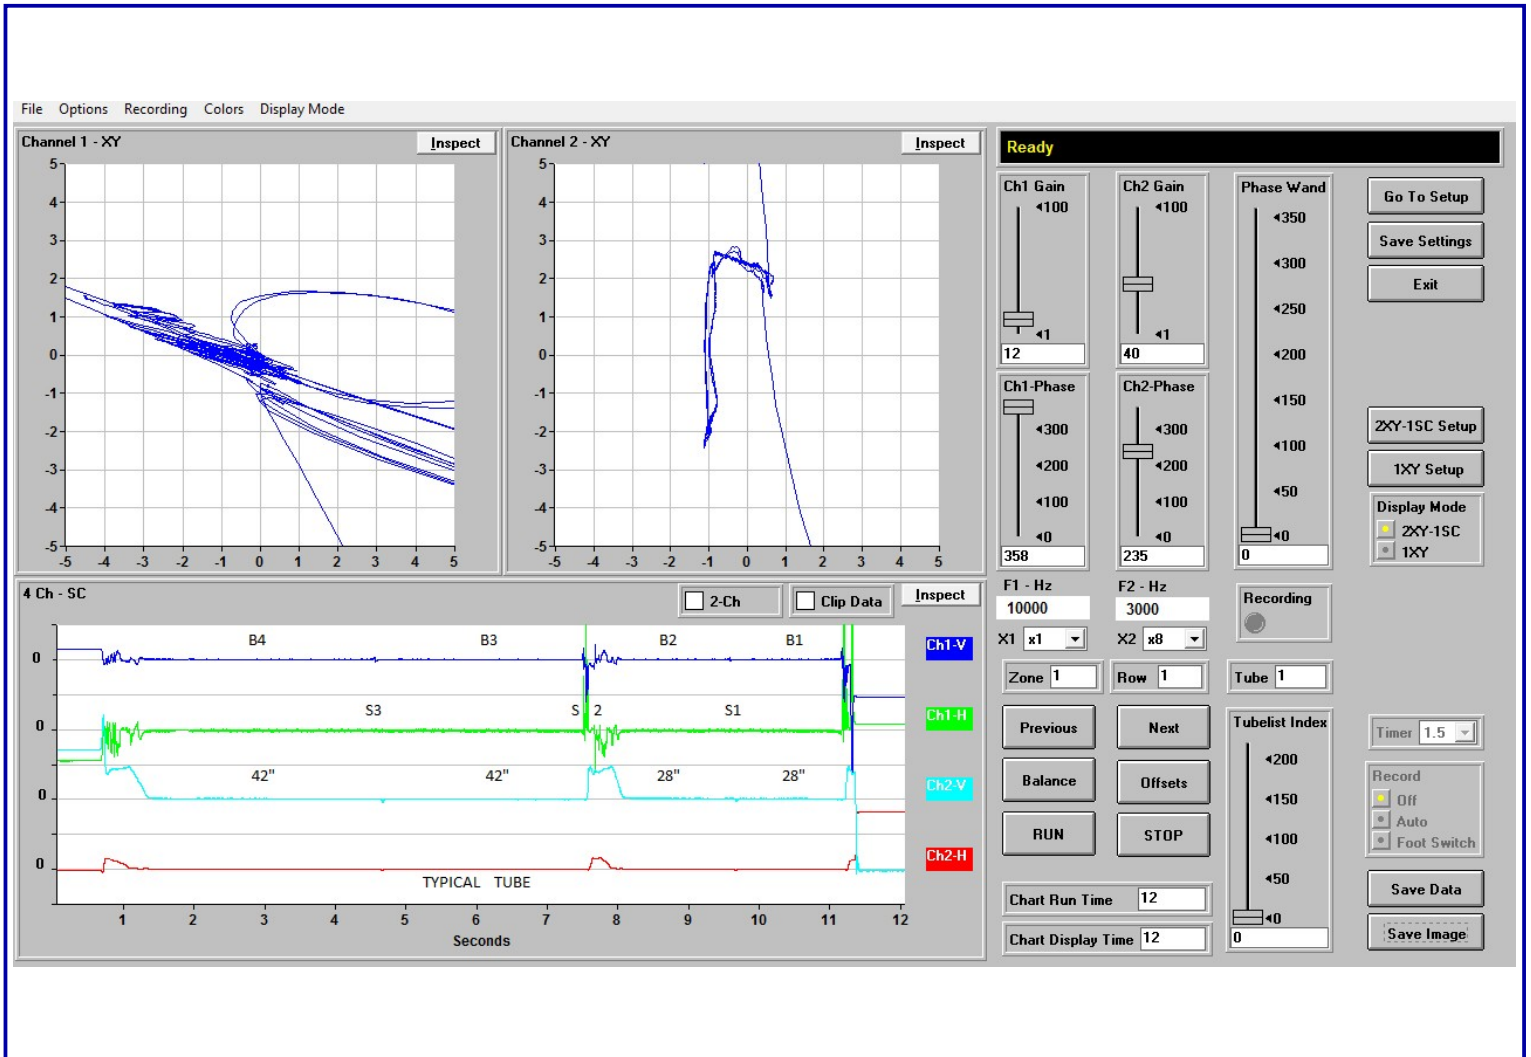
NO SIGNIFICANT DEFECTS (Row 1 Tube 1)

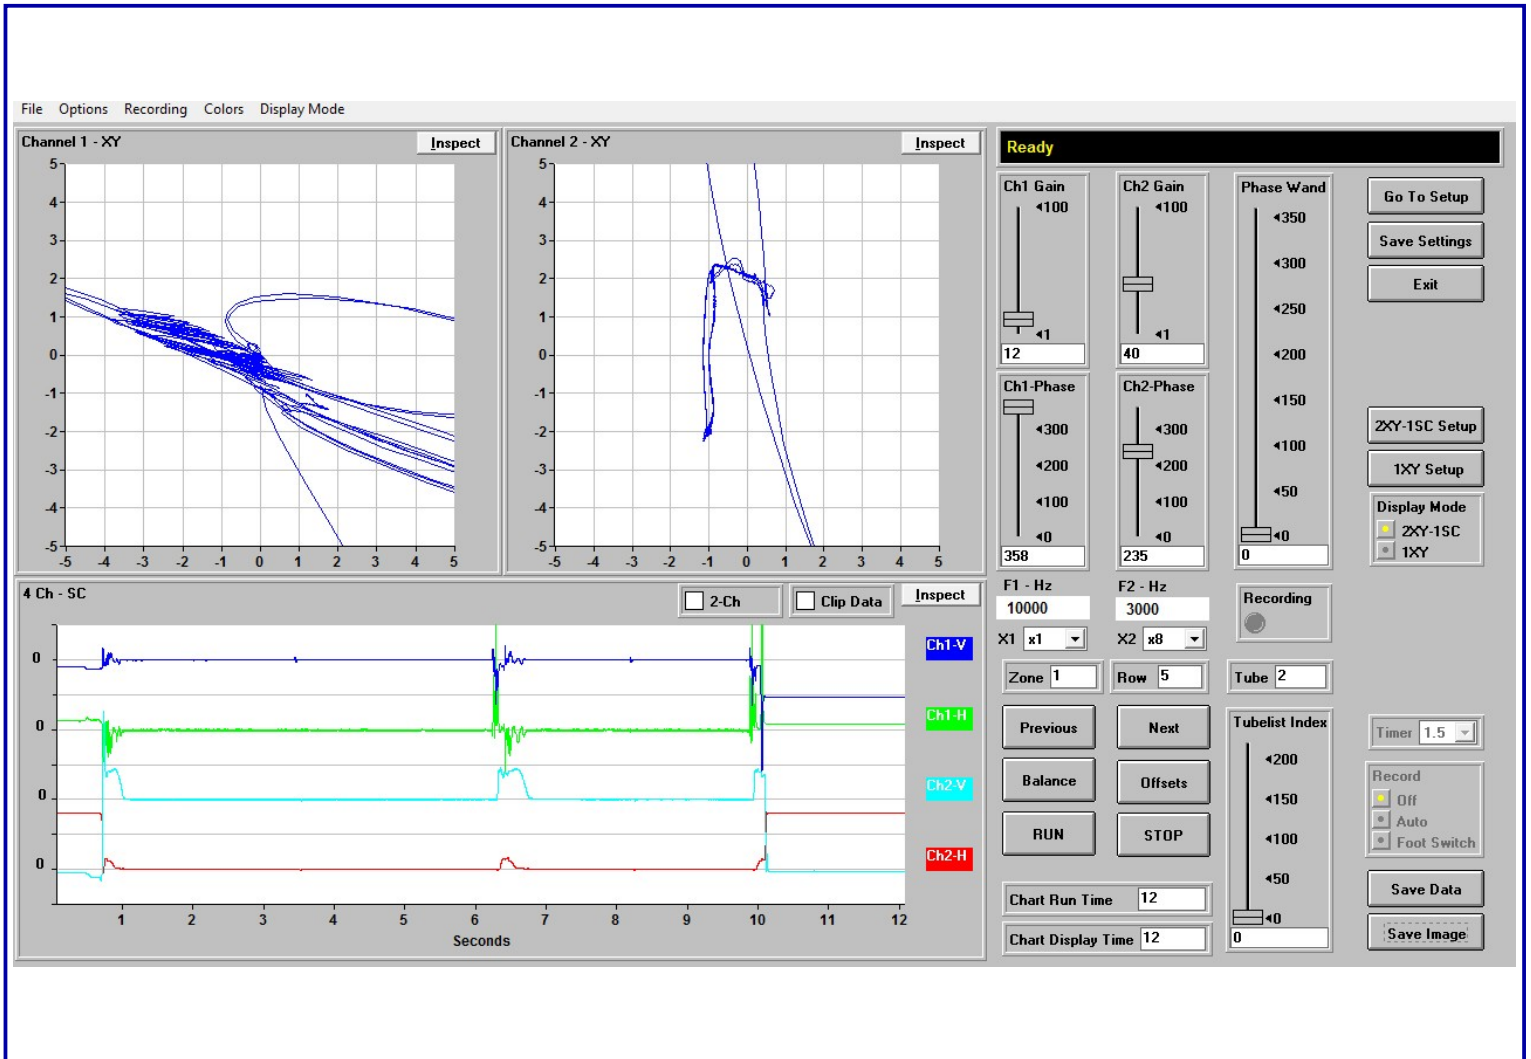
NO SIGNIFICANT DEFECTS (Row 5 Tube 2)

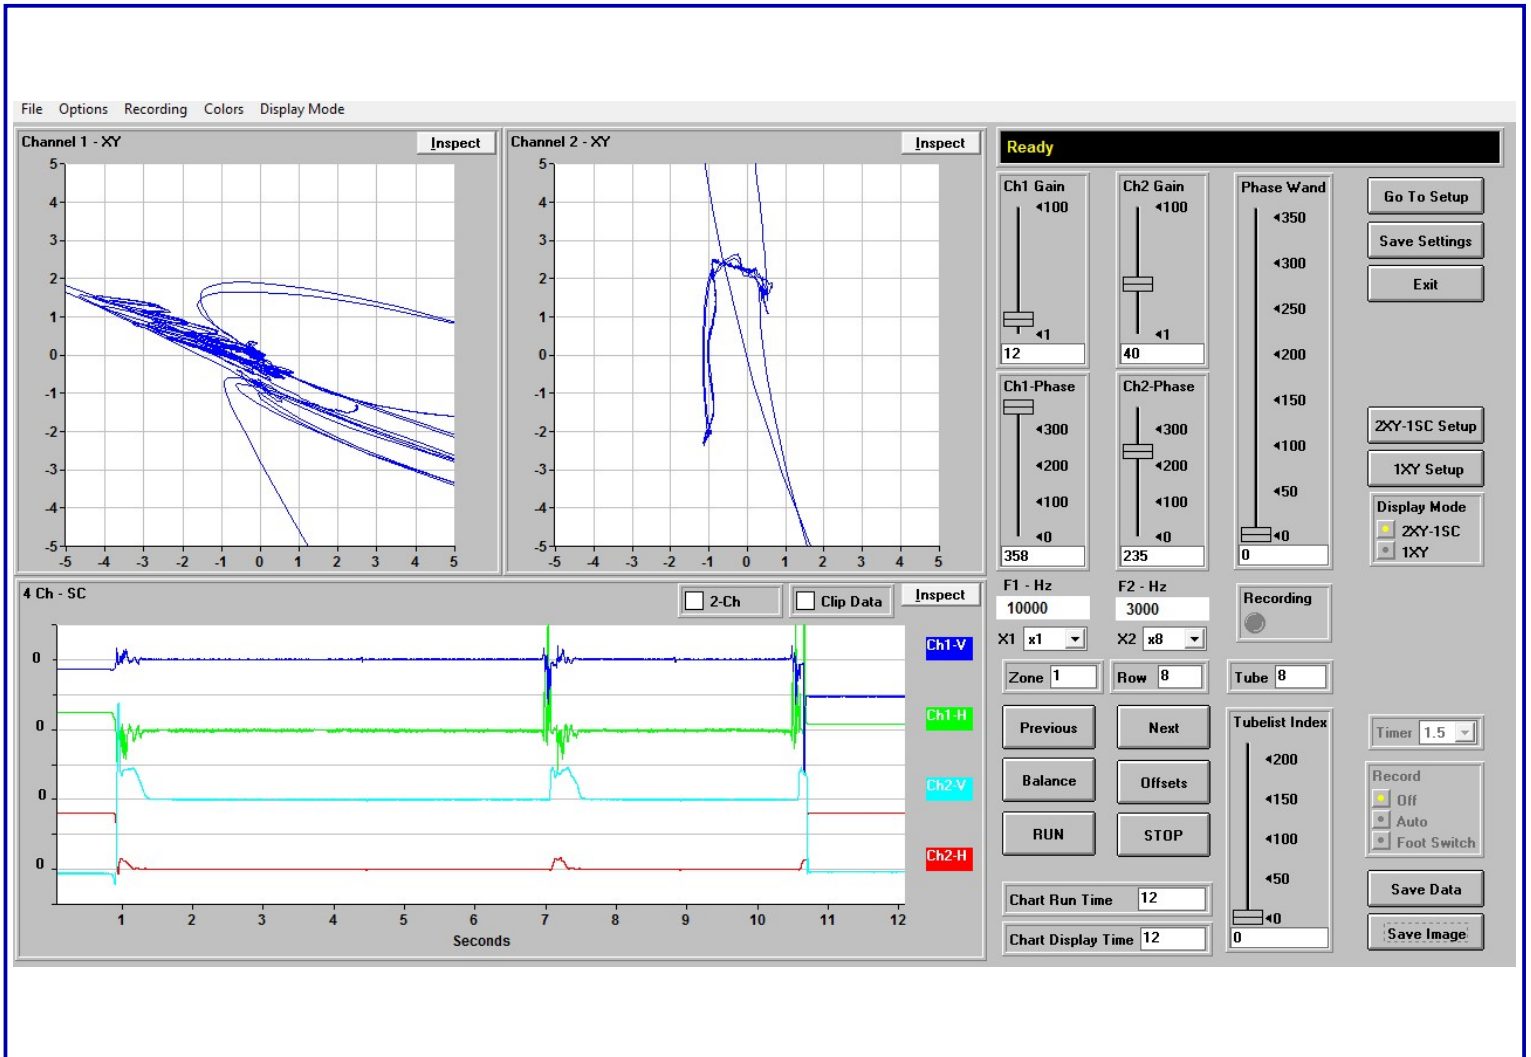
NO SIGNIFICANT DEFECTS (Row 8 Tube 8)

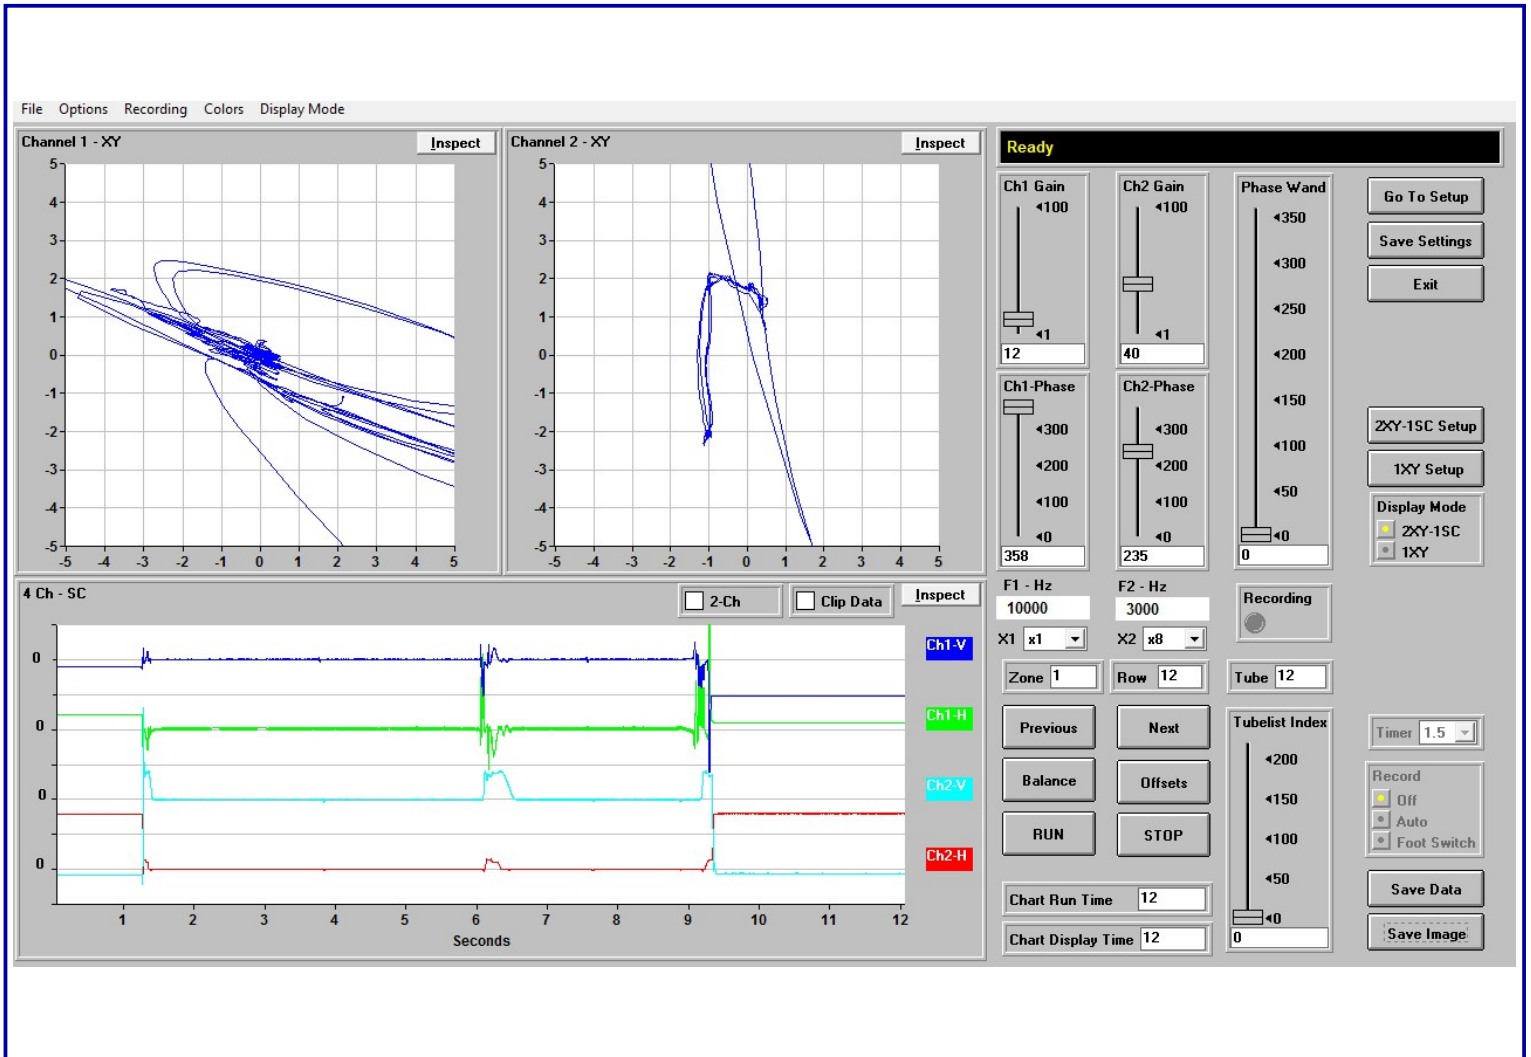
NO SIGNIFICANT DEFECTS (Row 12 Tube 12)

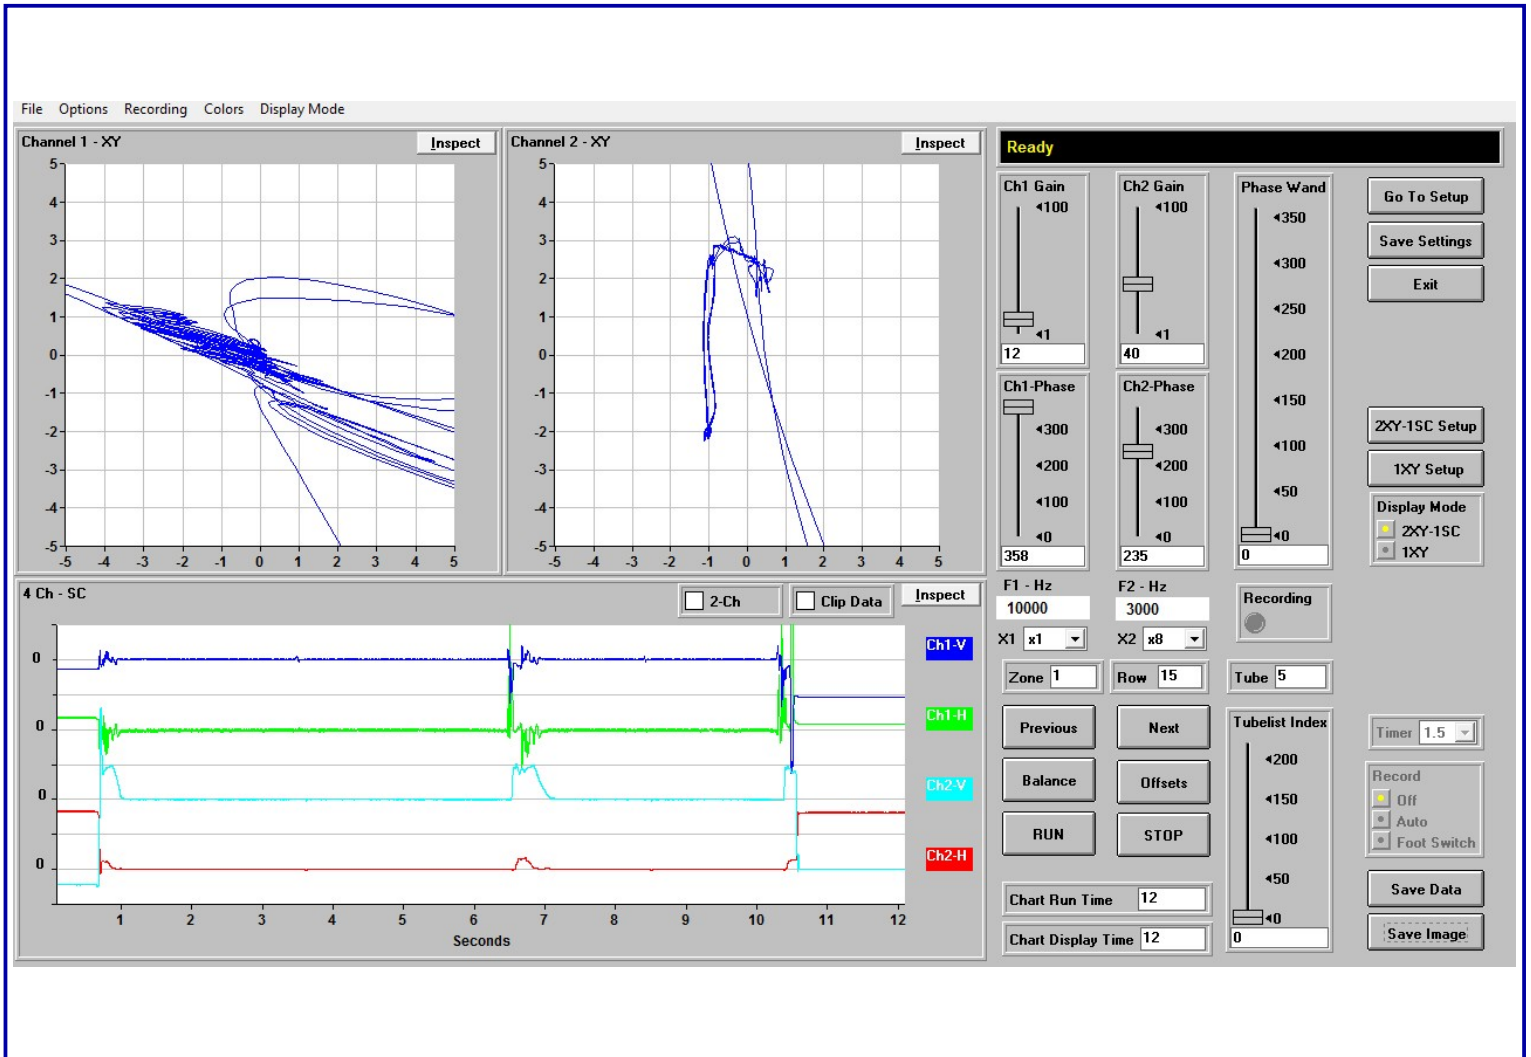
NO SIGNIFICANT DEFECTS (Row 15 Tube 5)

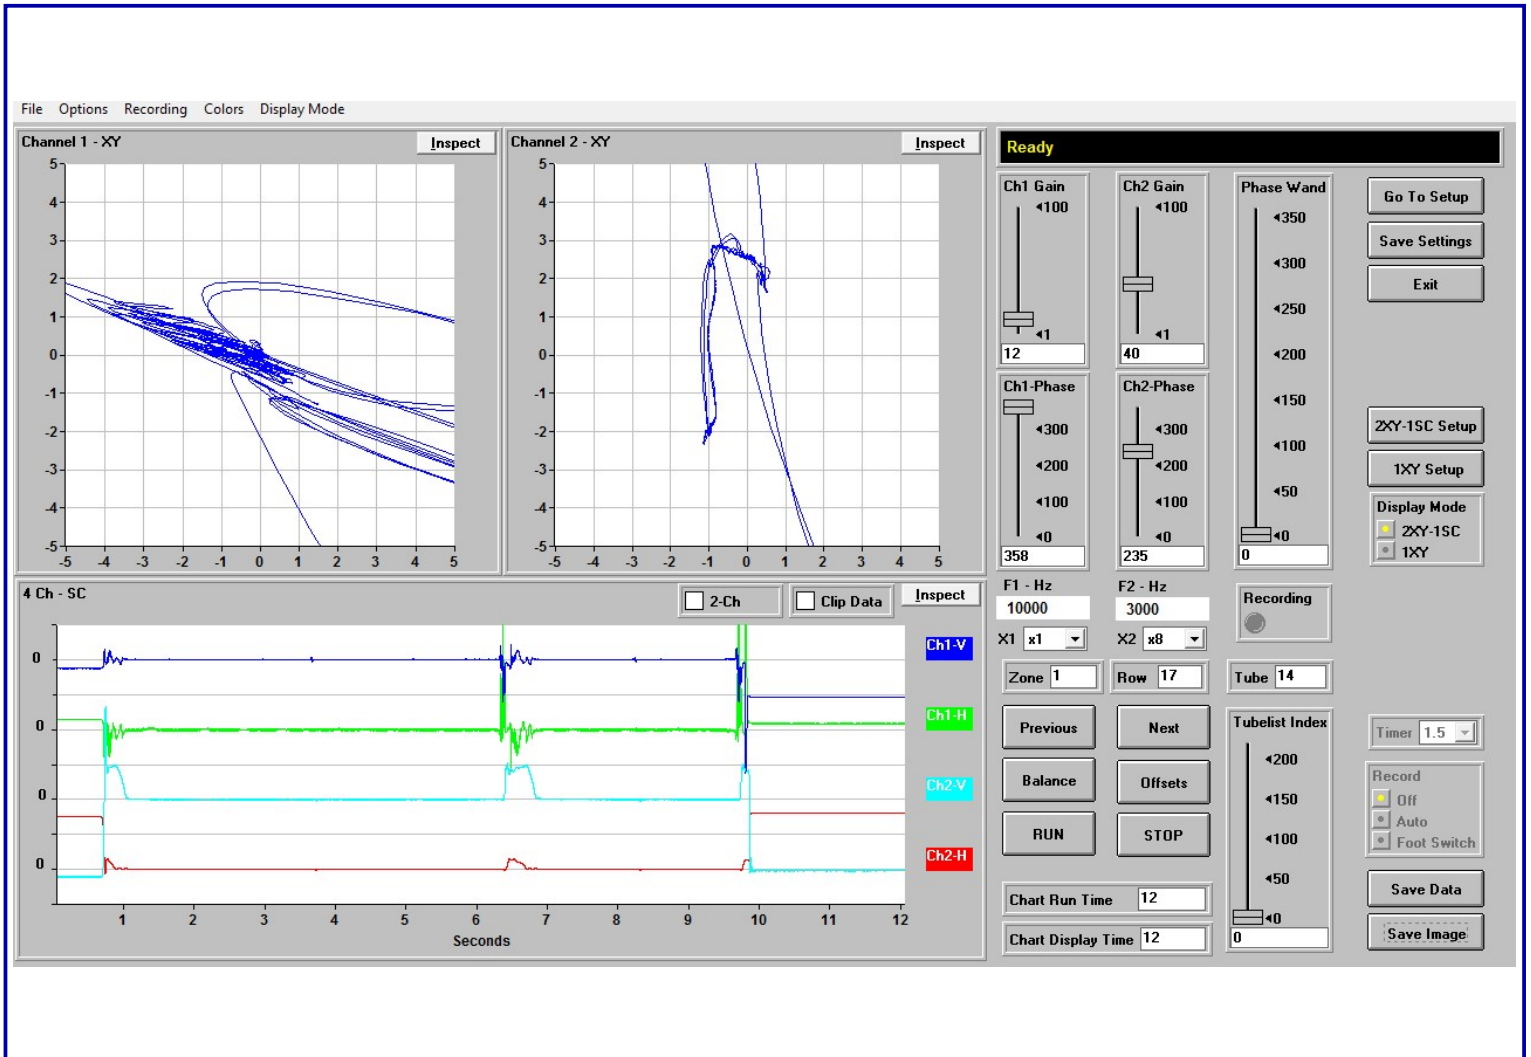
NO SIGNIFICANT DEFECTS (Row 17 Tube 14)

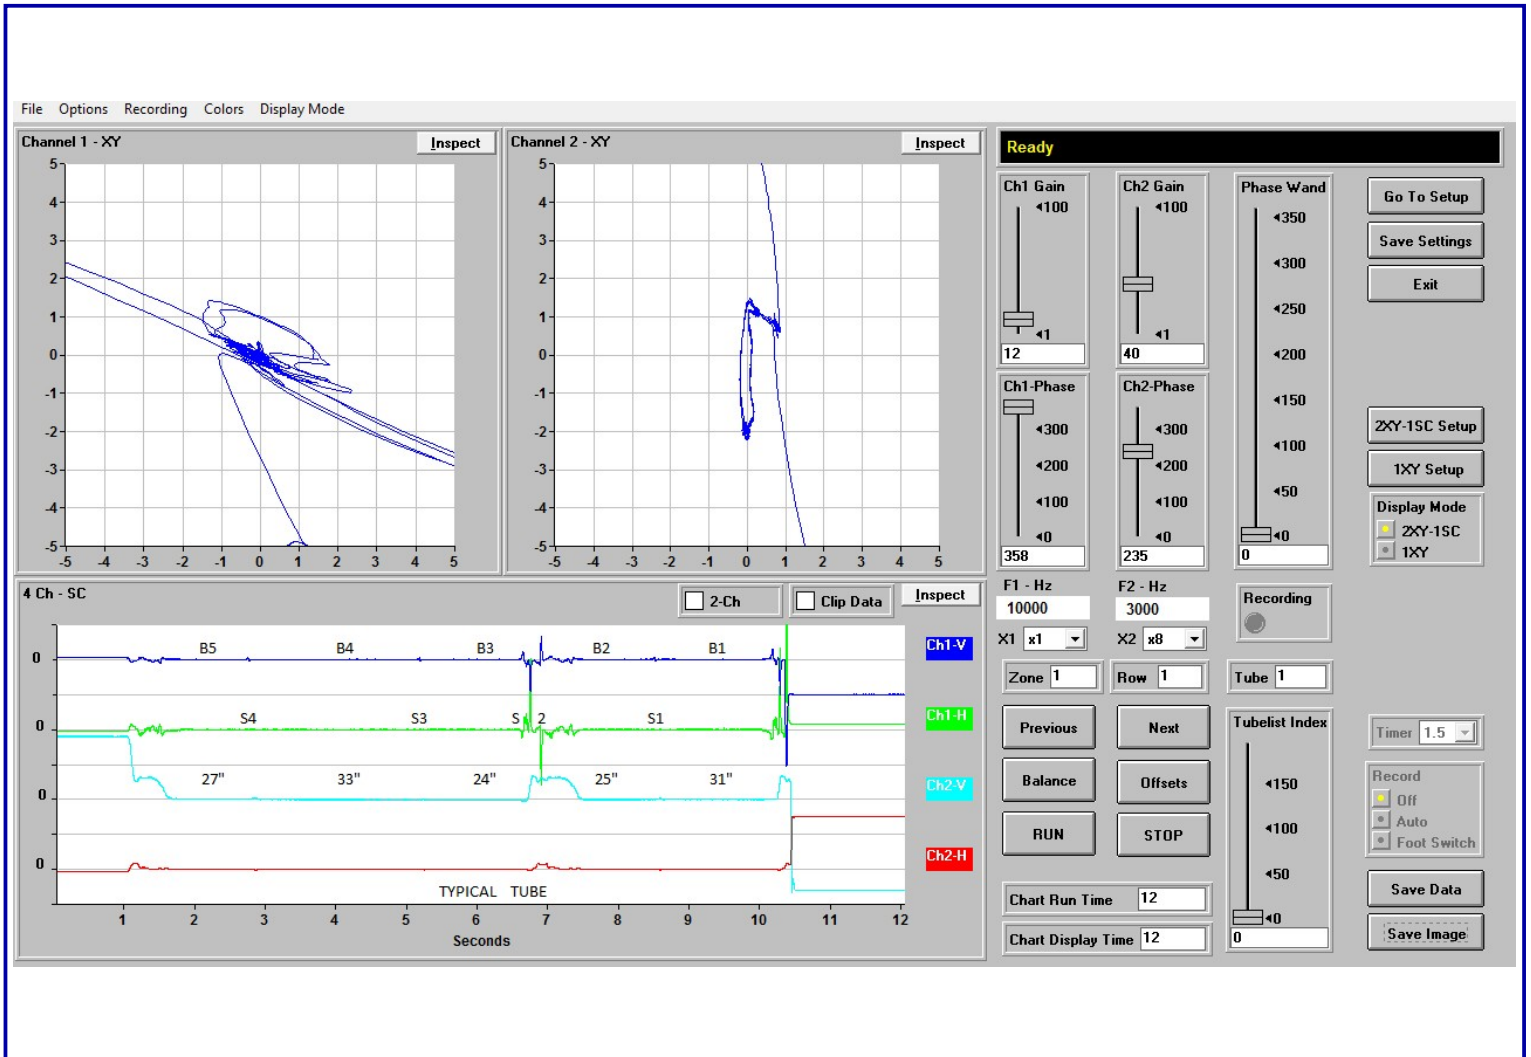
NO SIGNIFICANT DEFECTS (Row 1 Tube 1)

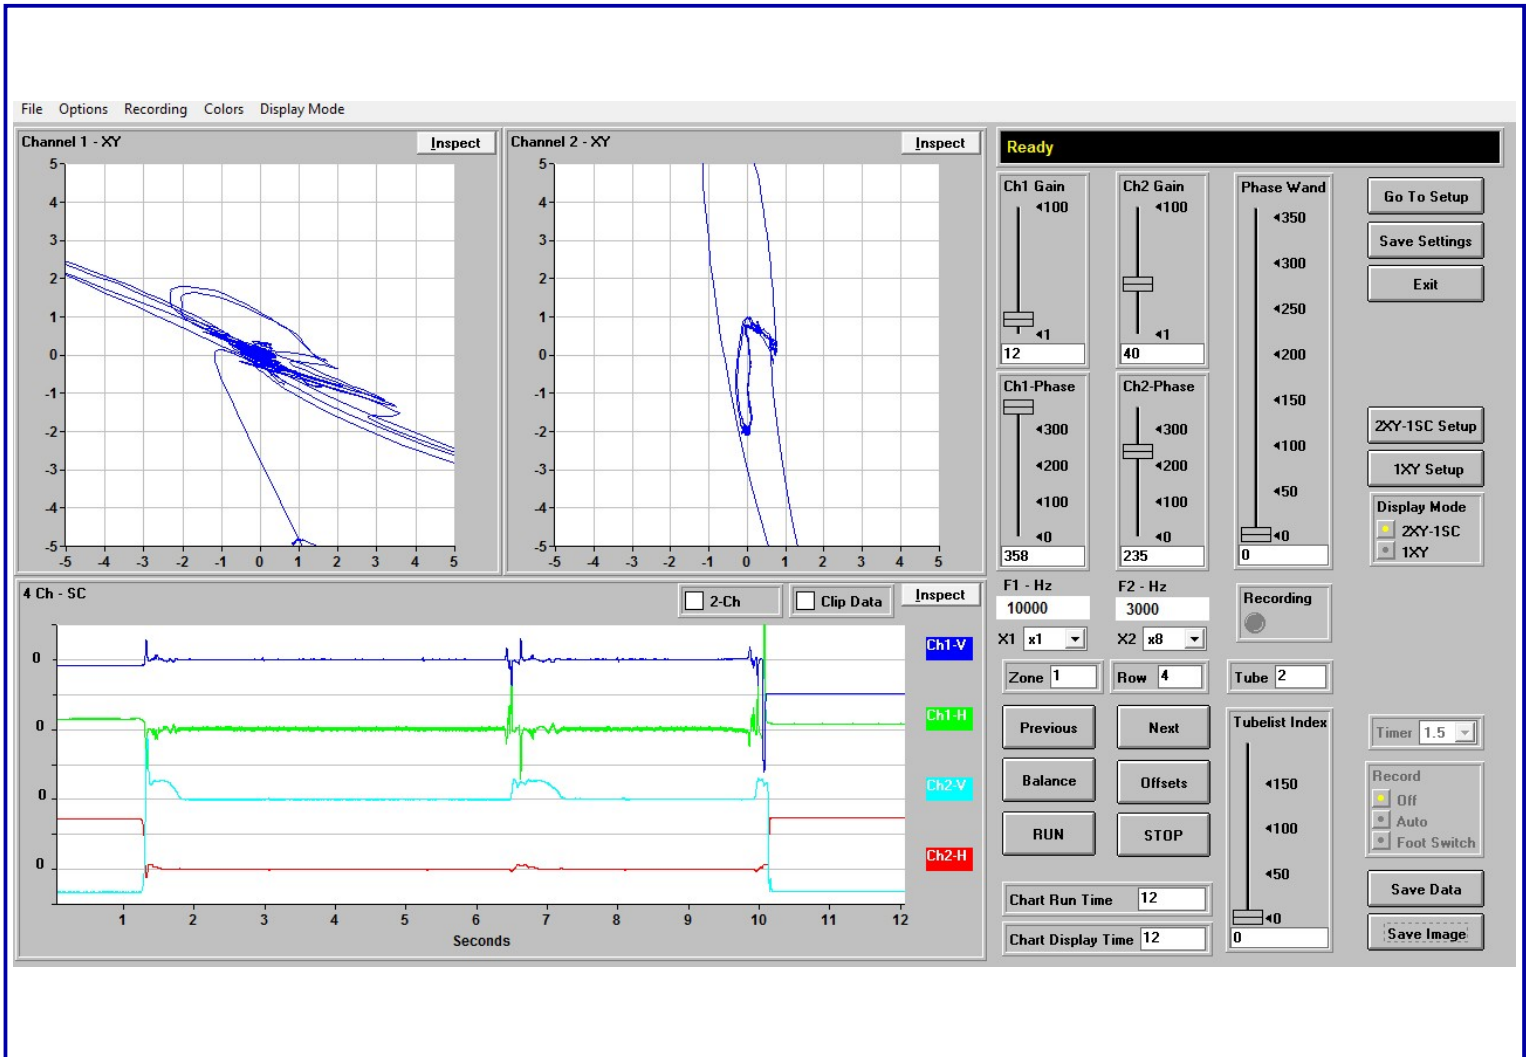
NO SIGNIFICANT DEFECTS (Row 4 Tube 2)

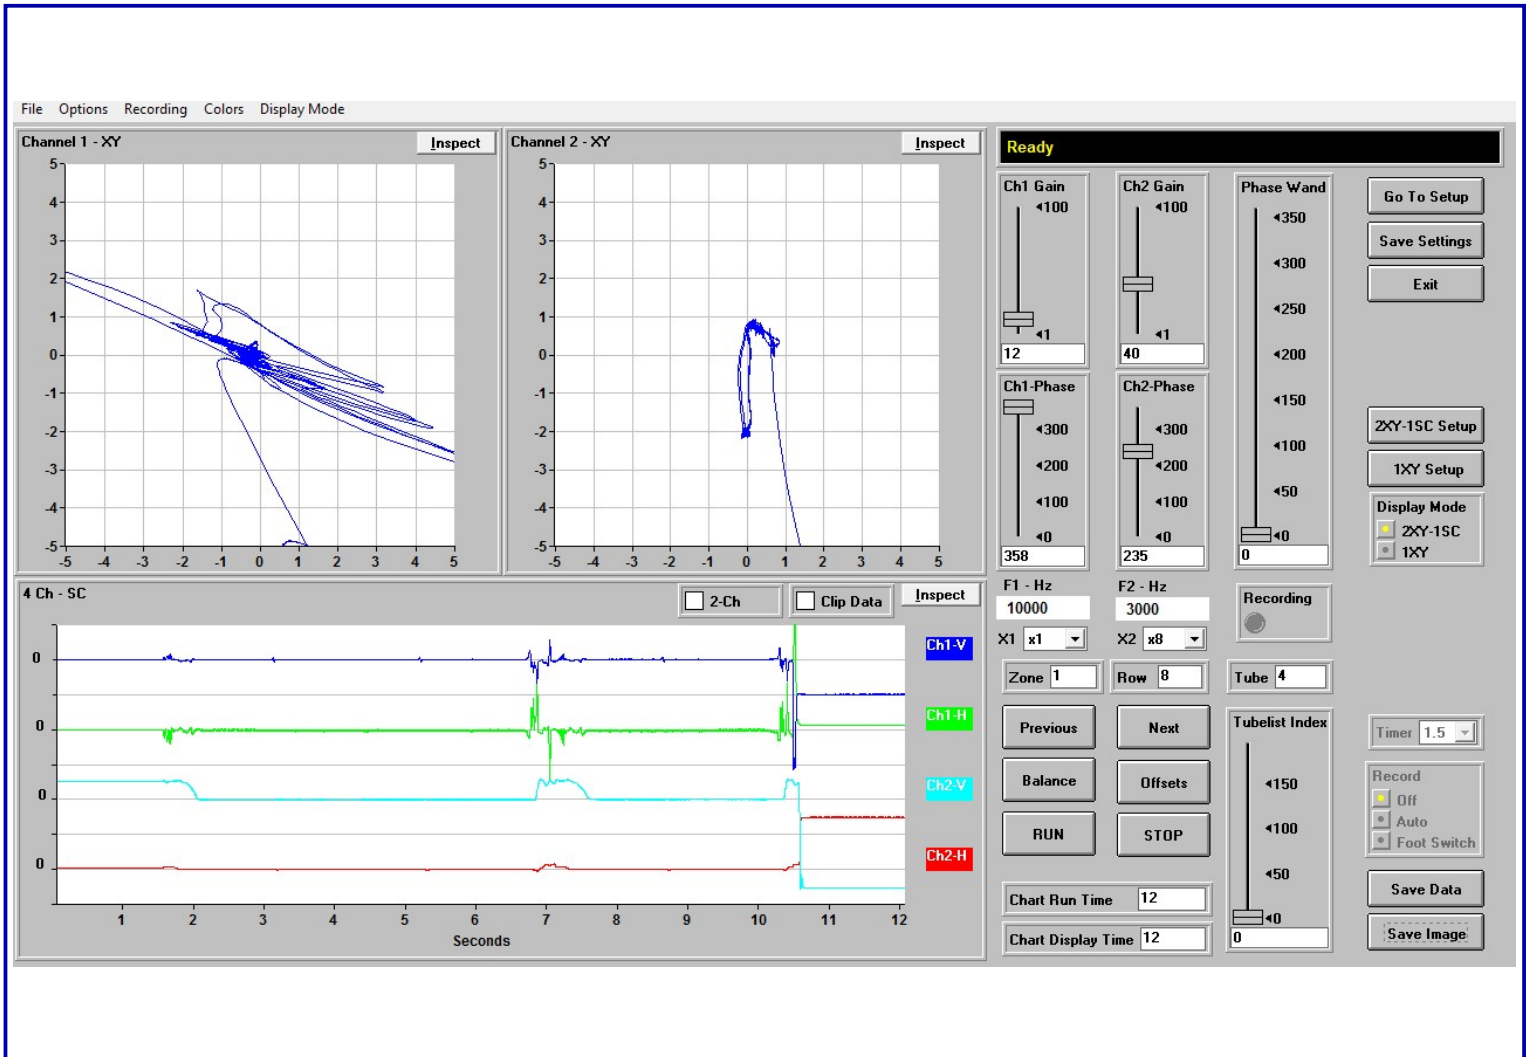
NO SIGNIFICANT DEFECTS (Row 8 Tube 4)

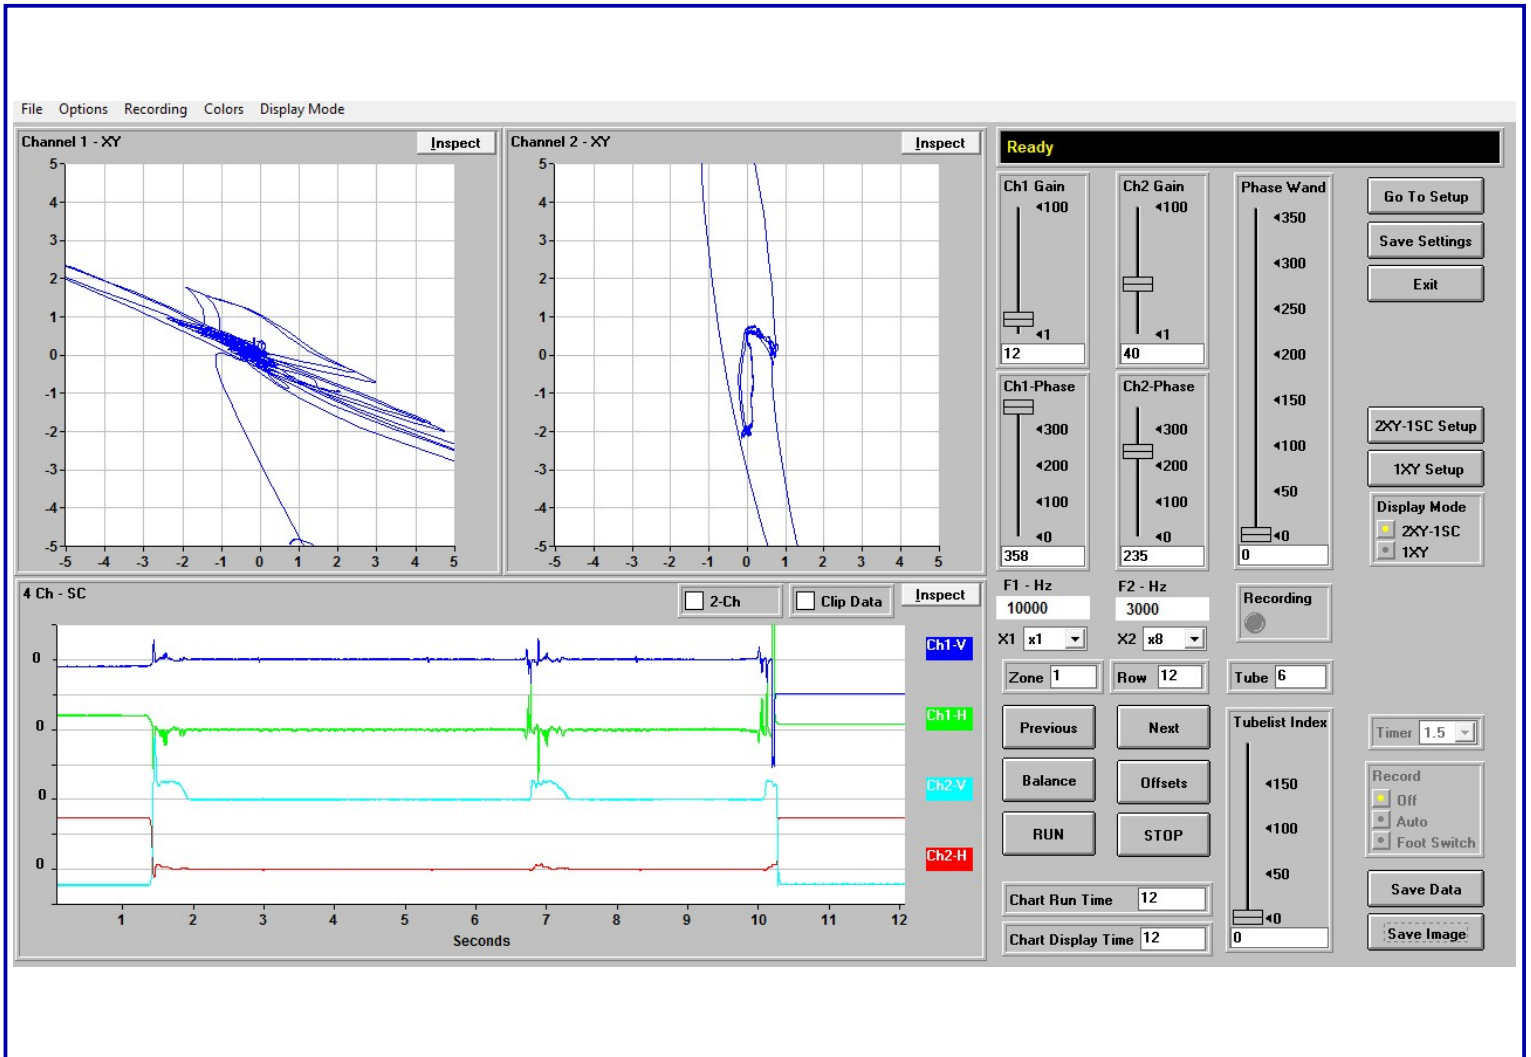
NO SIGNIFICANT DEFECTS (Row 12 Tube 6)

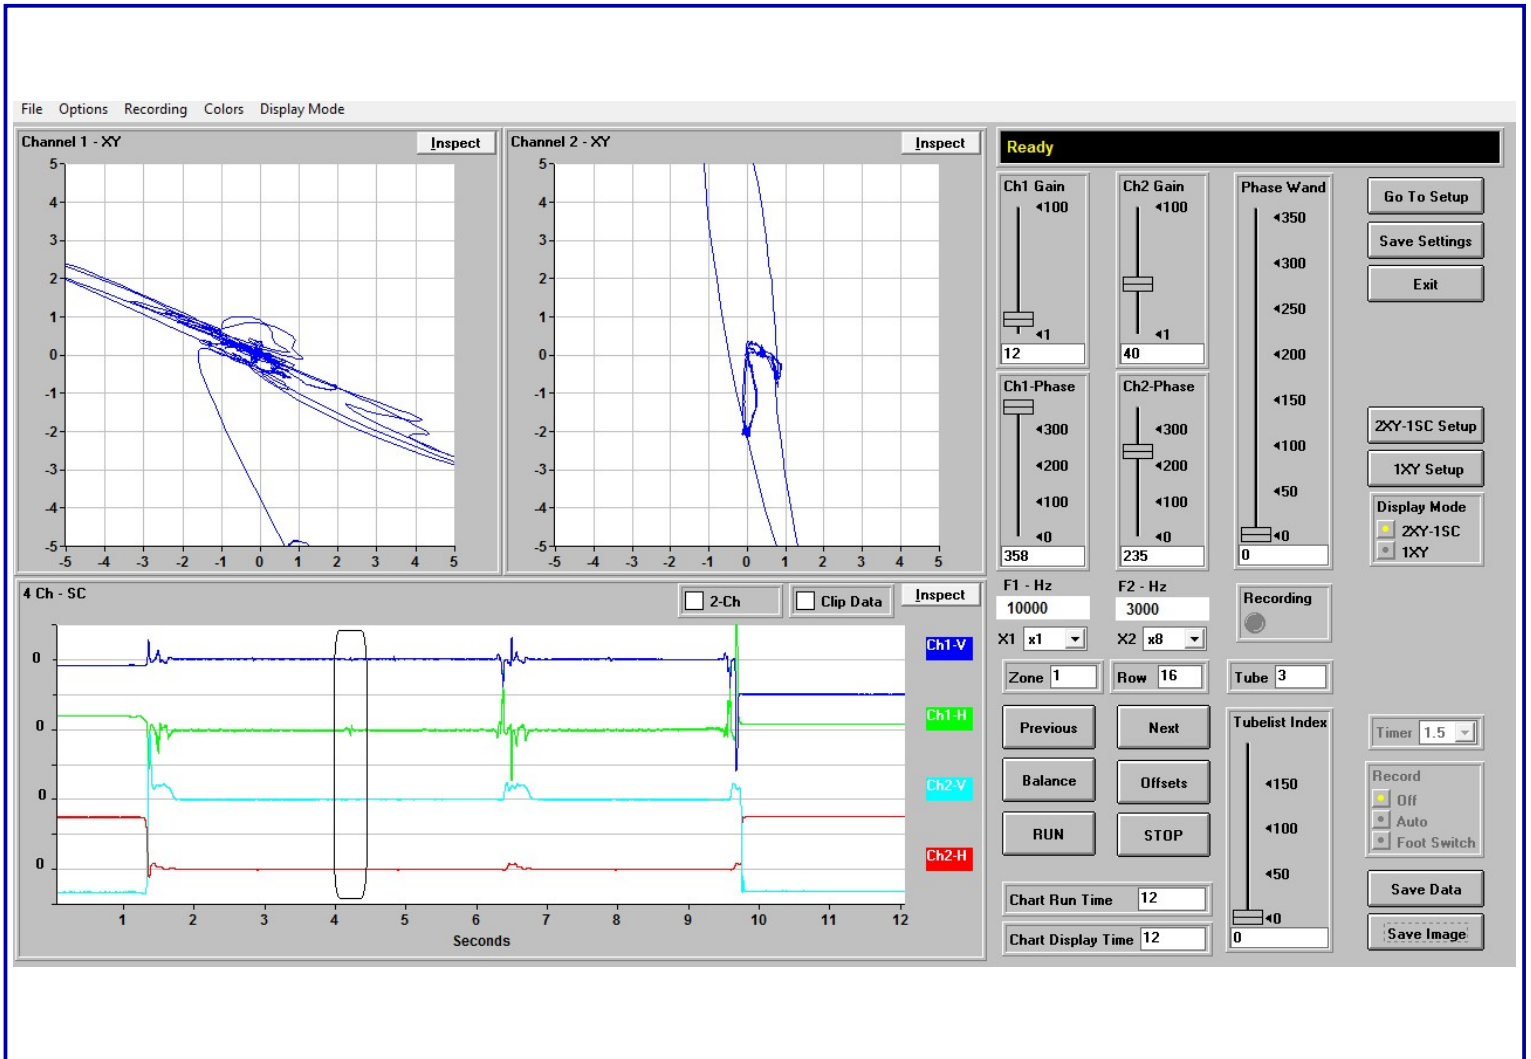
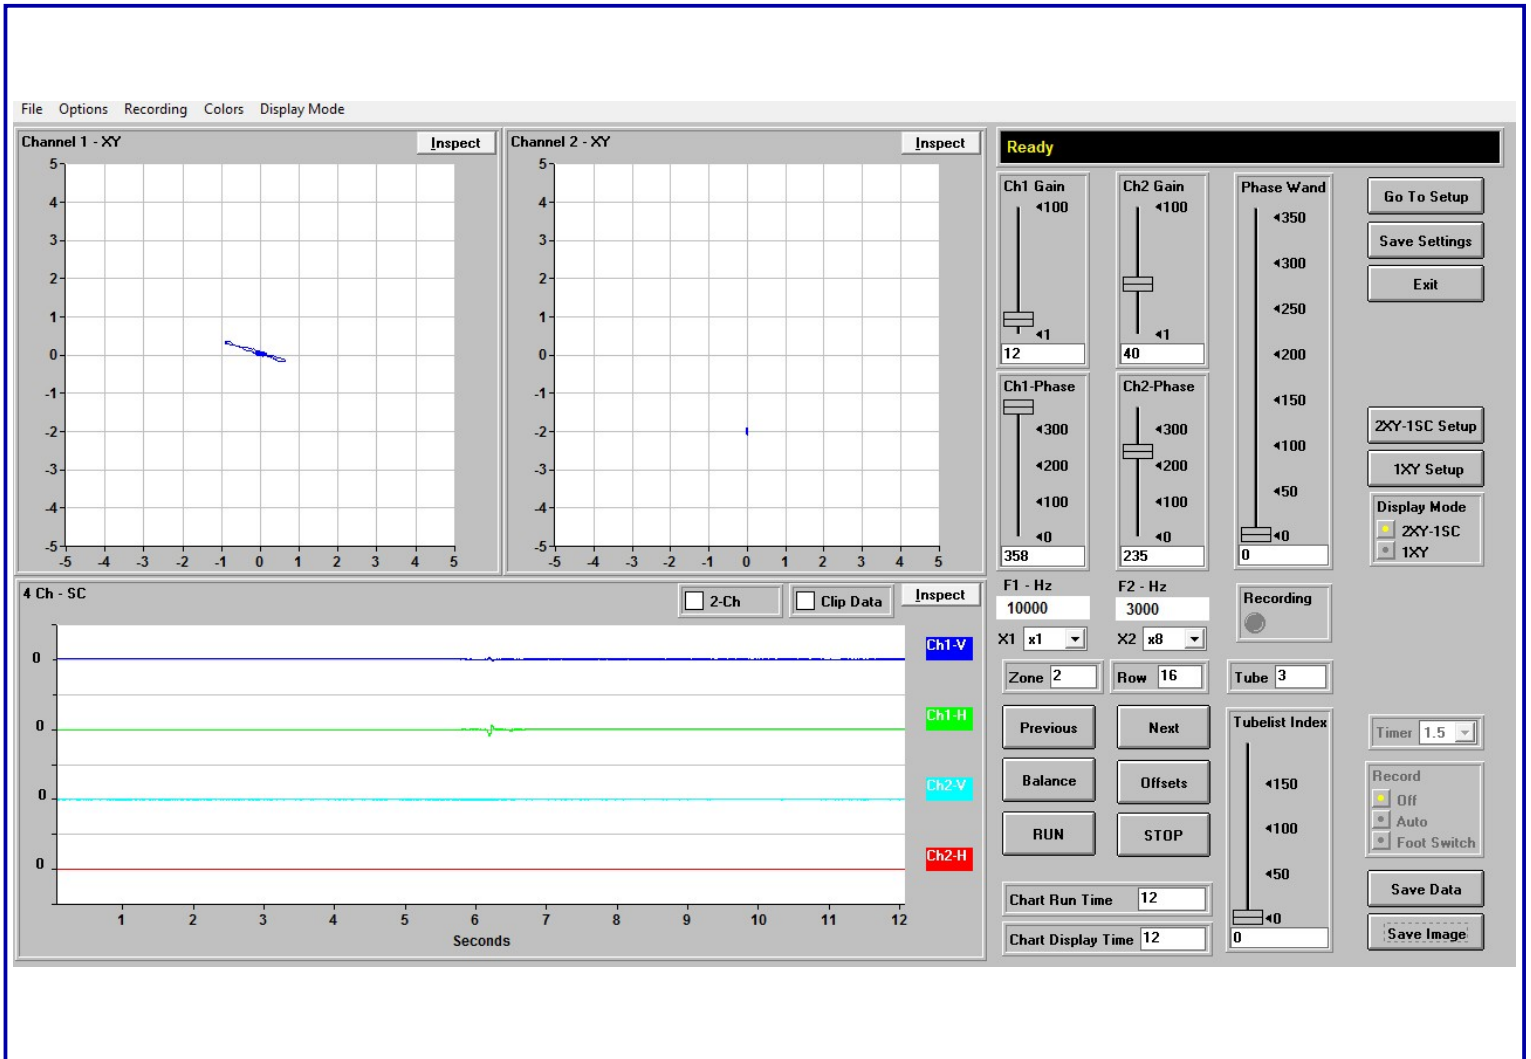
OD PIT < 20% (Row 16 Tube 3)
