## Report of Eddy Current Inspection

Manufacturer: Carrier

Model: 30HXC261RZ

Location: UNIVERSITY OF SOUTH CAROLINA  
HEALTH ED CENTER  
SPARTANBURG, SC 29301

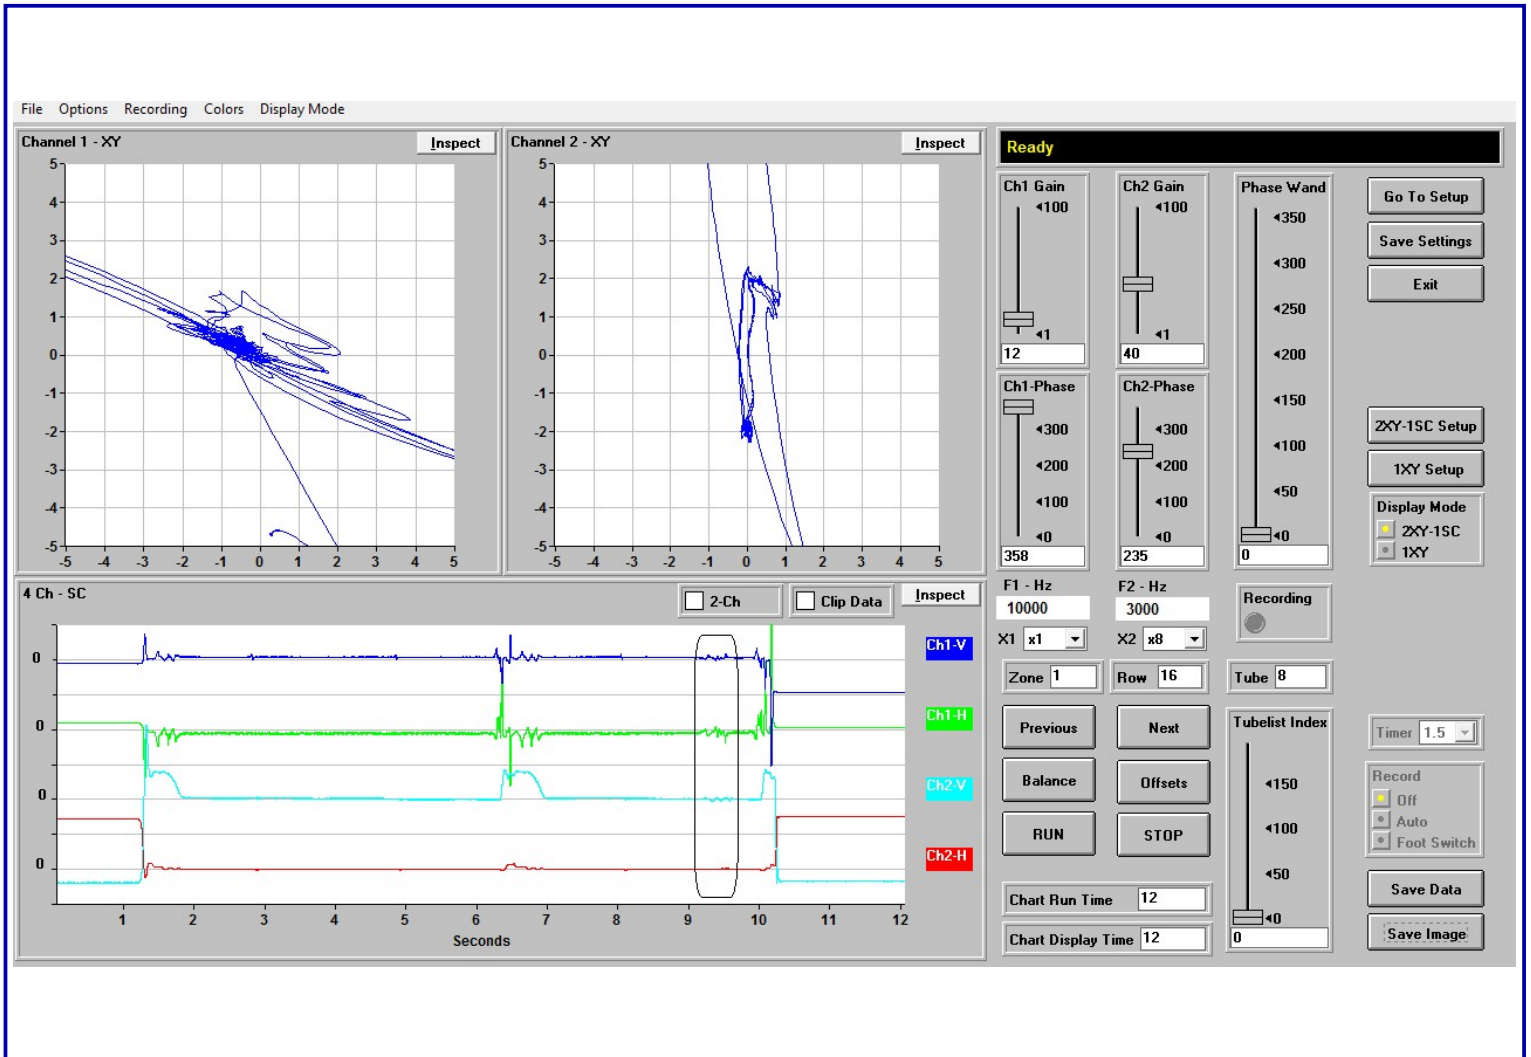
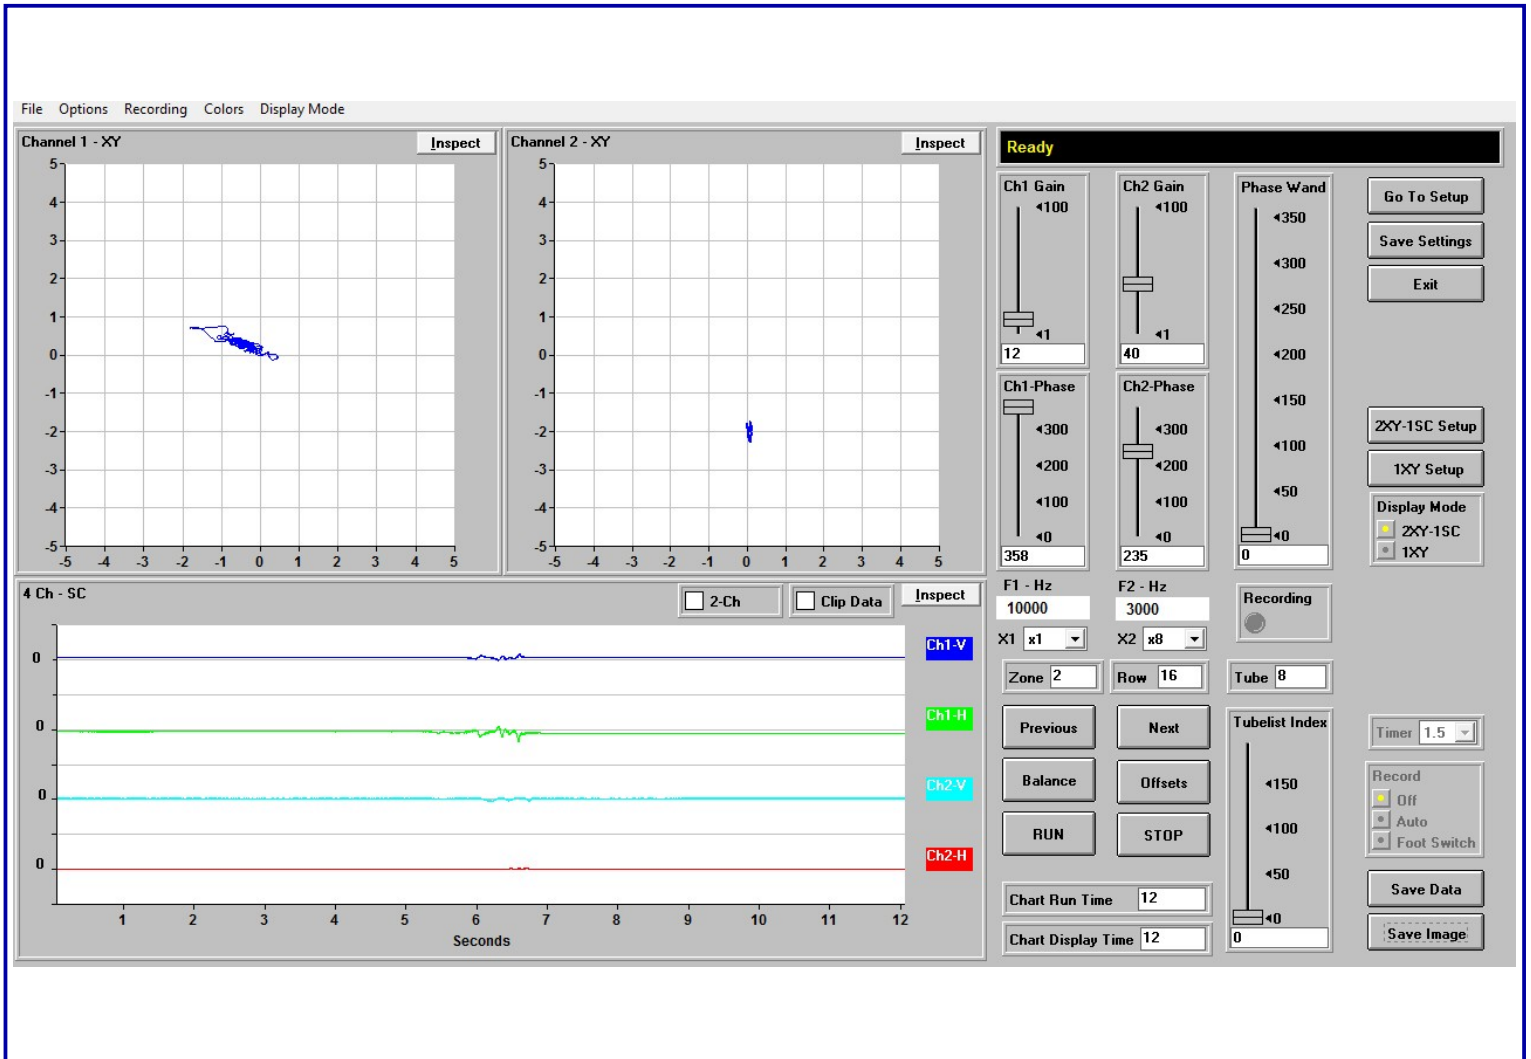
ID PIT < 20% (Row 16 Tube 8)

Tubes indicating ID Pits require no immediate corrective action. However, this type damage is usually progressive and should be monitored.
