Report of Eddy Current Inspection

Manufacturer: Carrier

Model: 23XRV3737

Location: UNIVERSITY OF SOUTH CAROLINA
800 UNIVERSITY WAY
HODGE BUILDING
SPARTANBURG, SC 29303

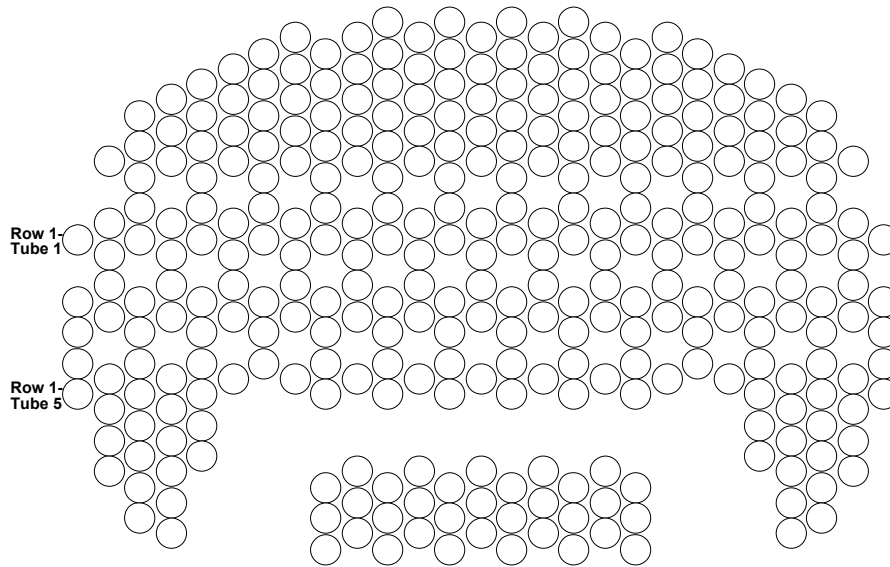
Condenser Section

There were no measurable defects noted during this inspection.

No Significant defects were found.

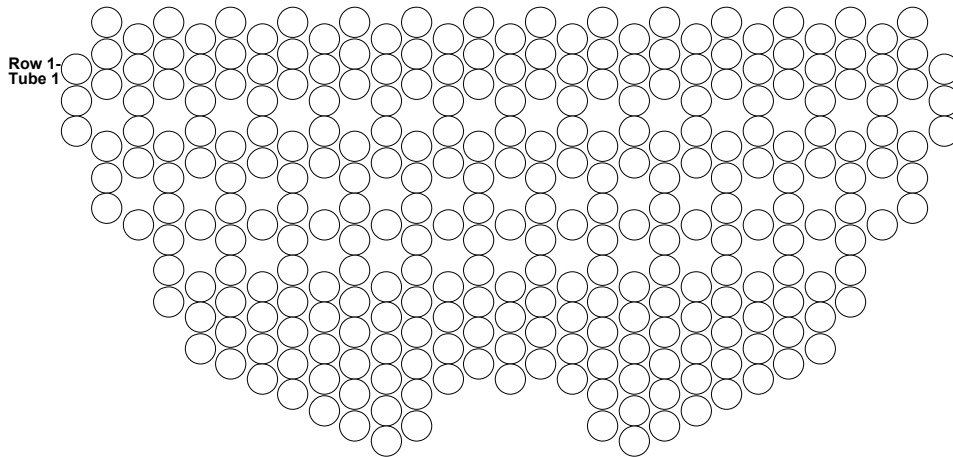
Evaporator Section

There were no measurable defects noted during this inspection.

No Significant defects were found.

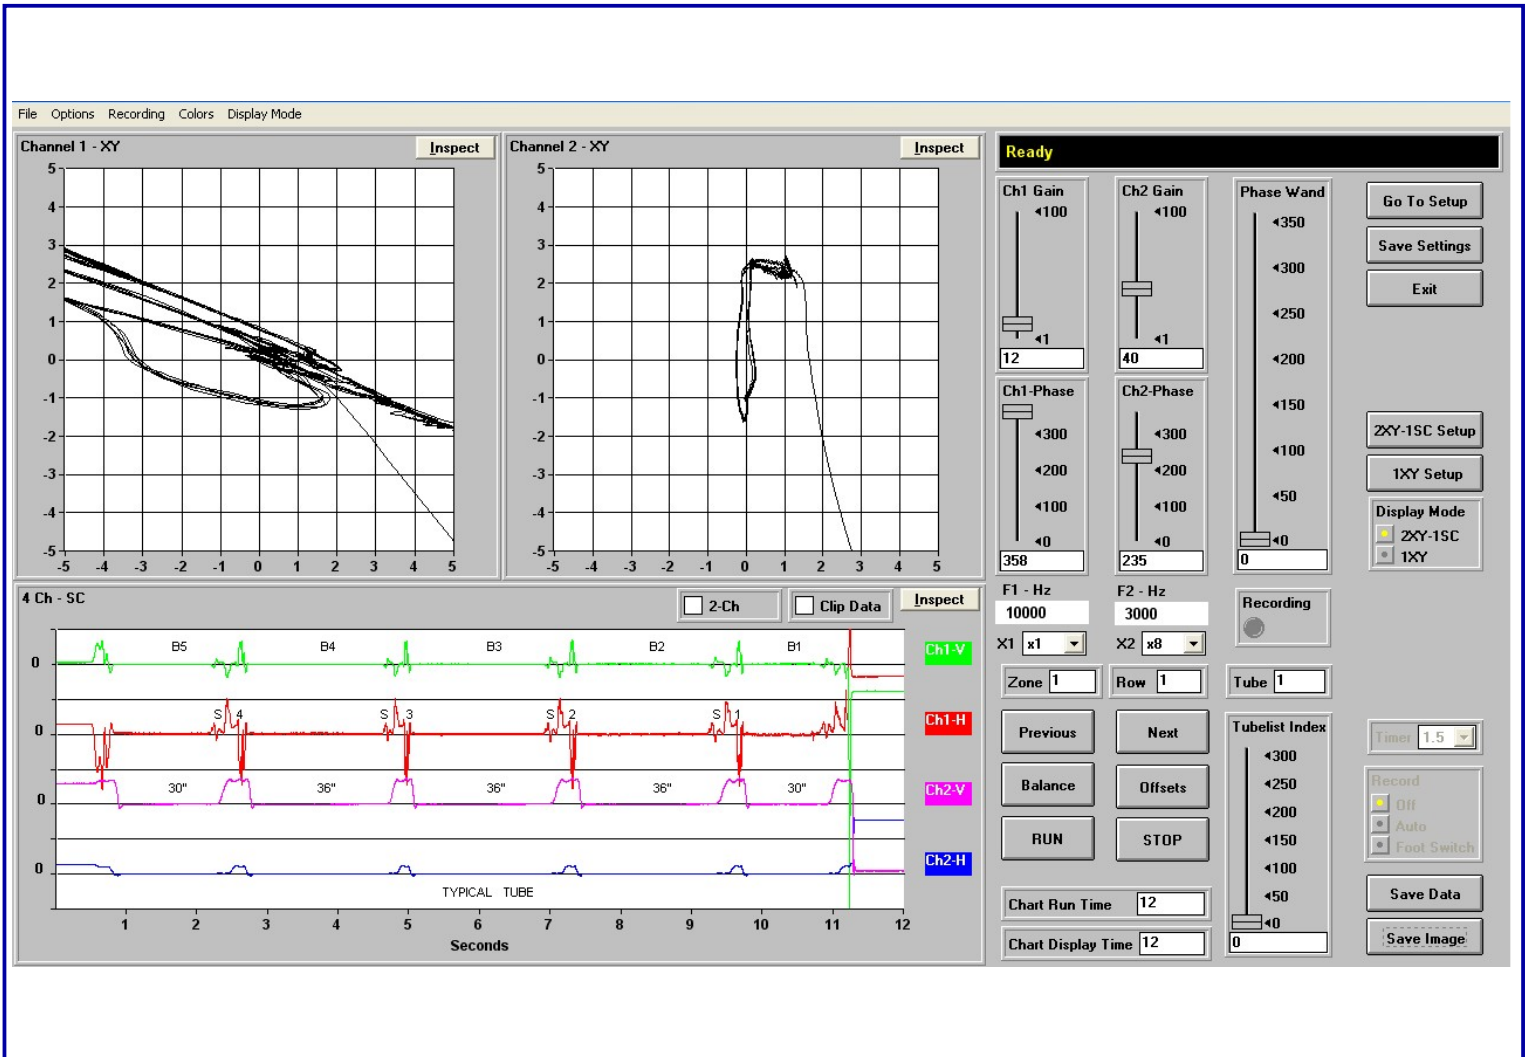
Condenser Section

NO SIGNIFICANT DEFECTS (Row 1 Tube 1)

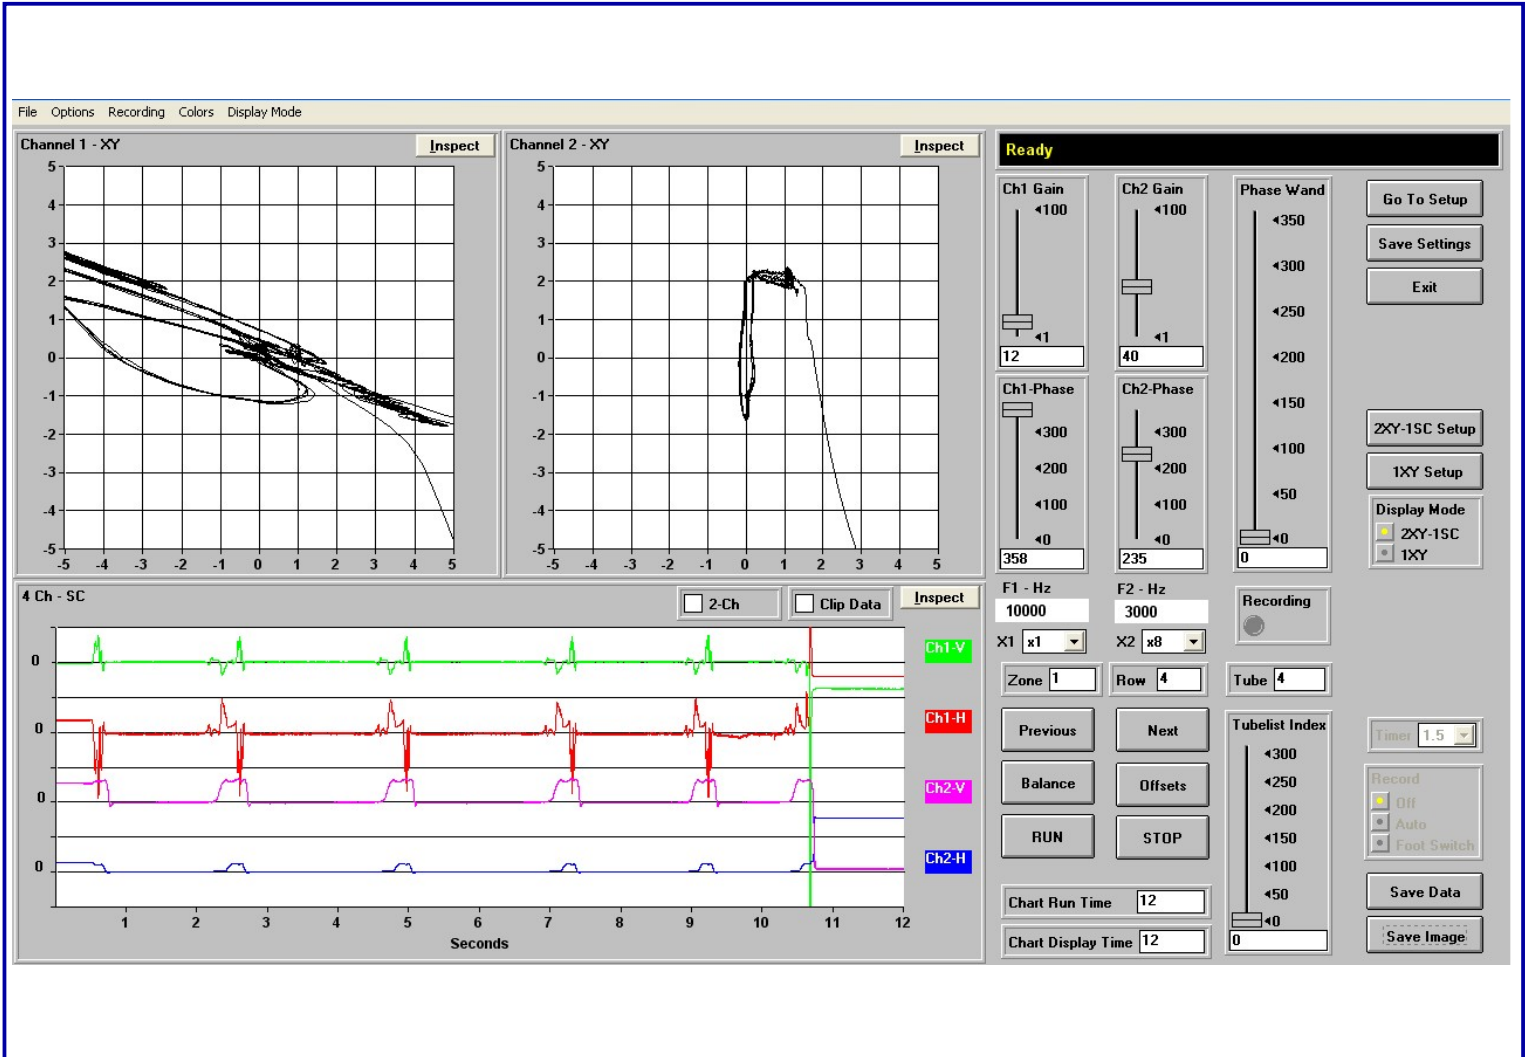
Condenser Section

NO SIGNIFICANT DEFECTS (Row 4 Tube 4)

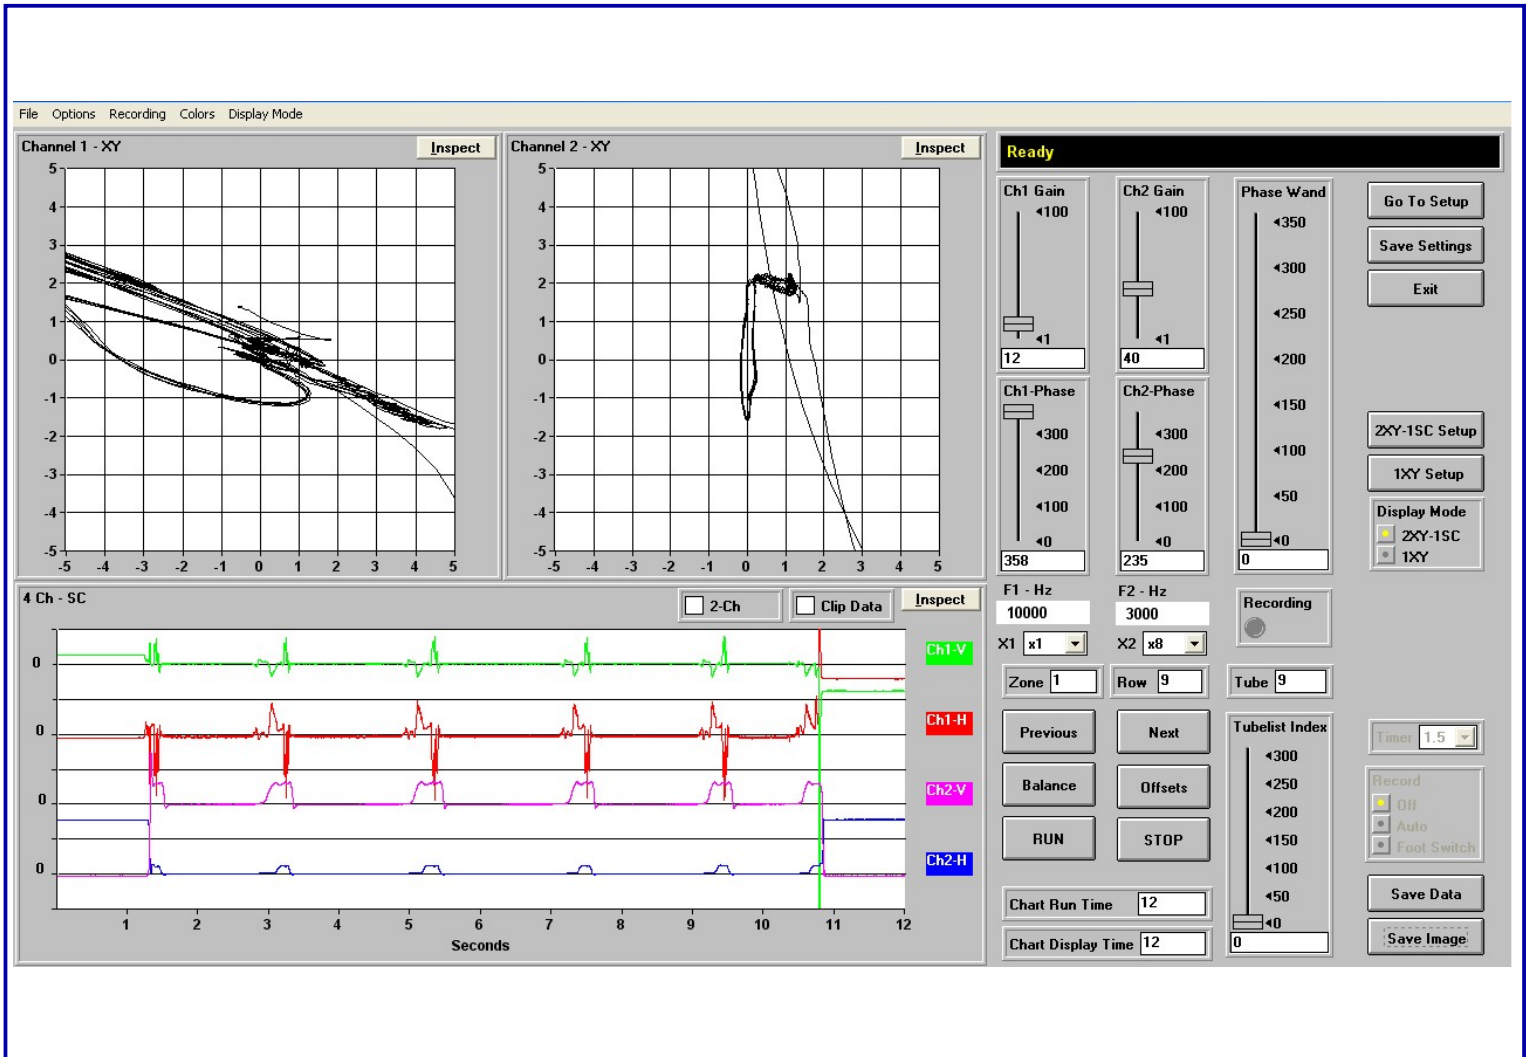
Condenser Section

NO SIGNIFICANT DEFECTS (Row 9 Tube 9)

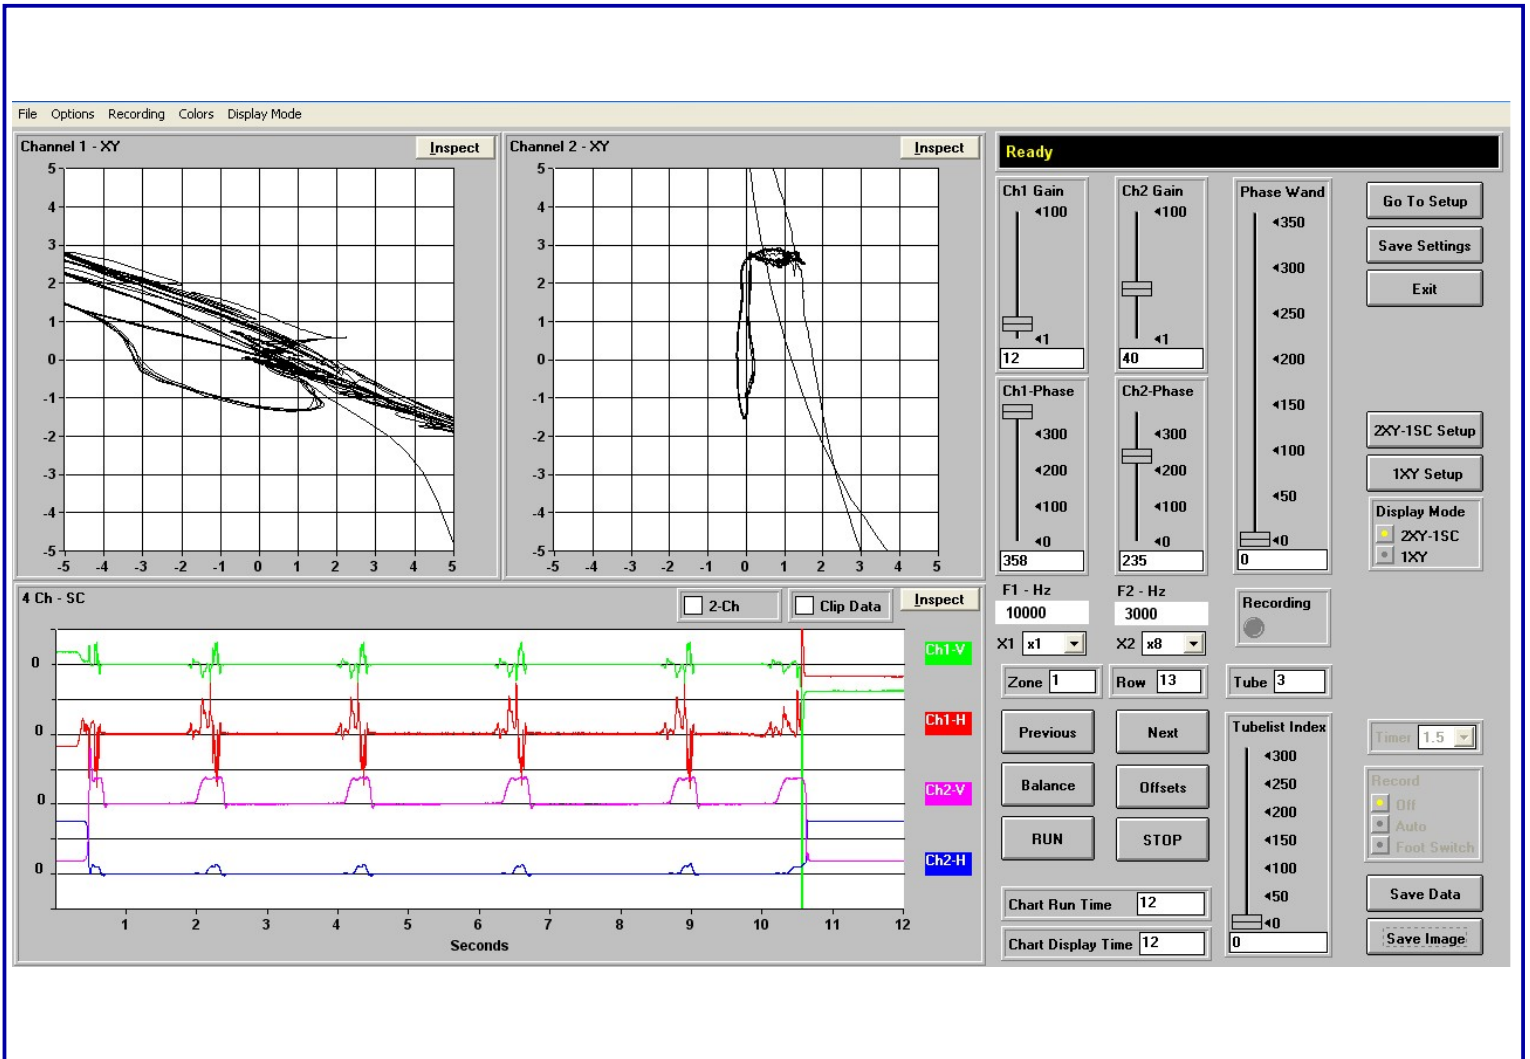
Condenser Section

NO SIGNIFICANT DEFECTS (Row 13 Tube 3)

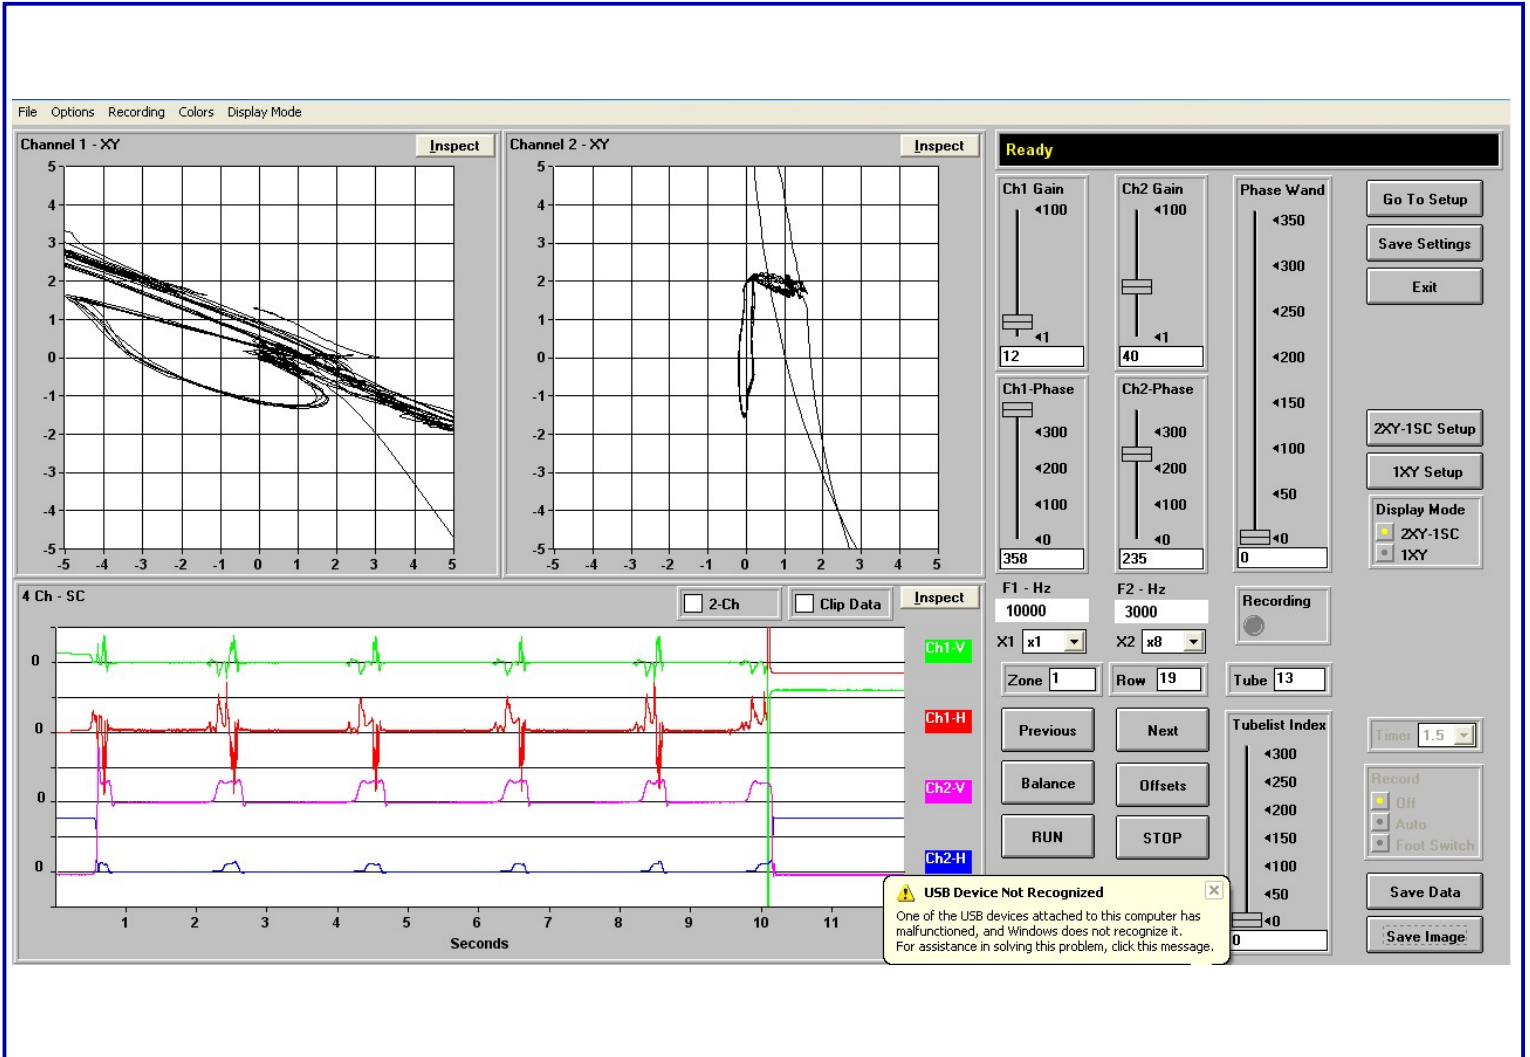
Condenser Section

NO SIGNIFICANT DEFECTS (Row 19 Tube 13)

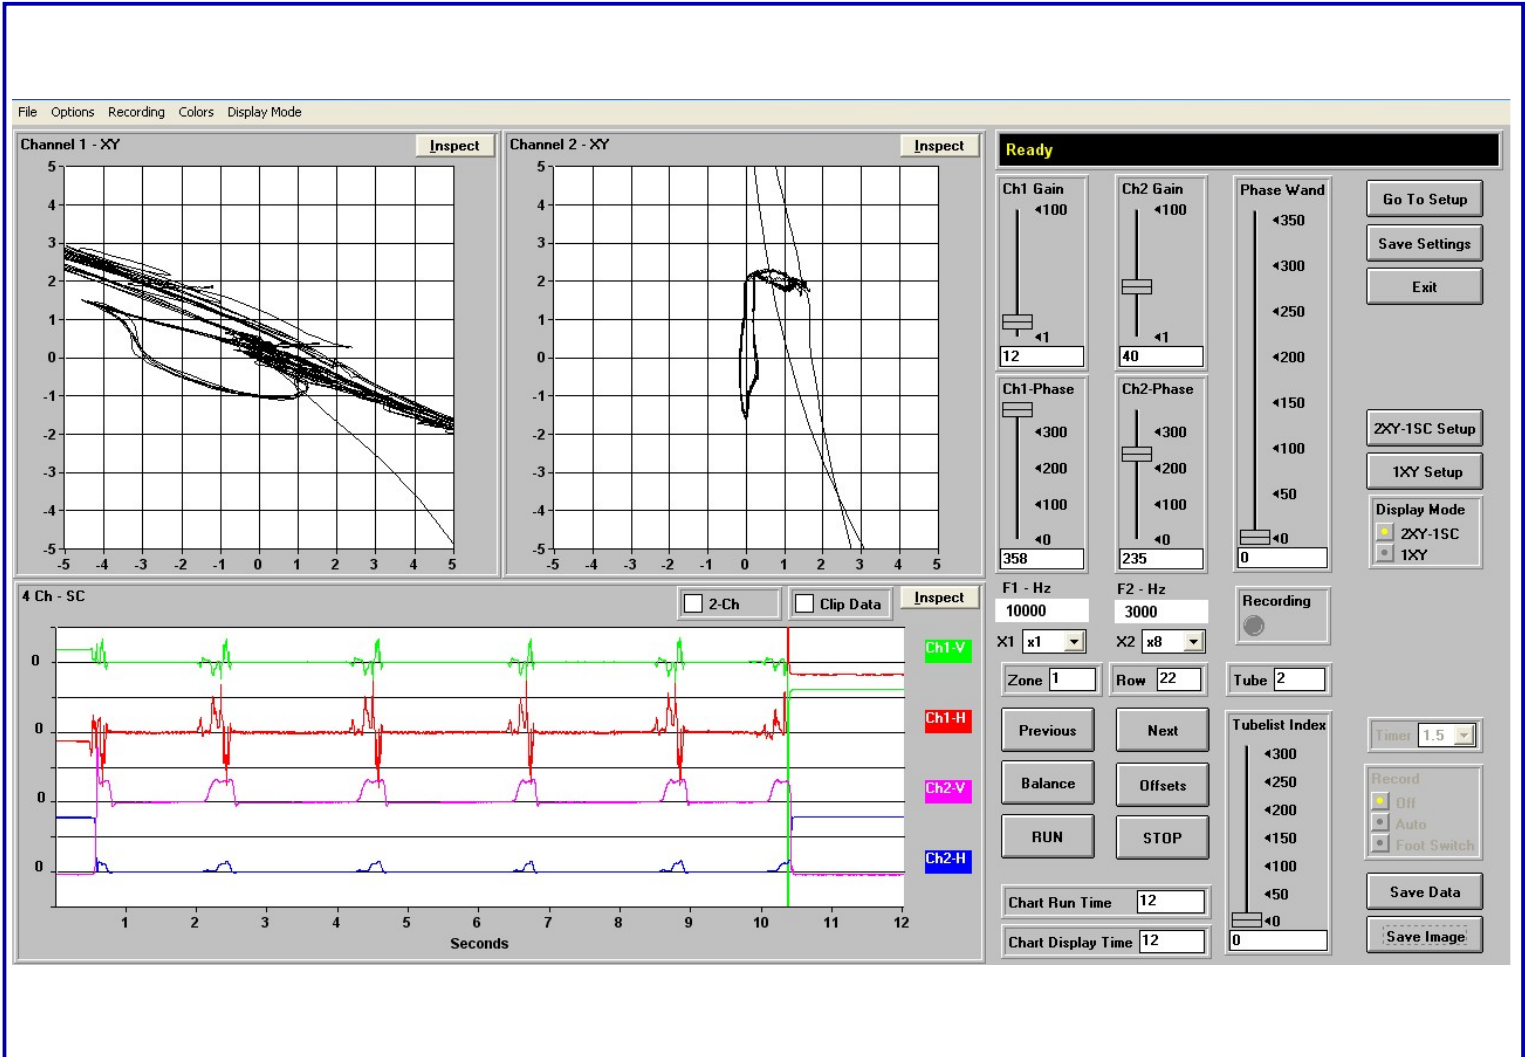
Condenser Section

NO SIGNIFICANT DEFECTS (Row 22 Tube 2)

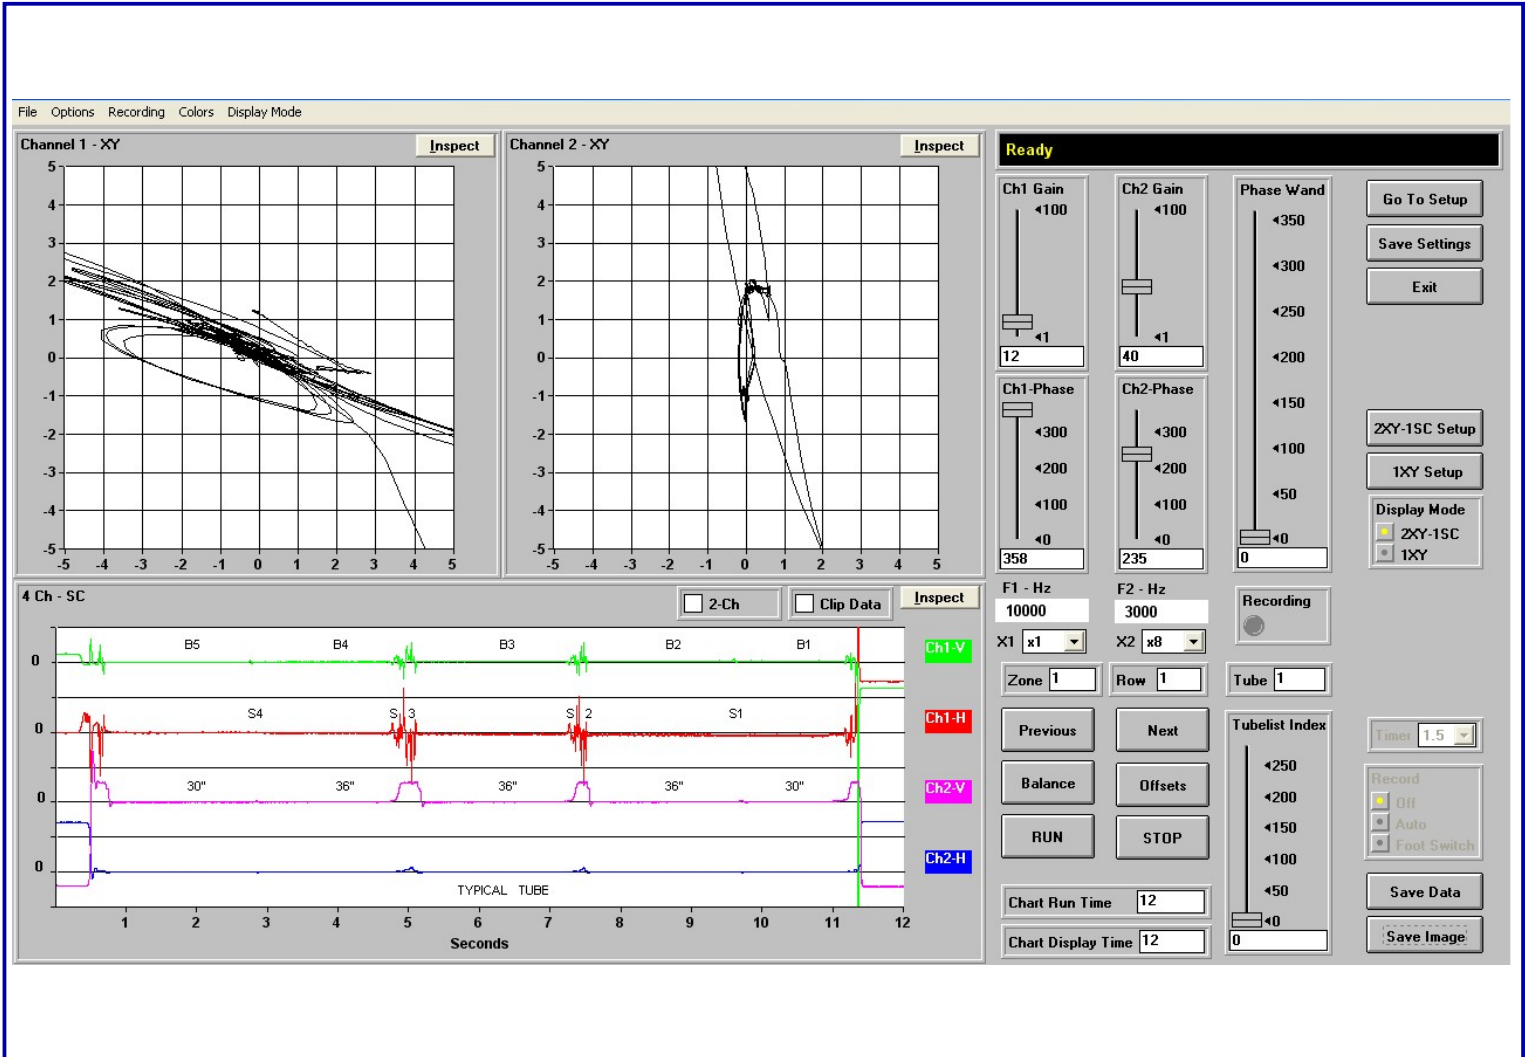
Evaporator Section

NO SIGNIFICANT DEFECTS (Row 1 Tube 1)

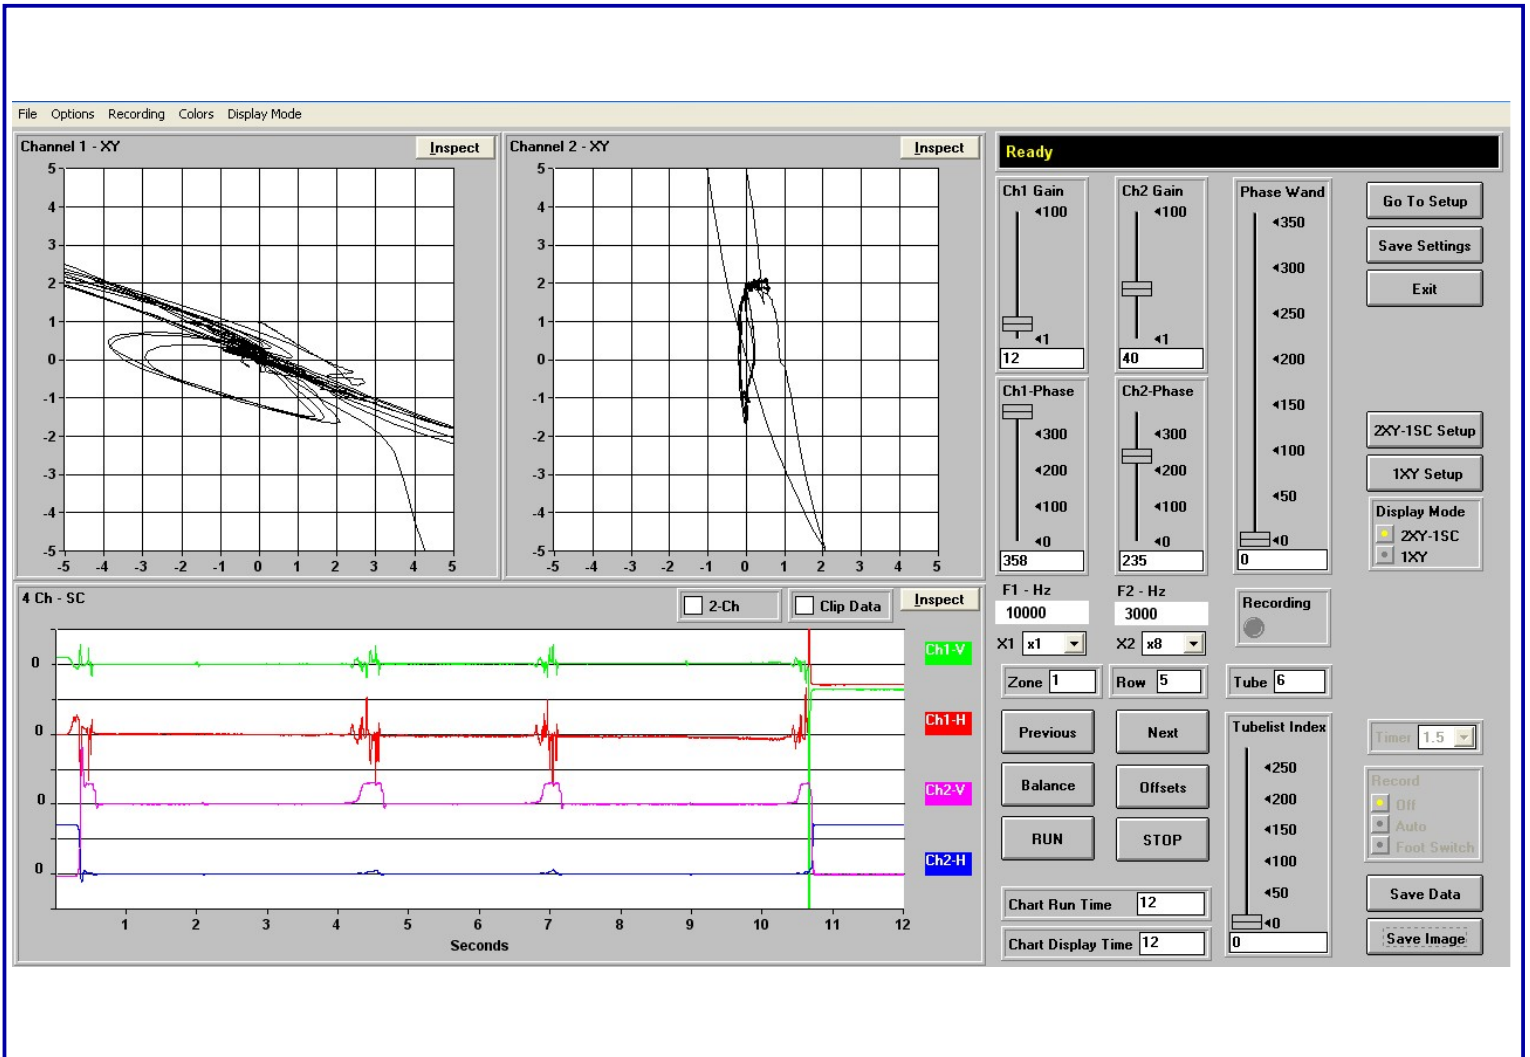
Evaporator Section

NO SIGNIFICANT DEFECTS (Row 5 Tube 6)

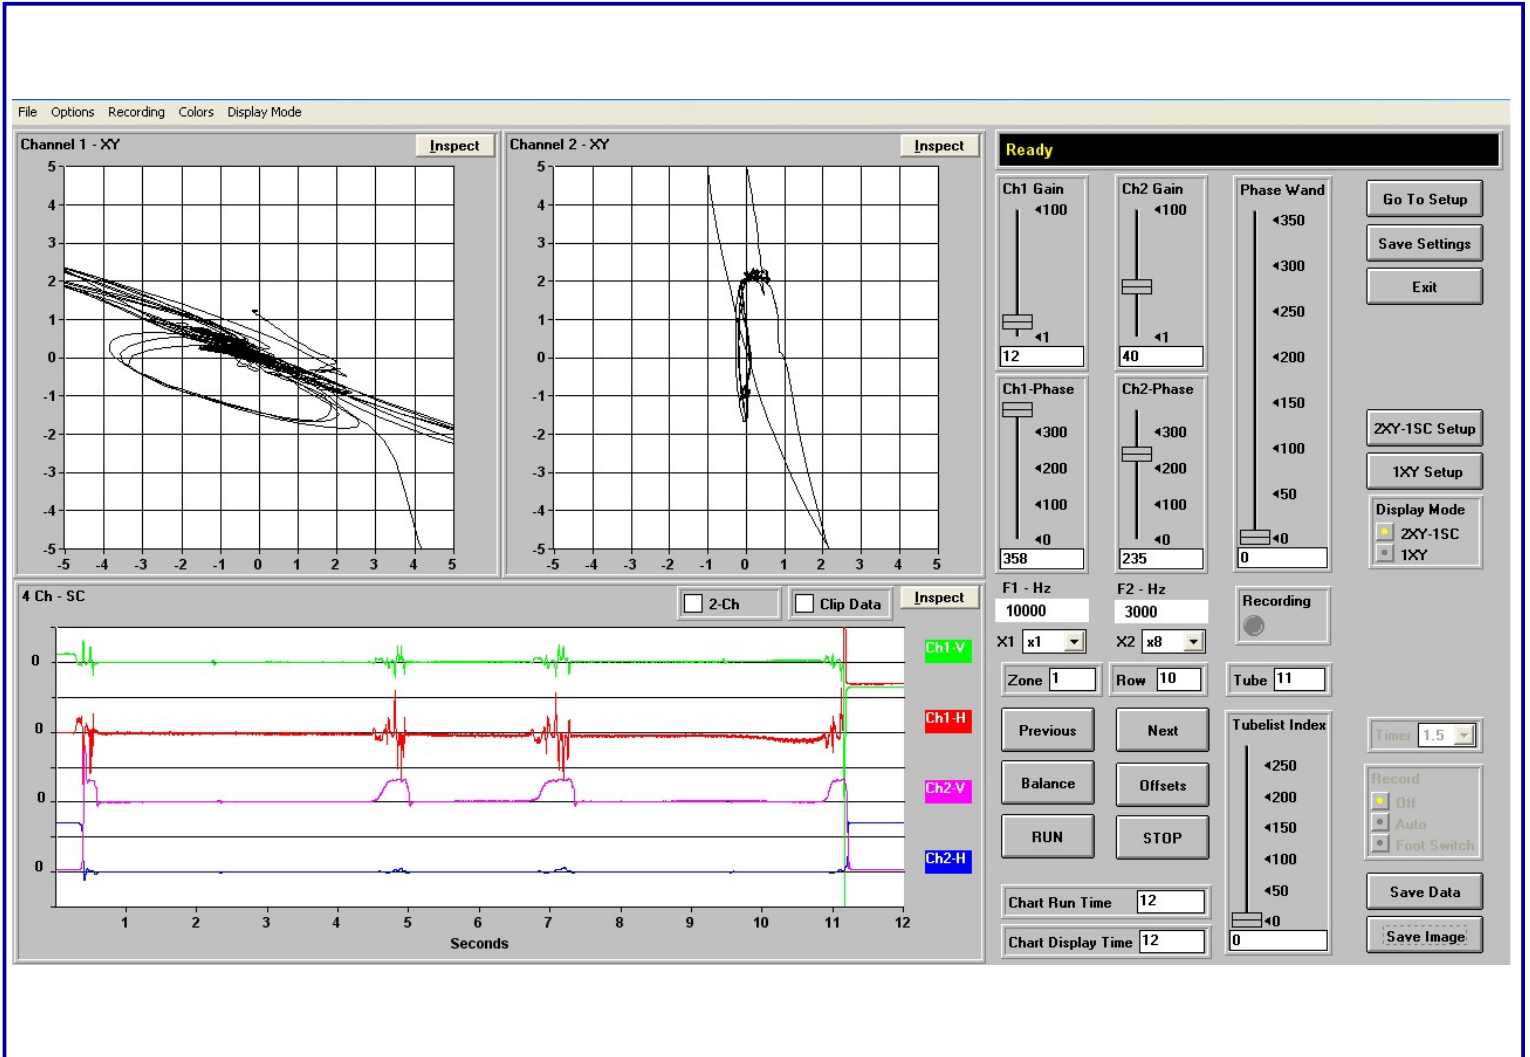
Evaporator Section

NO SIGNIFICANT DEFECTS (Row 10 Tube 11)

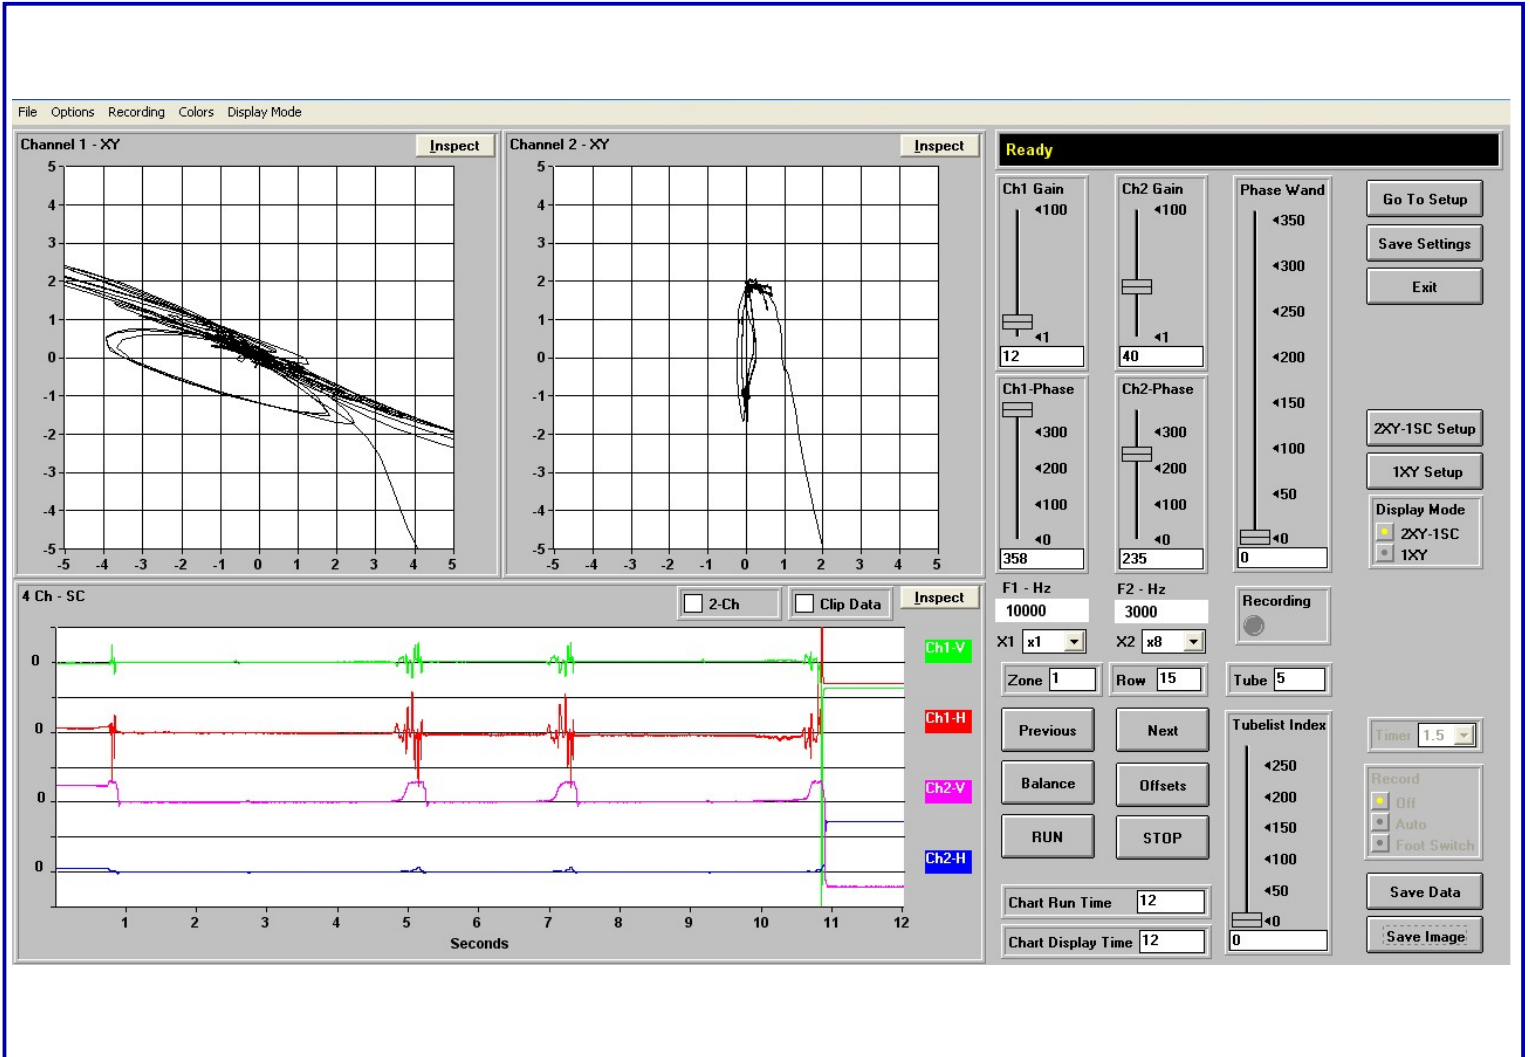
Evaporator Section

NO SIGNIFICANT DEFECTS (Row 15 Tube 5)

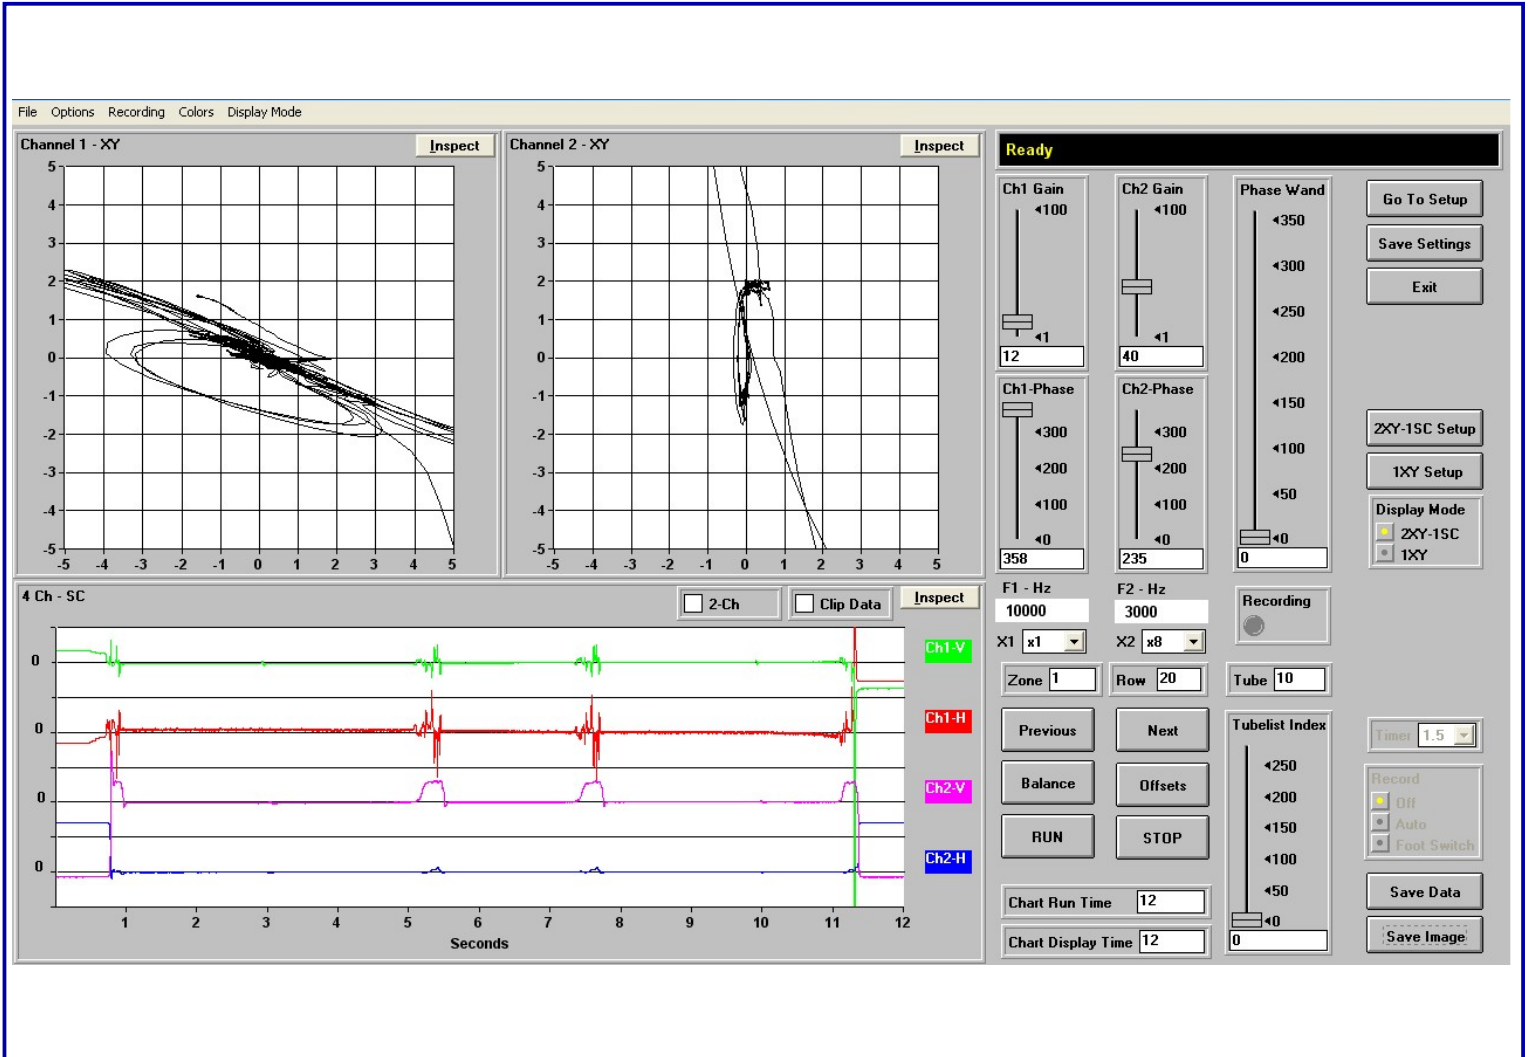
Evaporator Section

NO SIGNIFICANT DEFECTS (Row 20 Tube 10)

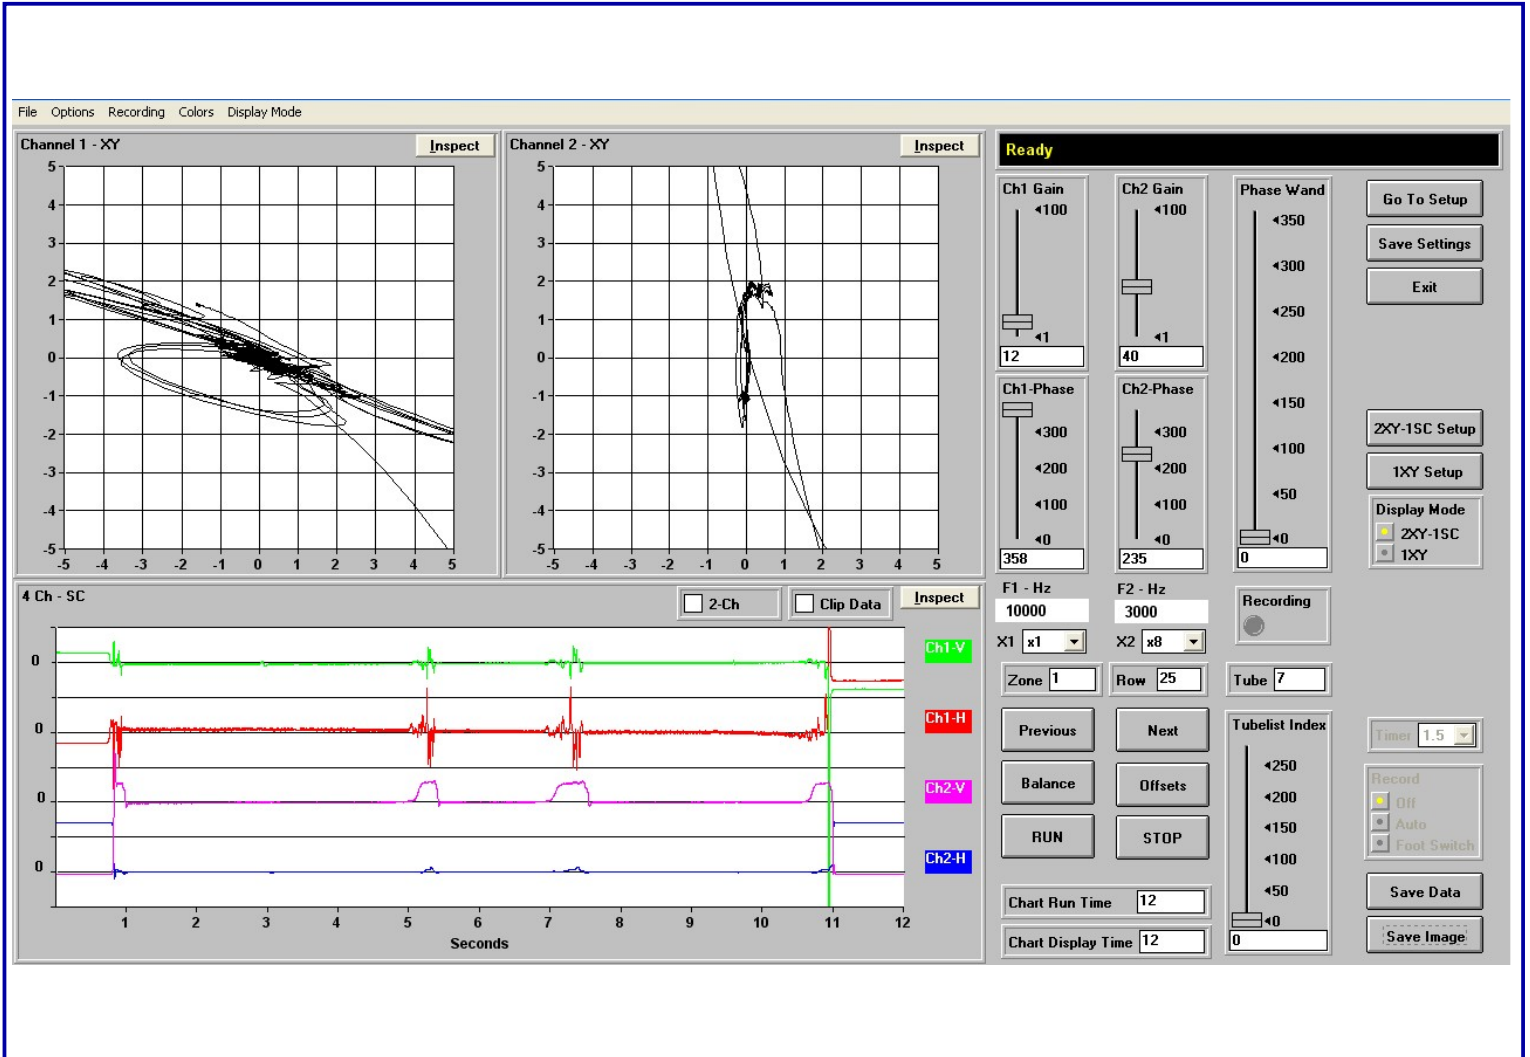
Evaporator Section

NO SIGNIFICANT DEFECTS (Row 25 Tube 7)
