Report of Eddy Current Inspection

Manufacturer: Carrier

Model: 19XR4546

Location: UNIVERSITY OF SOUTH CAROLINA
HODGE BUILDING
SPARTANBURG, SC 29301

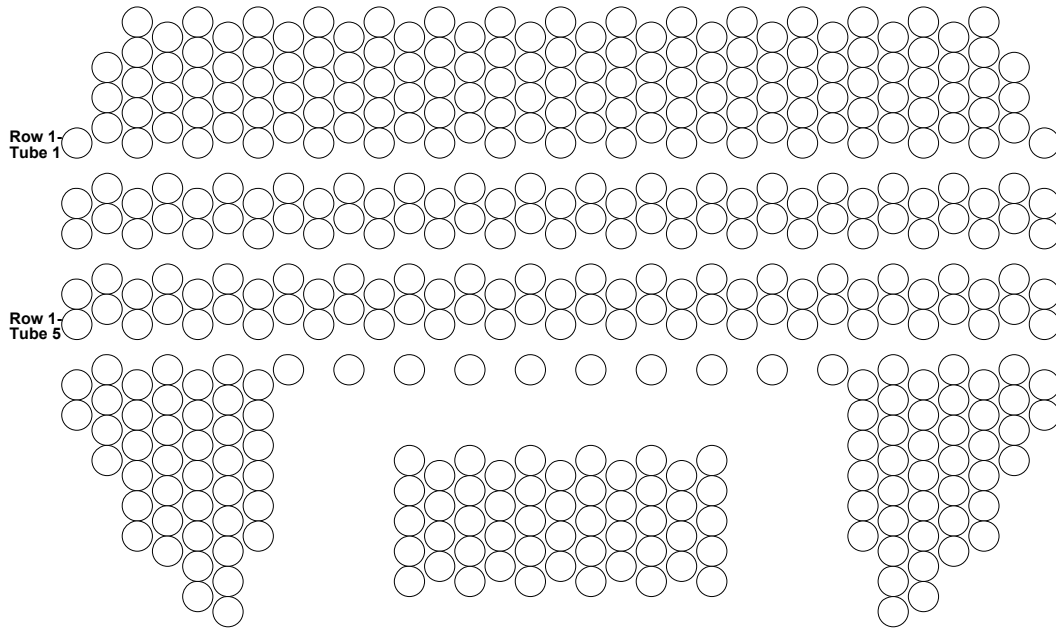
Condenser Section

No Significant defects were found.

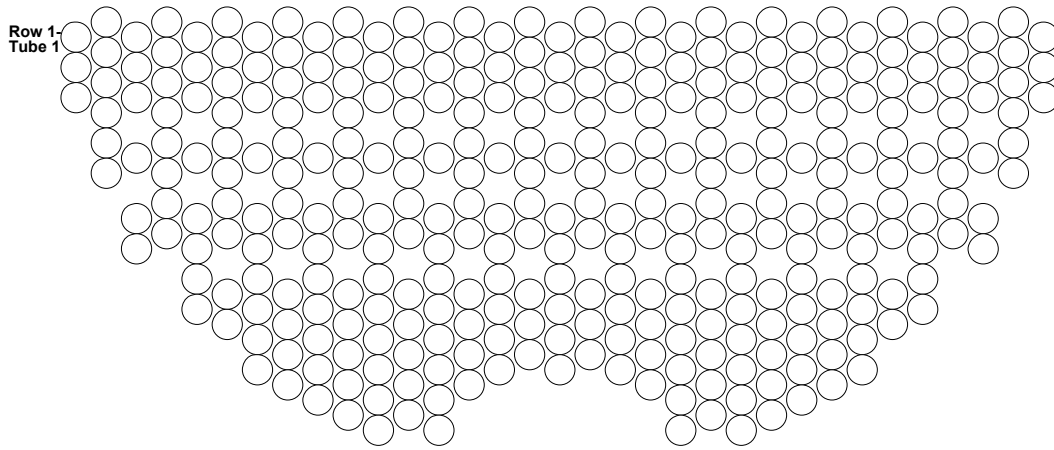
Evaporator Section

No Significant defects were found.

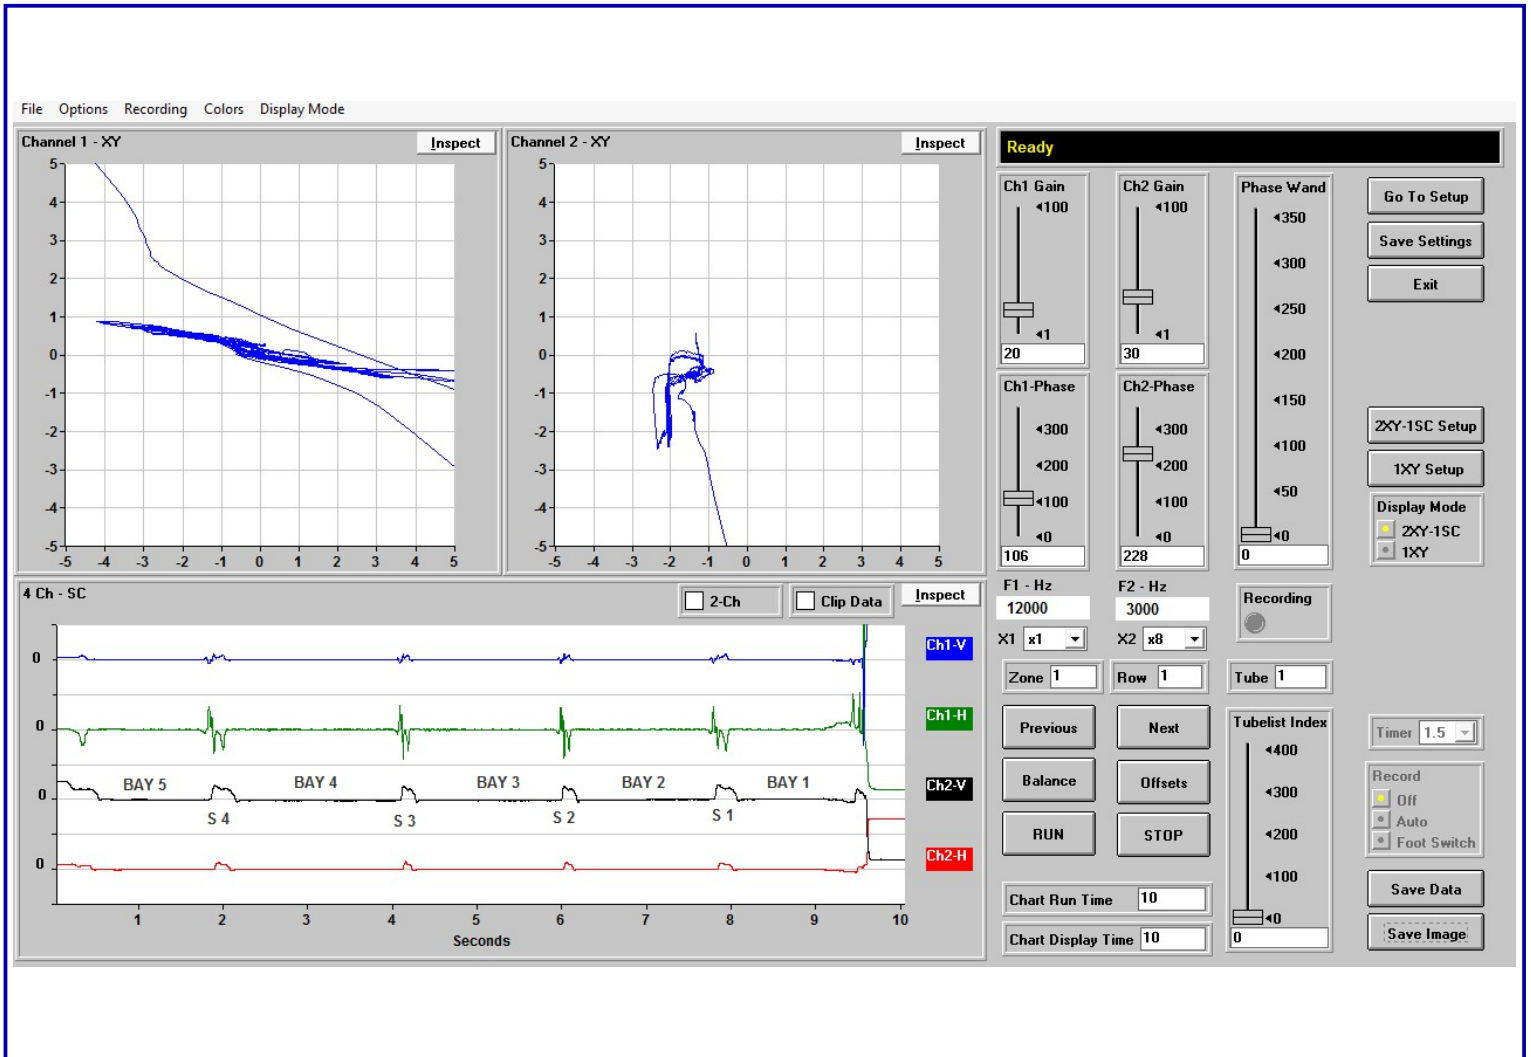
Condenser Section

TYPICAL GOOD TUBE (Row 1 Tube 1)

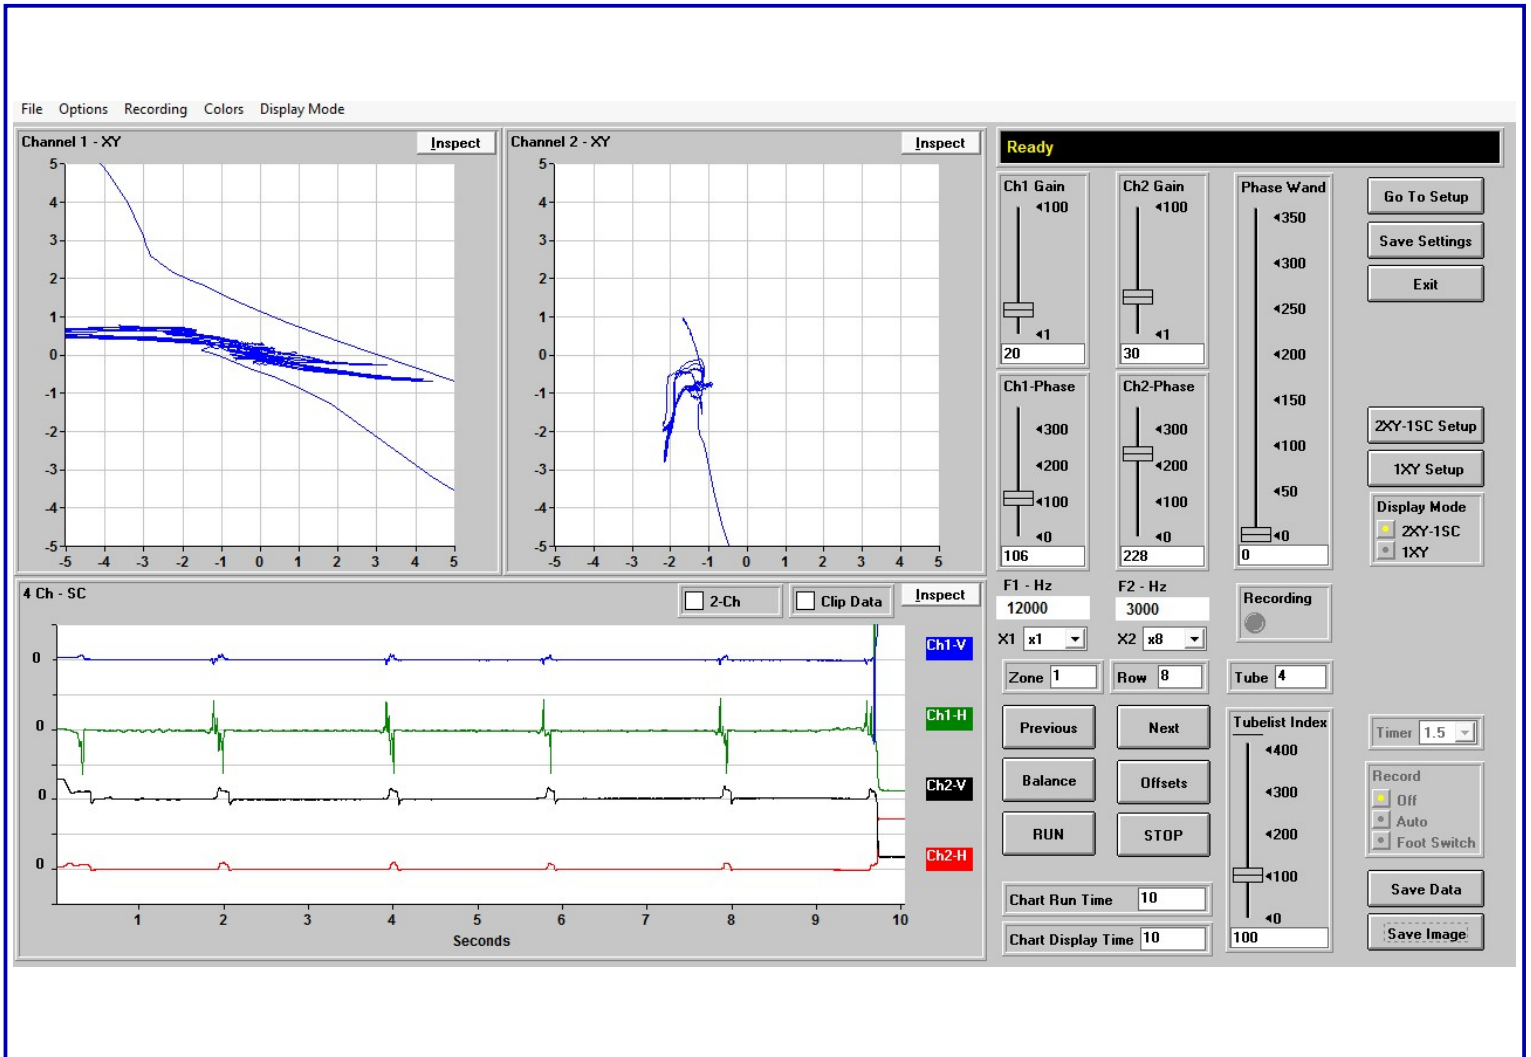
Condenser Section

NO SIGNIFICANT DEFECTS (Row 8 Tube 4)

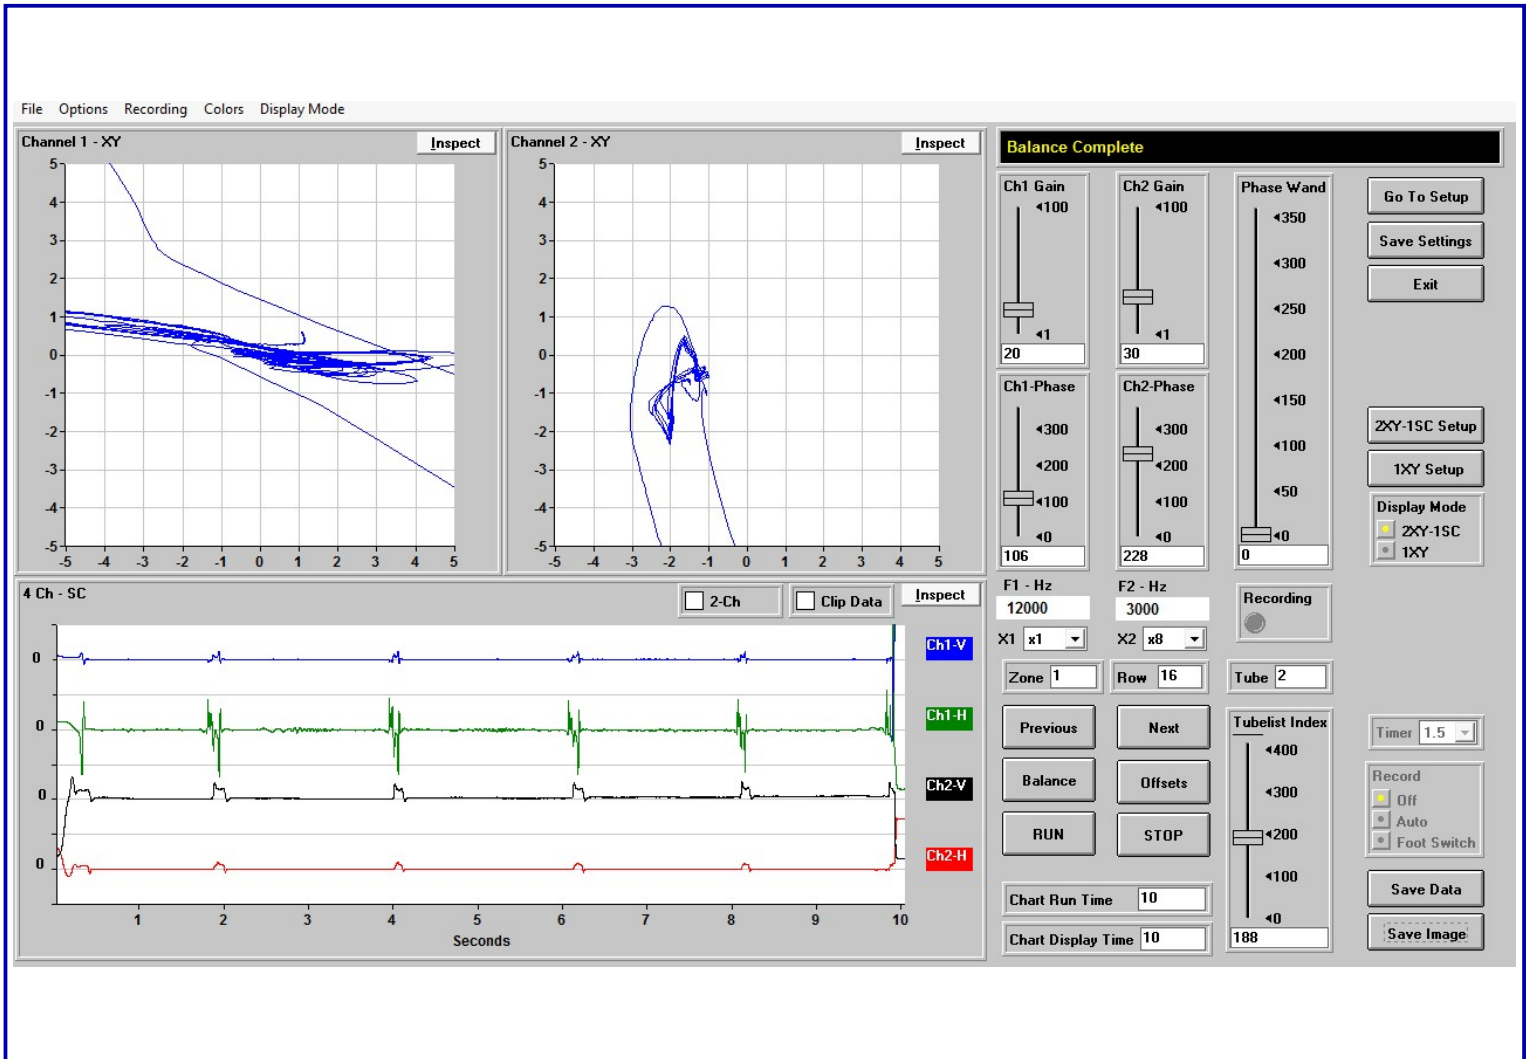
Condenser Section

NO SIGNIFICANT DEFECTS (Row 16 Tube 2)

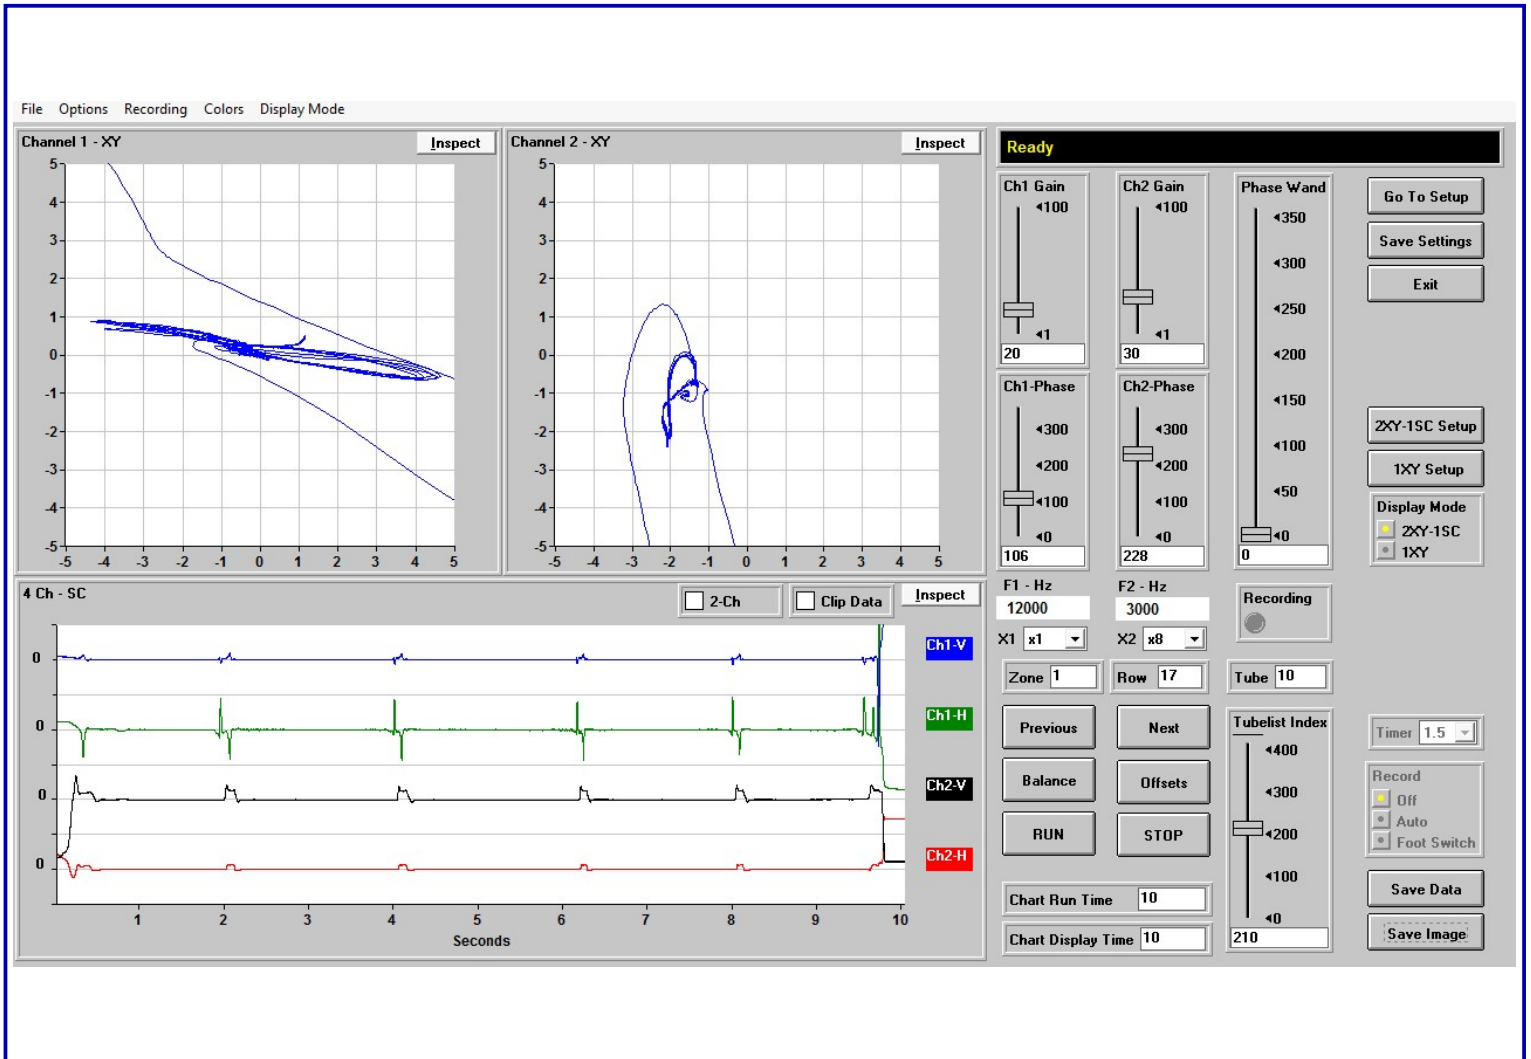
Condenser Section

NO SIGNIFICANT DEFECTS (Row 17 Tube 10)

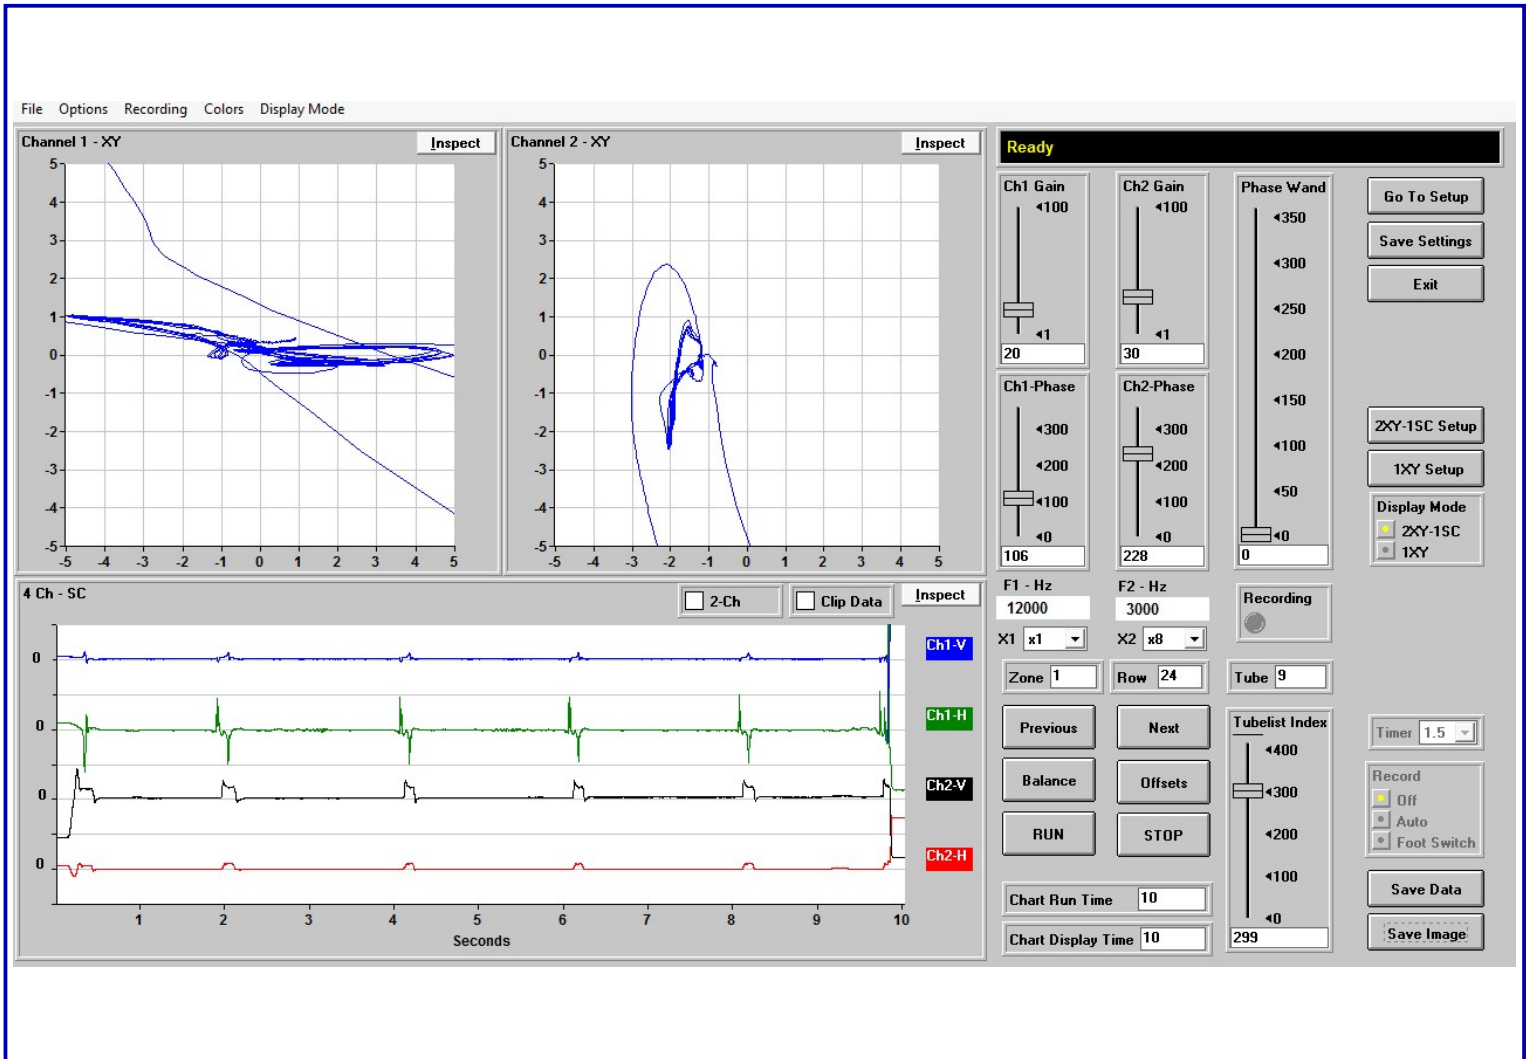
Condenser Section

NO SIGNIFICANT DEFECTS (Row 24 Tube 9)

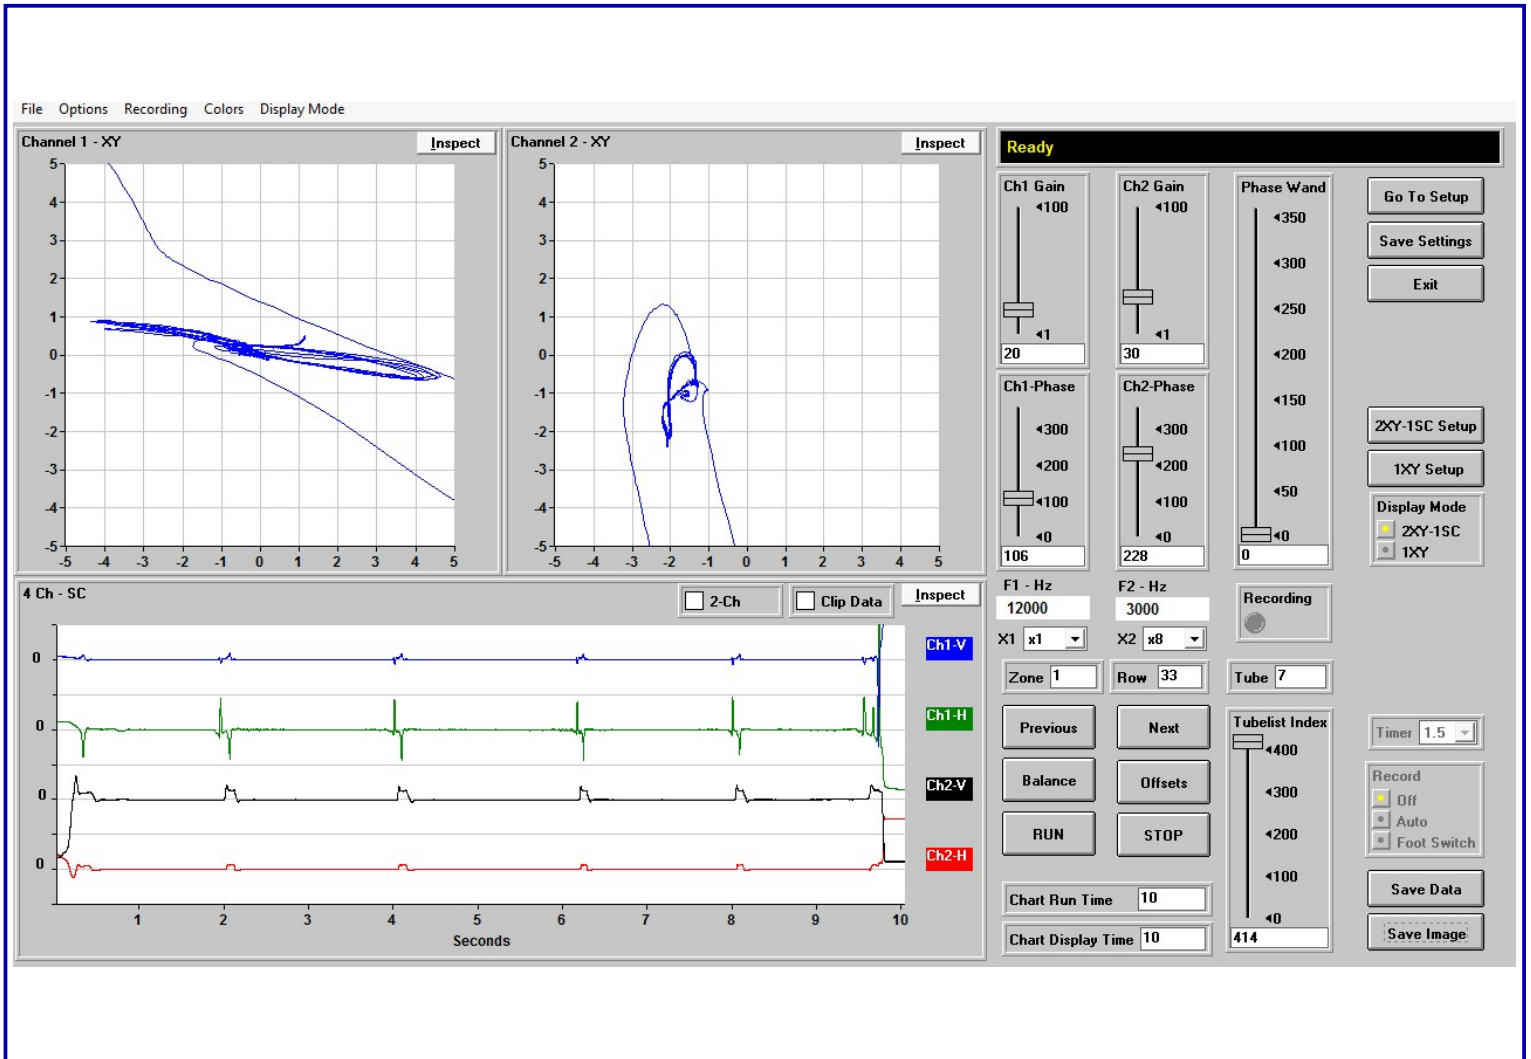
Condenser Section

NO SIGNIFICANT DEFECTS (Row 33 Tube 7)

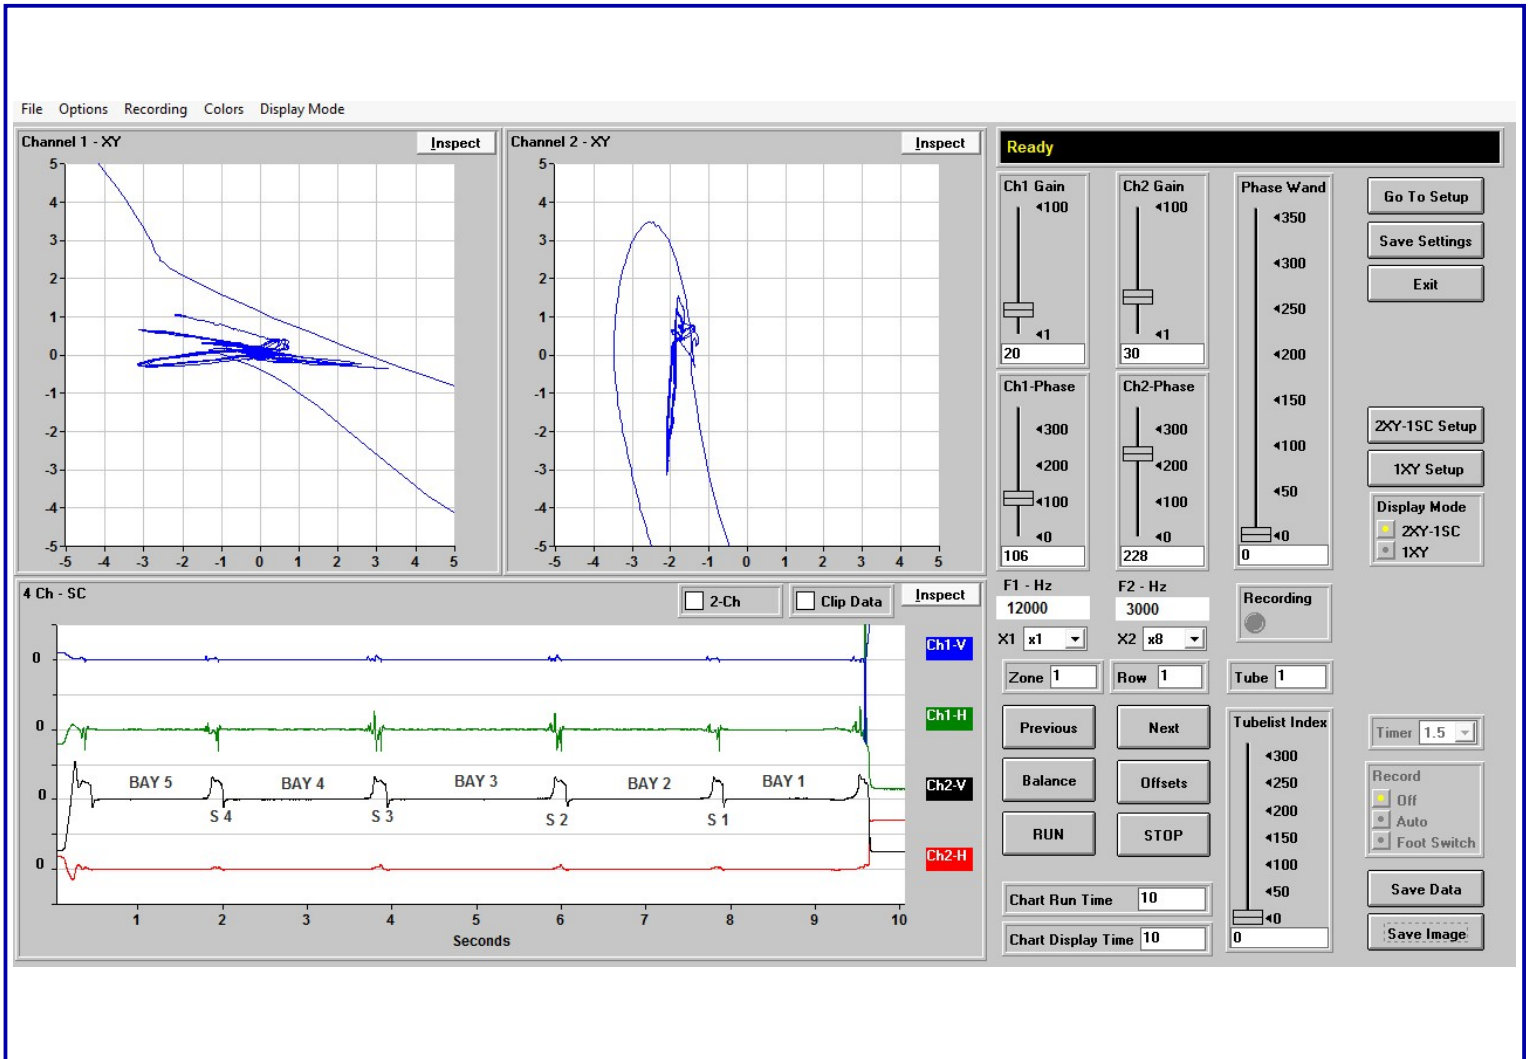
Evaporator Section

TYPICAL GOOD TUBE (Row 1 Tube 1)

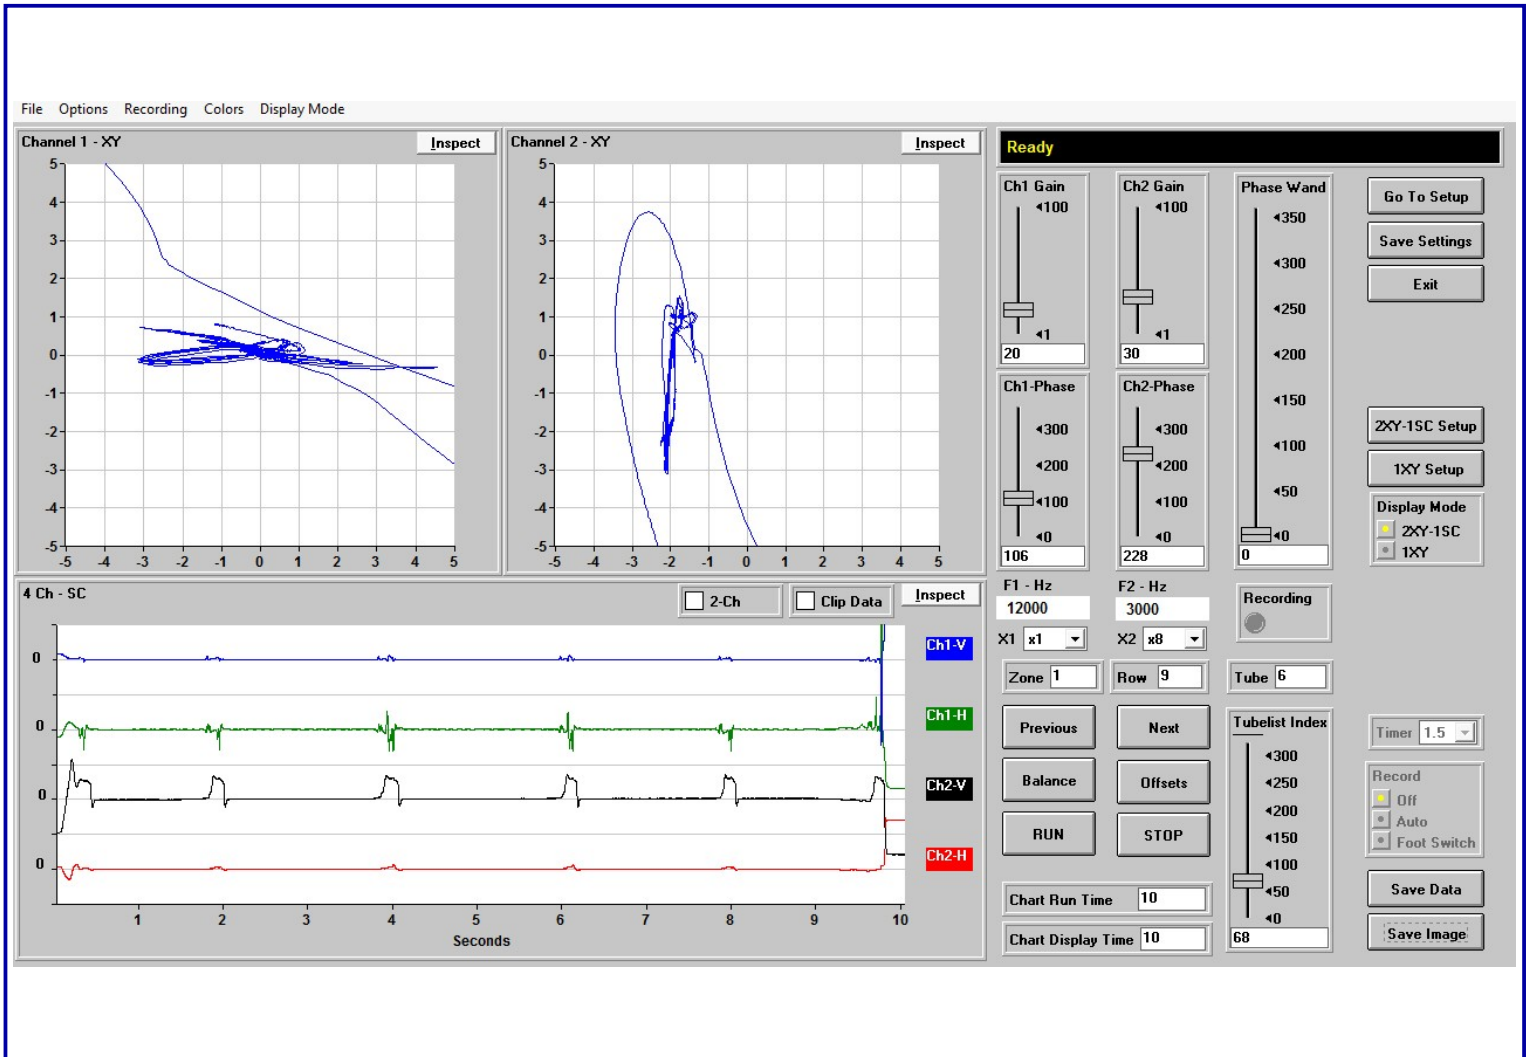
Evaporator Section

NO SIGNIFICANT DEFECTS (Row 9 Tube 6)

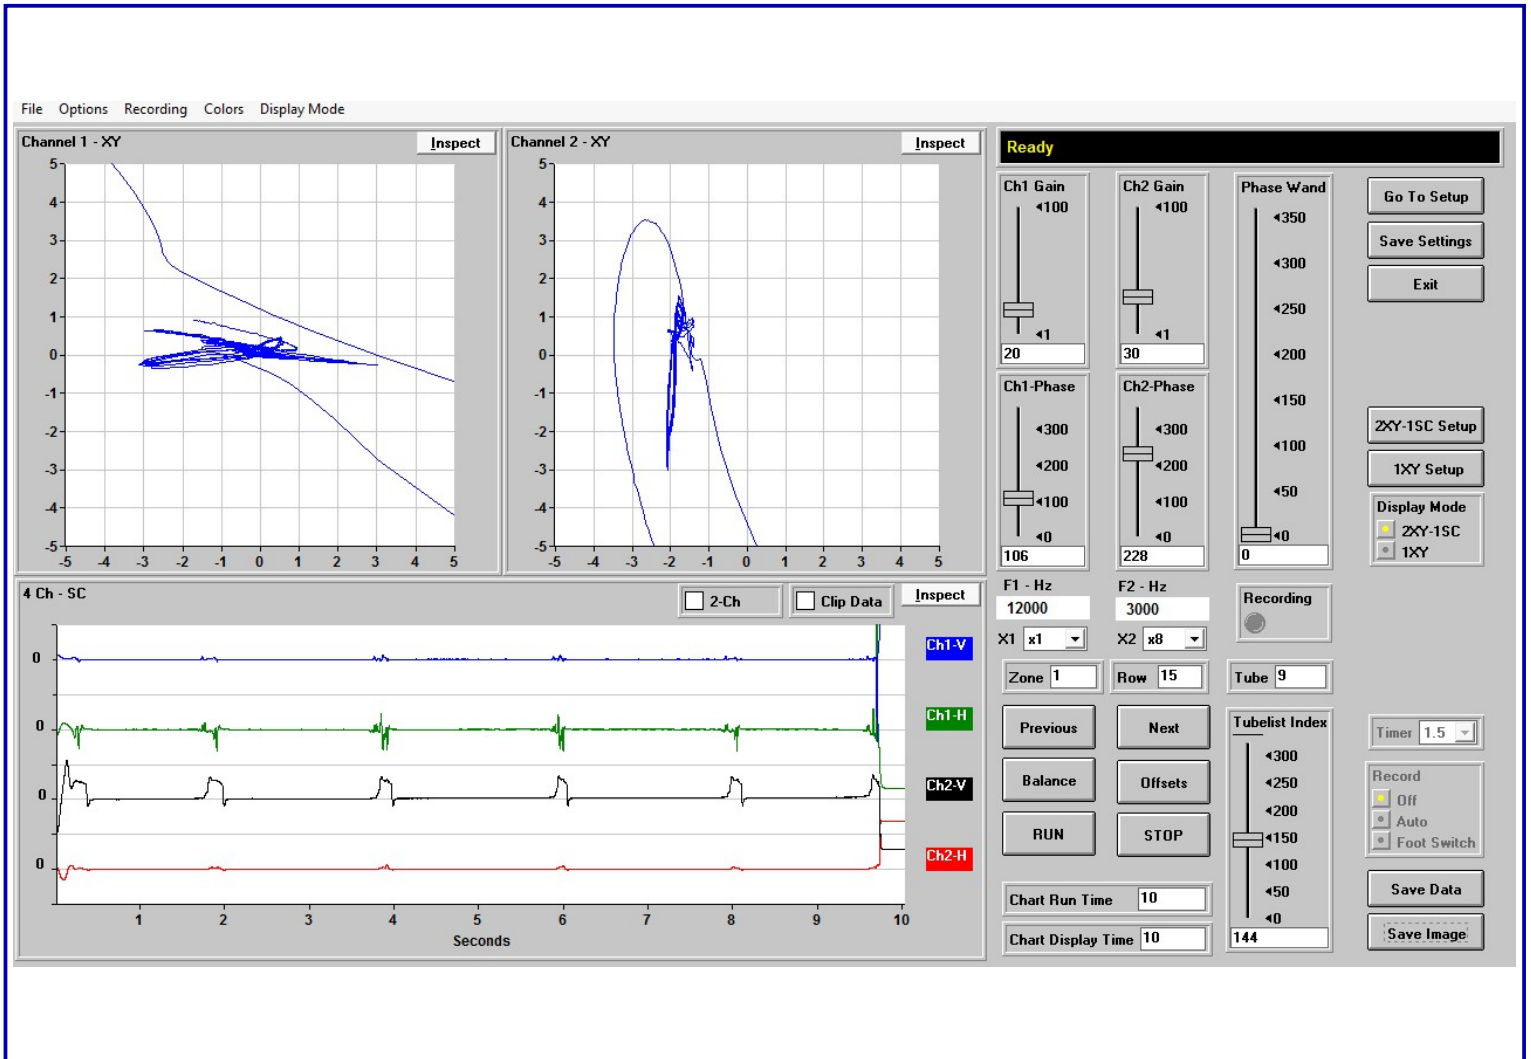
Evaporator Section

NO SIGNIFICANT DEFECTS (Row 15 Tube 9)

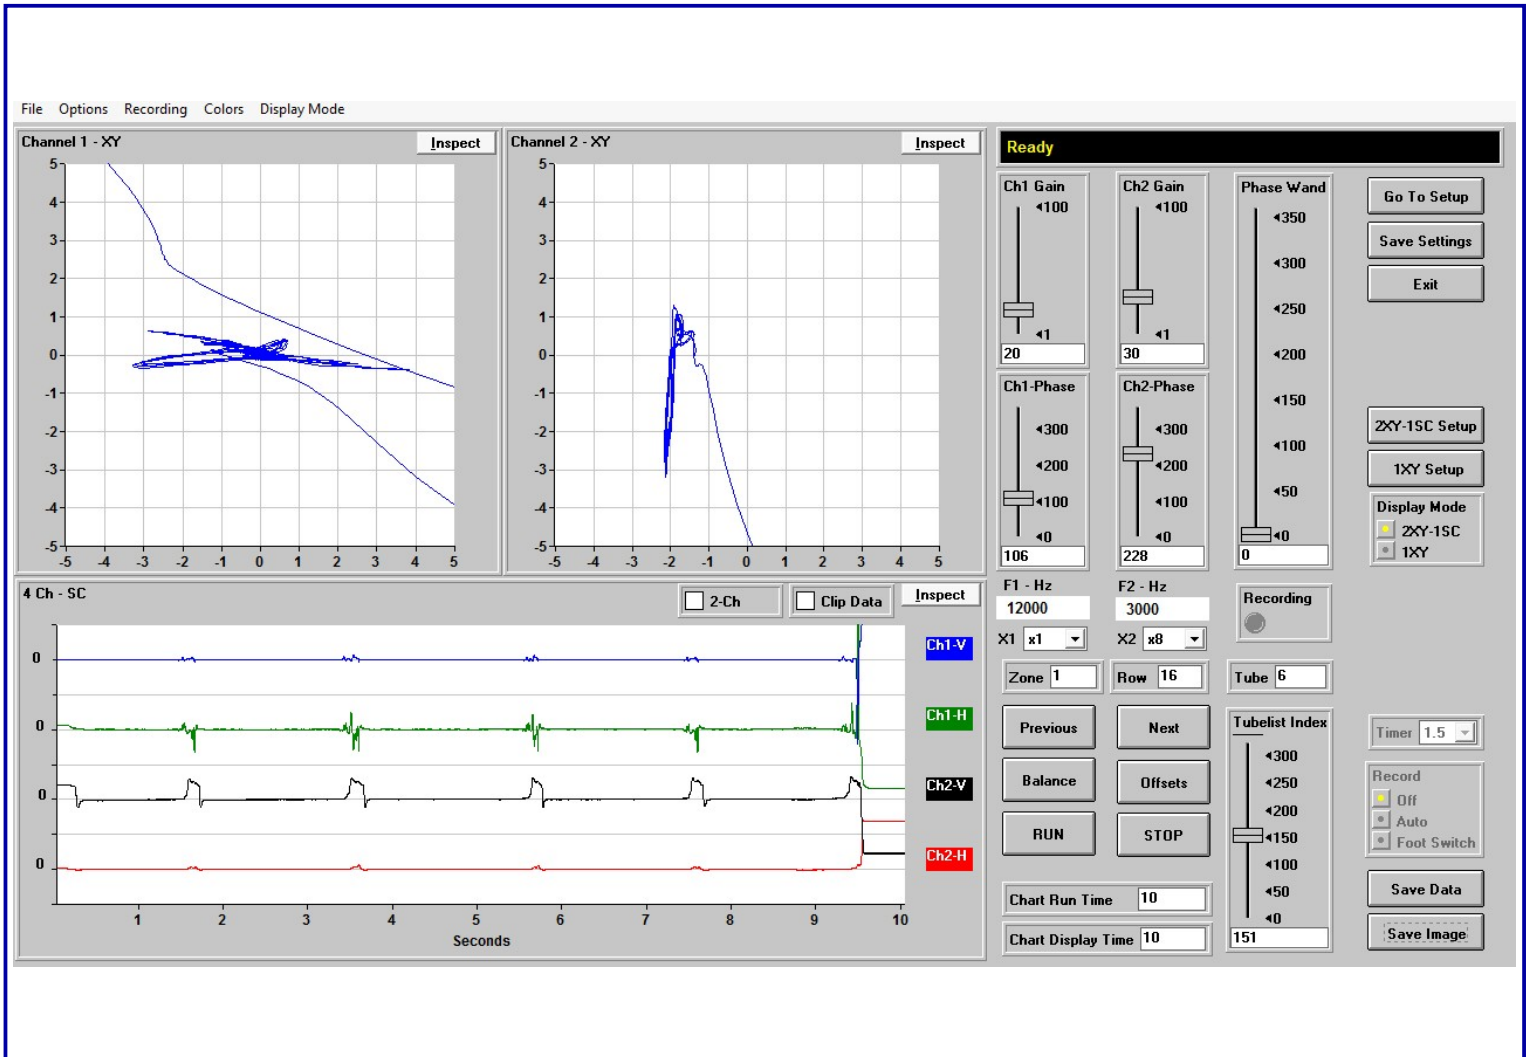
Evaporator Section

NO SIGNIFICANT DEFECTS (Row 16 Tube 6)

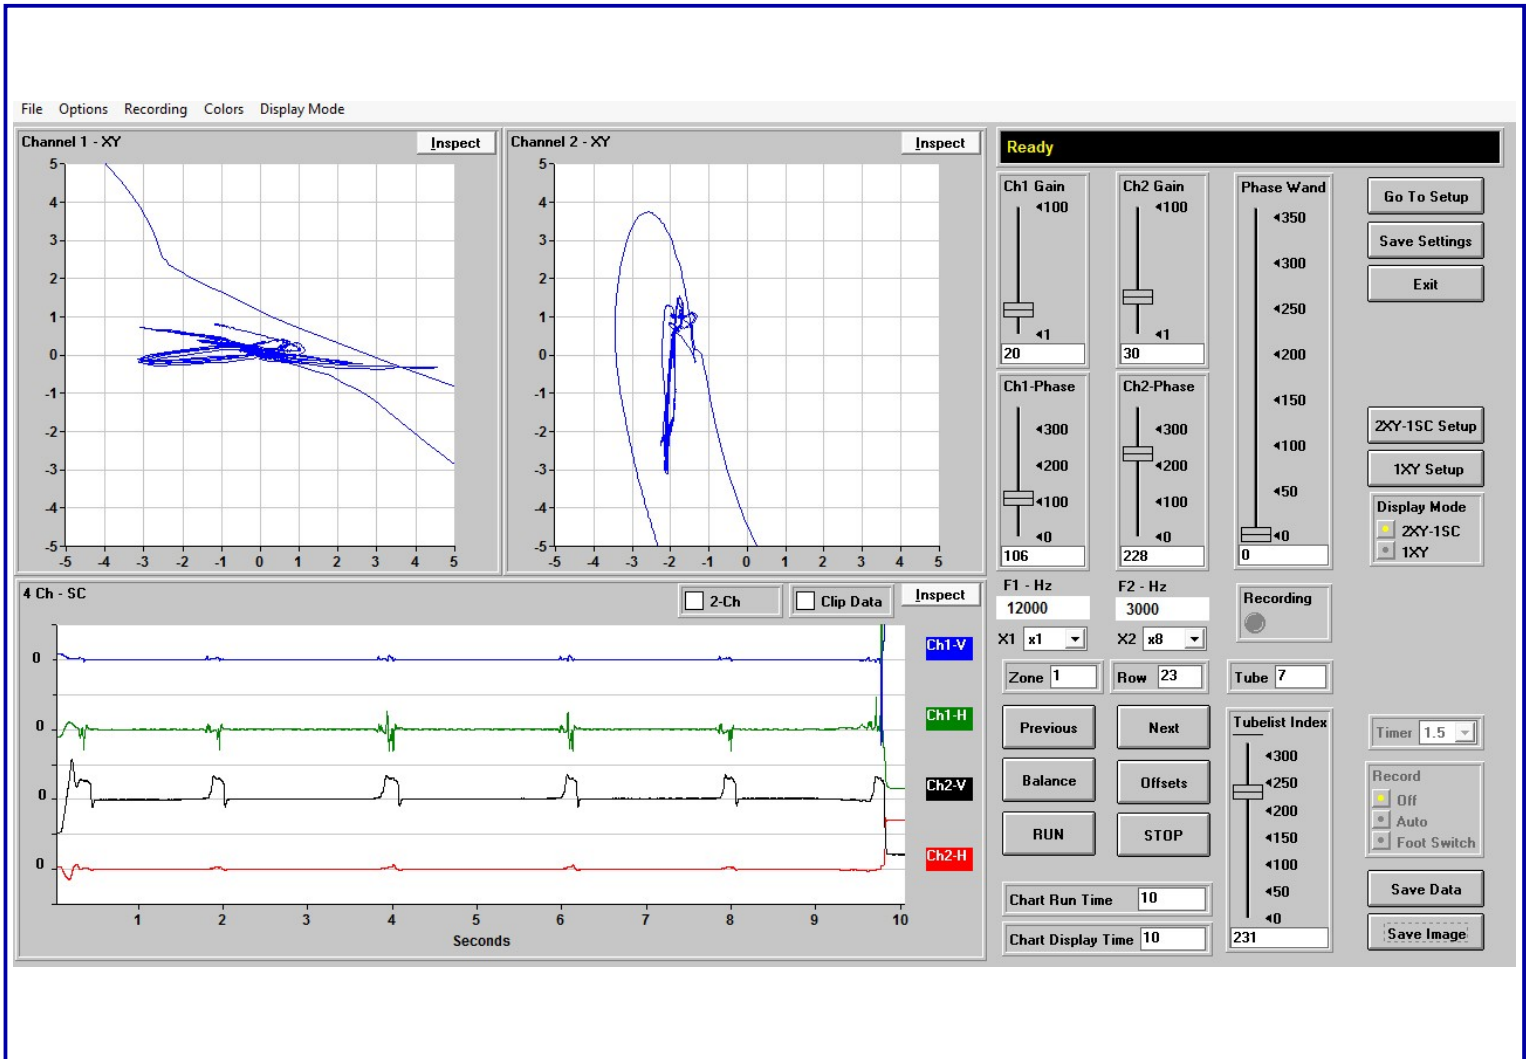
Evaporator Section

NO SIGNIFICANT DEFECTS (Row 23 Tube 7)

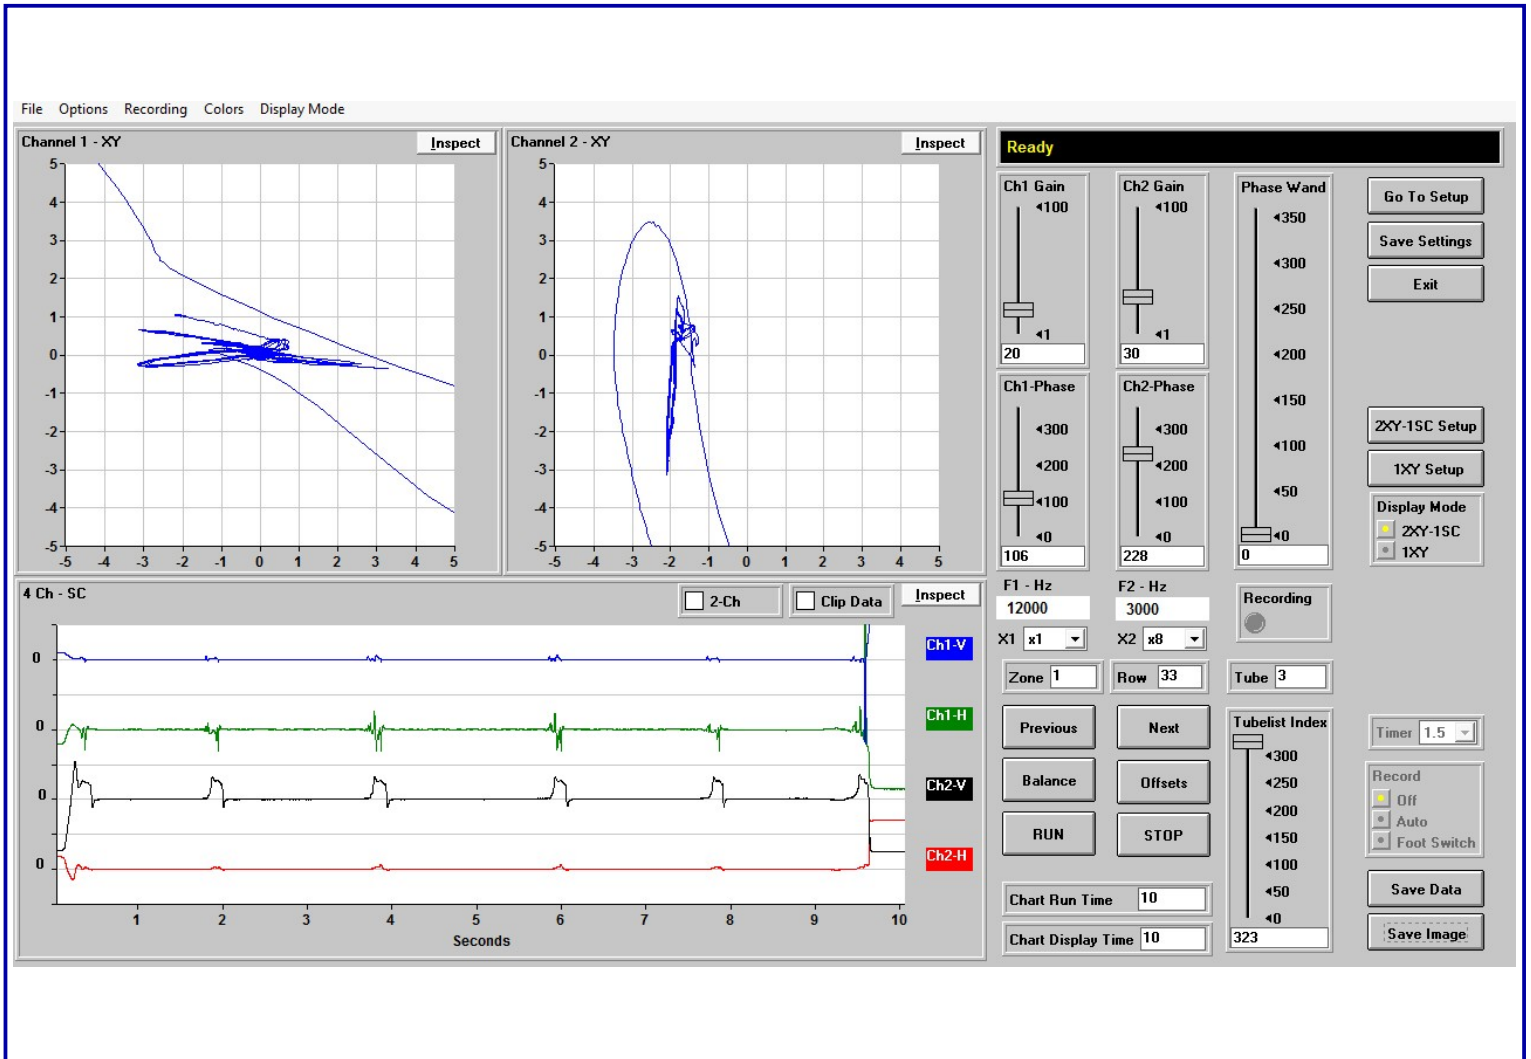
Evaporator Section

NO SIGNIFICANT DEFECTS (Row 33 Tube 3)
