## Report of Eddy Current Inspection

Manufacturer: Carrier

Model: 23XRV3737

Location: UNIVERSITY OF SOUTH CAROLINA  
HODGE BUILDING  
SPARTANBURG, SC 29301

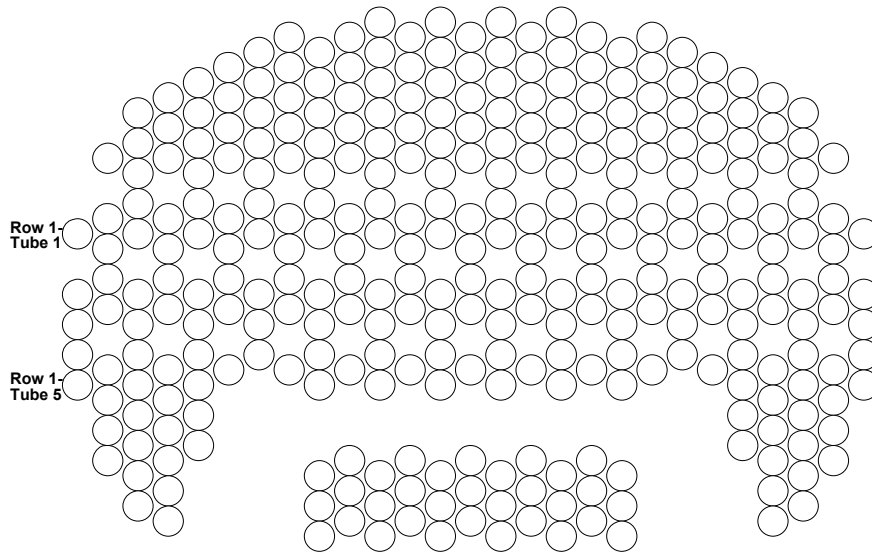
# Condenser Section

No Significant defects were found.

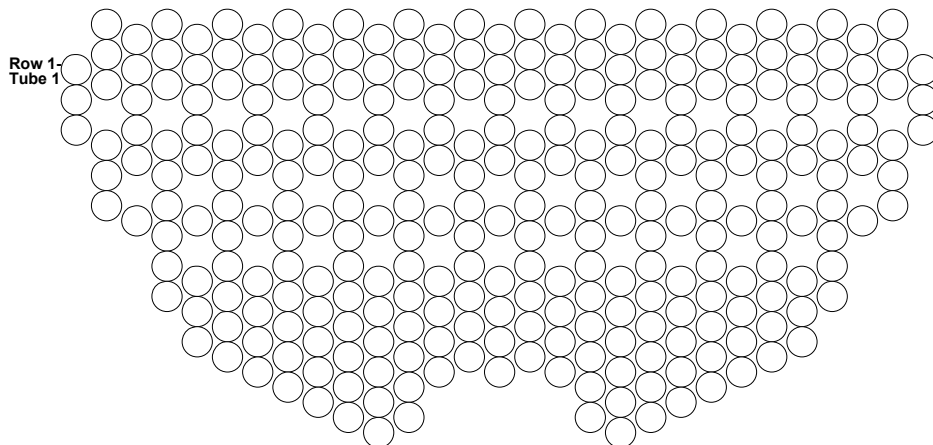
# Evaporator Section

No Significant defects were found.

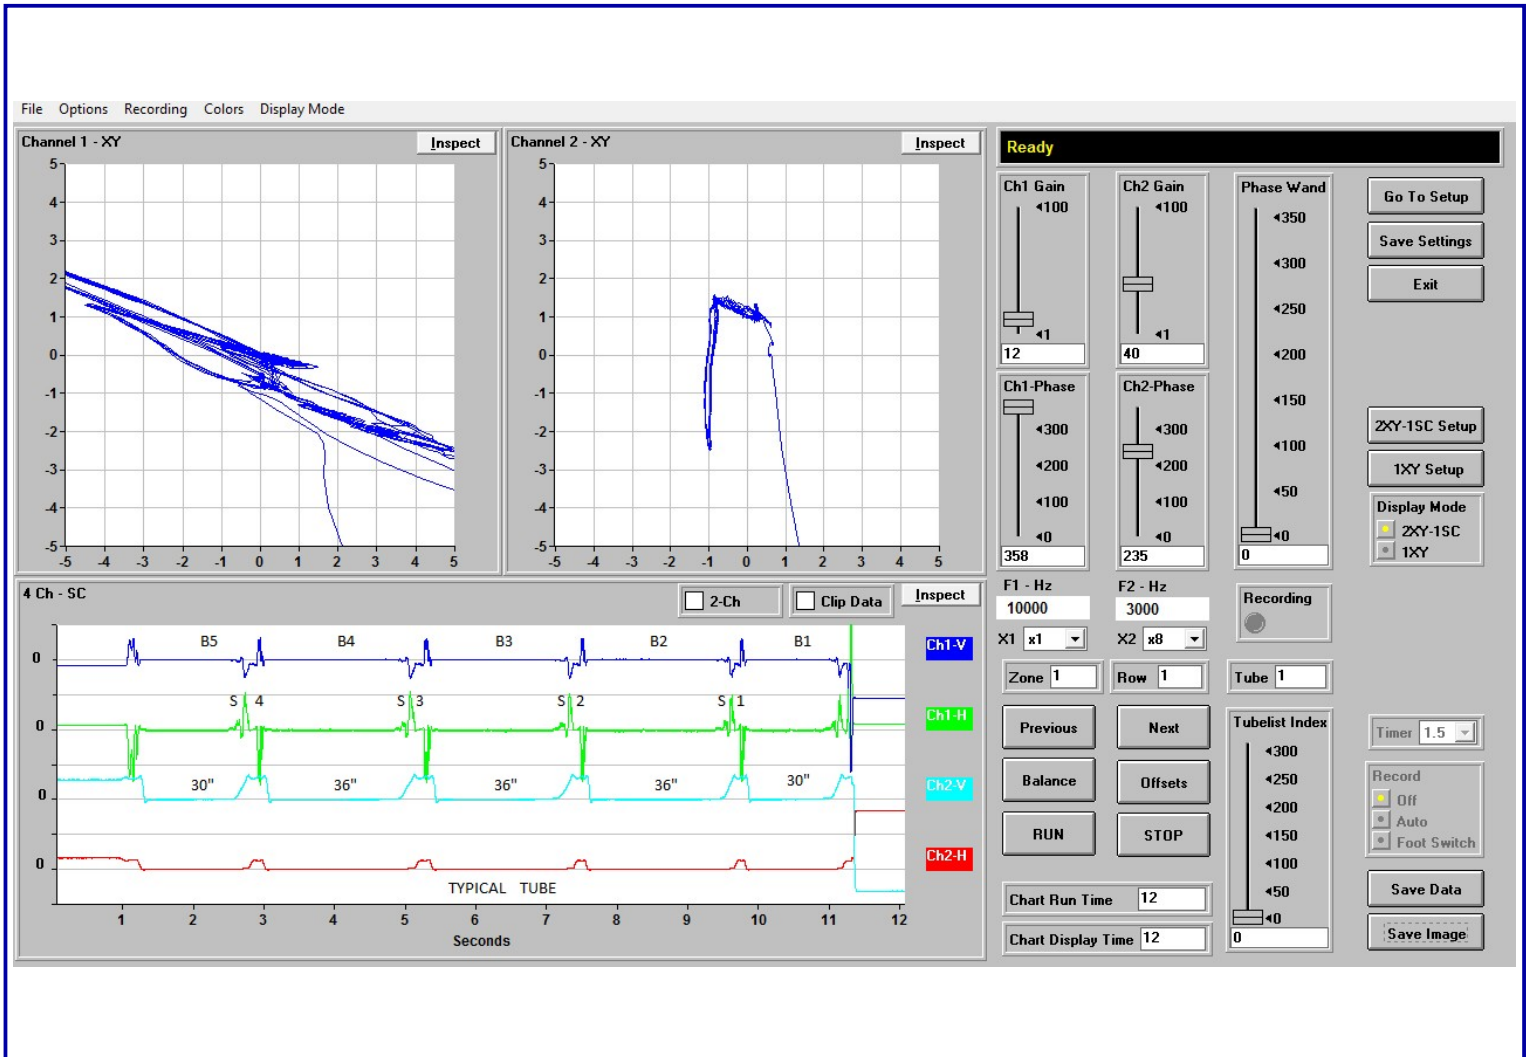
NO SIGNIFICANT DEFECTS (Row 1 Tube 1)

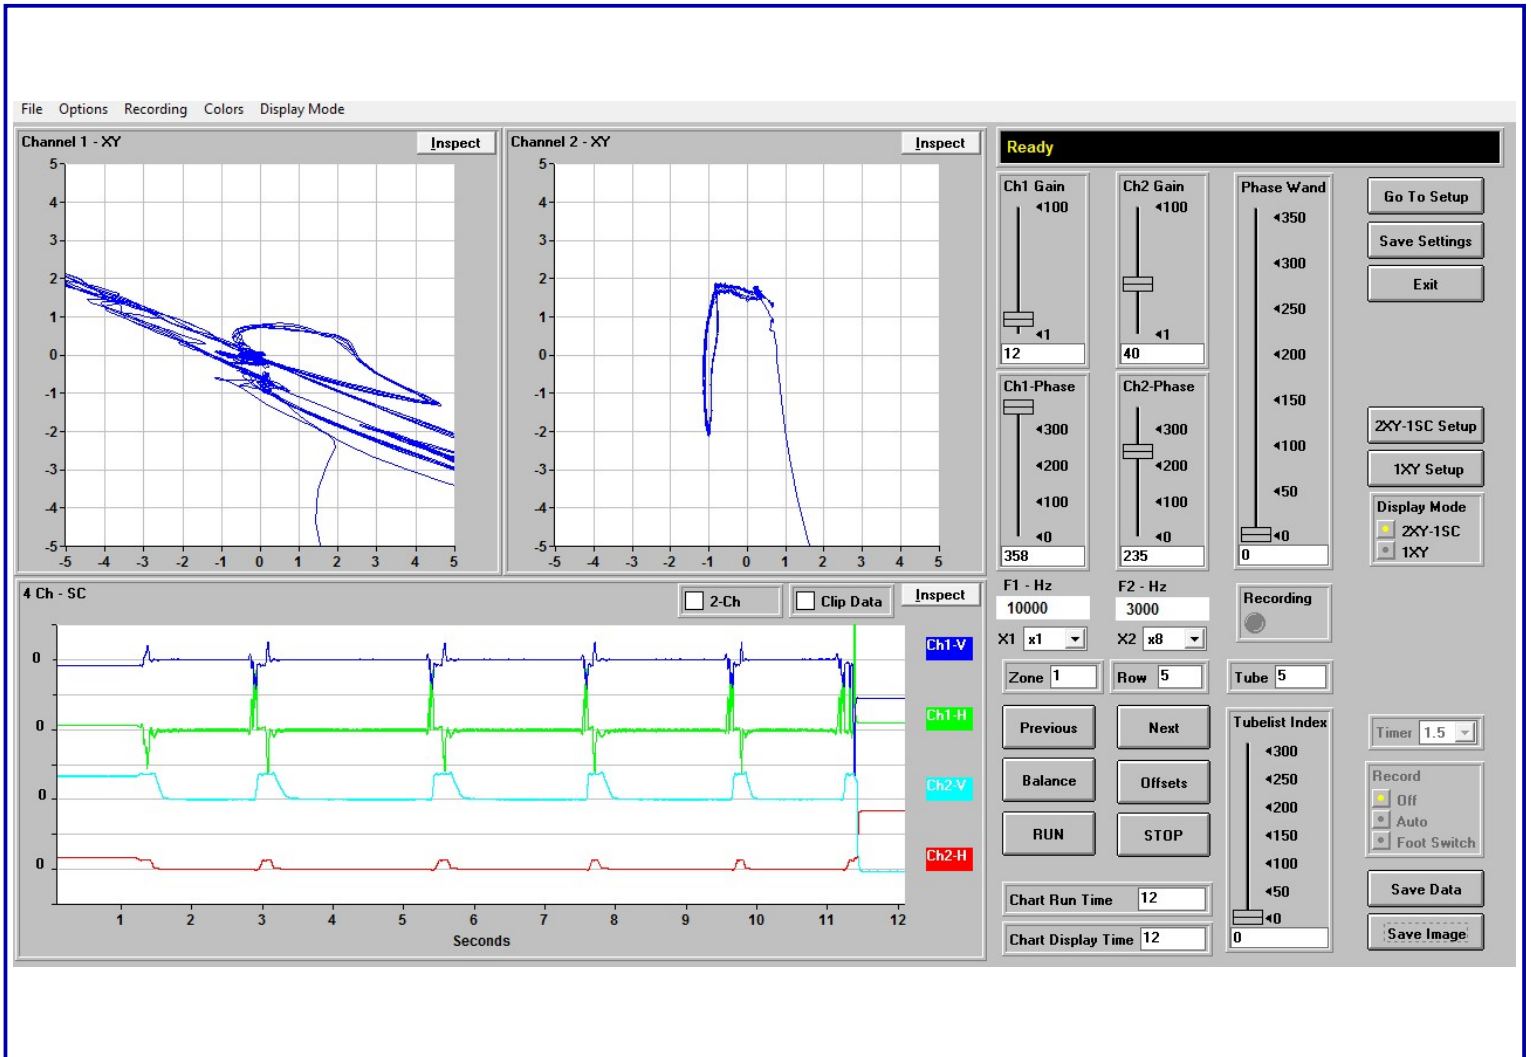
NO SIGNIFICANT DEFECTS (Row 5 Tube 5)

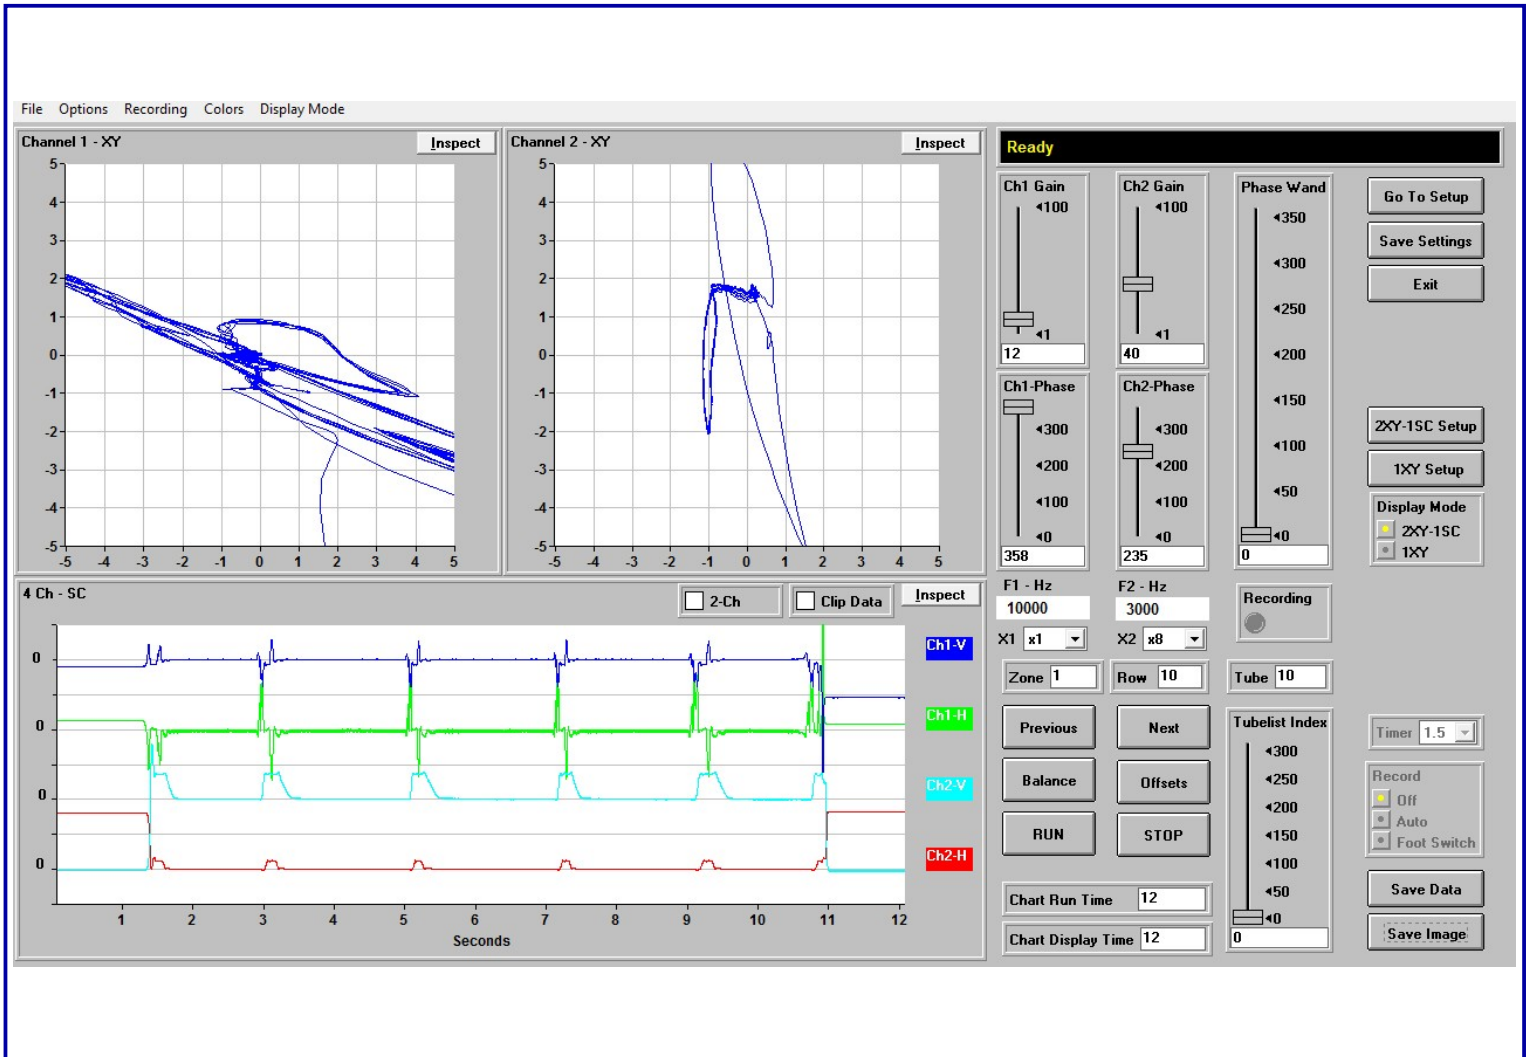
NO SIGNIFICANT DEFECTS (Row 10 Tube 10)

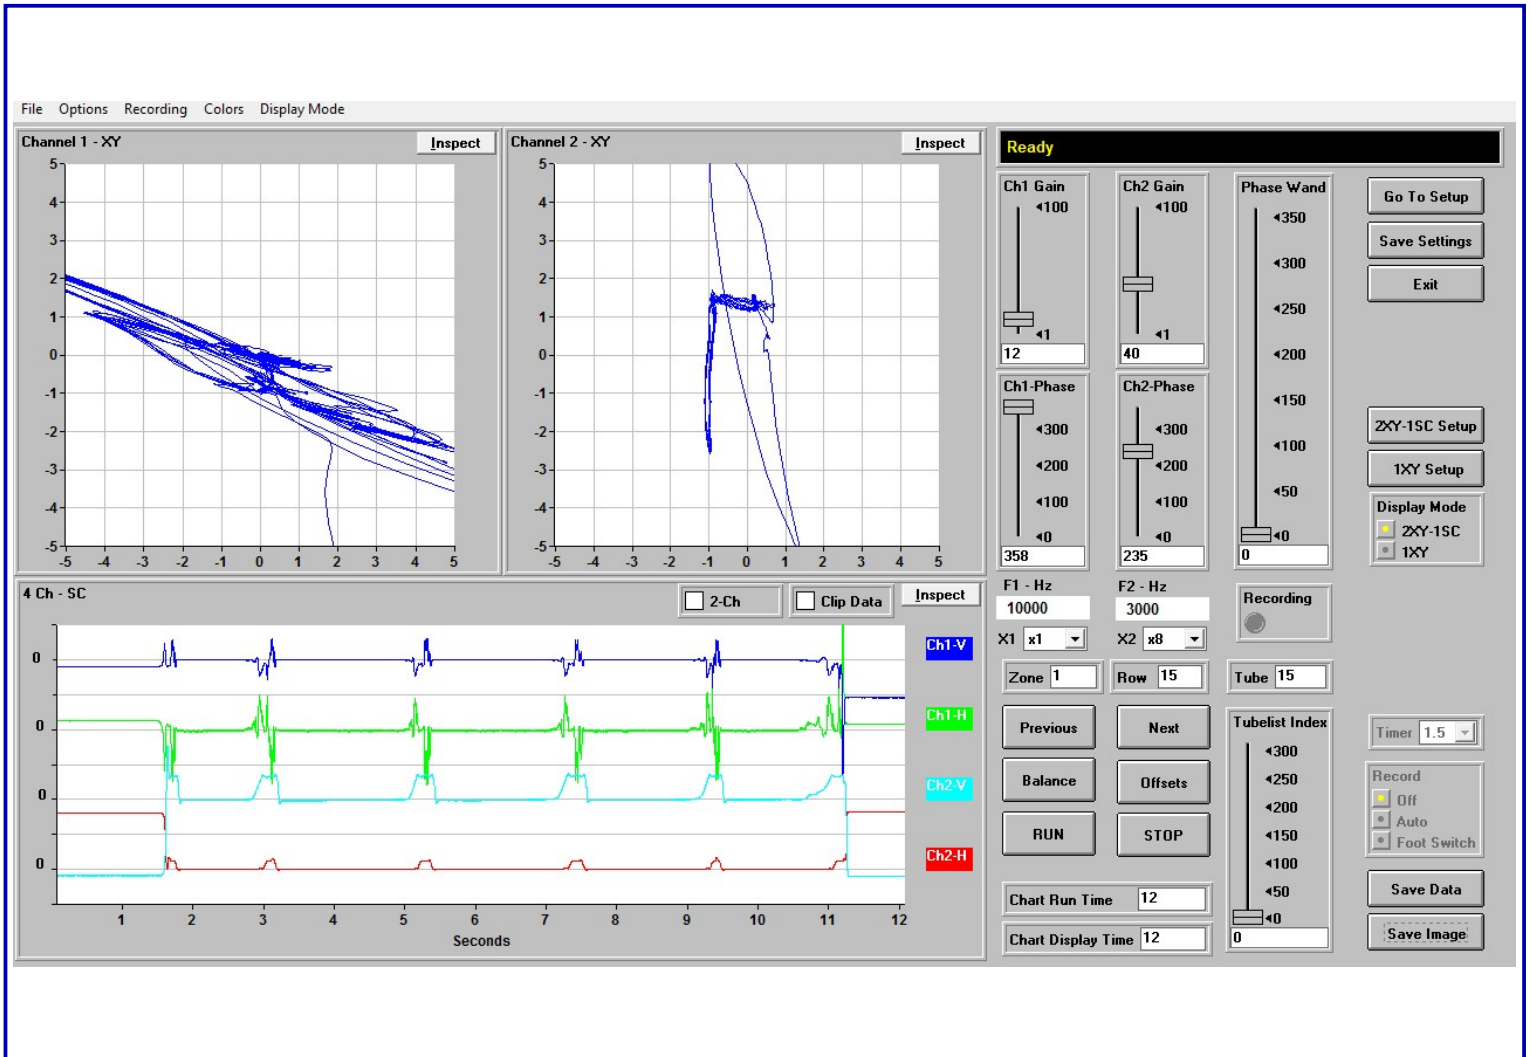
NO SIGNIFICANT DEFECTS (Row 15 Tube 15)

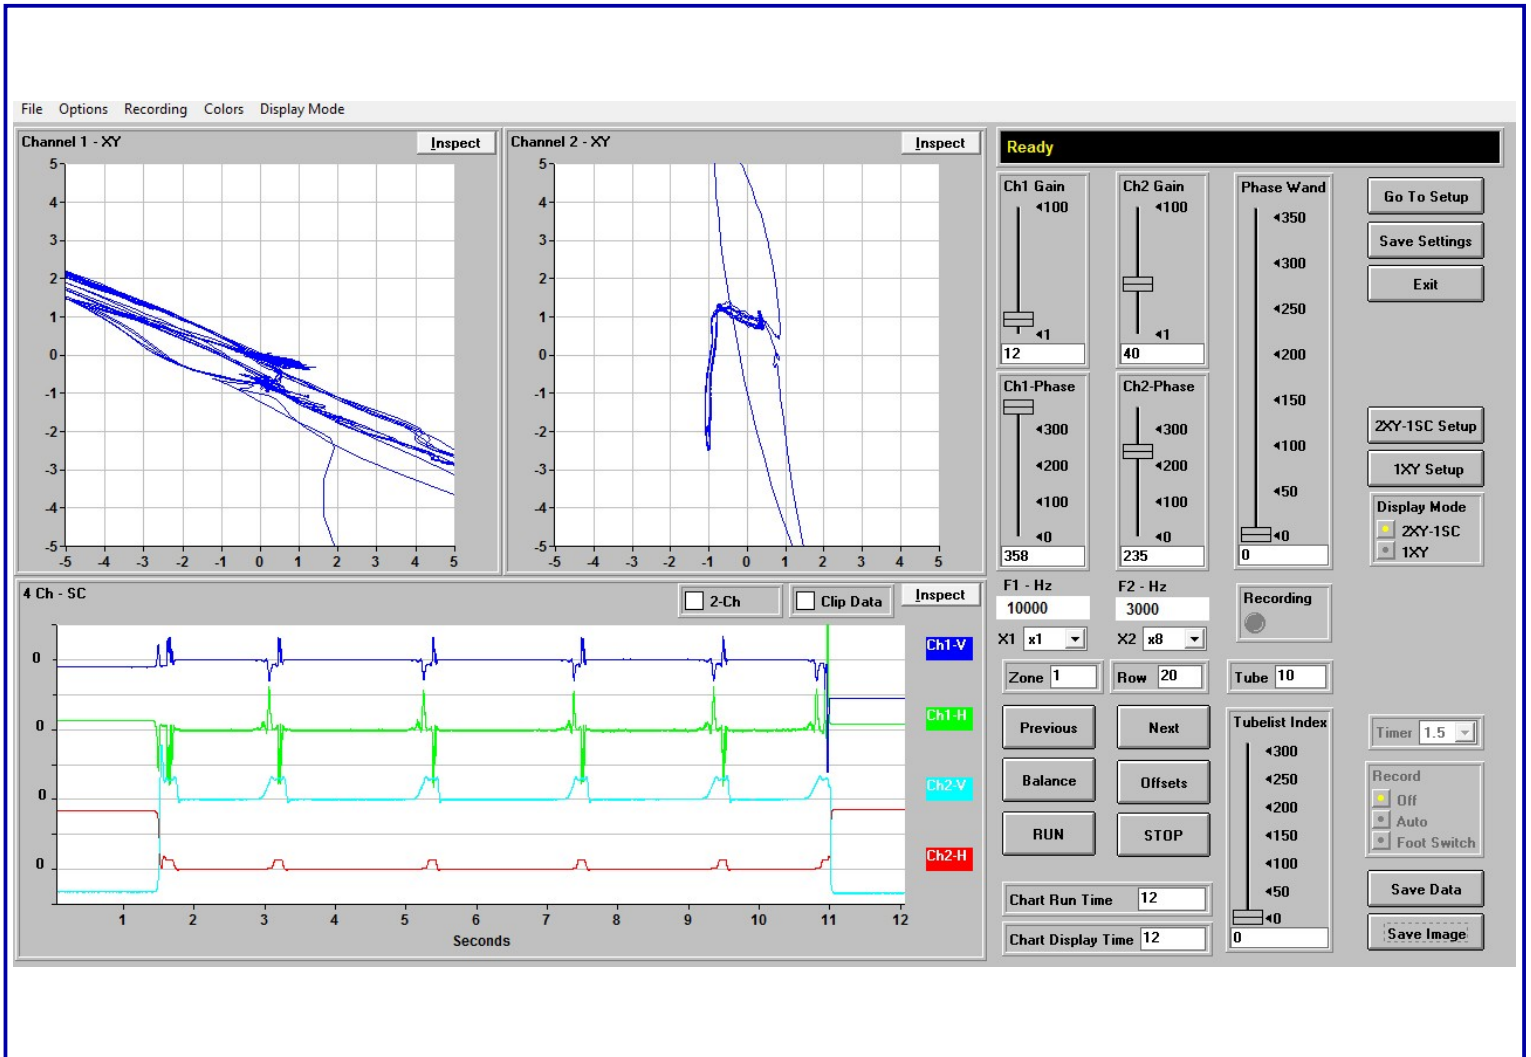
NO SIGNIFICANT DEFECTS (Row 20 Tube 10)

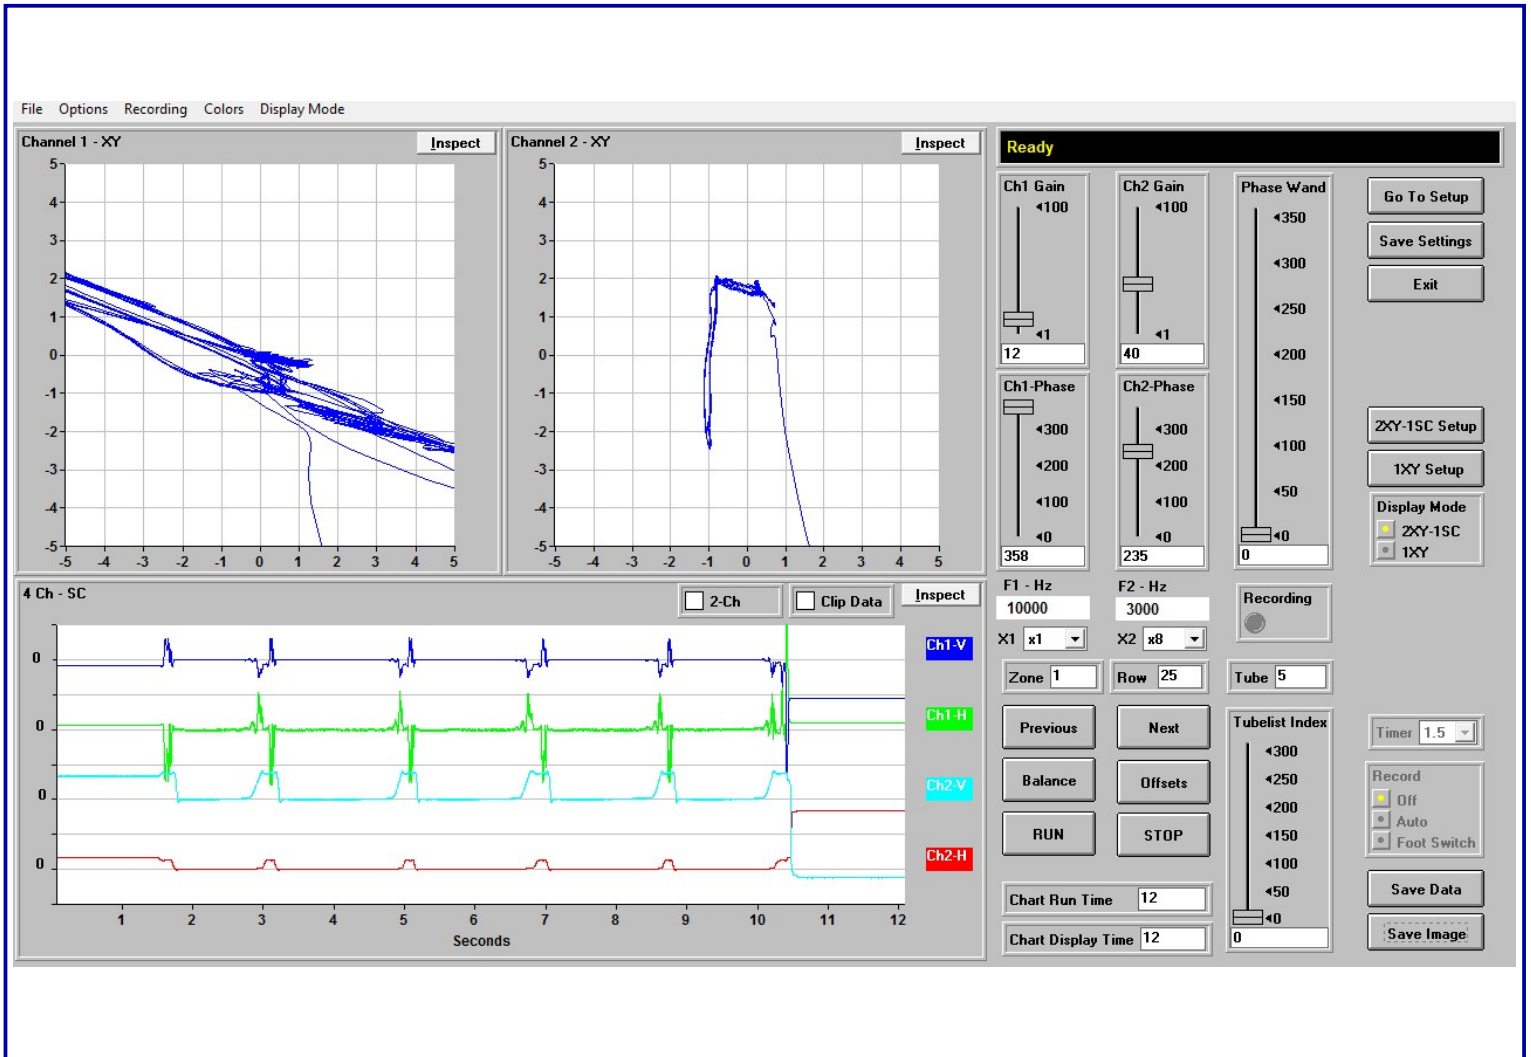
NO SIGNIFICANT DEFECTS (Row 25 Tube 5)

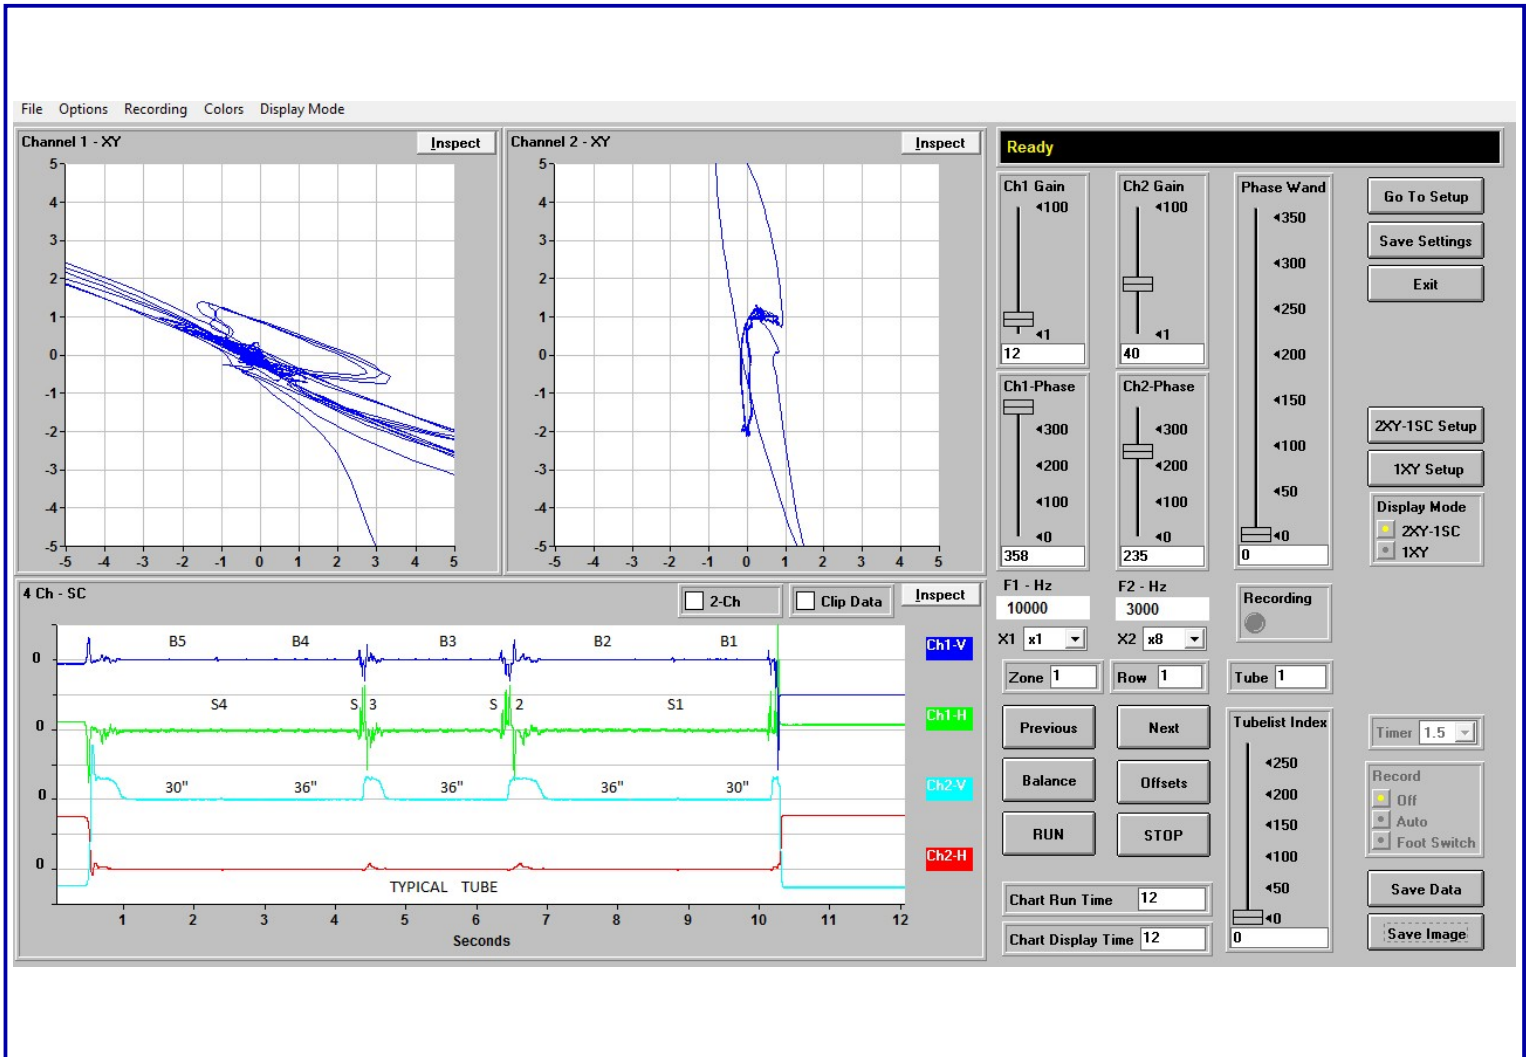
NO SIGNIFICANT DEFECTS (Row 1 Tube 1)

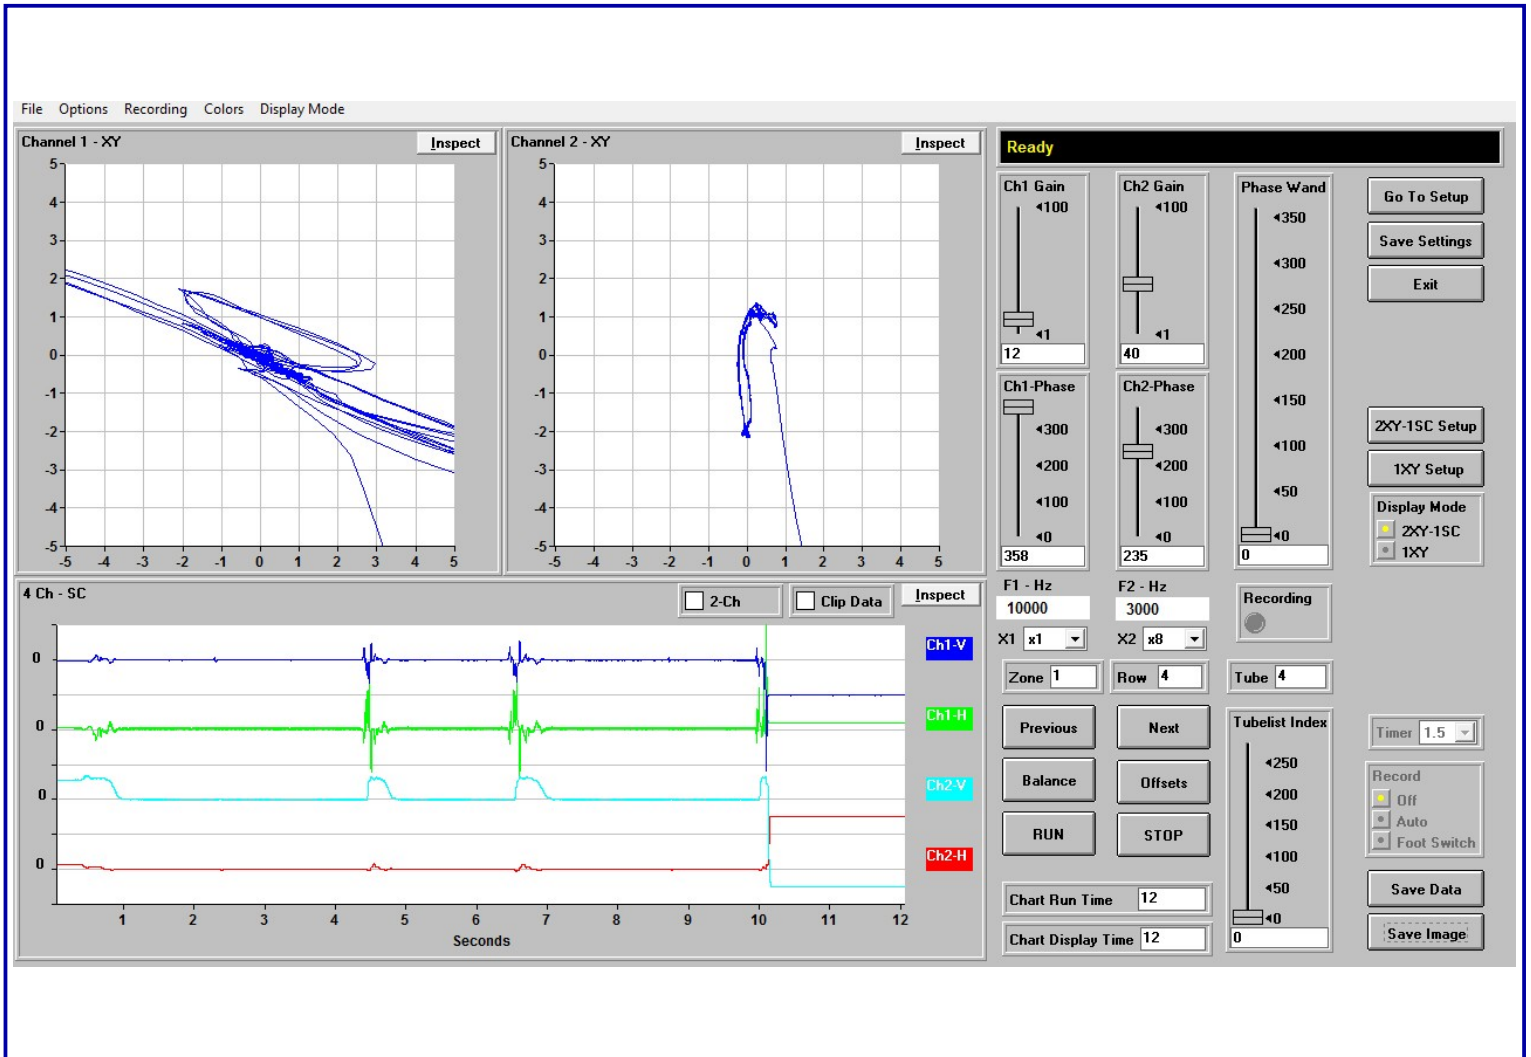
NO SIGNIFICANT DEFECTS (Row 4 Tube 4)

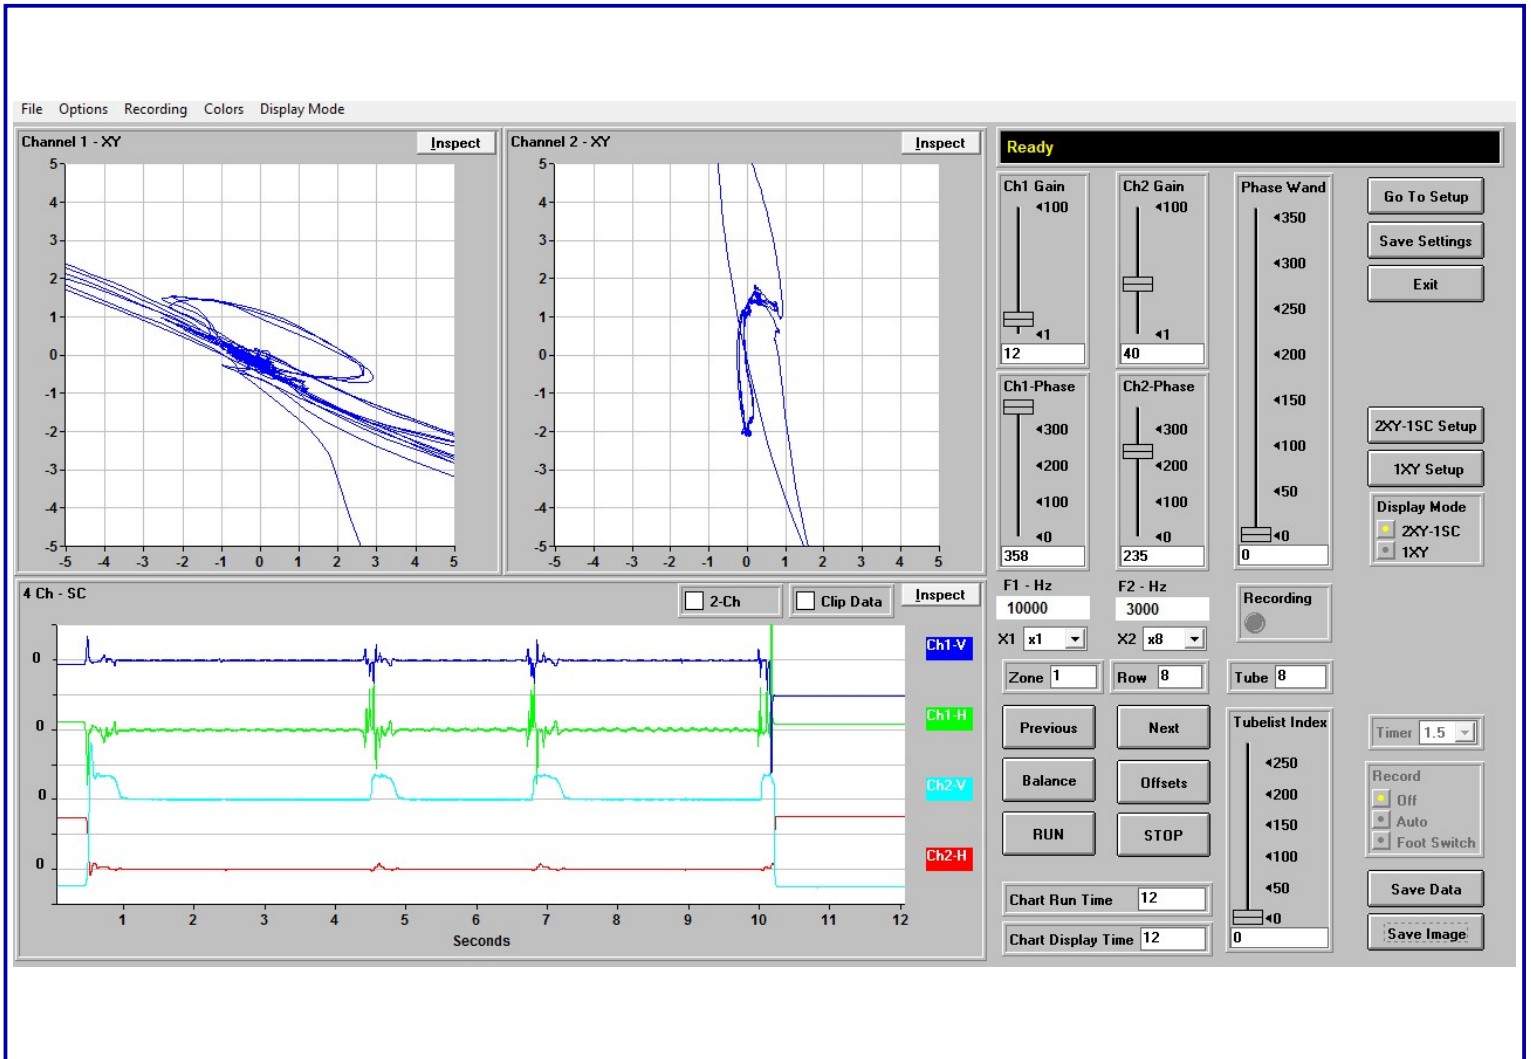
NO SIGNIFICANT DEFECTS (Row 8 Tube 8)

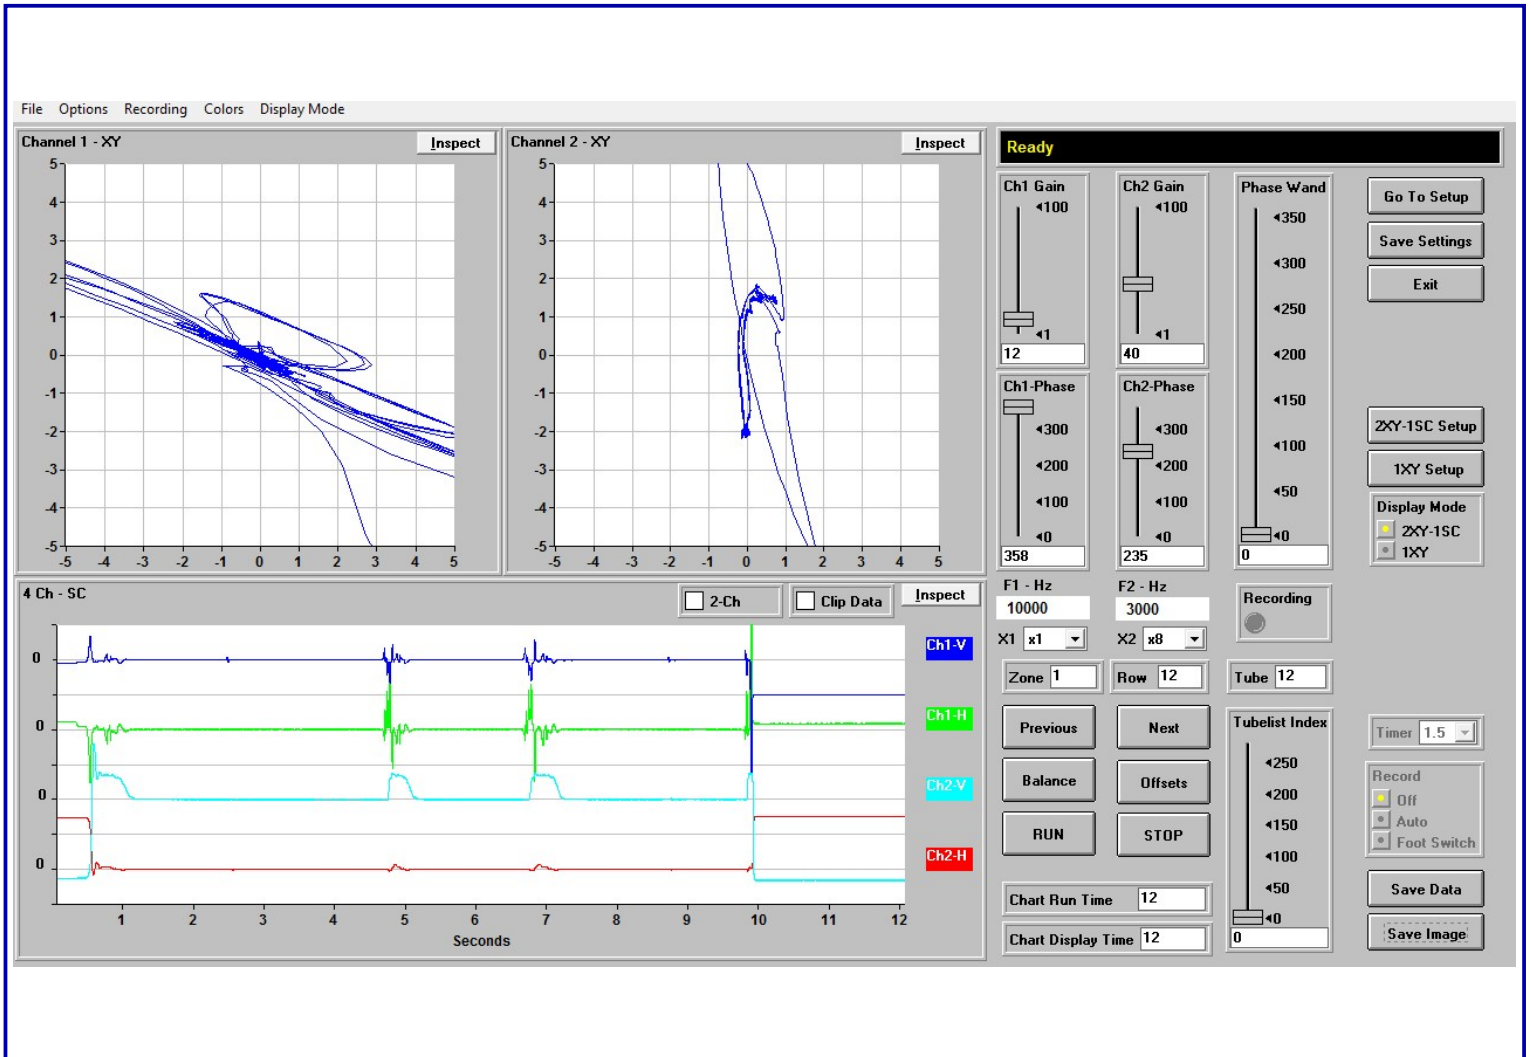
NO SIGNIFICANT DEFECTS (Row 12 Tube 12)

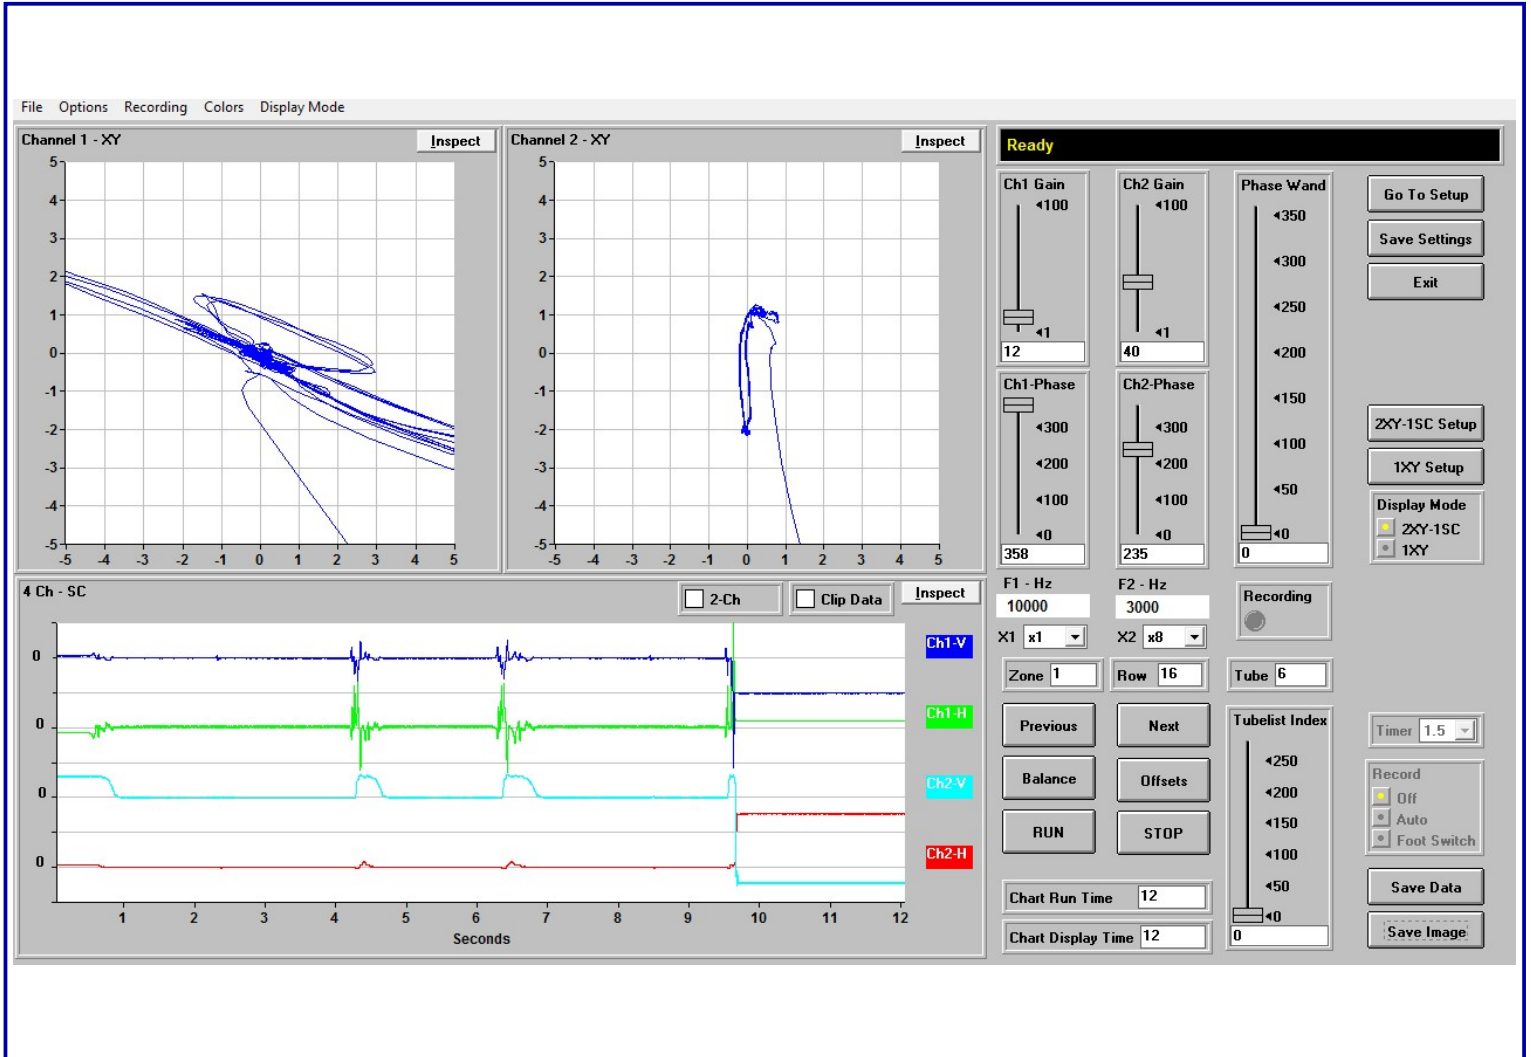
NO SIGNIFICANT DEFECTS (Row 16 Tube 6)

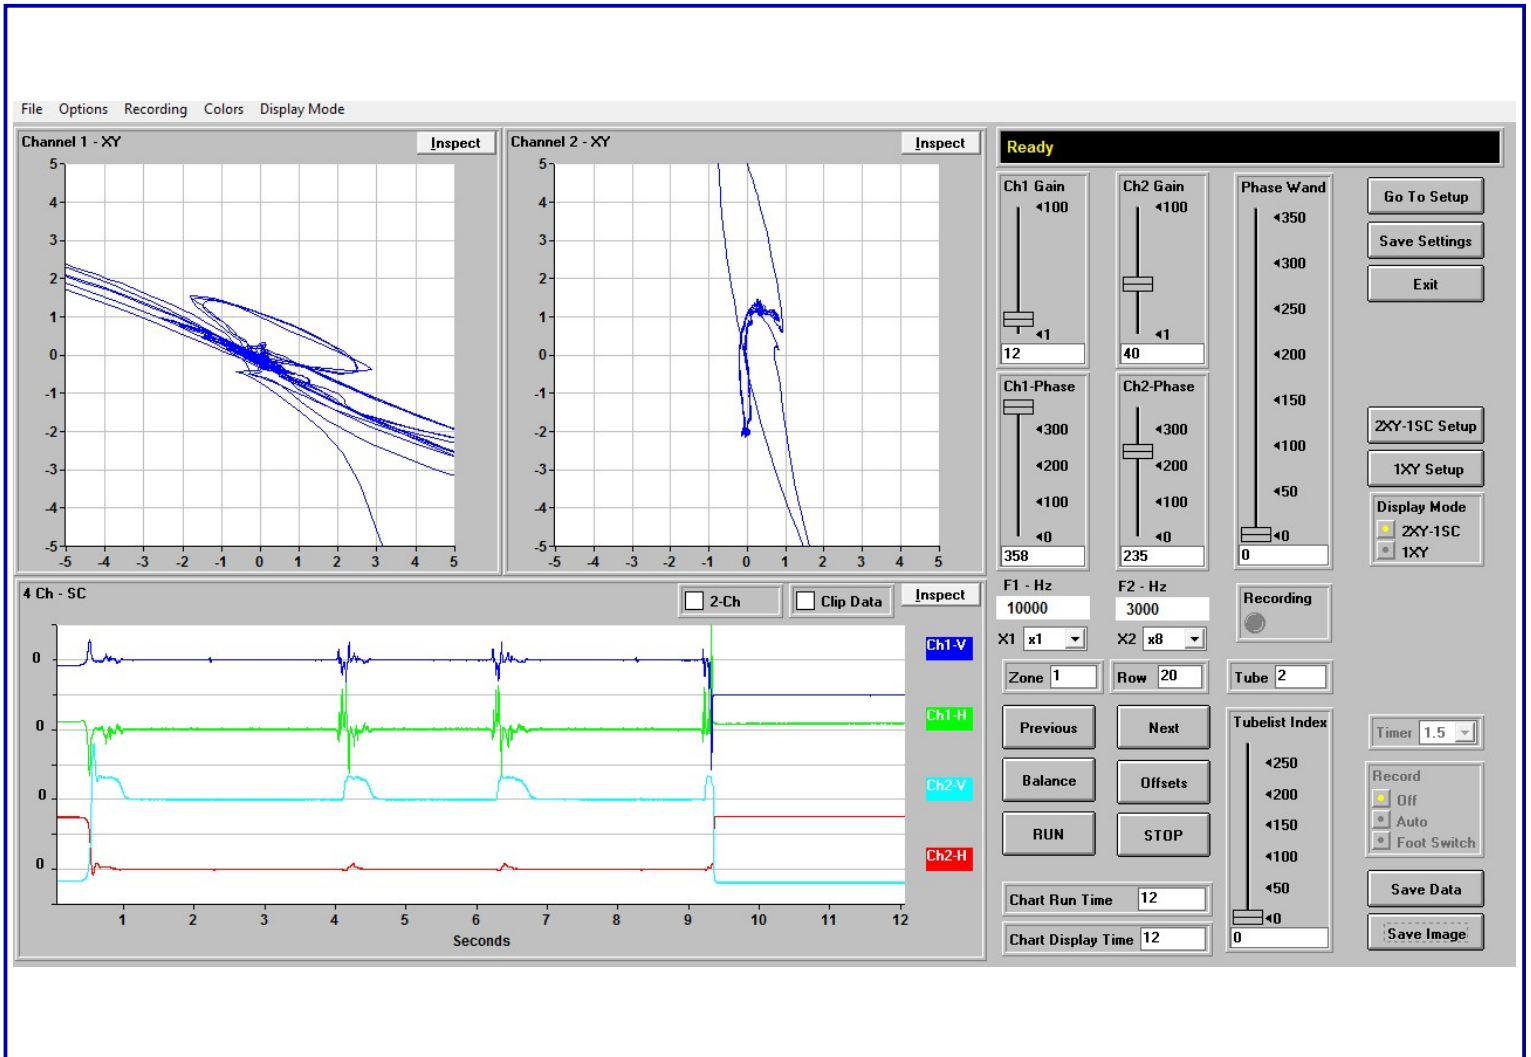
NO SIGNIFICANT DEFECTS (Row 20 Tube 2)
