Report of Eddy Current Inspection

Manufacturer: Carrier

Model: 30HXC136MY

Location: UNIVERSITY OF SOUTH CAROLINA
READINESS CENTER
SPARTANBURG, SC 29301

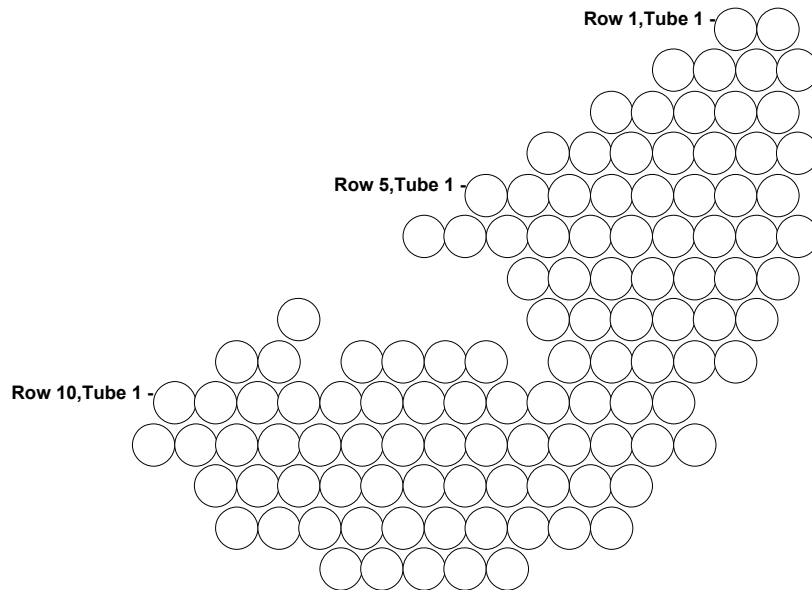
Condenser Section

No Significant defects were found.

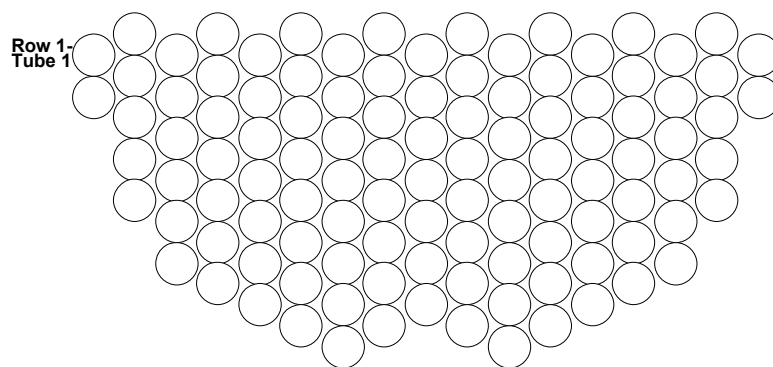
Evaporator Section

No Significant defects were found.

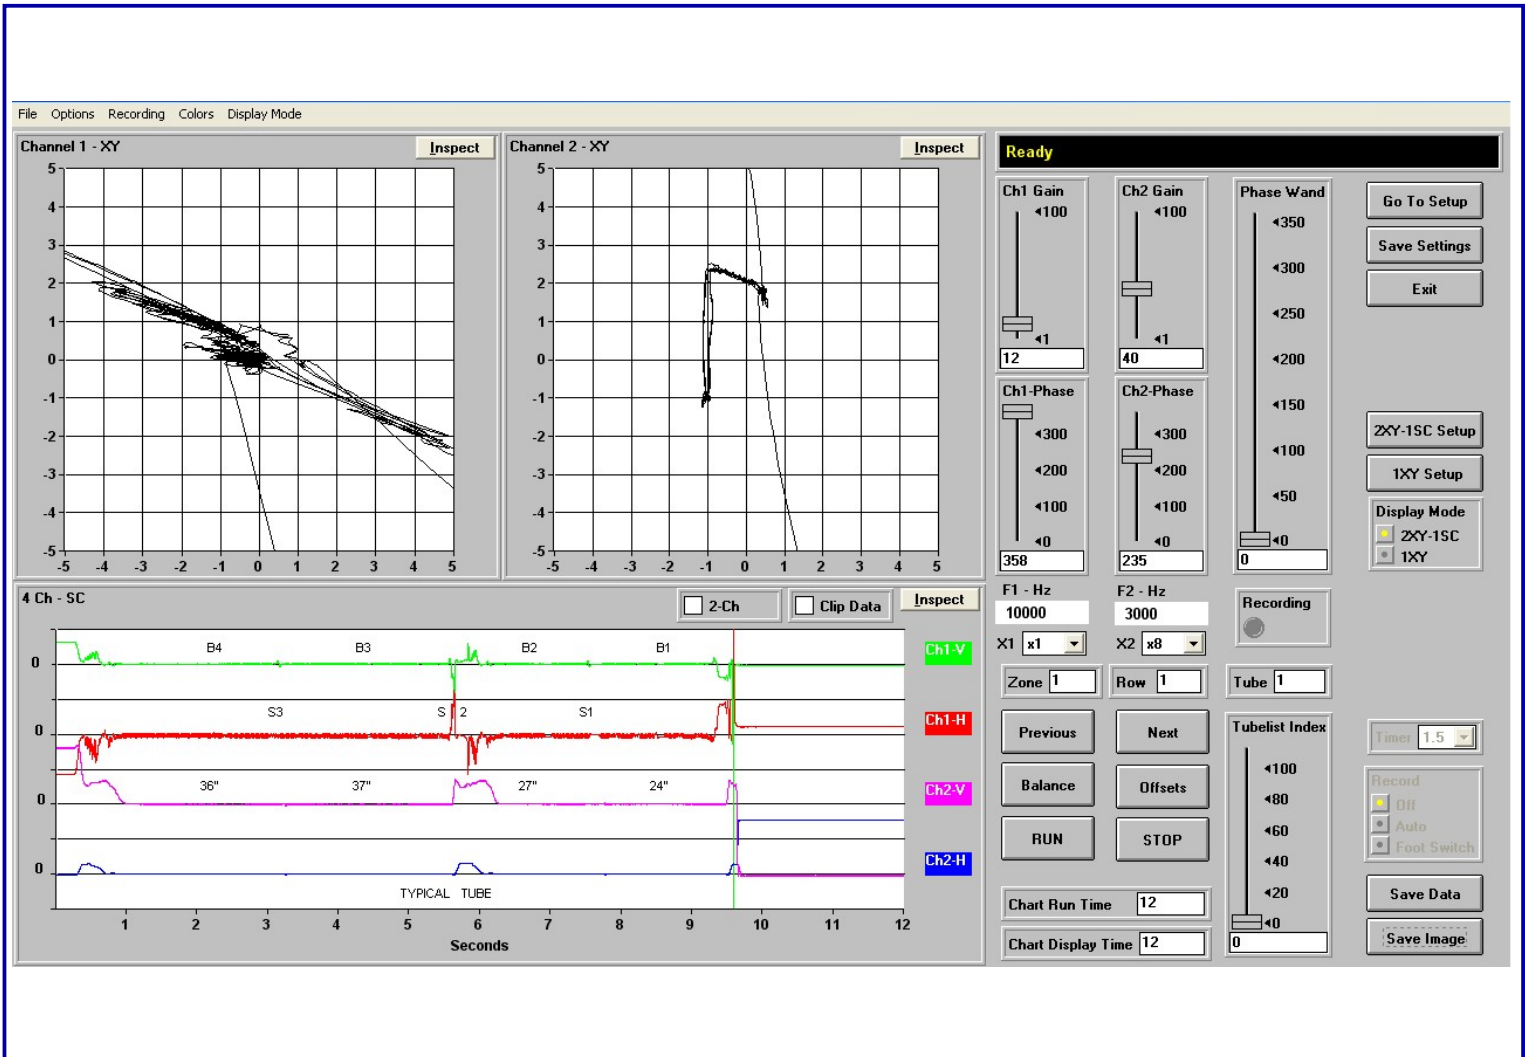
Condenser Section

NO SIGNIFICANT DEFECTS (Row 1 Tube 1)

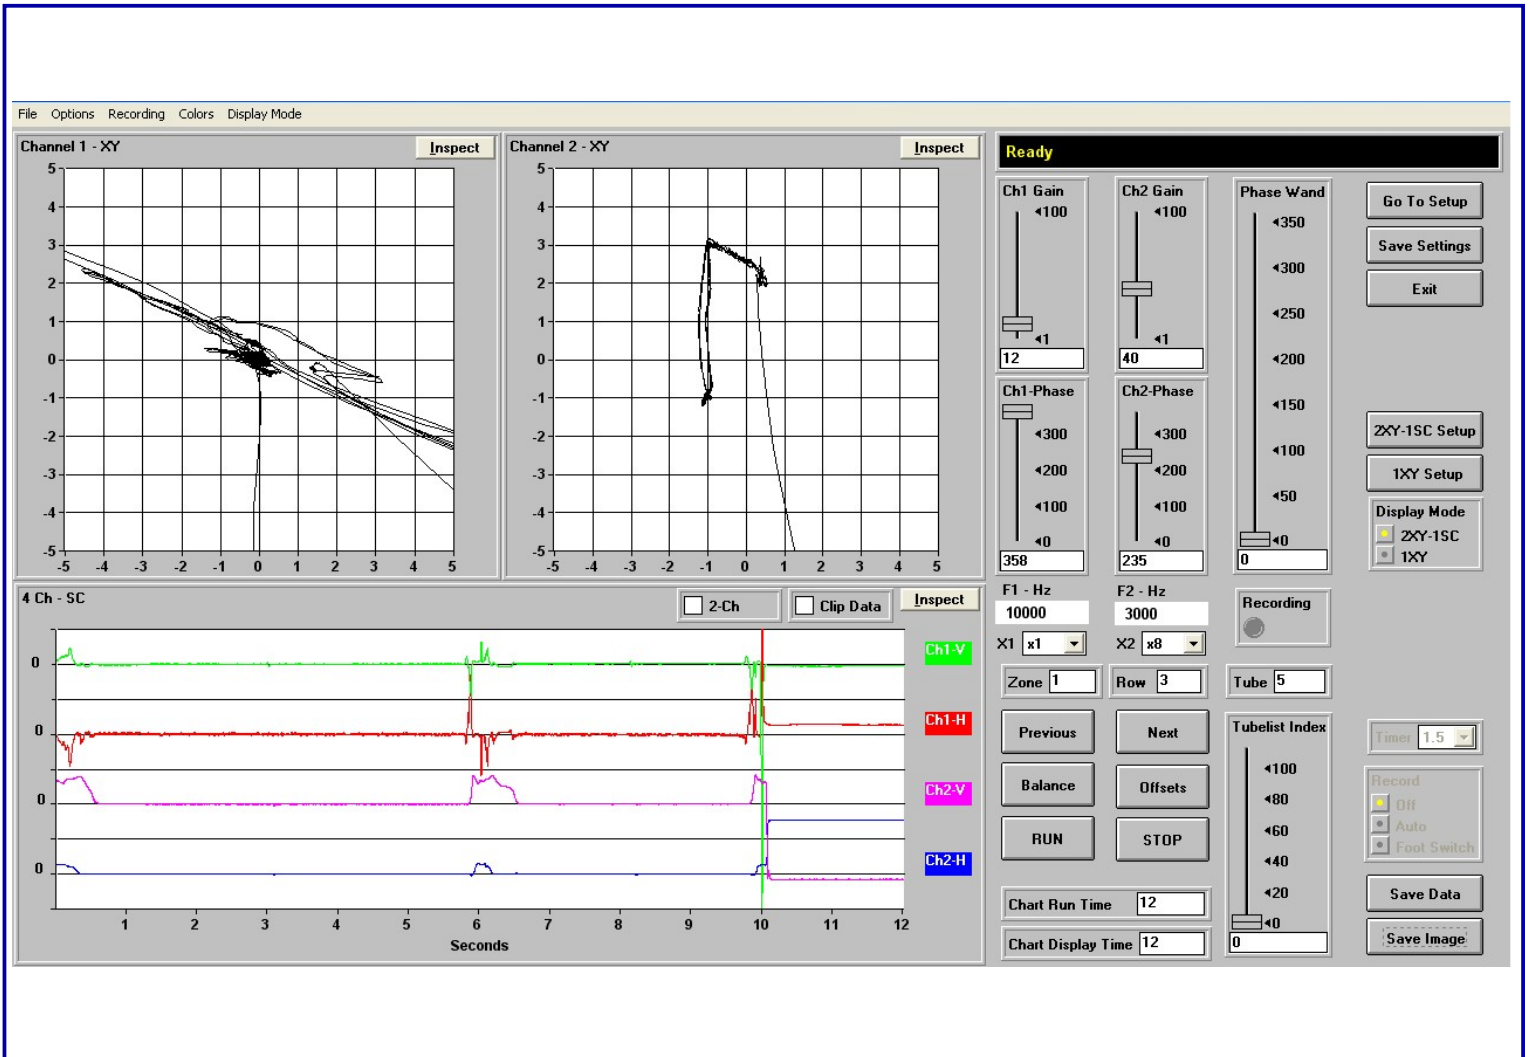
Condenser Section

NO SIGNIFICANT DEFECTS (Row 3 Tube 5)

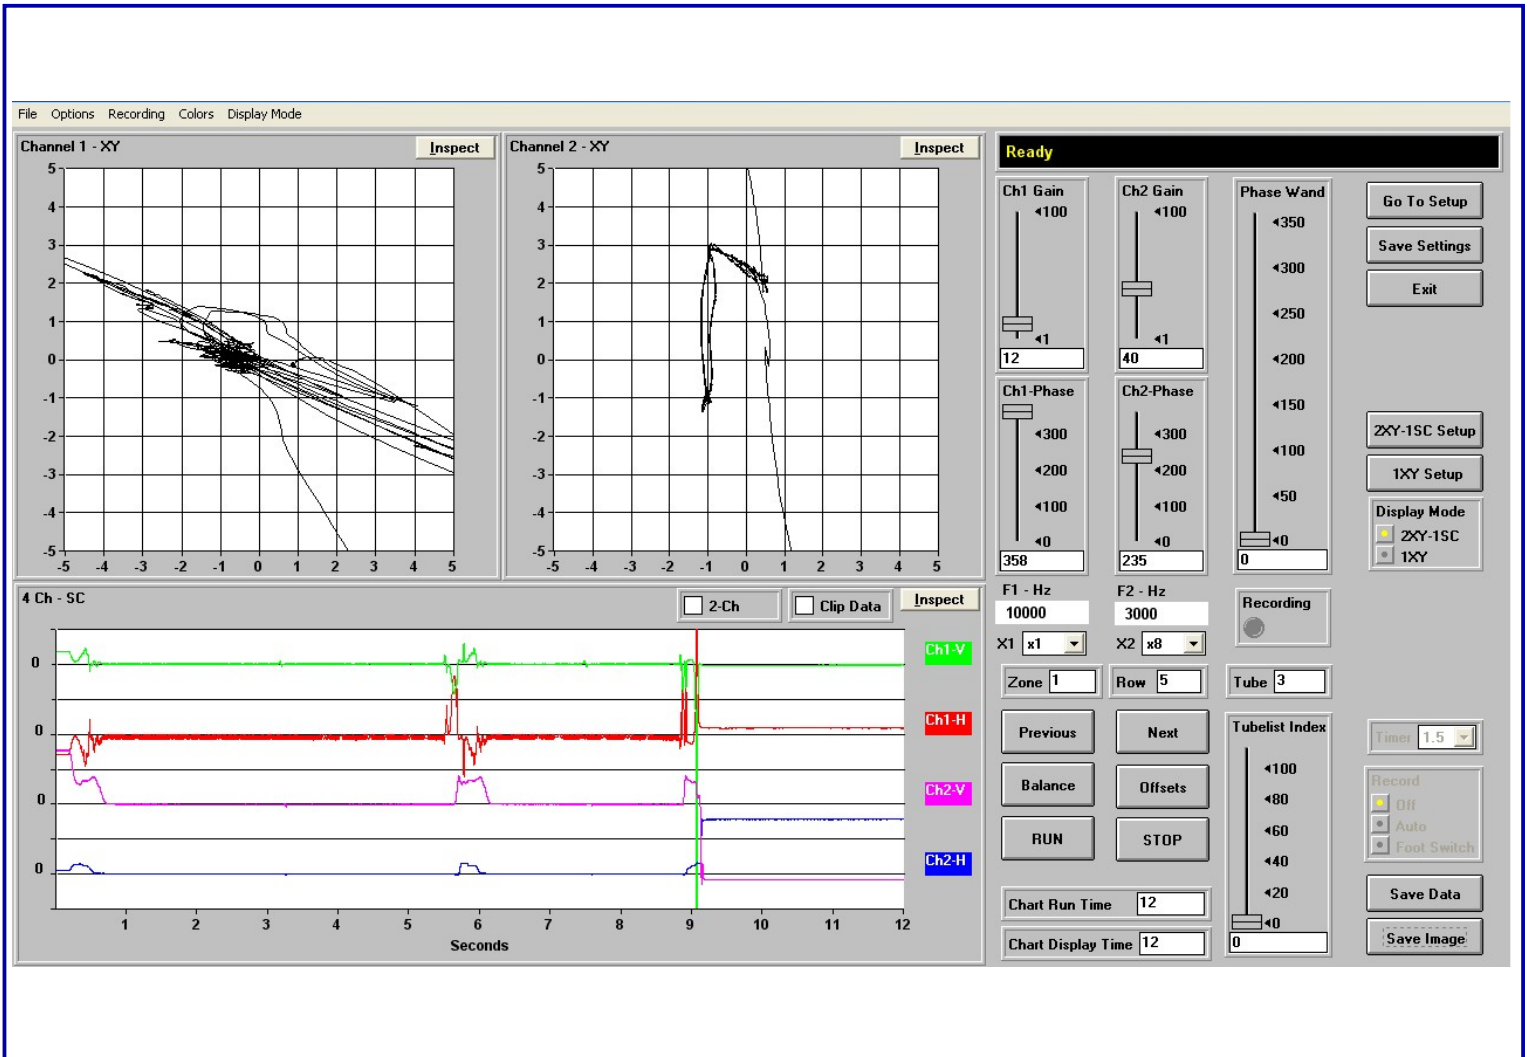
Condenser Section

NO SIGNIFICANT DEFECTS (Row 5 Tube 3)

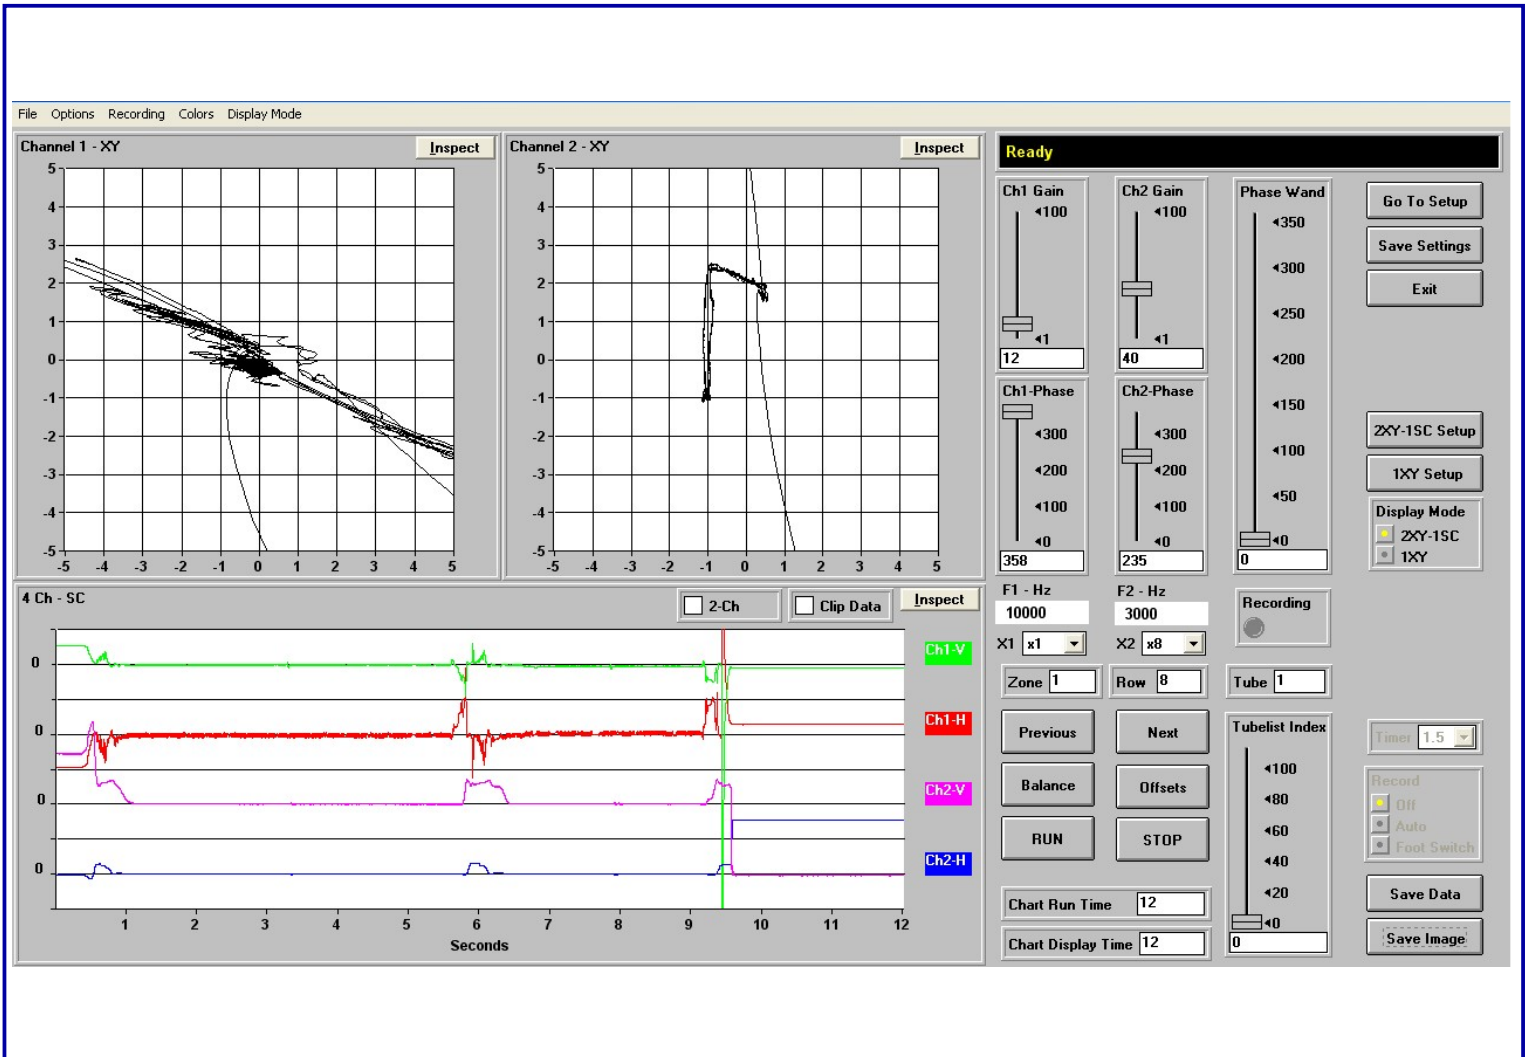
Condenser Section

NO SIGNIFICANT DEFECTS (Row 8 Tube 1)

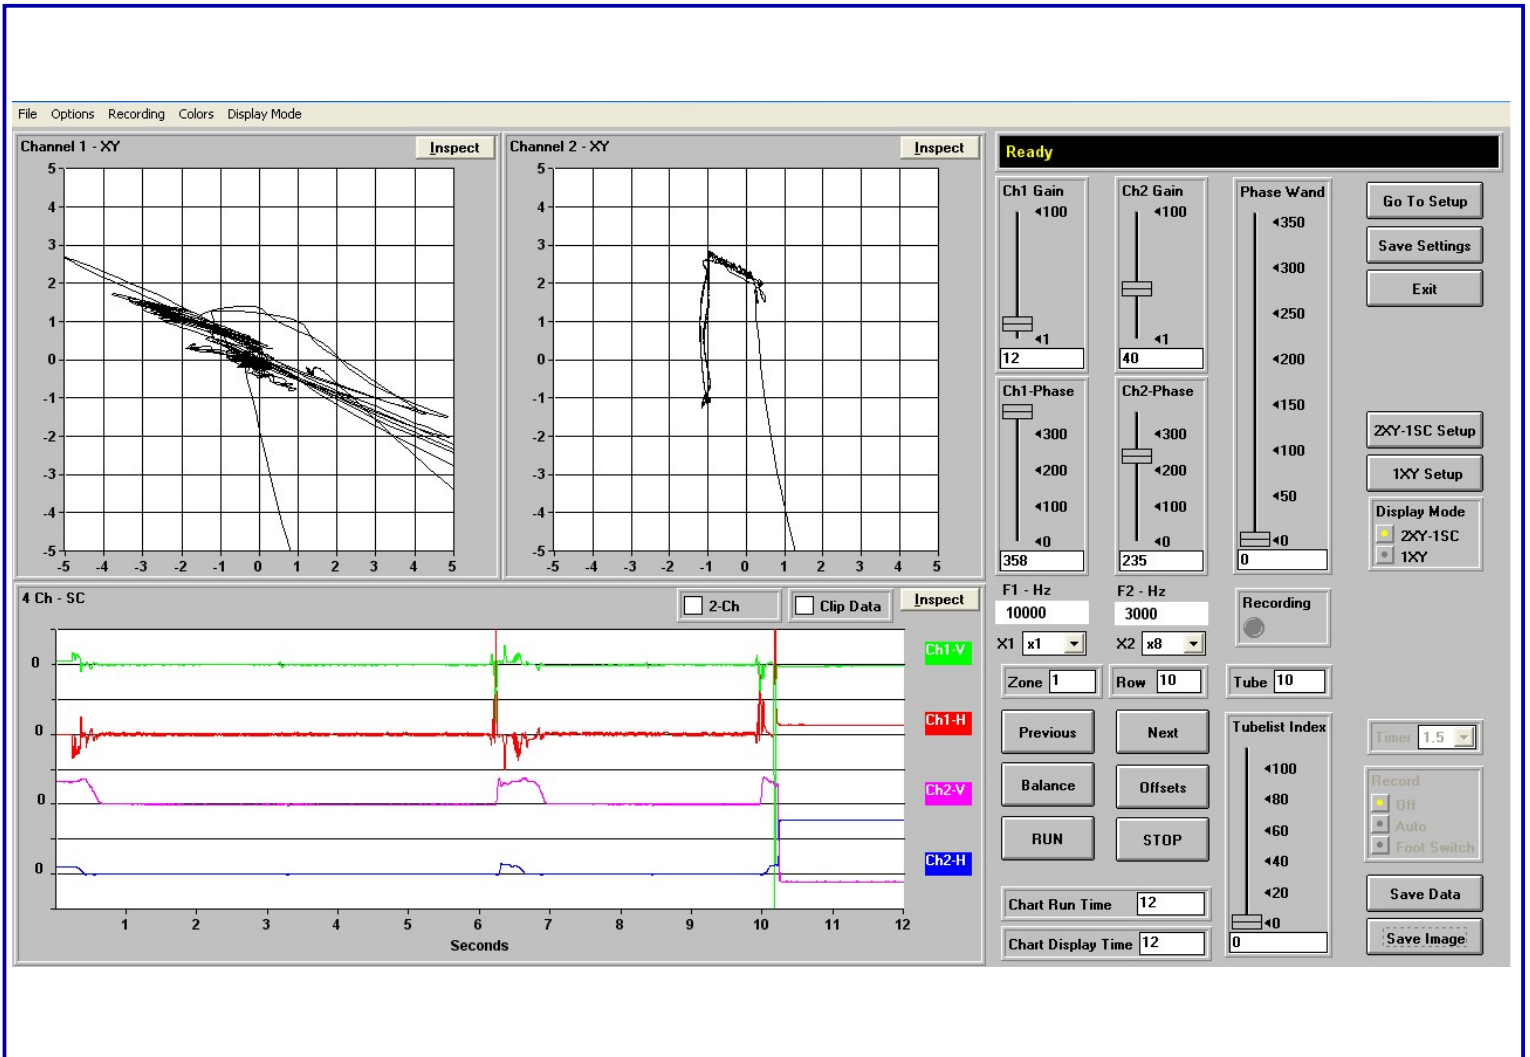
Condenser Section

NO SIGNIFICANT DEFECTS (Row 10 Tube 10)

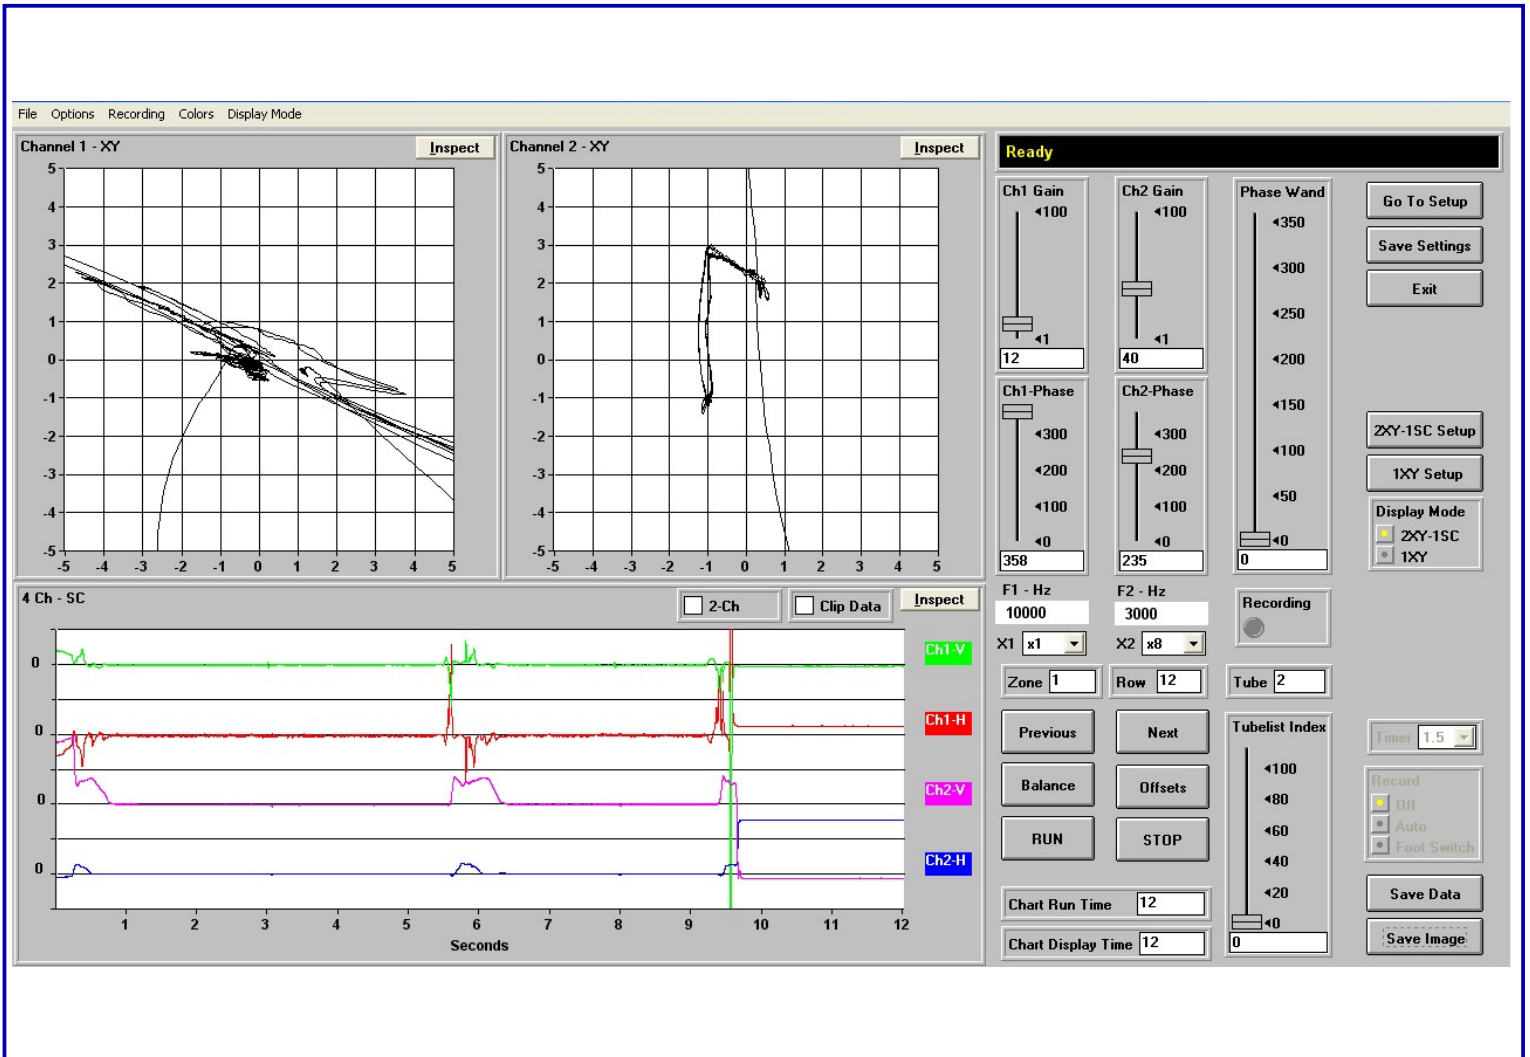
Condenser Section

NO SIGNIFICANT DEFECTS (Row 12 Tube 2)

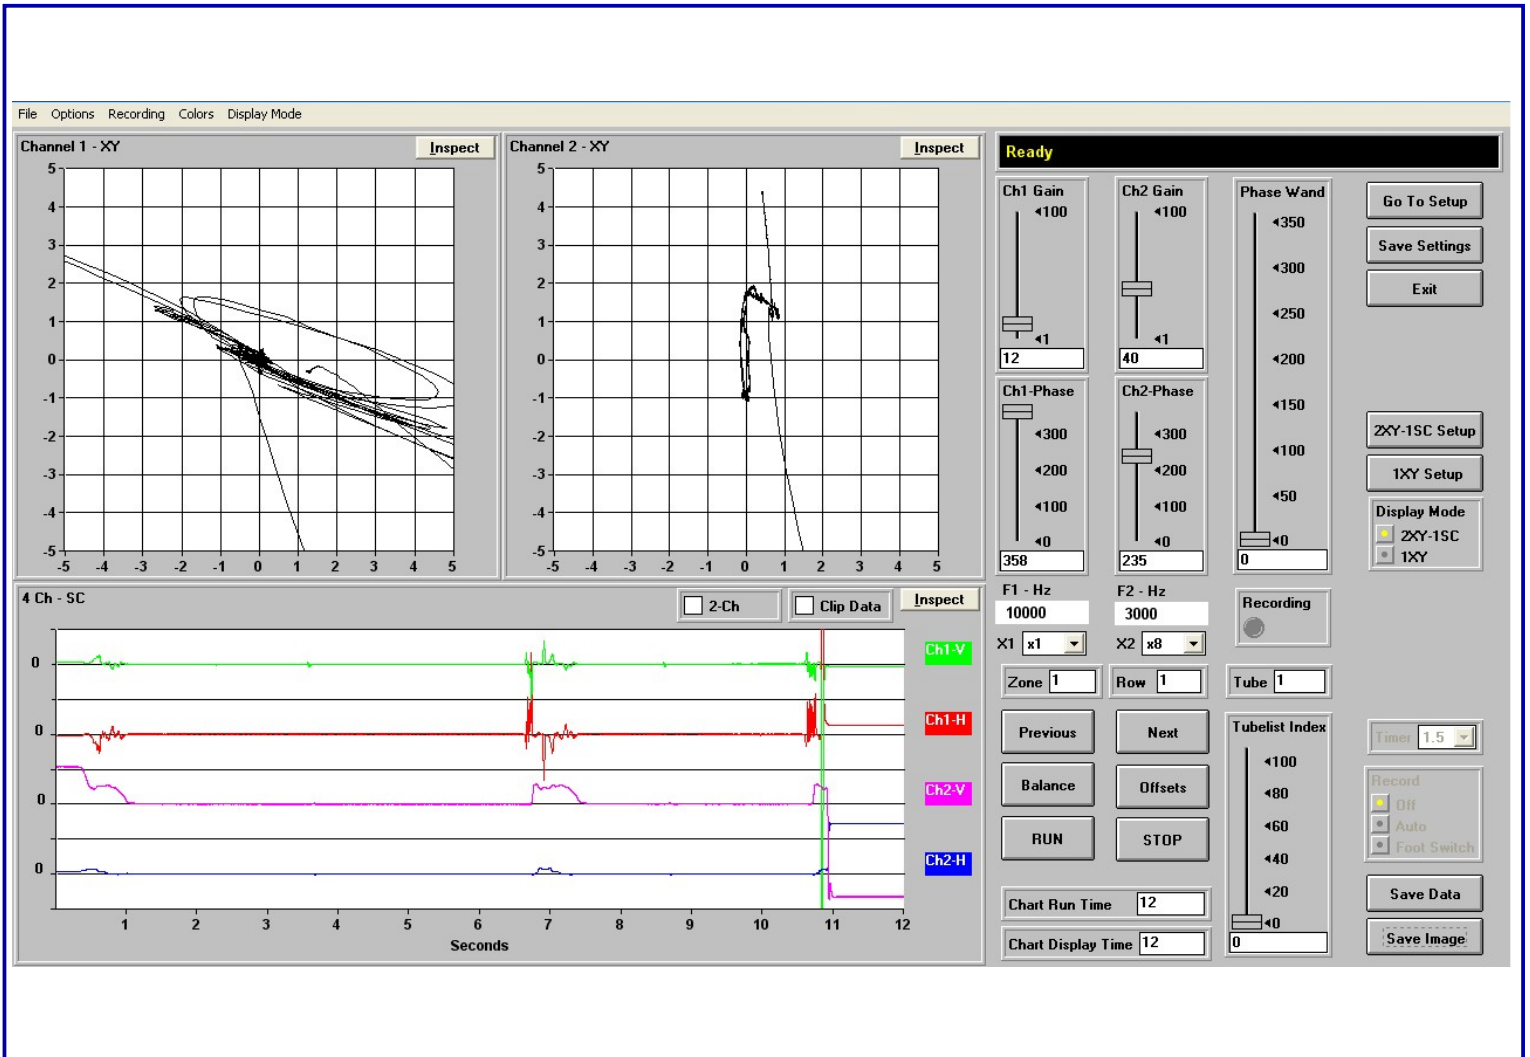
Evaporator Section

NO SIGNIFICANT DEFECTS (Row 1 Tube 1)

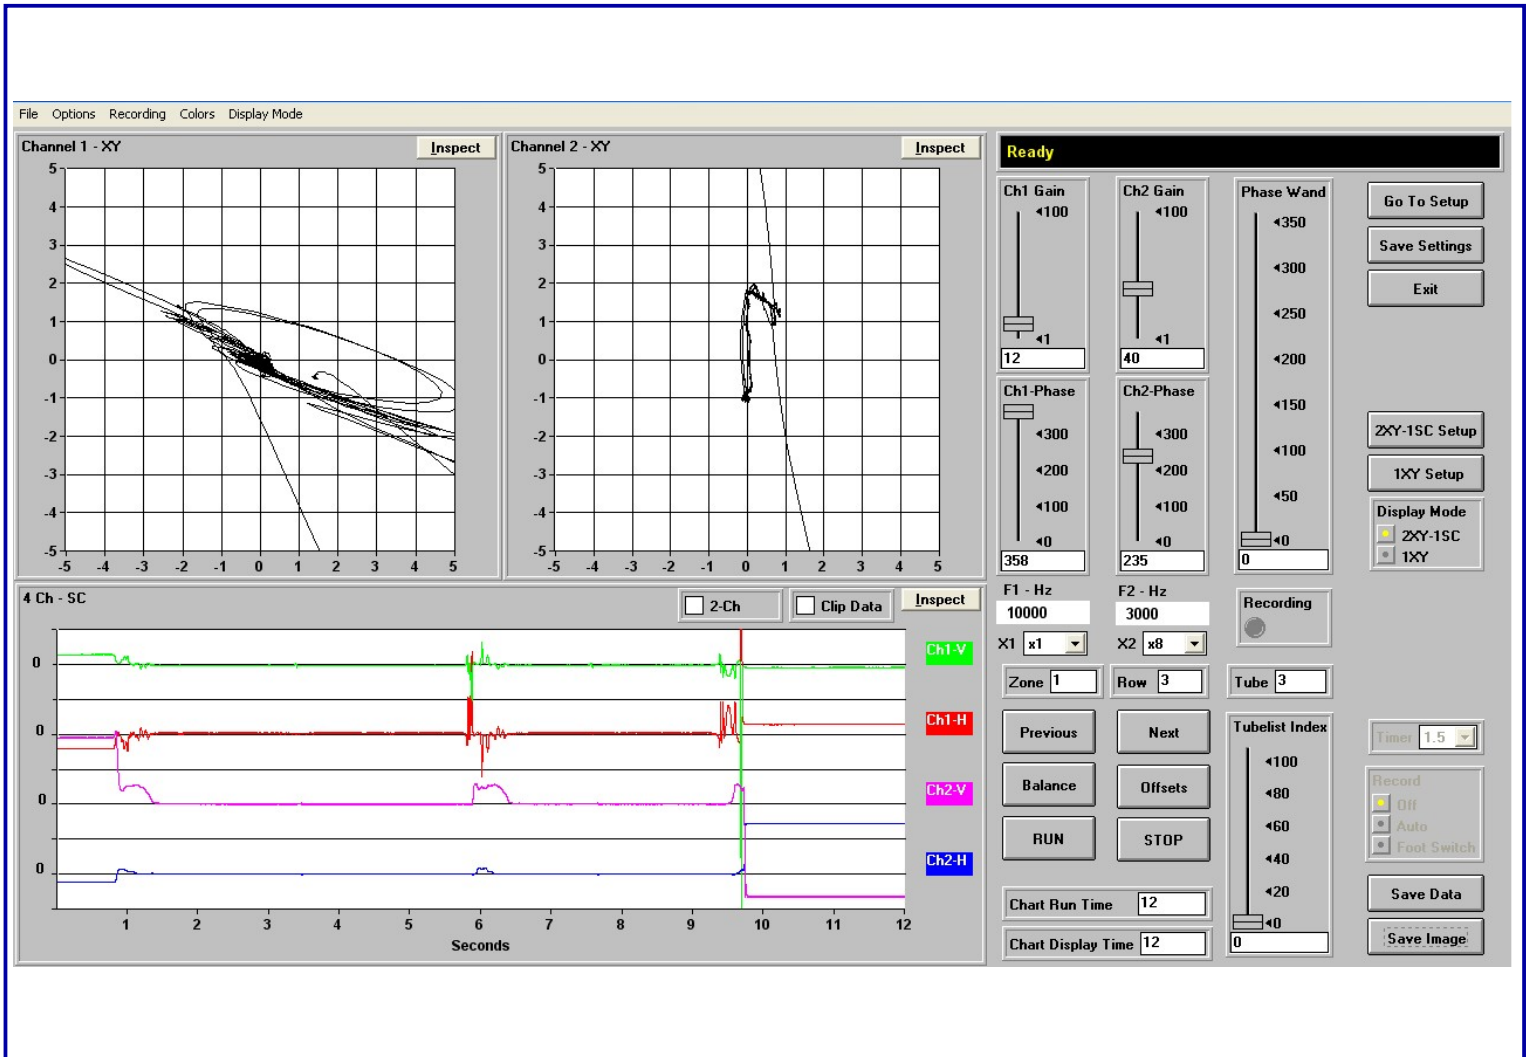
Evaporator Section

NO SIGNIFICANT DEFECTS (Row 3 Tube 3)

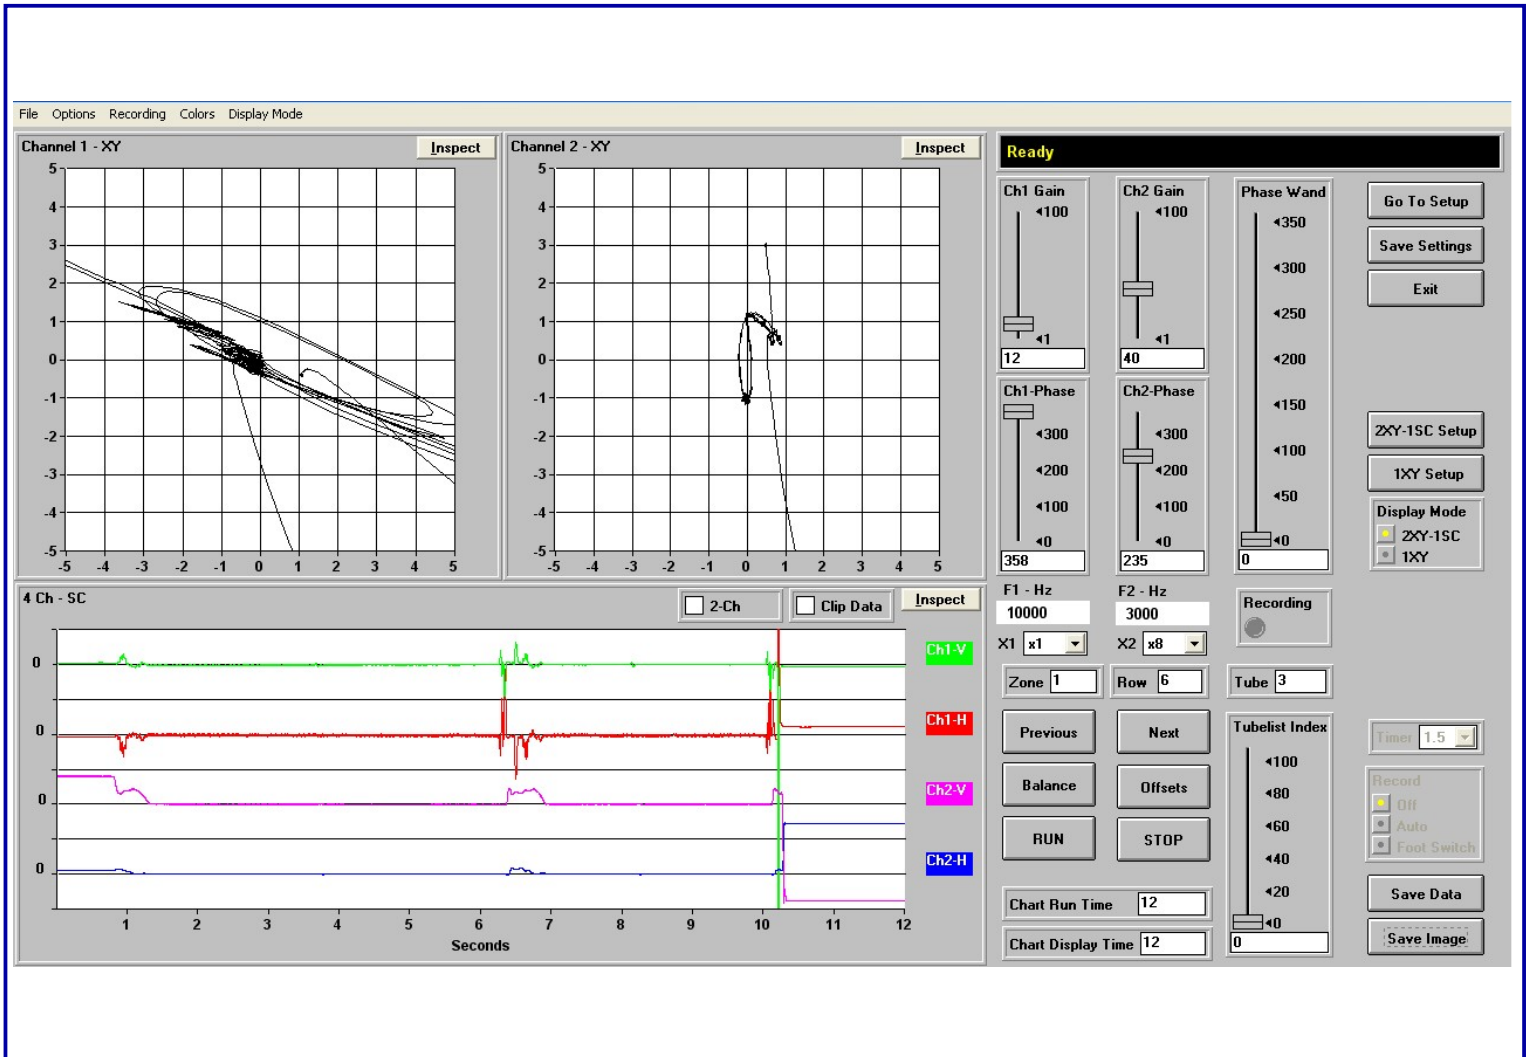
Evaporator Section

NO SIGNIFICANT DEFECTS (Row 6 Tube 3)

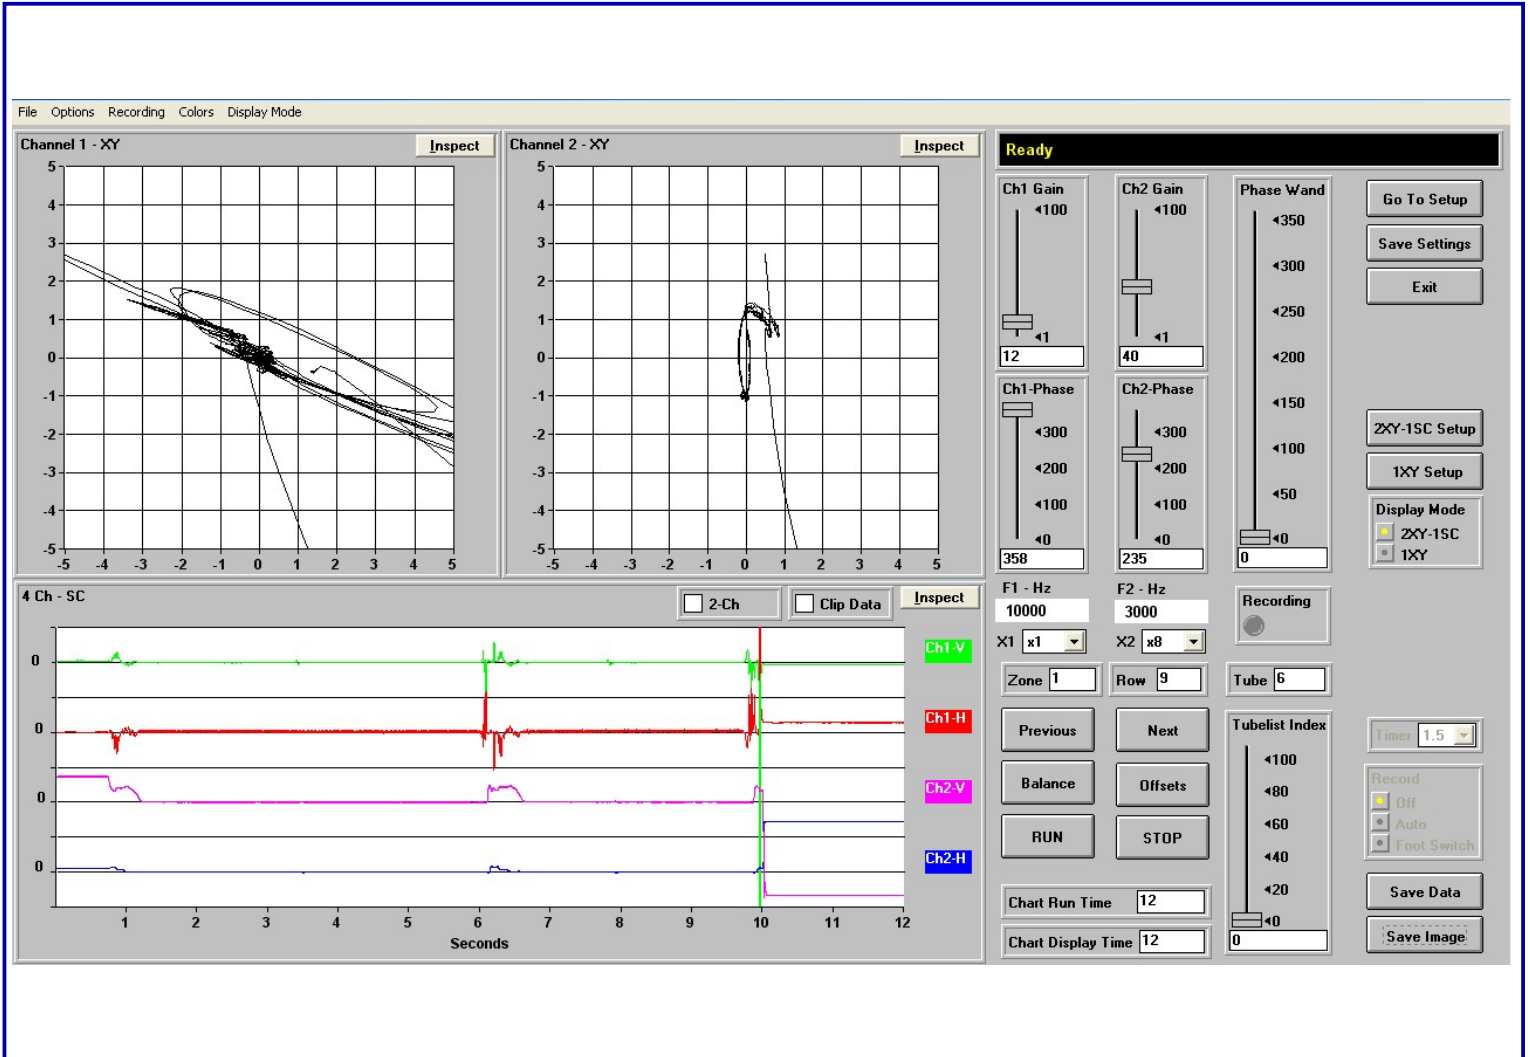
Evaporator Section

NO SIGNIFICANT DEFECTS (Row 9 Tube 6)

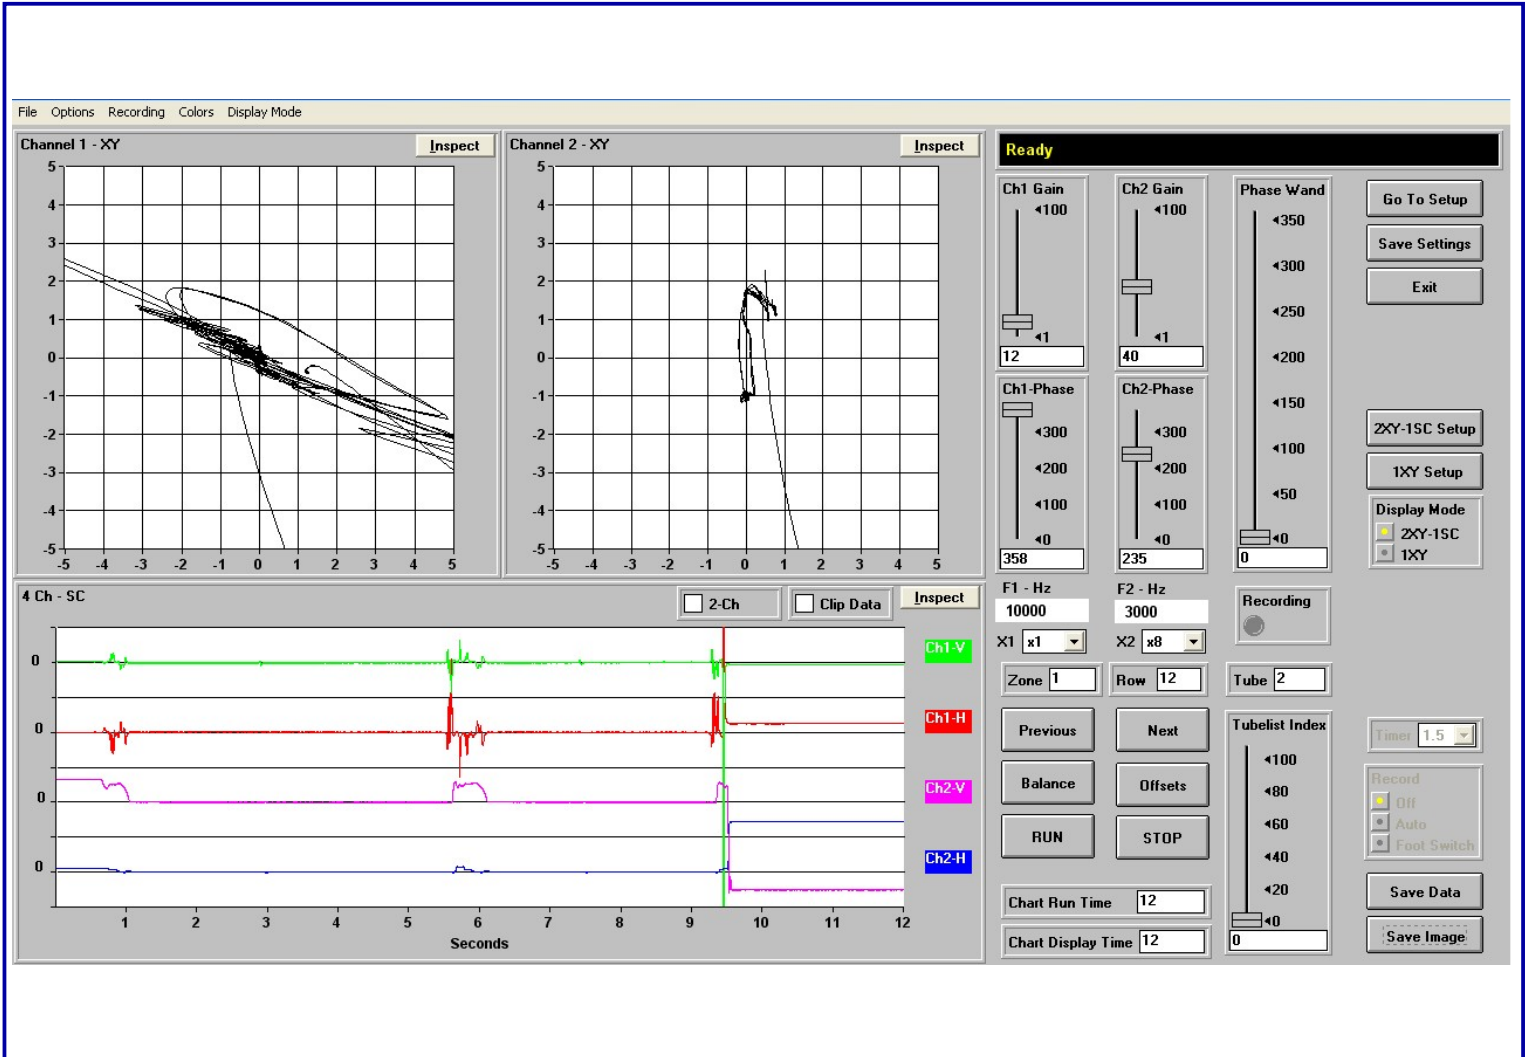
Evaporator Section

NO SIGNIFICANT DEFECTS (Row 12 Tube 2)

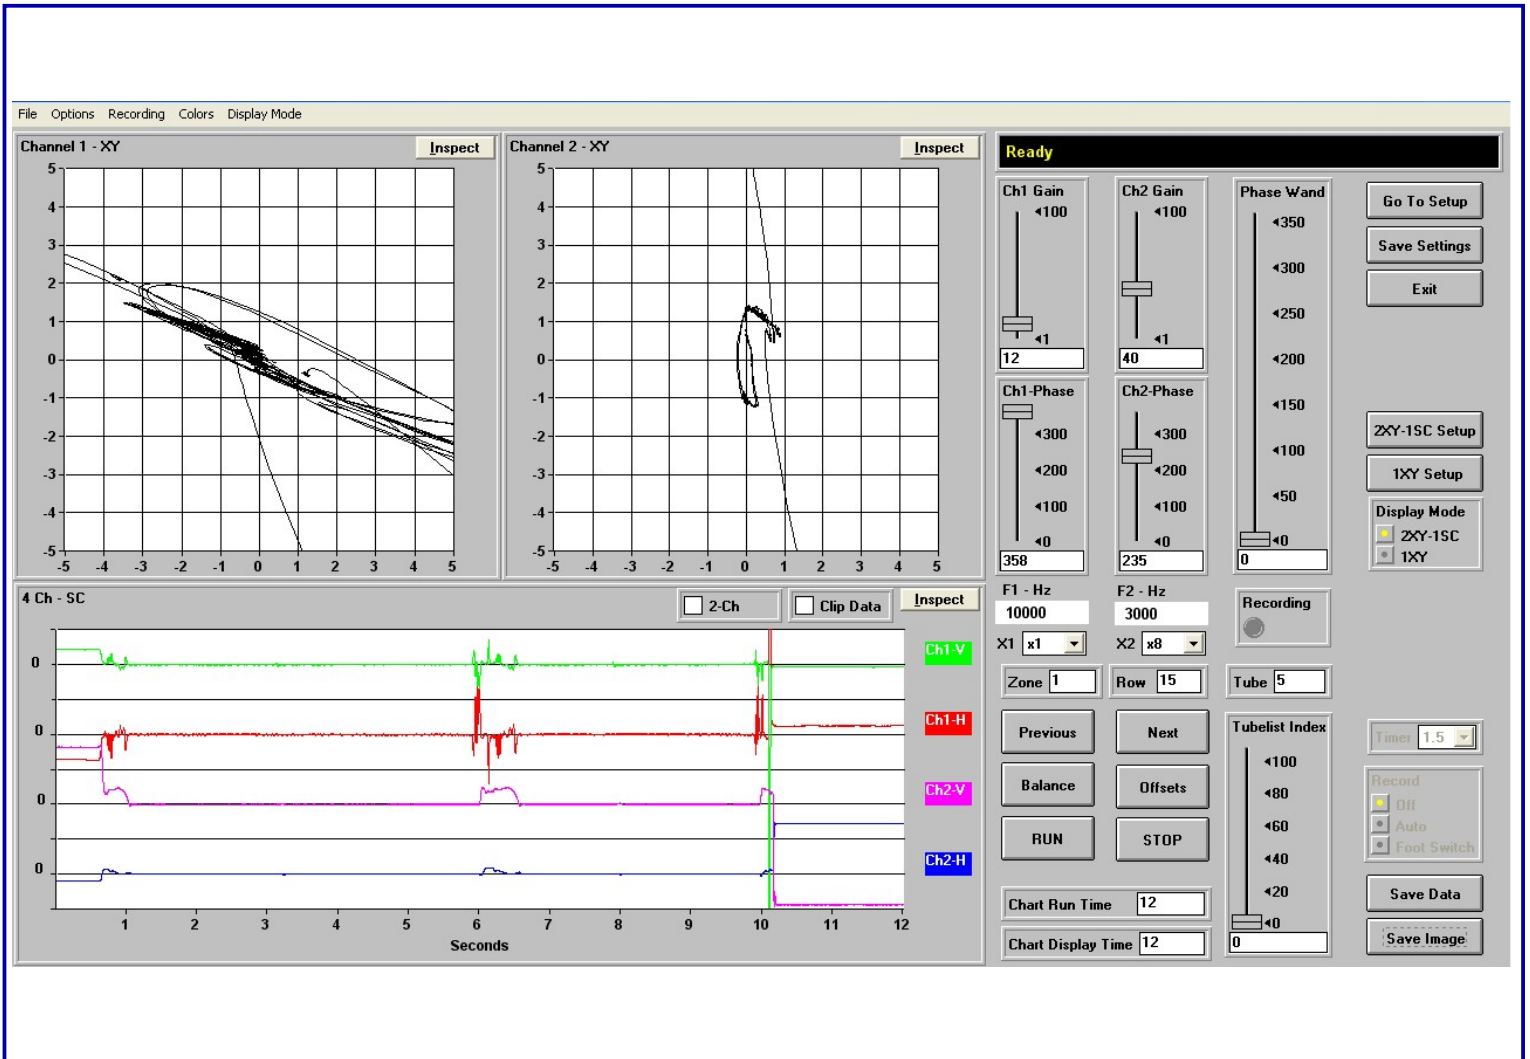
Evaporator Section

NO SIGNIFICANT DEFECTS (Row 15 Tube 5)
