LIMITED ASBESTOS & LEAD INSPECTION REPORT

**USC- Union, Central Building- Roof Replacement/ Repair Project
309 East Academy Street
Union, South Carolina 29379**

INSPECTION DATE: November 9, 2017

**Crossroads Environmental, LLC
1258 Boiling Springs Road
Spartanburg, South Carolina 29303
(864) 541-8736
CRE Project # 15584-IN**

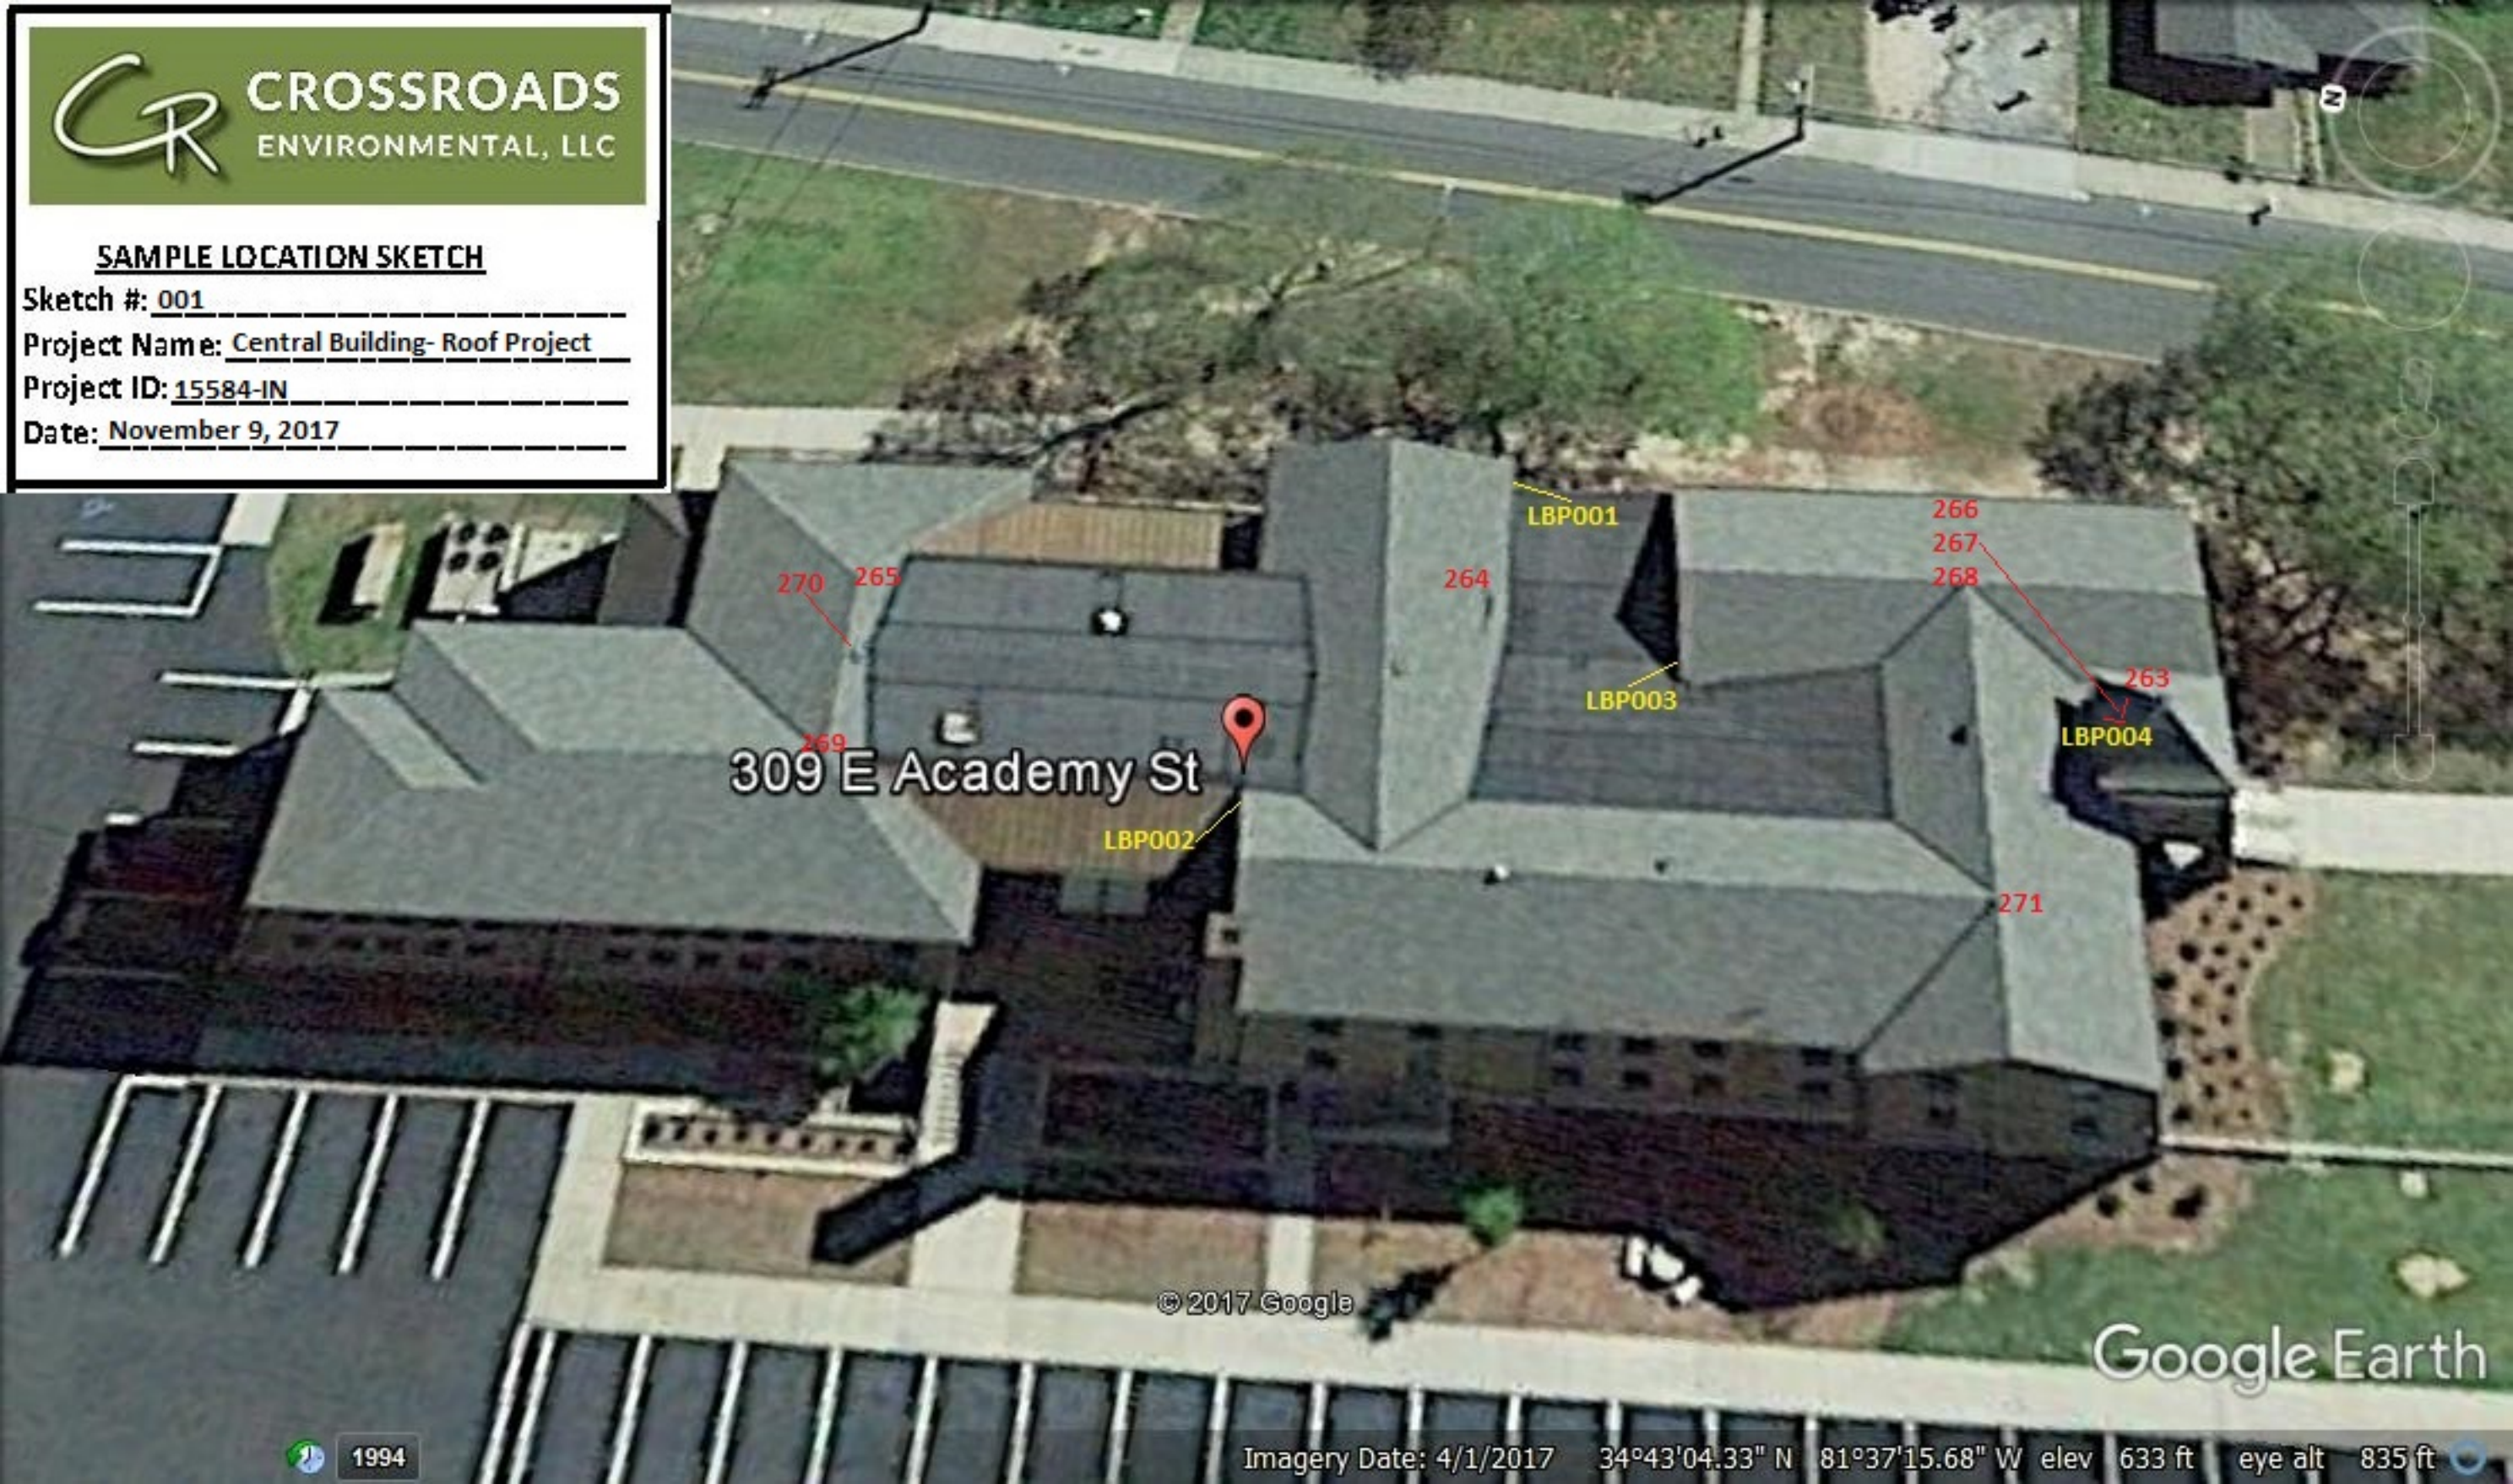
Sketch #: 001
Project Name: Central Building- Roof Project
Project ID: 15584-IN
Date: November 9, 2017

Lead-based paint was detected on the fascia/soffit of the south (original) section, central section and copula. Please Note: The north section fascia/soffit could not be accessed due to height, but is assumed as homogeneous to the other sections.

In summary, Contractors disturbing components paint with LBP must:

- Be properly trained in accordance with OSHA 29 CFR 1926.62
- Use safe lead-work practices at all times
- Perform an initial exposure assessment for each task being performed
- Utilize proper respiratory protection and have documentation including Respiratory Protection and Medical Surveillance Plans

Additionally, all lead-based paint that has been scraped from its substrate must be properly disposed of following waste characterization by toxicity characteristic leaching procedure (TCLP).
