**ASBESTOS AND LEAD BASED PAINT
ASSESSMENT UPDATE REPORT**

**UNIVERSITY OF SOUTH CAROLINA
BEAUFORT HISTORICAL CAMPUS
BEAUFORT, SOUTH CAROLINA**

S&ME Project No. 1135-13-464

September 30, 2013

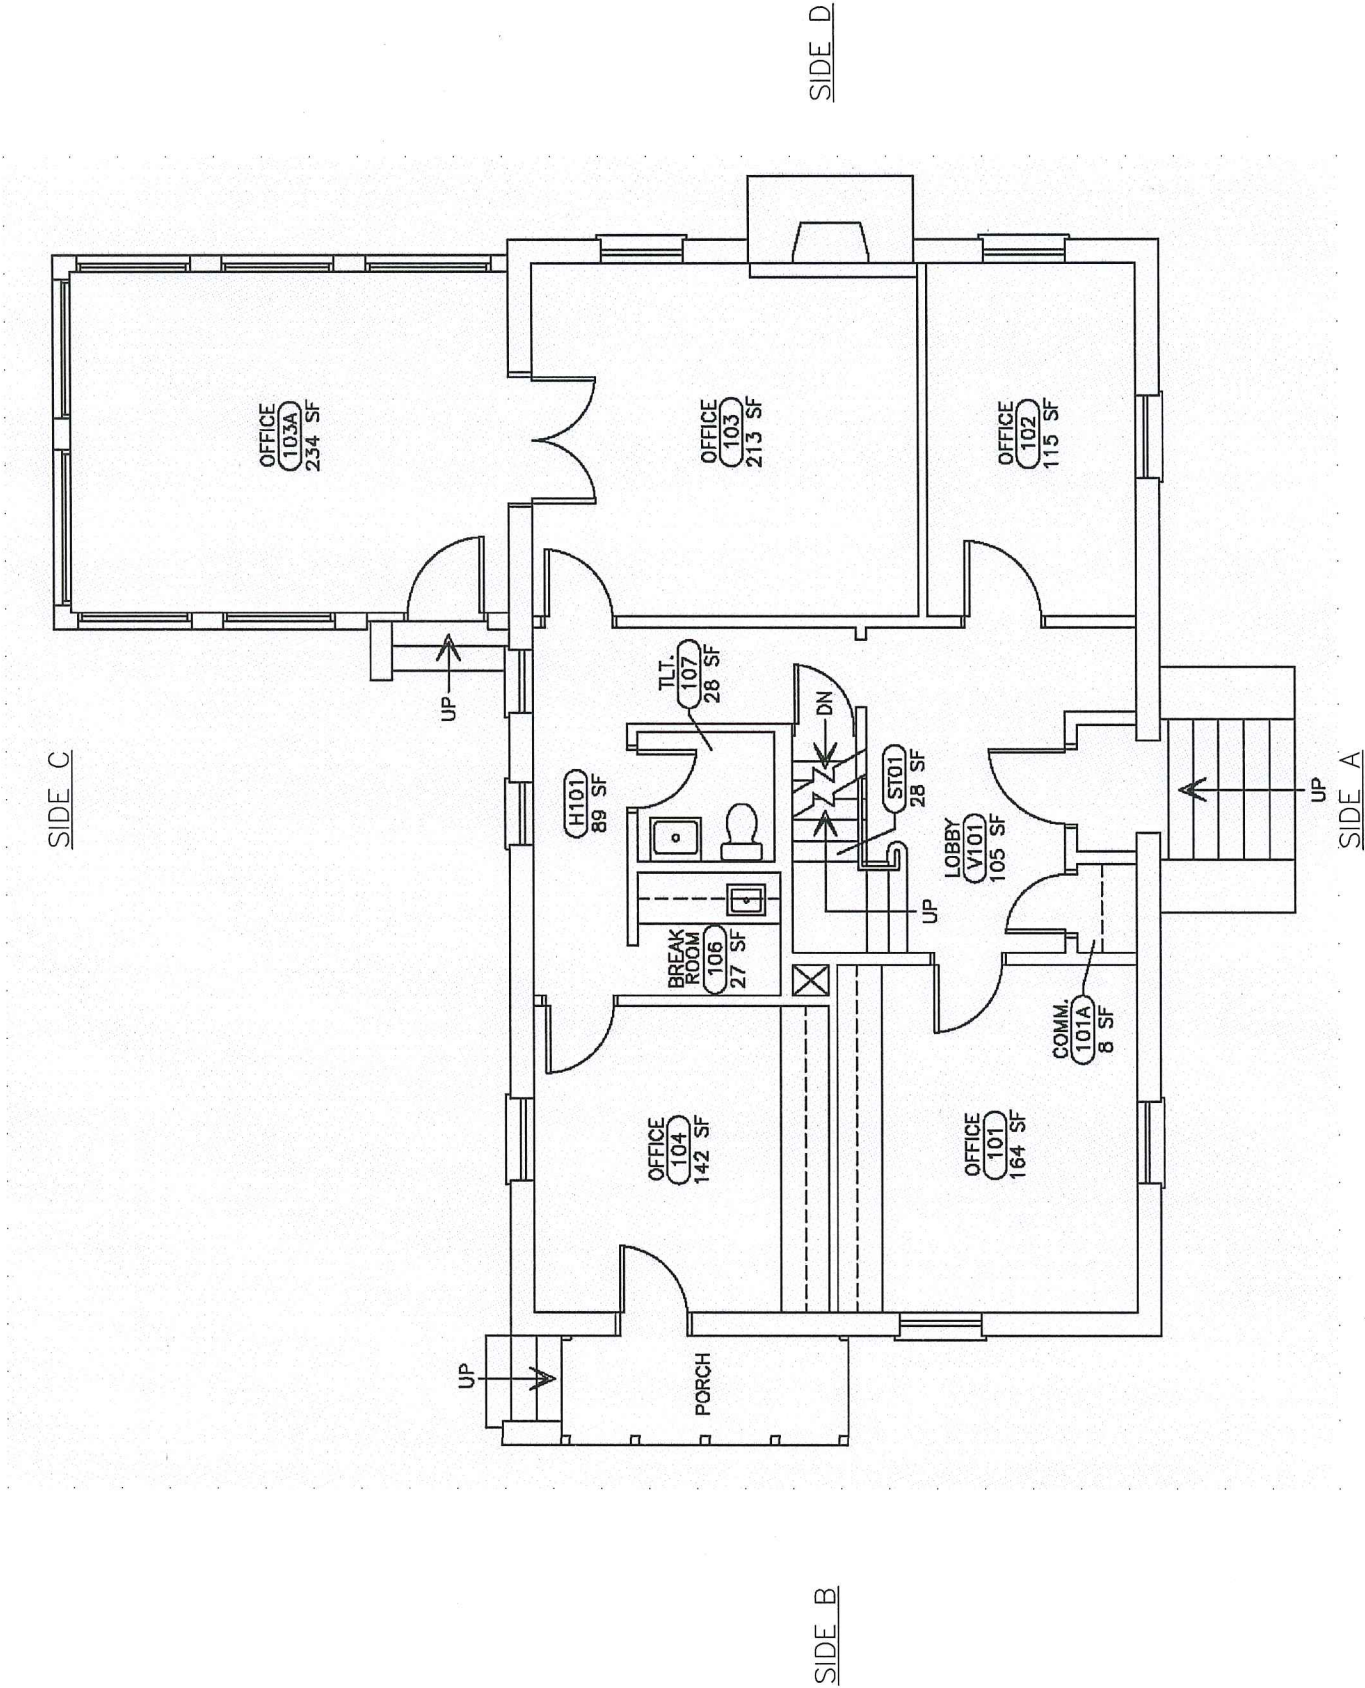
SCALE: NTS	DRAWN BY: LAJ	APPROVED BY: TR
PROJECT NO. 1135-13-464	DATE: 9-30-2013	FIGURE NO. 1.1

CONFIRMED ASBESTOS CONTAINING MATERIALS:

JOINT COMPOUND AND ASSOCIATED SHEETROCK
LOCATED IN BASEMENT STAIRWELL
- APPROXIMATELY 260 SQUARE FEET

WINDOW GLAZING - APPROXIMATELY 490 LINEAR FEET

INTERIOR AND EXTERIOR LINTELS (INTACT CONDITION);

INTERIOR AND EXTERIOR DOOR CASINGS (INTACT CONDITION);

EXTERIOR WINDOW COMPONENTS AND LINTELS (INTACT CONDITION);

EXTERIOR HANDRAILS ON ROOF (POOR CONDITION); AND

EXTERIOR PORCH CEILING (INTACT CONDITION).

The SCDHEC and EPA require proper removal and disposal, by a SCDHEC licensed contractor, of ACMs that will be disturbed by renovation and/or demolition activities. We recommend repairing or removing the damaged ACMs located at Grayson House. If additional suspect materials not previously sampled are discovered during renovation and/or demolition activities, bulk samples should be collected by a SCDHEC licensed inspector and analyzed for asbestos content. If any suspect asbestos containing roofing materials will be destructively impacted, we recommend bulk sampling and analysis for asbestos content, prior to the destructive activities, as required by SCDHEC and EPA. This report should be provided to in-house maintenance staff and contractor(s) potentially impacting the identified materials to assist with compliance with applicable State and Federal regulations.

The lead-based paint surfaces noted to be in poor (chipping and flaking) condition should be repaired via interim controls (e.g. scraping loose and flaking paint and repainted) or considered for removal, provided the work is performed by appropriately trained personnel and properly disposed. Lead-based paint coated waste must be disposed in a Class II or Class III, lined landfill. Accumulations of paint waste (chips, dust, or flakes) must be tested by TCLP to determine if the waste is classified as hazardous, which requires disposal in a Subtitle C (hazardous waste) landfill. Lead waste, at a minimum, must be disposed in a Class II or Class III, lined landfill.

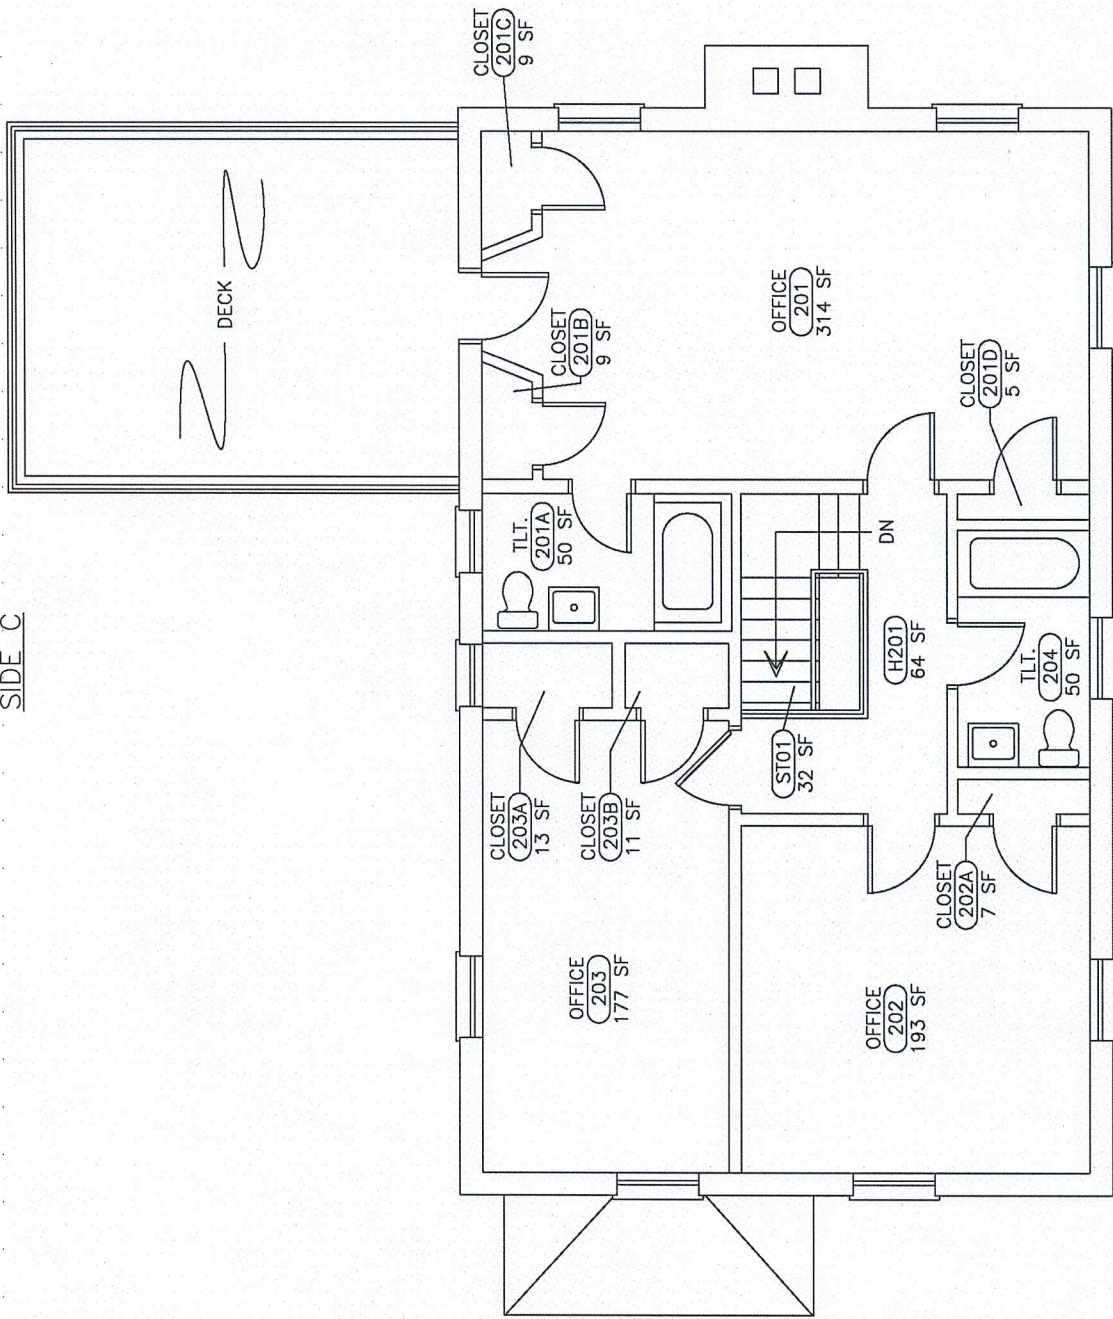
SCALE: NTS	DRAWN BY: LAJ	APPROVED BY: TR
PROJECT NO. 1135-13-464	DATE: 9-30-2013	FIGURE NO. 1.2

INTERIOR AND EXTERIOR LINTELS (INTACT CONDITION);

INTERIOR AND EXTERIOR DOOR CASINGS (INTACT CONDITION);

EXTERIOR WINDOW COMPONENTS AND LINTELS (INTACT CONDITION);

EXTERIOR HANDRAILS ON ROOF (POOR CONDITION); AND

EXTERIOR PORCH CEILING (INTACT CONDITION).

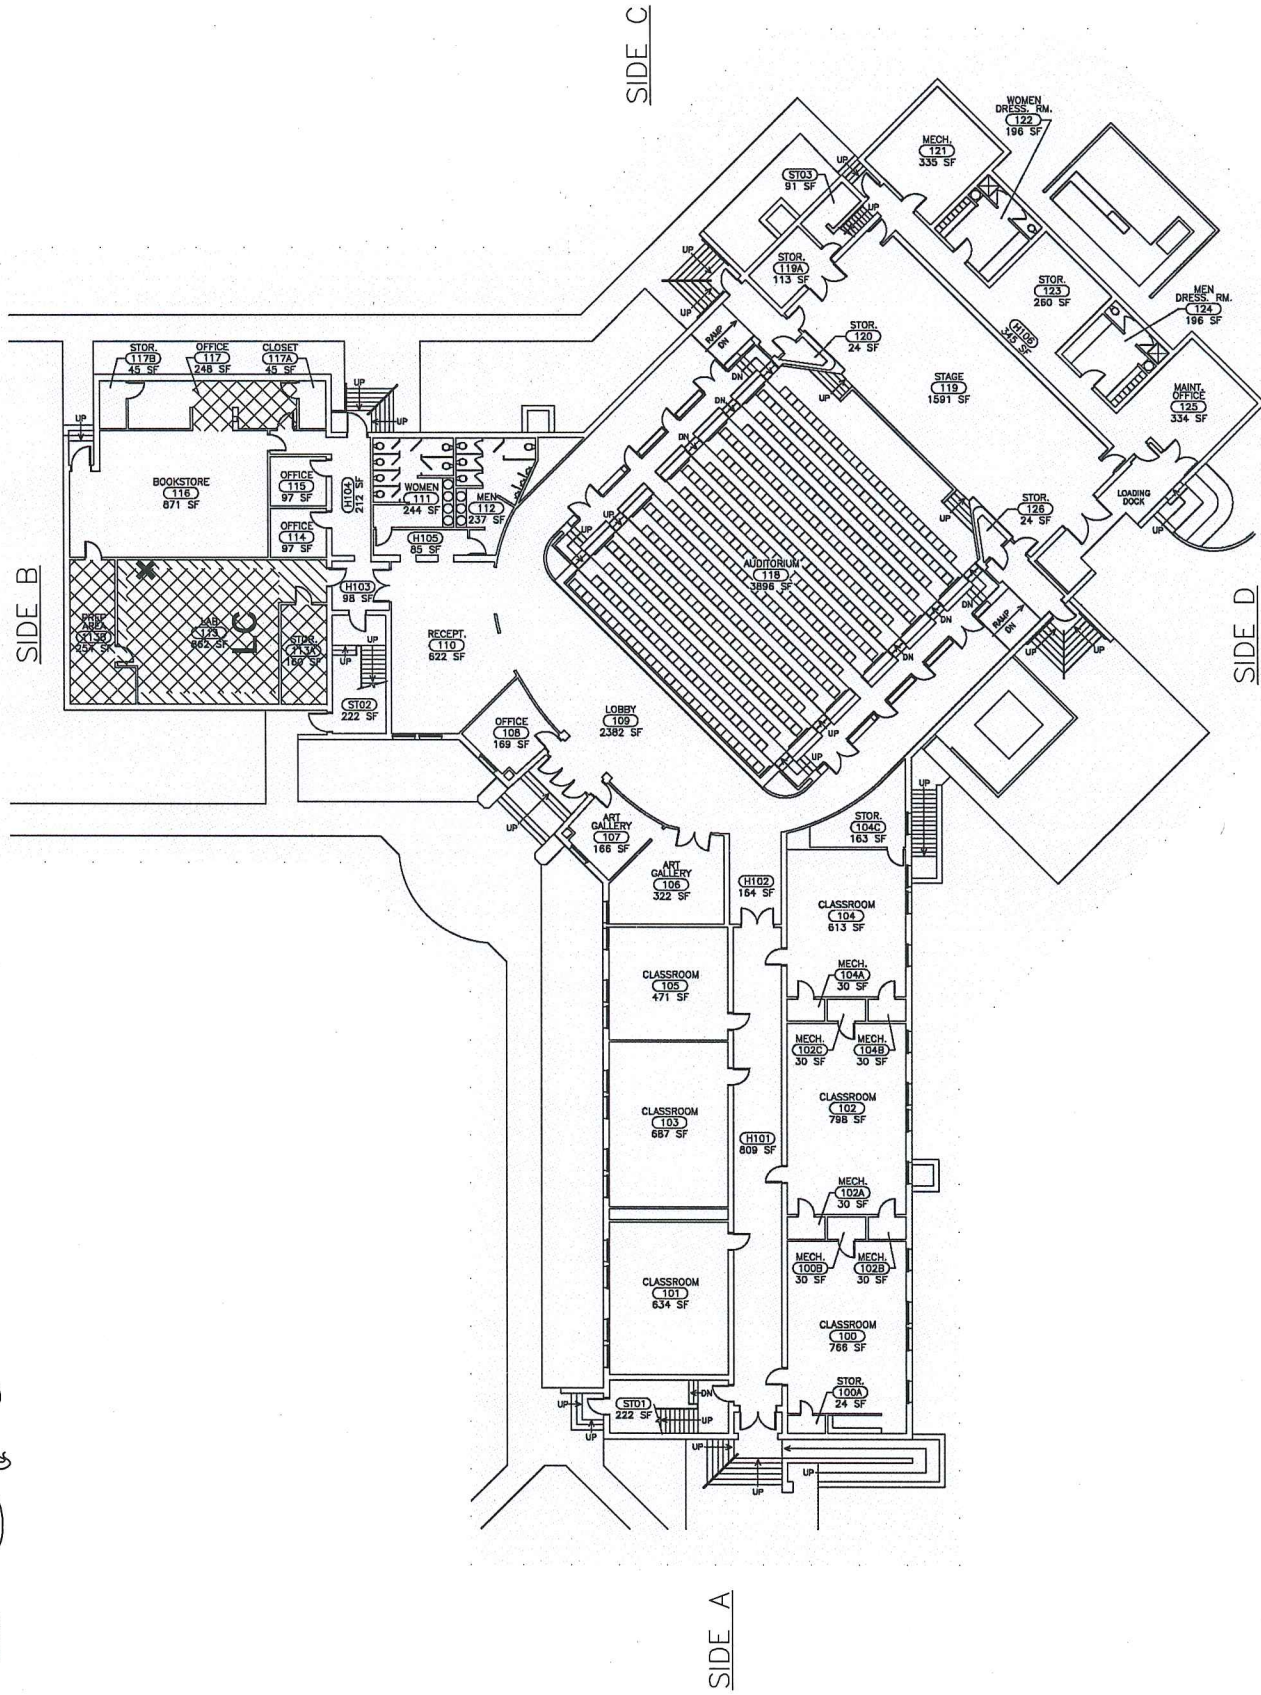
SCALE: NTS	DRAWN BY: LAJ	APPROVED BY: TR
PROJECT NO. 1135-13-464	DATE: 9-30-2013	FIGURE NO. 2.1

CONFIRMED ASBESTOS CONTAINING MATERIALS:

MASTIC (BLACK) ASSOCIATED WITH FLOOR TILE (12" WHITE)
- APPROXIMATELY 955 SQUARE FEET

INTERIOR AND EXTERIOR DOOR LINTELS (FAIR CONDITION);

INTERIOR METAL STAIRCASE BALUSTERS (INTACT CONDITION); AND
RUBBER BUMPER AT LOADING DOCK (POOR CONDITION).

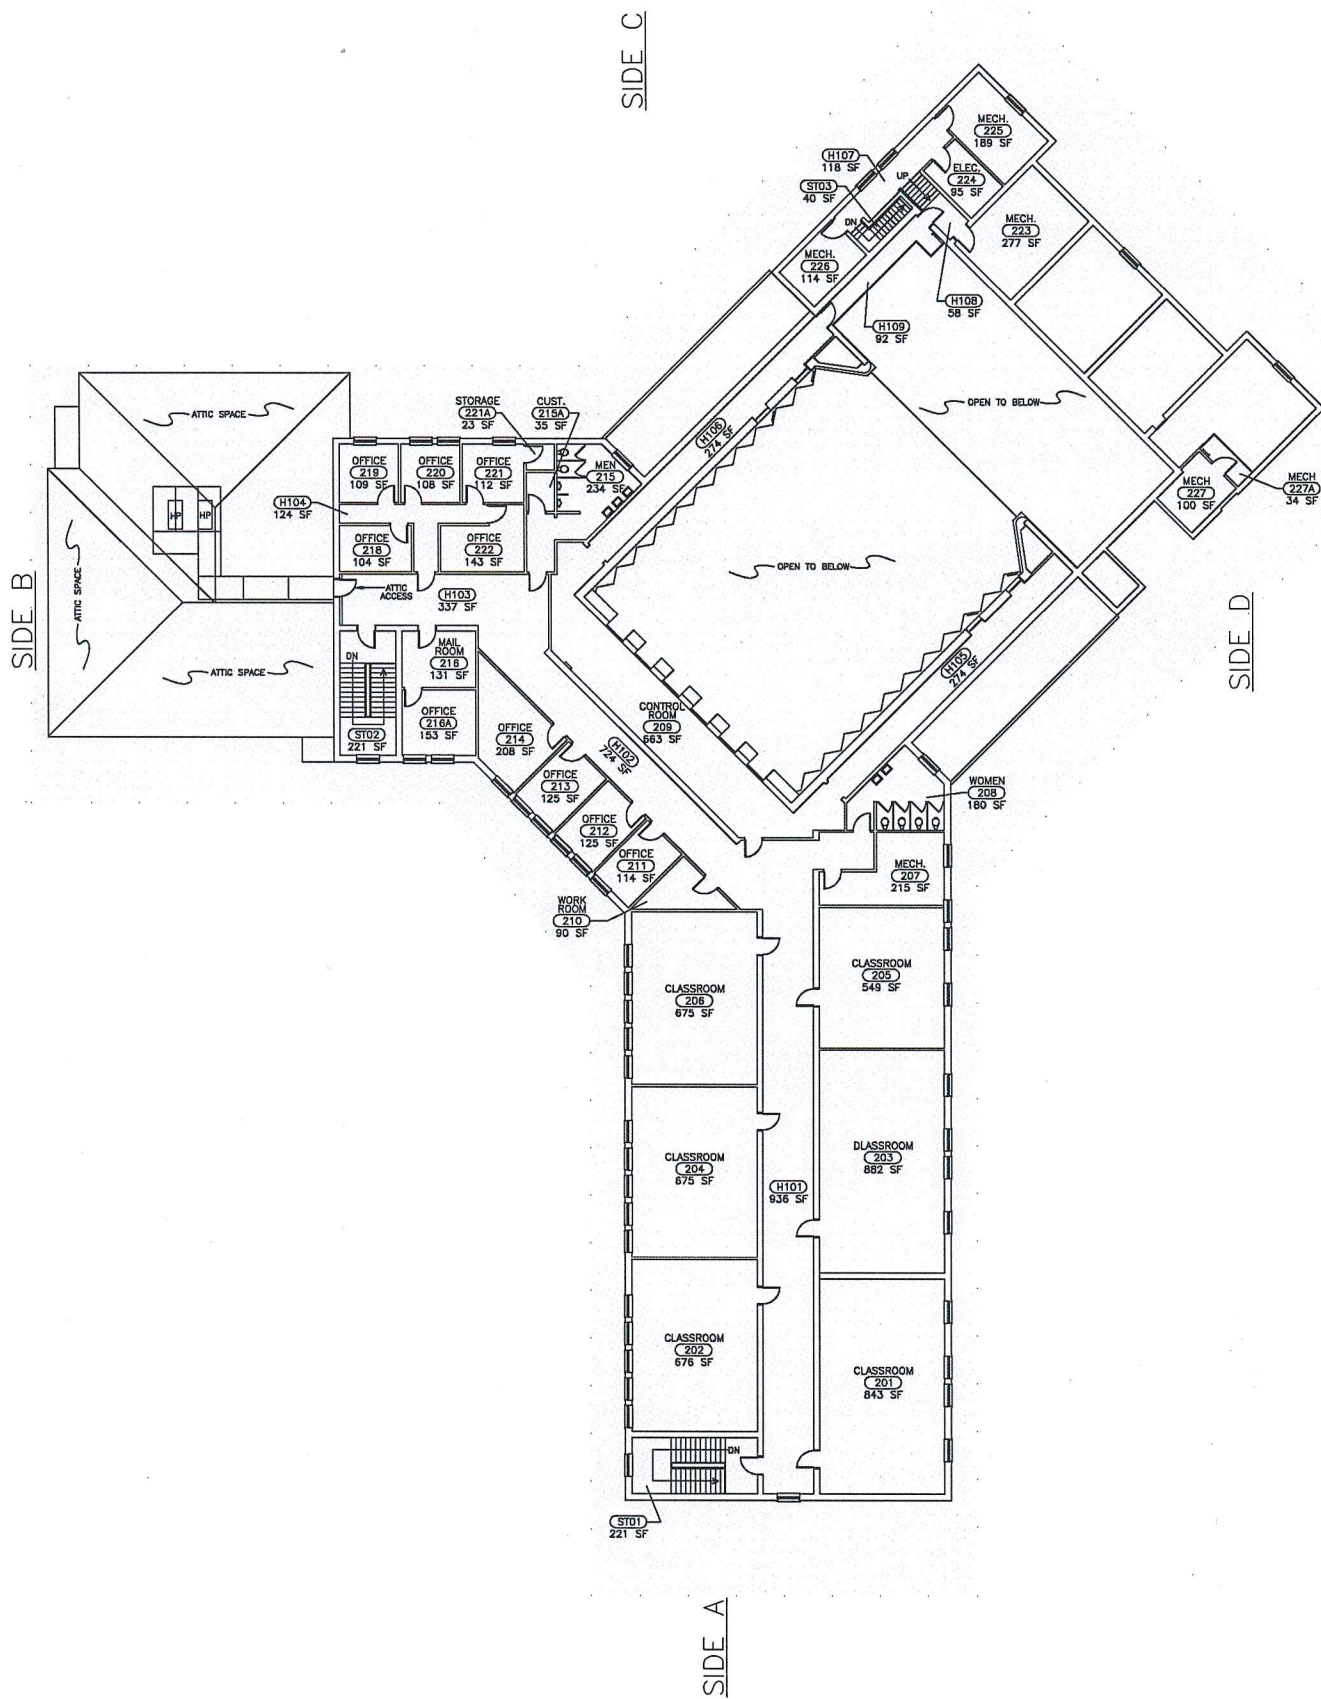
CONFIRMED LEAD-BASED PAINT COATED COMPONENTS:

INTERIOR AND EXTERIOR DOOR LINTELS (INTACT CONDITION);
INTERIOR METAL STAIRCASE BALUSTERS (INTACT CONDITION);
RUBBER BUMPER AT LOADING DOCK (INTACT CONDITION).

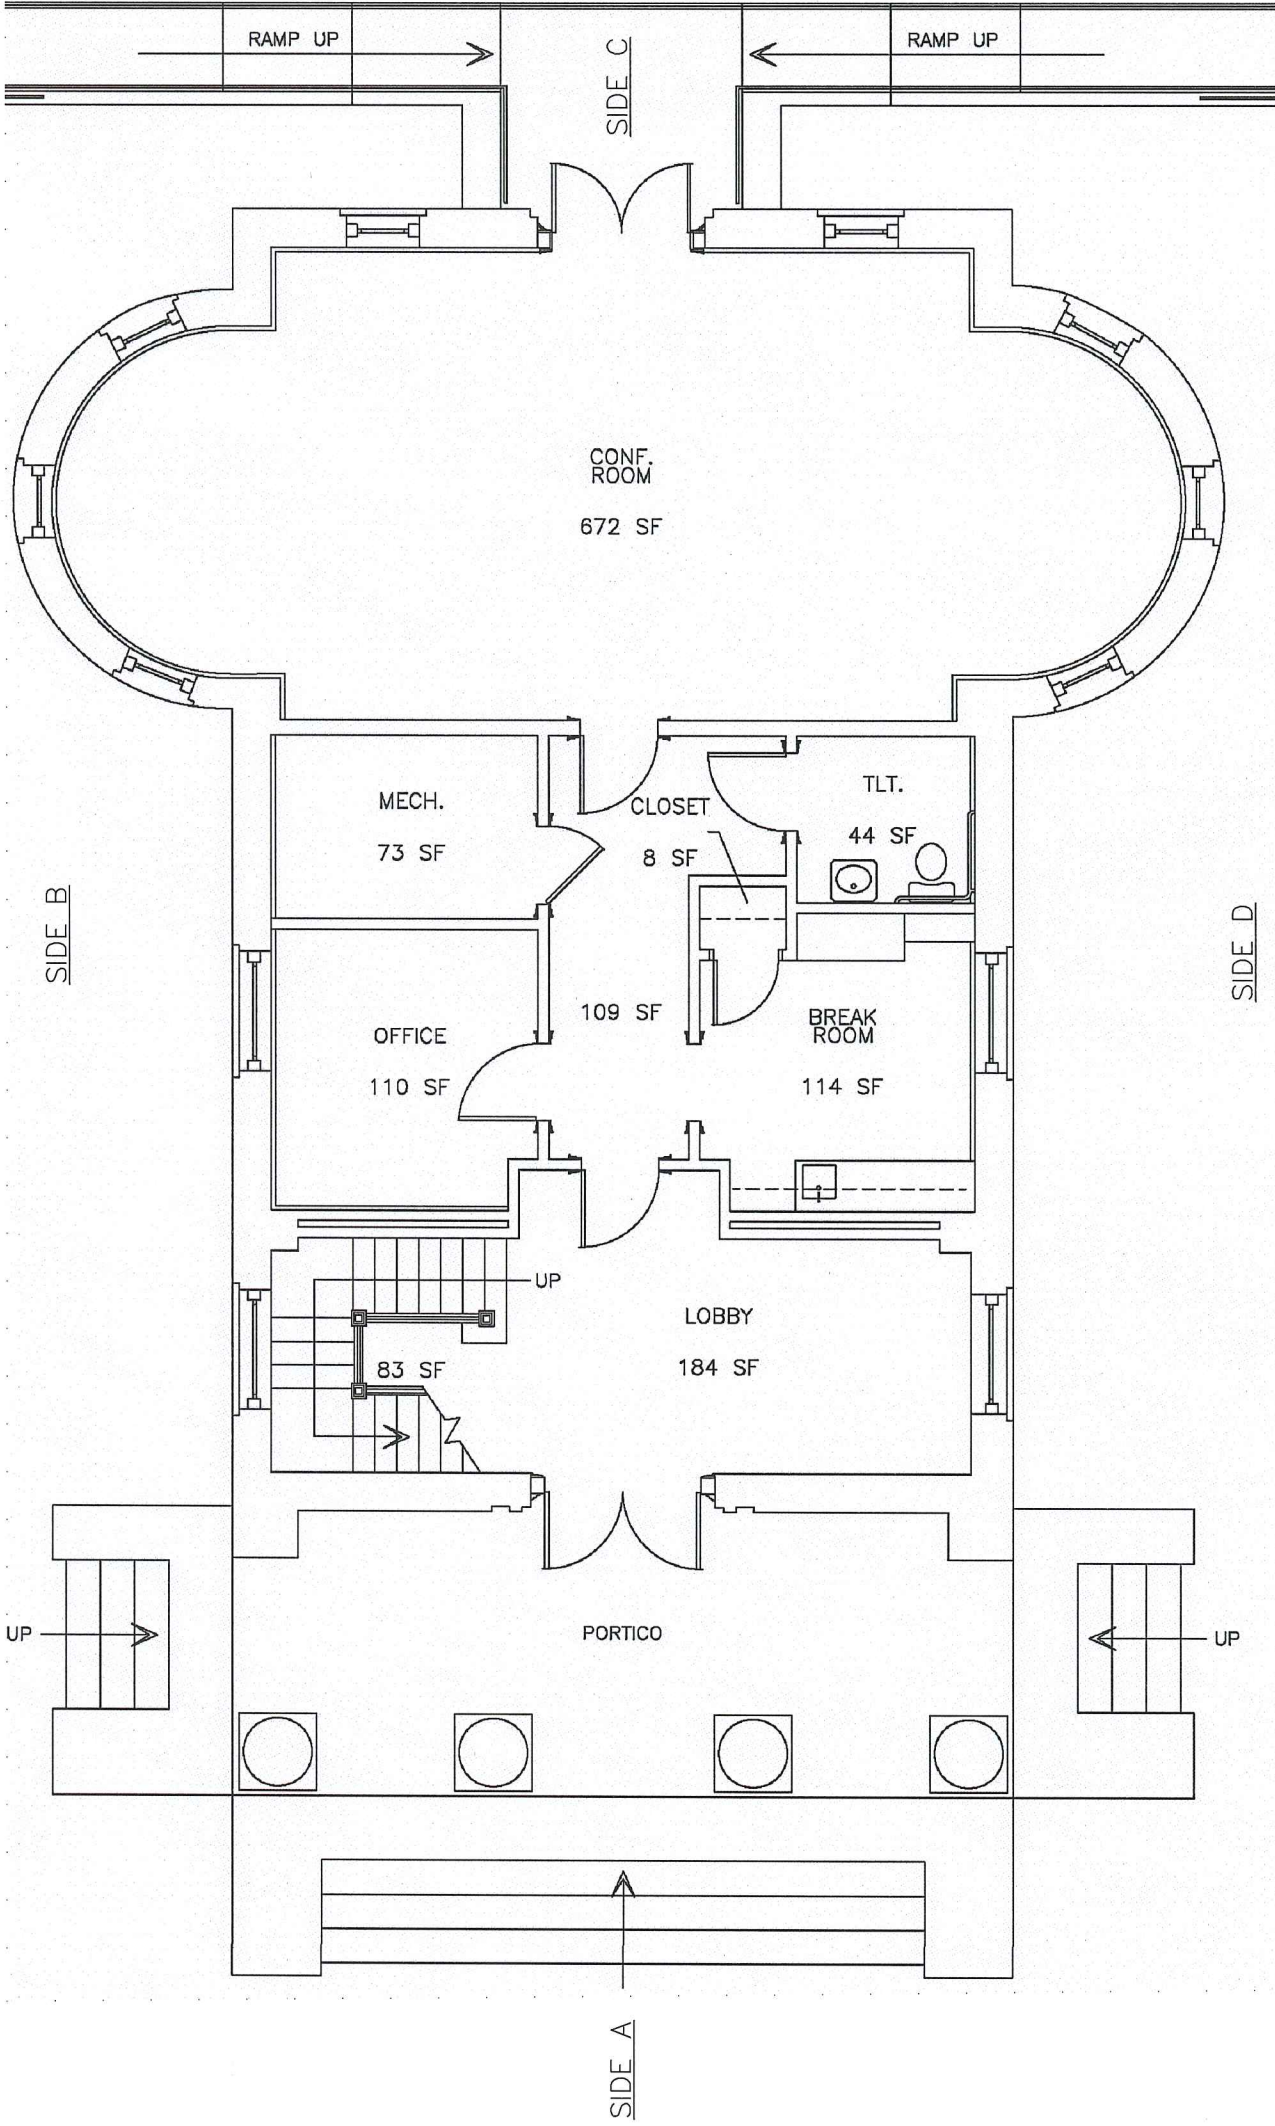
SCALE: NTS	DRAWN BY: LAJ	APPROVED BY: <i>TR</i>
PROJECT NO. 1135-13-464	DATE: 9-30-2013	FIGURE NO. 3.1

NO ASBESTOS WAS DETECTED.

CONFIRMED LEAD-BASED PAINT COATED COMPONENTS:

INTERIOR AND EXTERIOR DOOR CASINGS (INTACT CONDITION); AND

INTERIOR STAIRCASE BALUSTERS (INTACT CONDITION).

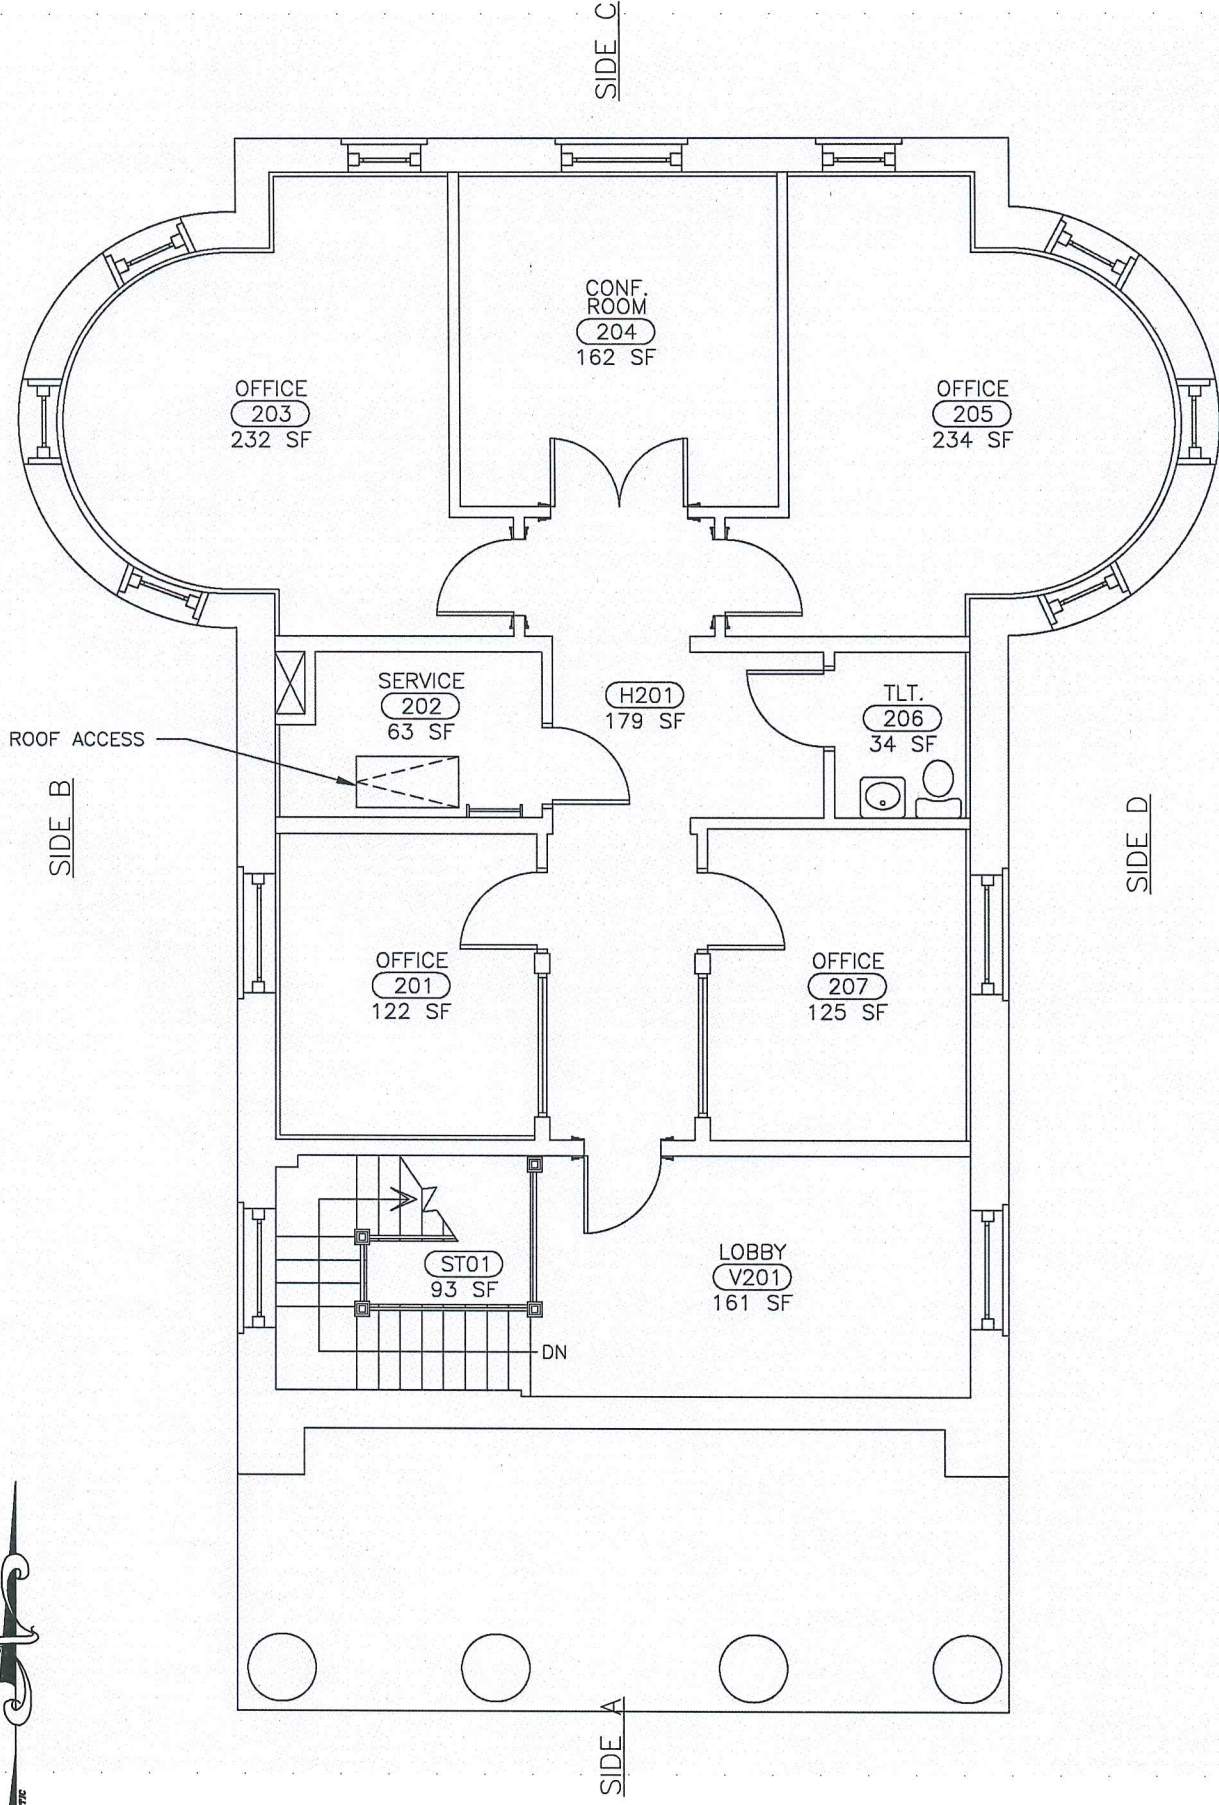
SCALE: NTS	DRAWN BY: LAJ	APPROVED BY: <i>TR</i>
PROJECT NO. 1135-13-464	DATE: 9-30-2013	FIGURE NO. 3.2

NO ASBESTOS WAS DETECTED.

CONFIRMED LEAD-BASED PAINT COATED COMPONENTS:

INTERIOR AND EXTERIOR DOOR CASINGS (INTACT CONDITION); AND

INTERIOR STAIRCASE BALUSTERS (INTACT CONDITION).

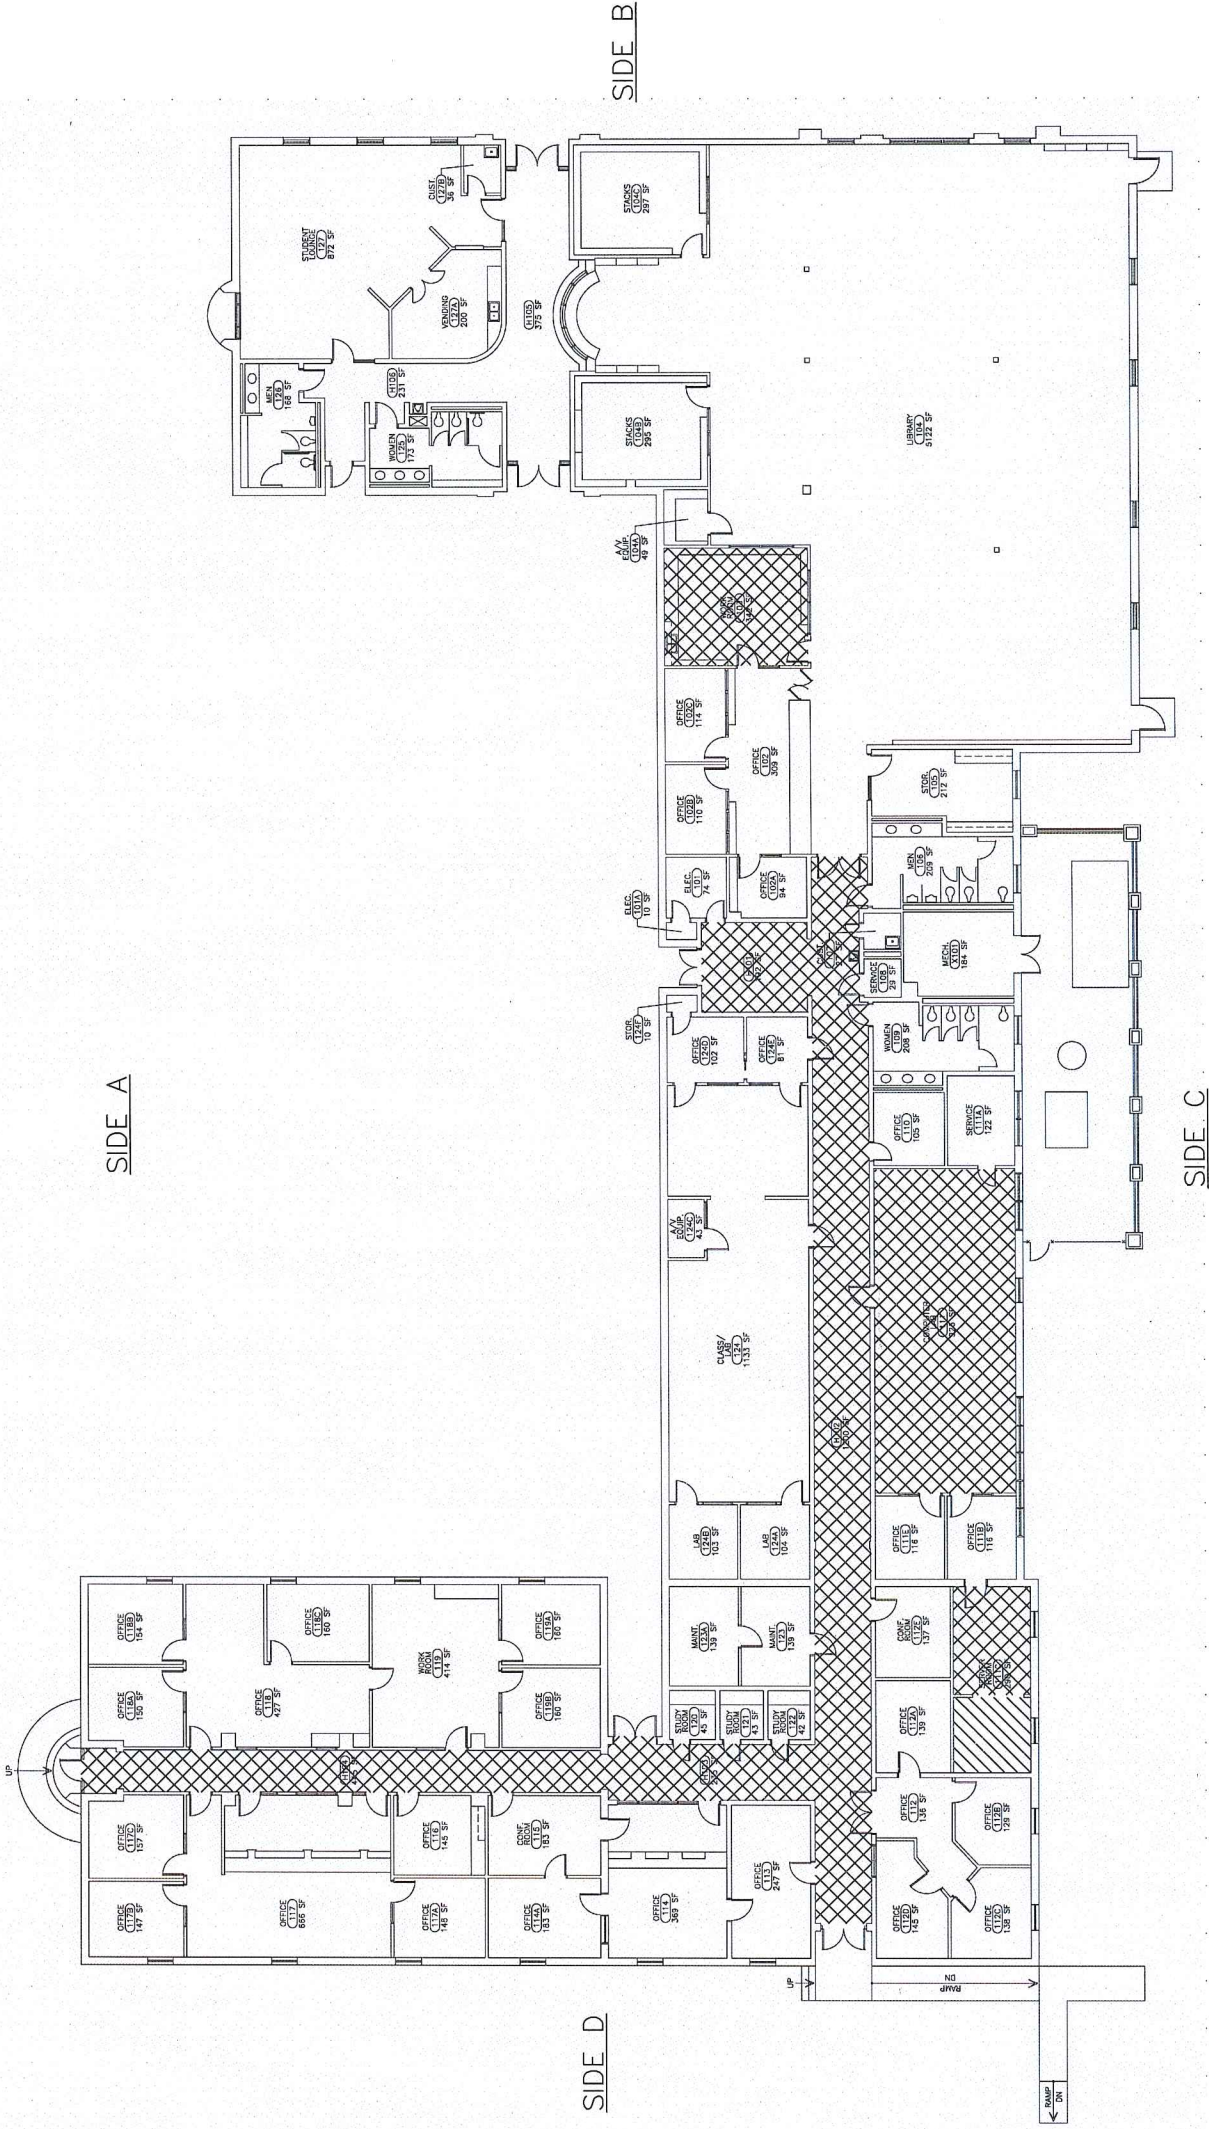
SCALE: NTS	DRAWN BY: LAJ	APPROVED BY: TR
PROJECT NO. 1135-13-464	DATE: 9-30-2013	FIGURE NO. 4.0

CONFIRMED ASBESTOS CONTAINING MATERIALS:

- MASTIC (BLACK) ASSOCIATED WITH FLOOR TILE (12" WHITE)
- APPROXIMATELY 3,960 SQUARE FEET
- MASTIC (BLACK) ASSOCIATED WITH FLOOR TILE (12" TAN)
- APPROXIMATELY 120 SQUARE FEET

EXTERIOR DOOR LINTELS (INTACT CONDITION).

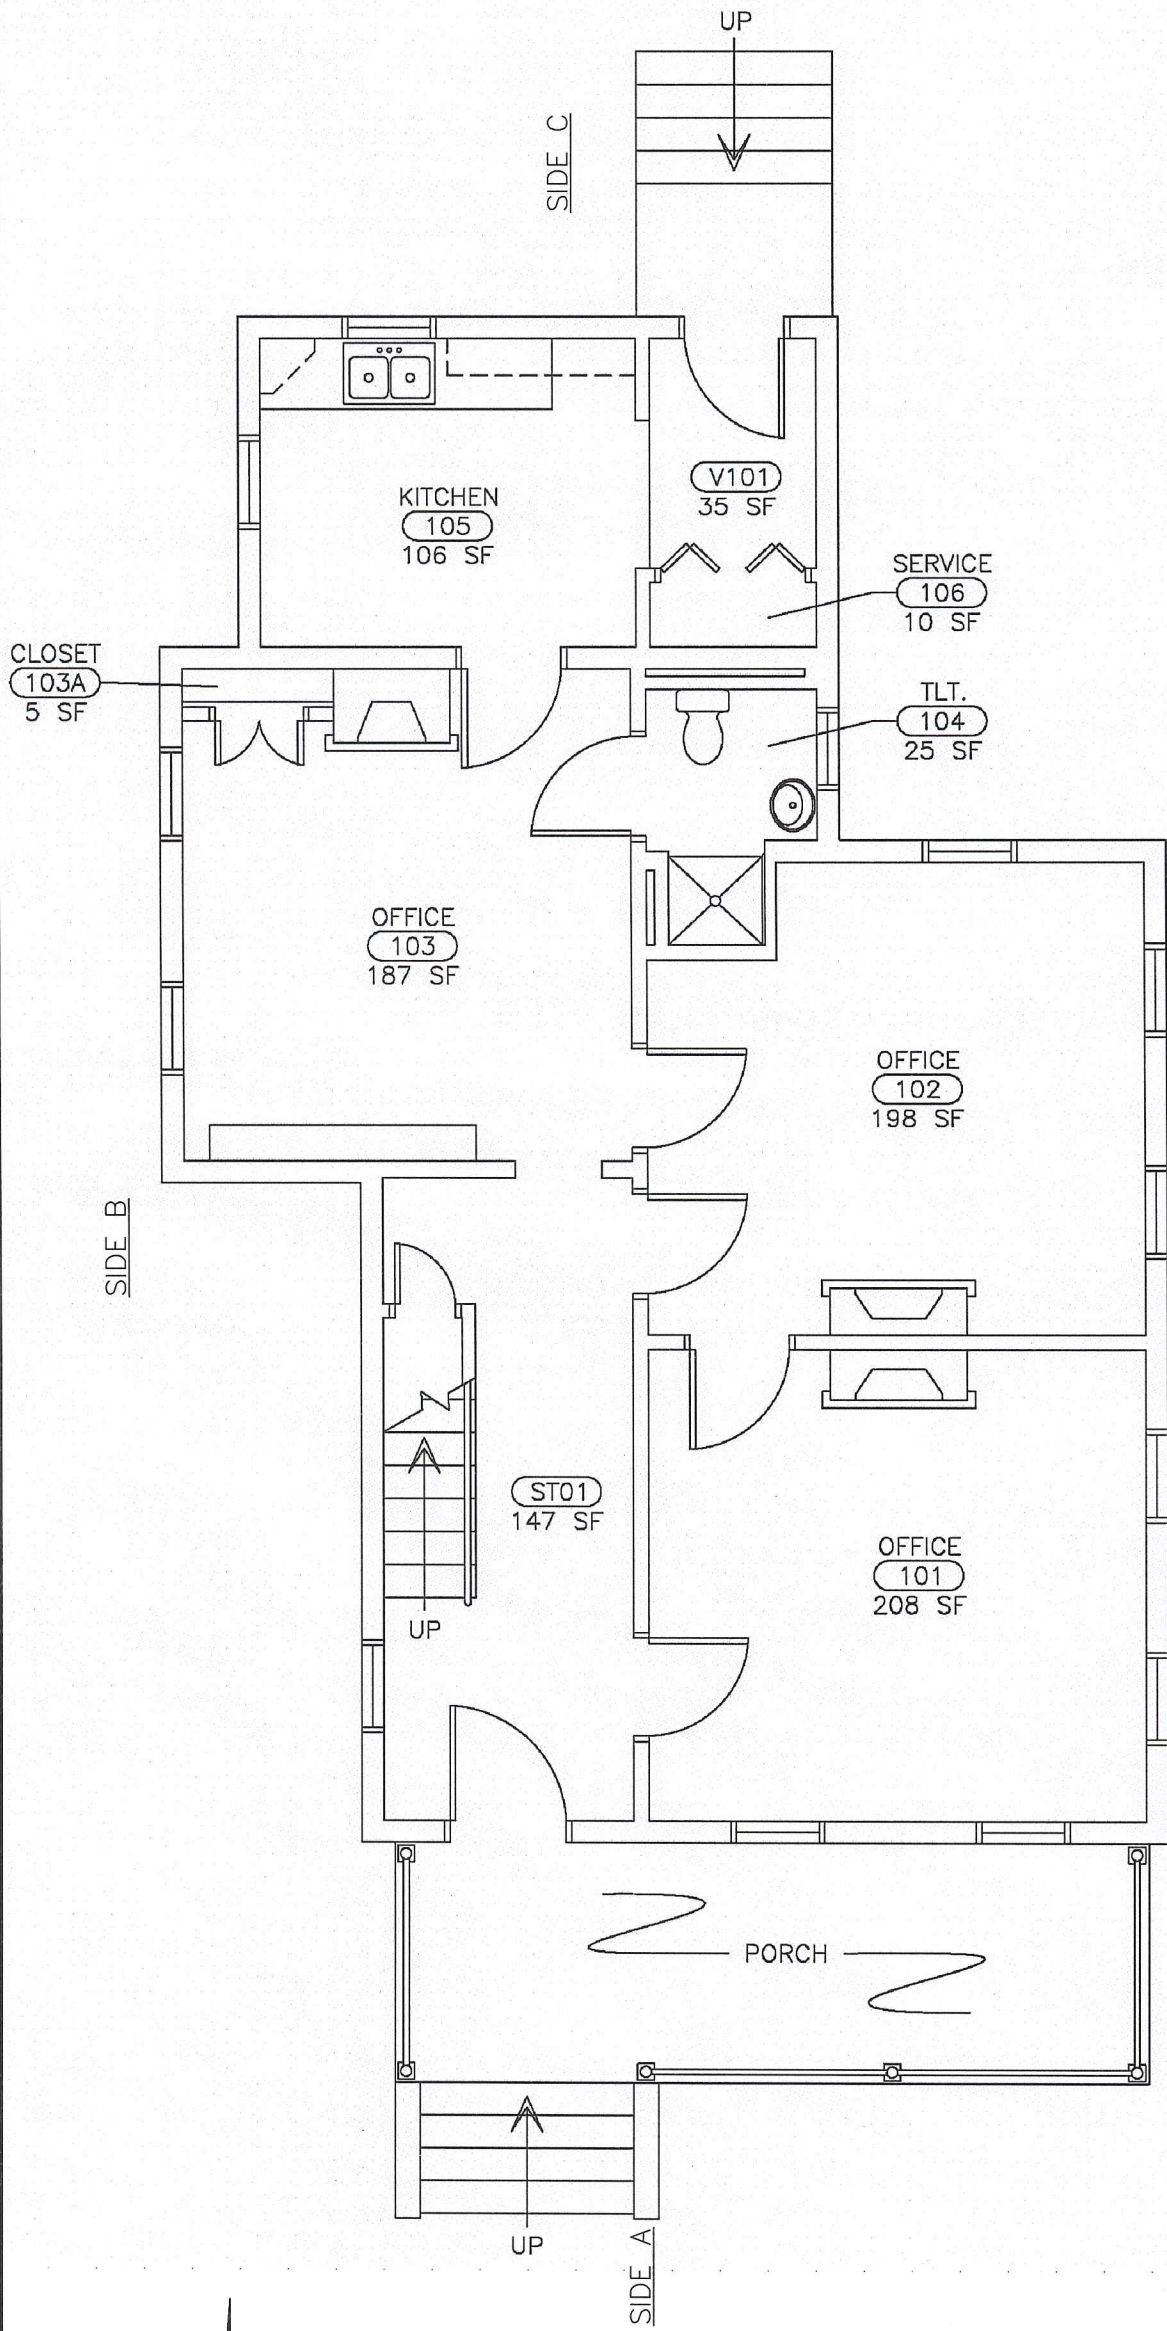
5.1

NO ASBESTOS WAS DETECTED.

CONFIRMED LEAD-BASED PAINT COATED COMPONENTS:

INTERIOR BASEBOARDS (INTACT CONDITION);

INTERIOR AND EXTERIOR WINDOW COMPONENTS (INTACT CONDITION);

INTERIOR AND EXTERIOR DOORS AND DOOR CASINGS (INTACT CONDITION);

INTERIOR STAIR RISERS AND STRINGERS (INTACT CONDITION);

INTERIOR CROWN MOLDING (INTACT CONDITION);

INTERIOR FIREPLACE MANTLE (INTACT CONDITION);

EXTERIOR PORCH COLUMNS AND BALUSTERS (INTACT CONDITION); AND

EXTERIOR SIDING (INTACT CONDITION).

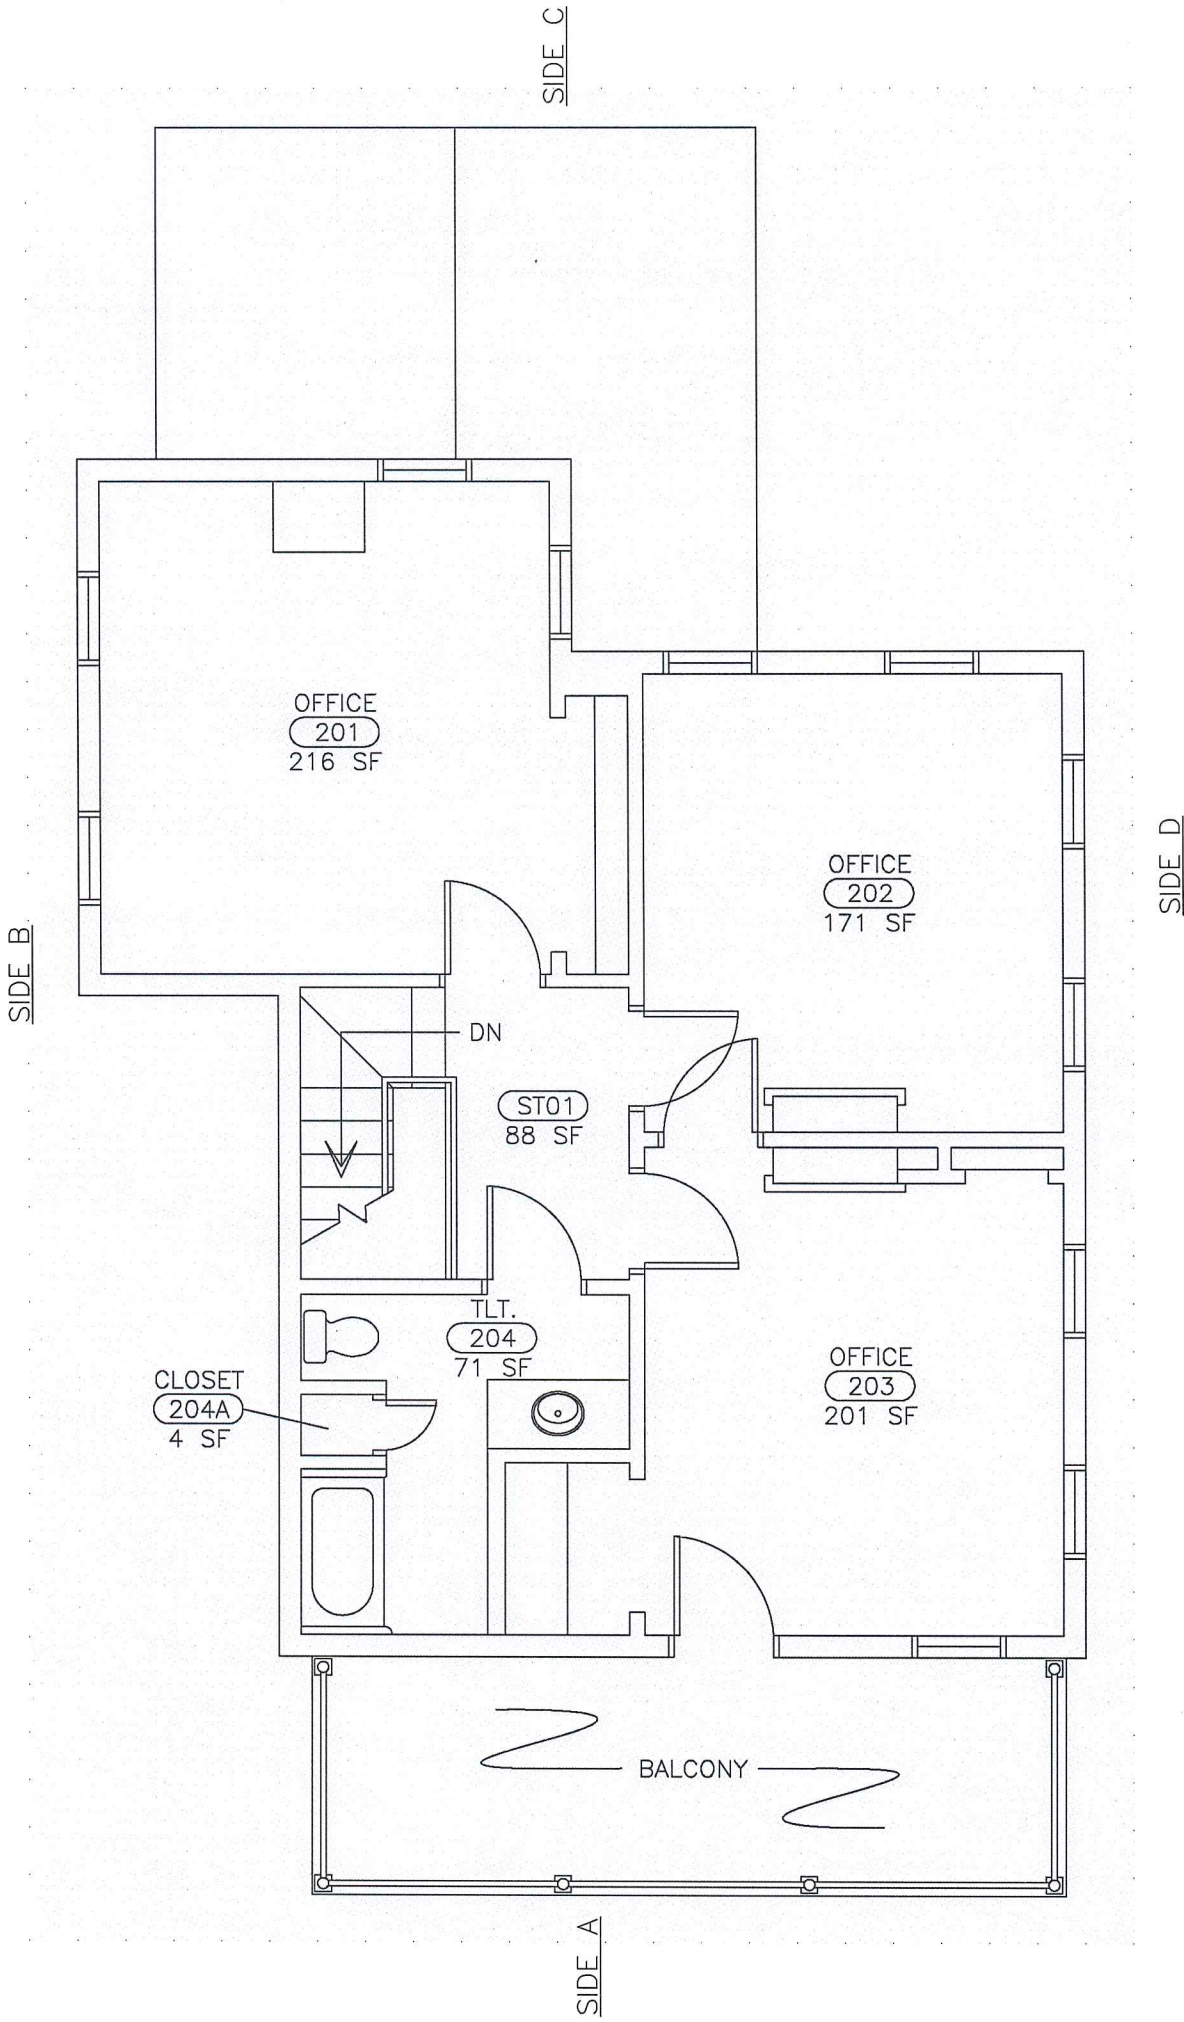
SCALE: NTS	DRAWN BY: LAJ	APPROVED BY: TR
PROJECT NO. 1135-13-464	DATE: 9-30-2013	FIGURE NO. 5.2

NO ASBESTOS WAS DETECTED.

CONFIRMED LEAD-BASED PAINT COATED COMPONENTS:

- INTERIOR BASEBOARDS (INTACT CONDITION);
- INTERIOR AND EXTERIOR WINDOW COMPONENTS (INTACT CONDITION);
- INTERIOR AND EXTERIOR DOORS AND DOOR CASINGS (INTACT CONDITION);
- INTERIOR STAIR RISERS AND STRINGERS (INTACT CONDITION);
- INTERIOR CROWN MOLDING (INTACT CONDITION);
- INTERIOR FIREPLACE MANTLE (INTACT CONDITION);
- EXTERIOR PORCH COLUMNS AND BALUSTERS (INTACT CONDITION); AND
- EXTERIOR SIDING (INTACT CONDITION).
