**ASBESTOS AND LEAD BASED PAINT
ASSESSMENT UPDATE REPORT**

**UNIVERSITY OF SOUTH CAROLINA
BEAUFORT HISTORICAL CAMPUS
BEAUFORT, SOUTH CAROLINA**

S&ME Project No. 1135-13-464

September 30, 2013

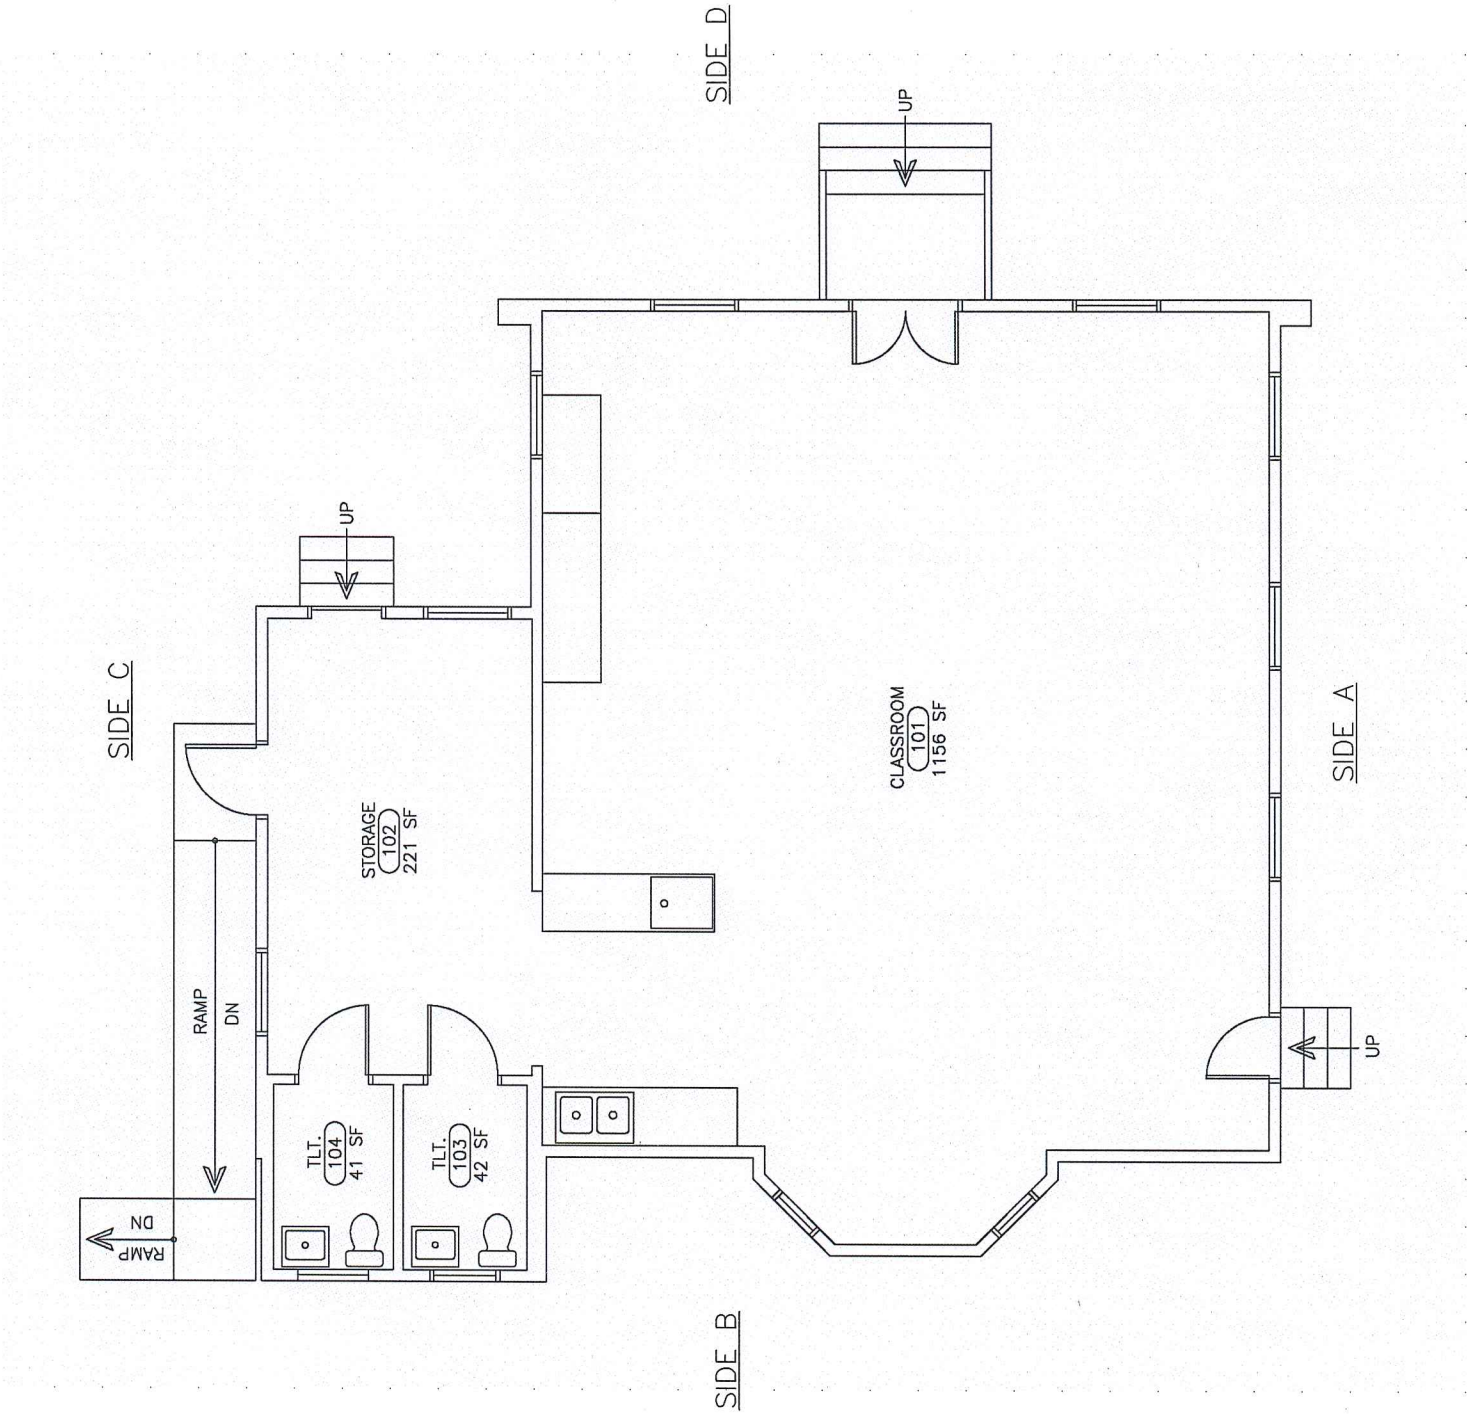
ASBESTOS AND LEAD BASED PAINT UPDATE			
ART STUDIO			
UNIVERSITY OF SOUTH CAROLINA – BEAUFORT BEAUFORT, SOUTH CAROLINA			
SCALE: NTS	DRAWN BY: LAJ	APPROVED BY: TR	
PROJECT NO. 1135-13-464	DATE: 9-30-2013	FIGURE NO. 6.0

NO ASBESTOS WAS DETECTED.

CONFIRMED LEAD-BASED PAINT COATED COMPONENTS:
EXTERIOR SIDING AND TRIM (POOR CONDITION);
EXTERIOR WINDOW COMPONENTS (POOR CONDITION); AND
EXTERIOR PORCH COMPONENTS (POOR CONDITION).

The lead-based paint surfaces noted to be in poor (chipping and flaking) condition should be repaired via interim controls (e.g. scraping loose and flaking paint and repainted) or considered for removal, provided the work is performed by appropriately trained personnel and properly disposed. Lead-based paint coated waste must be disposed in a Class II or Class III, lined landfill. Accumulations of paint waste (chips, dust, or flakes) must be tested by TCLP to determine if the waste is classified as hazardous, which requires disposal in a Subtitle C (hazardous waste) landfill. Lead waste, at a minimum, must be disposed in a Class II or Class III, lined landfill.

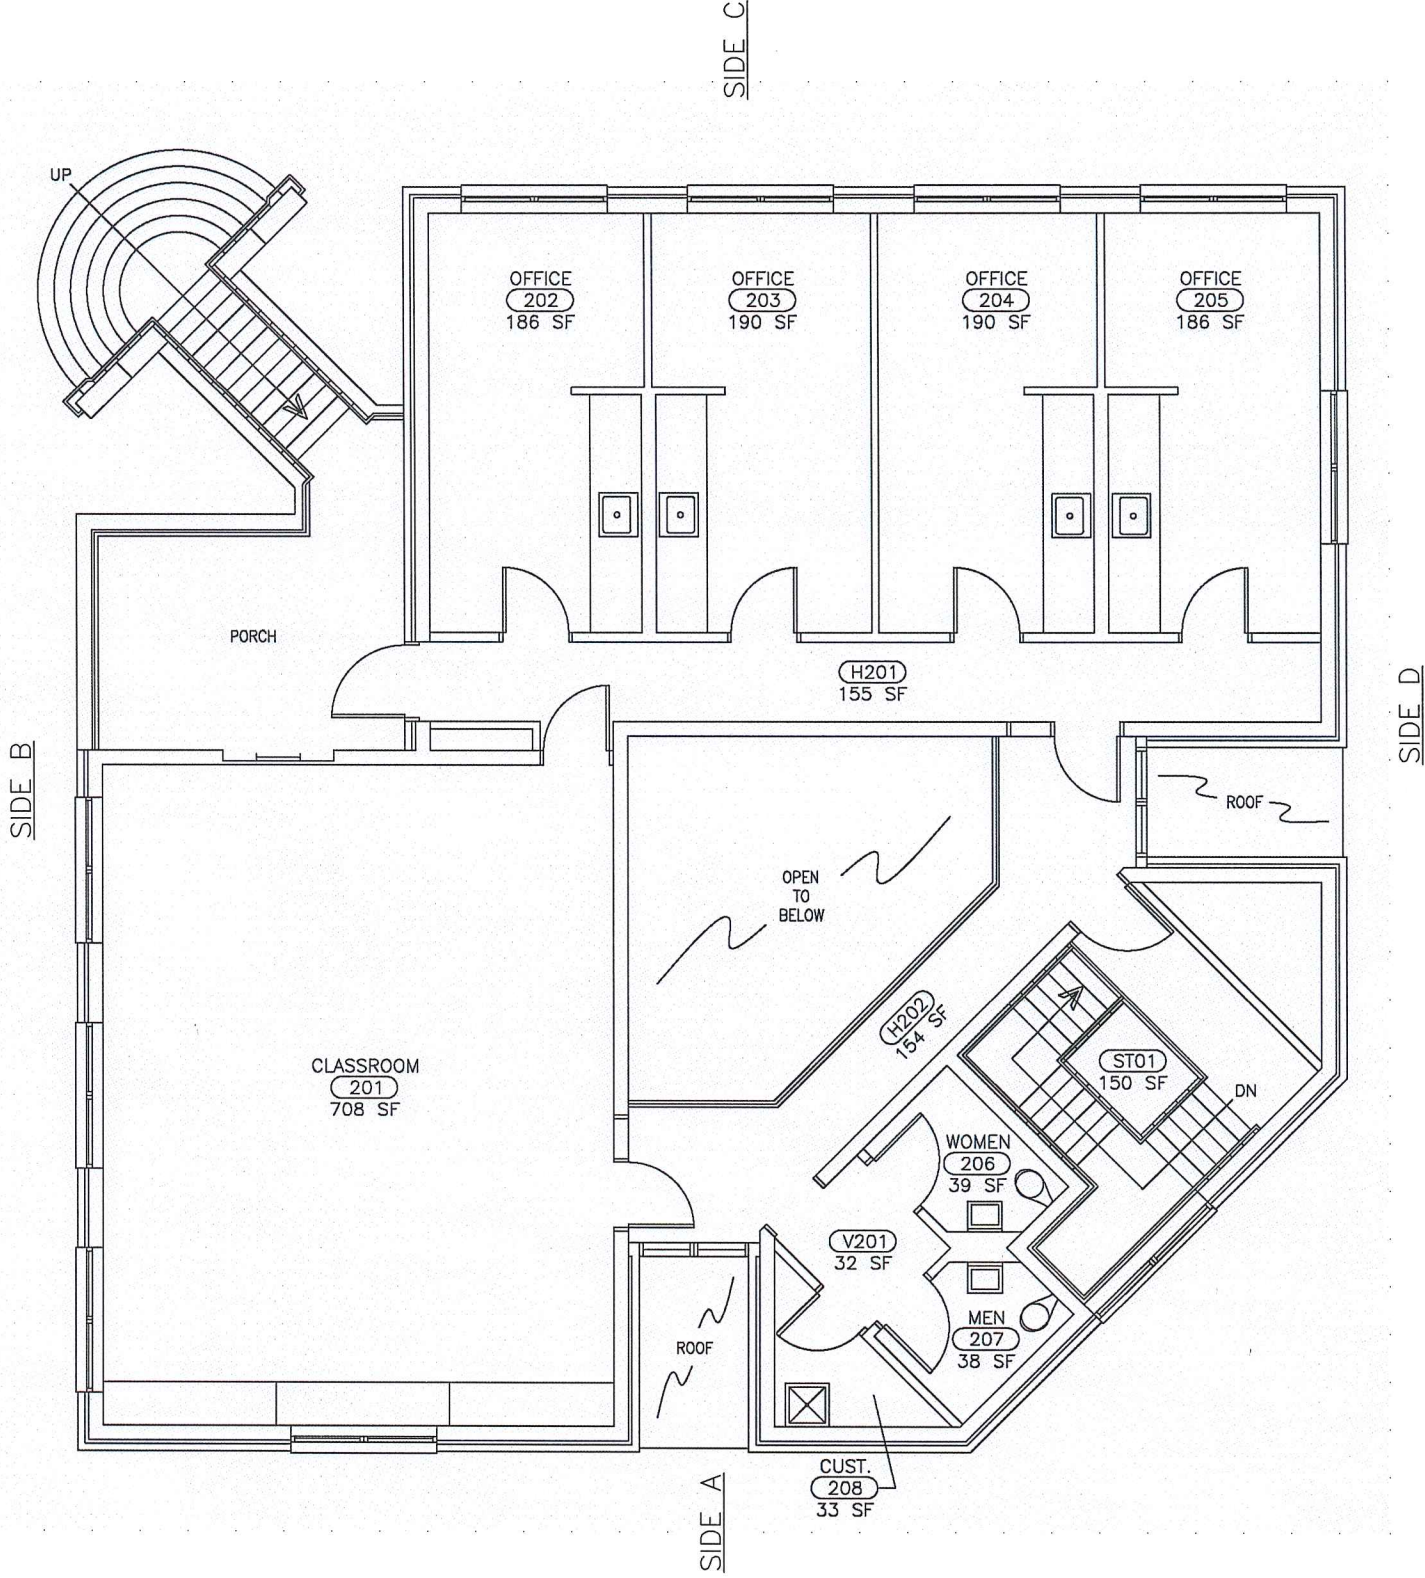
NO ASBESTOS WAS DETECTED.
DETECTABLE LEVELS OF LEAD, APPLICABLE TO OSHA, WERE IDENTIFIED.

Destructive actions to components containing any level of lead (hand scraping, component removal, demolition, sanding, grinding, burning, paint preparation, etc.) require the contractor to comply with the standards of OSHA 29 CFR 1926.62 (Lead in Construction), including but not limited to training, initial exposure monitoring, the use of personal protective equipment, and medical surveillance.
