USC SOM BUILDING 661 FIRST FLOOR BATHROOMS

USC Project Number: FP0000091

ADDENDUM NO. 1

ASBESTOS CONTAINING MATERIAL INVESTIGATION REPORT

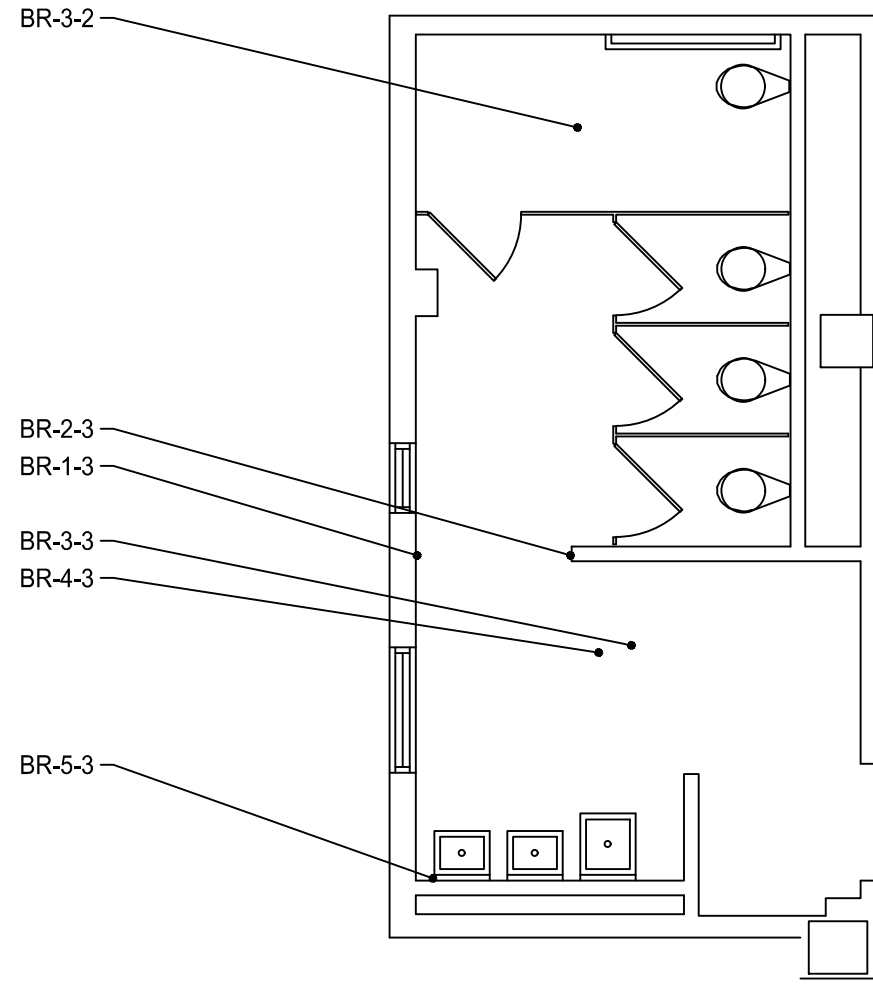
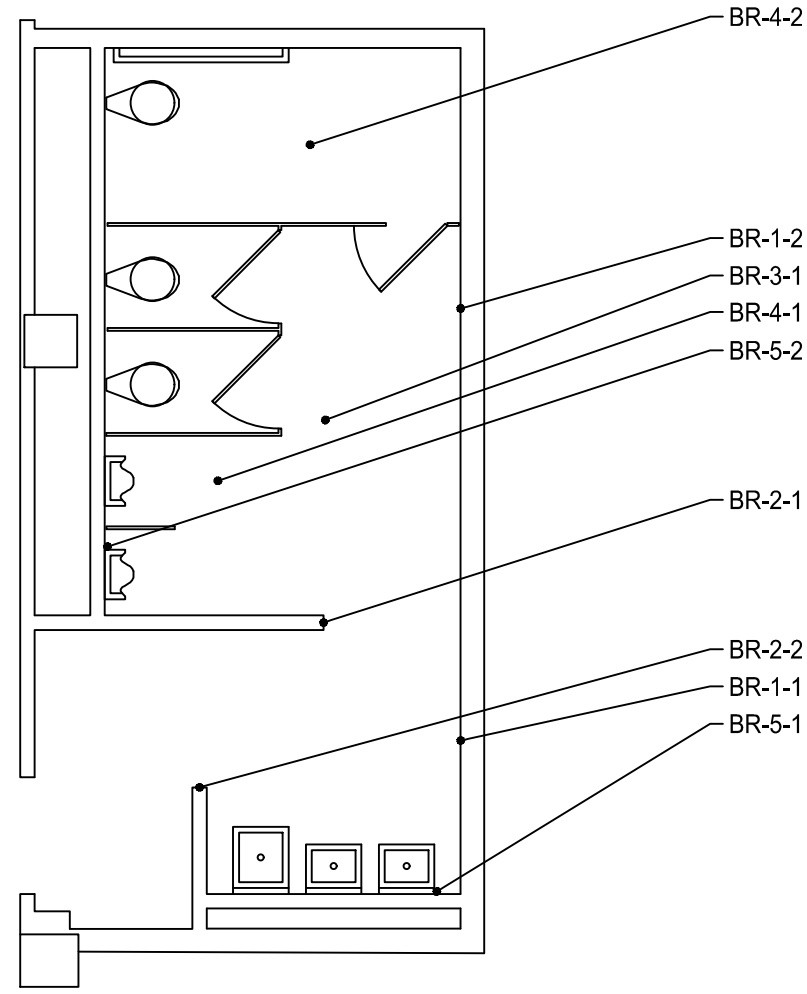
Sample Location Plans

by PLM and two (2) were TEM-confirmed. Laboratory analysis determined that all suspect materials identified and sampled during the investigation do not contain asbestos. See Appendix C –Sample Location Plan, for the various sample locations.

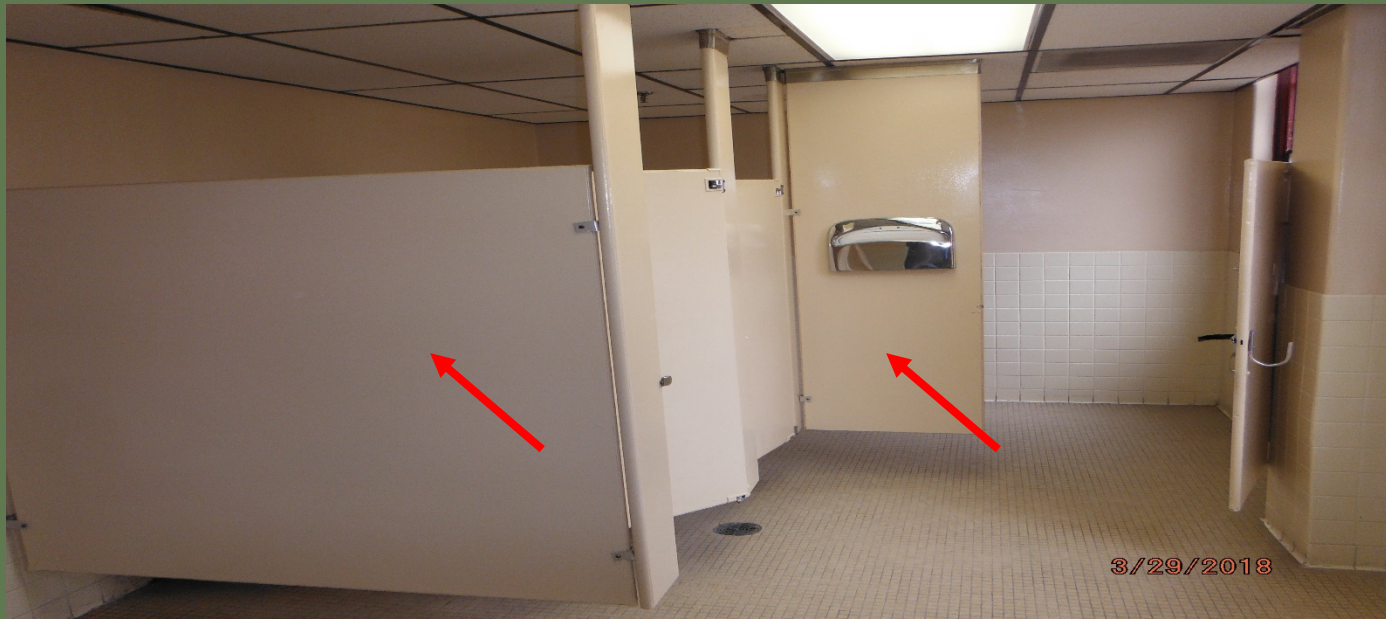
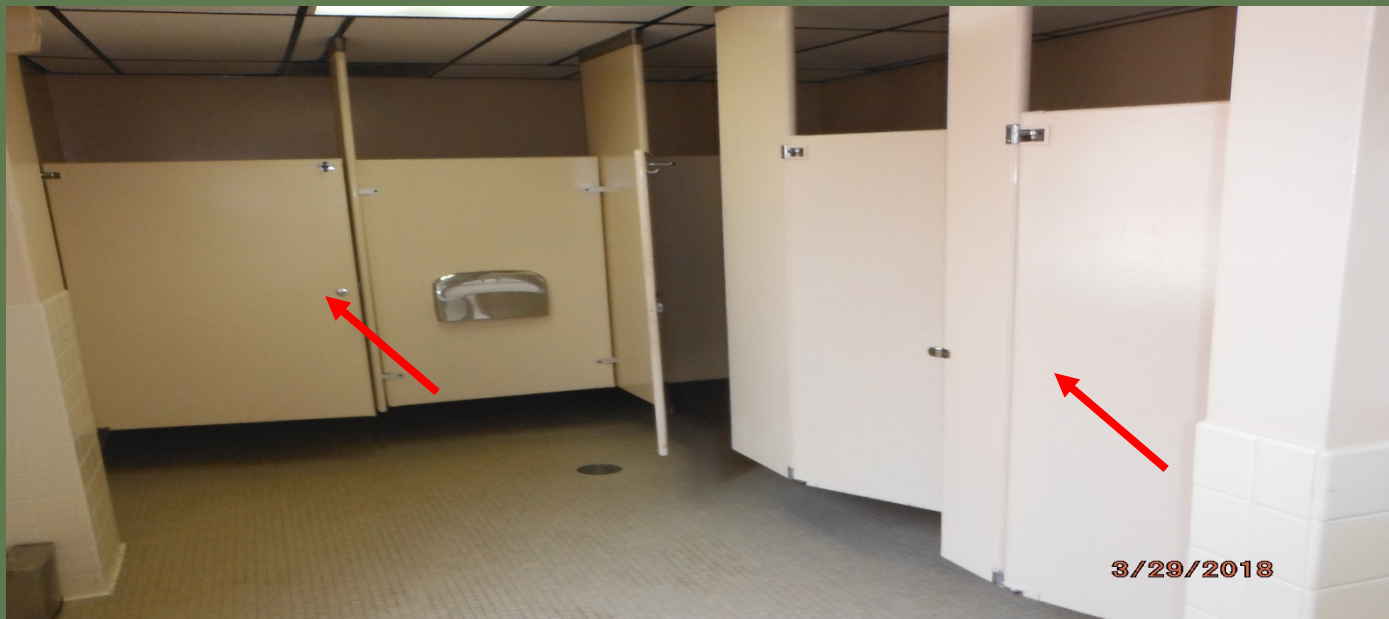
Photographs 1 & 2

The results from the XRF quantitative testing indicate that lead is present in paint and/or coatings on two (2) building components associated with the bathrooms. The two (2) components found to equal or exceed the threshold for lead (0.7 mg/cm²) were the tan painted metal bathroom stall partitions and the red painted metal window components located in the men's and women's bathrooms.

Photographs of lead positive metal bathroom stall partitions in the men's and women's bathrooms on the first floor (Rooms B37 & B38)

Components found to contain lead should be handled appropriately. It is recommended that work tasks which require grinding, sanding, cutting torch, or other disturbance of the LBP surfaces identified herein be performed in accordance with federal regulations pertaining to worker protection from exposure to LBP. When lead containing items are disturbed or begin to decay they become a concern with regard to human health and the environment. The typical routes of exposure to lead are through the inhalation or ingestion of lead-contaminated materials. Minimal risk of exposure exists where the lead-containing paint and coating are intact (e.g., has not been aerosolized, free of chipping or flaking, etc.).

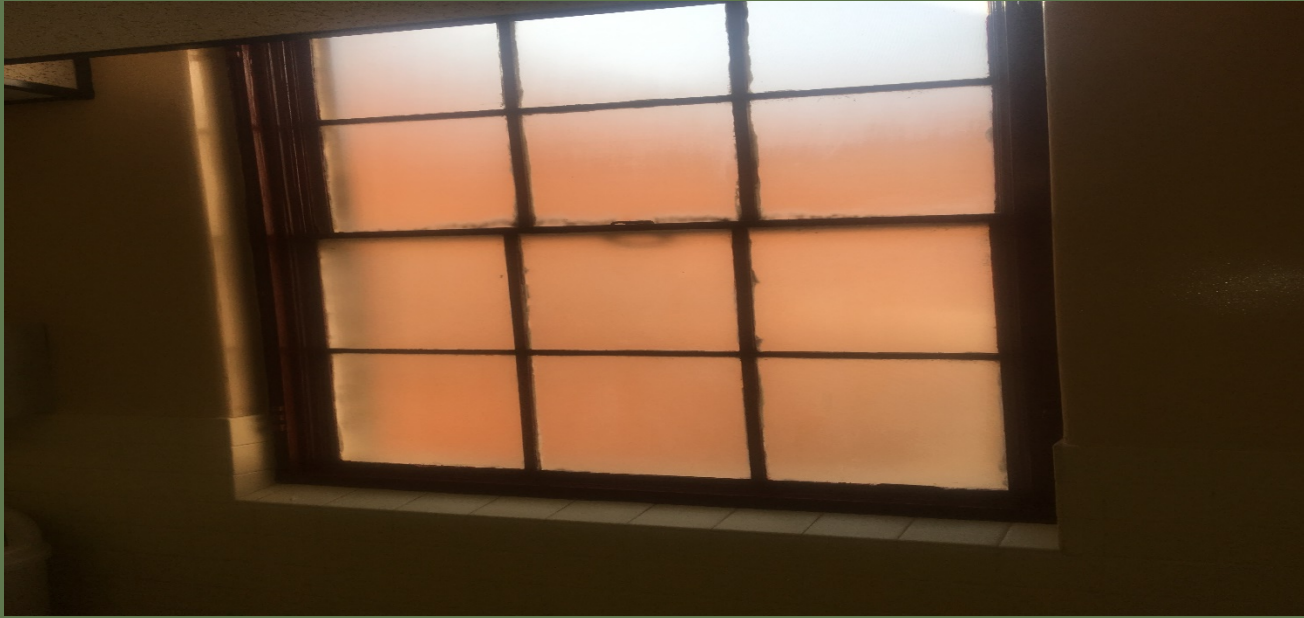
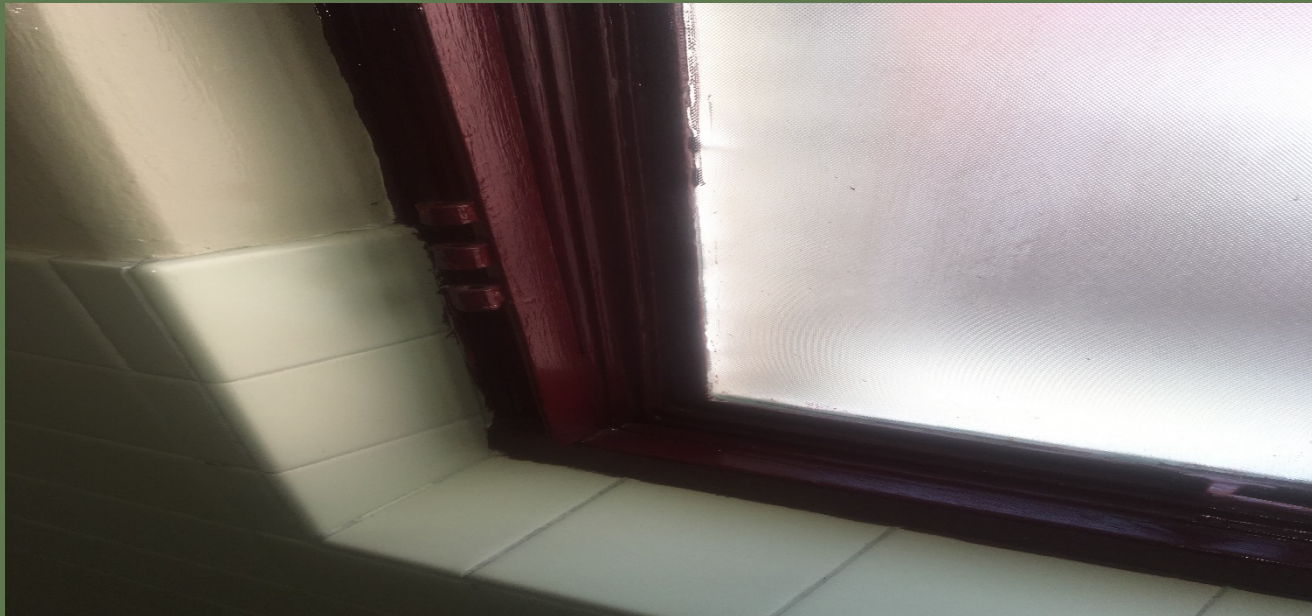
Photographs 3 & 4

Photographs of lead positive windows in the men's and women's bathrooms on the first floor (Rooms B37 & B38)
