Addendum No.	ONE
Project:	Hargray Building Exterior Repairs
	University of South Carolina Beaufort University of South Carolina
	WTS # 1704 USC # FP00000104
From:	Gene Bell, AIA LEED AP BD+C
To:	Prospective Bidders / Plan Holders

**Limited Asbestos and Lead-Based
Paint Assessment Report
USCB Bluffton – Hargray Building
Bluffton, South Carolina
S&ME Project No. 4261-18-029**

Reference: **Limited Asbestos and Lead-Based Paint Assessment Report**
Hargray Building - Exterior Sealant and Roof
USCB – Bluffton Campus
Bluffton, South Carolina
S&ME Project No. 4261-18-029

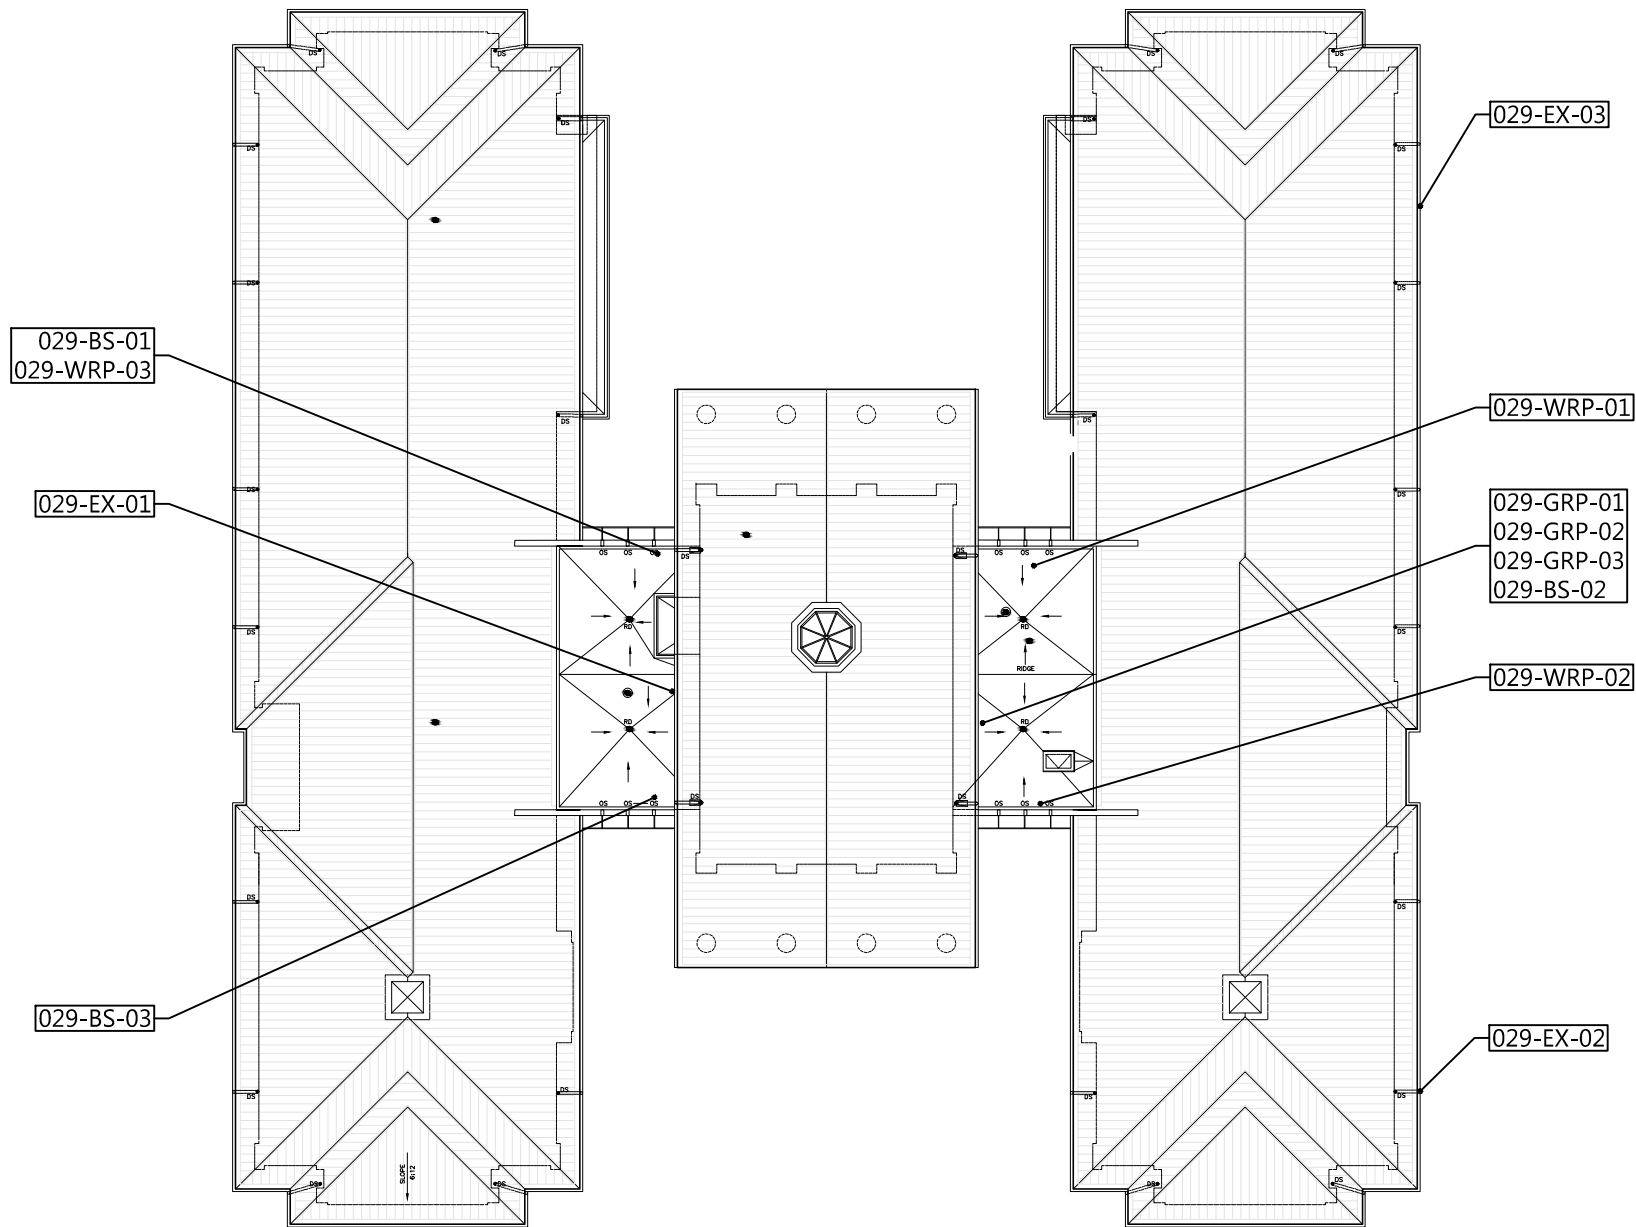
LIMITED ASBESTOS & LEAD-BASED PAINT ASSESSMENT	
HARGRAY BUILDING 1 UNIVERSITY BOULEVARD BLUFFTON, SOUTH CAROLINA	
SCALE: AS SHOWN	
DATE: 3-05-2018	
PROJECT NUMBER 4261-18-029	
FIGURE NO.	
1

NOTES: NO ASBESTOS WAS DETECTED IN THE BULK SAMPLES COLLECTED AND ANALYZED.
NO PAINTED SURFACES MEETING THE SCDHEC DISPOSAL LIMIT OF 0.7 mg/cm² WERE DETECTED.

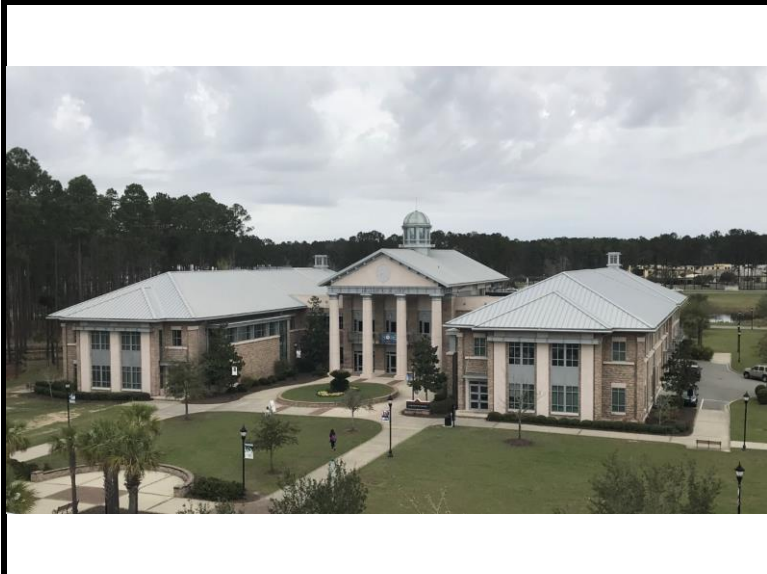
1 Typical exterior view of the Science and Technology Building

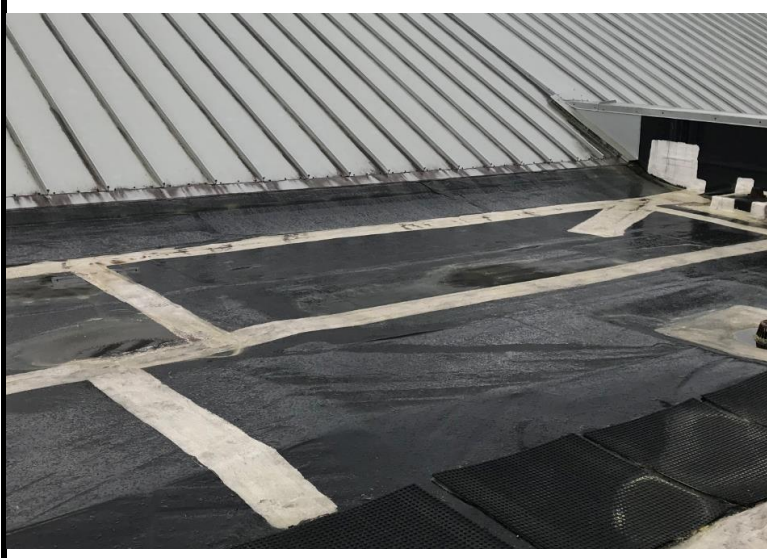
3 Asbestos results were negative for the white roof patch material.

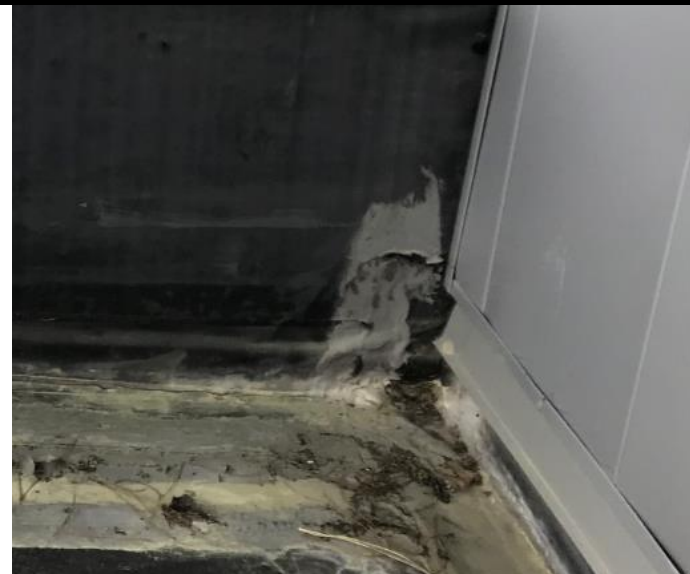
2 Asbestos results were negative for the grey roof patch material.

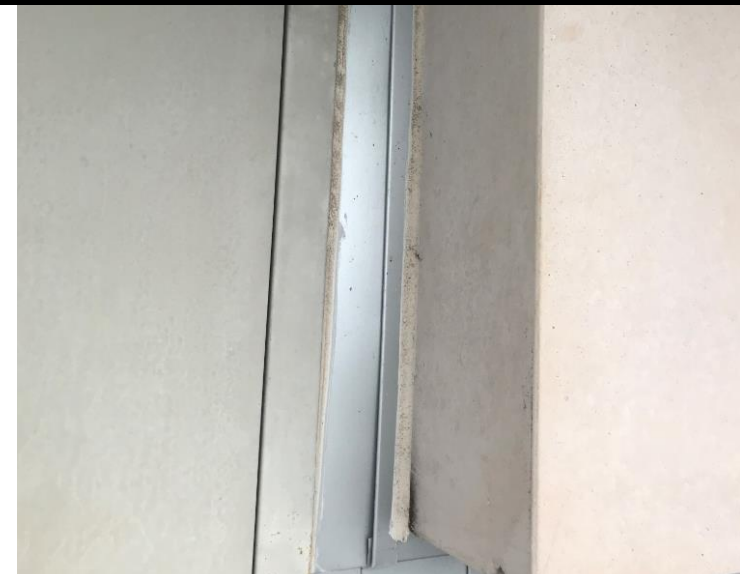
4 Asbestos results were negative for the expansion joint material.
