Project Name: Beaufort CFA ADA Compliant Elevator and Building Upgrades

Project Number: H36-I317

Addendum Number One

October 2, 2018

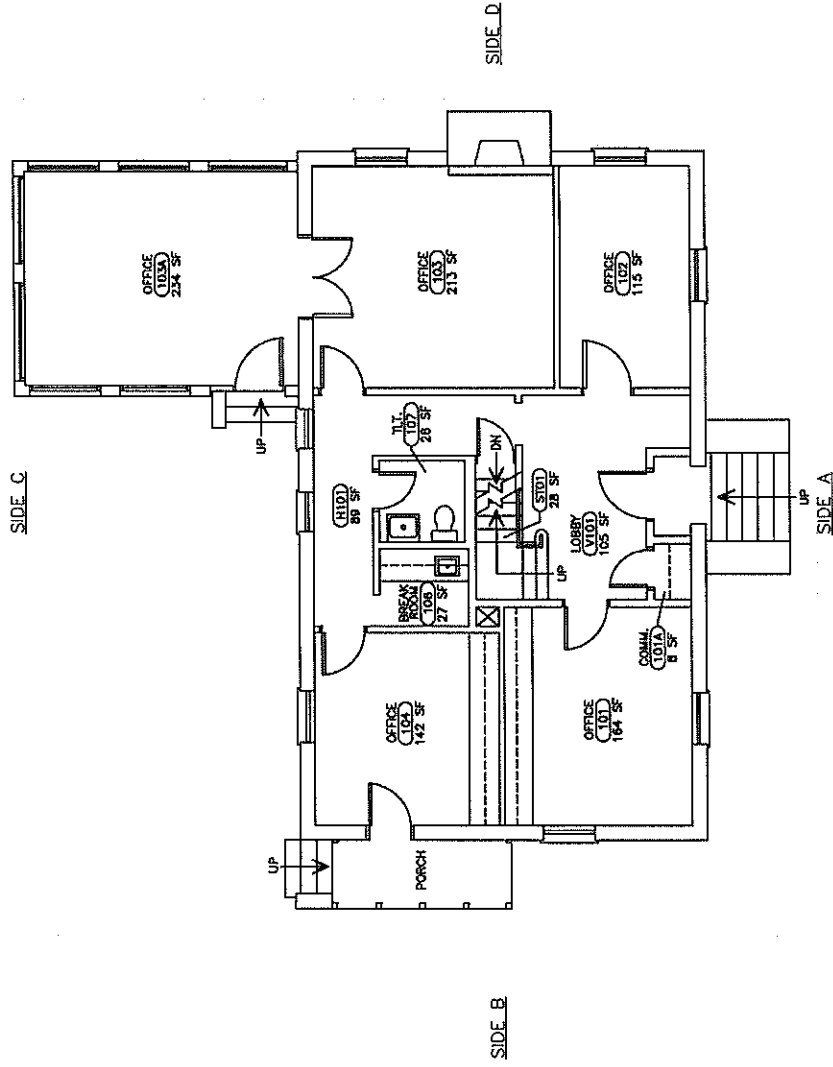
ASBESTOS AND LEAD BASED PAINT UPDATE	
GRAYSON HOUSE - FIRST FLOOR	
UNIVERSITY OF SOUTH CAROLINA - BEAUFORT	
BEAUFORT, SOUTH CAROLINA	
SCALE: NTS	DRAWN BY: LAJ
PROJECT NO. 135-13-464	DATE: 9-30-2013
	APPROVED BY: TR
	FIGURE NO. 1.1

CONFIRMED ASBESTOS CONTAINING MATERIALS:
 JOINT COMPOUND AND ASSOCIATED SHEETROCK
 LOCATED IN BASEMENT STAIRWELL
 - APPROXIMATELY 260 SQUARE FEET
 WINDOW GLAZING - APPROXIMATELY 490 LINEAR FEET

CONFIRMED LEAD-BASED PAINT COMPONENTS:
 INTERIOR AND EXTERIOR LINTELS (INTACT CONDITION);
 INTERIOR AND EXTERIOR DOOR CASINGS (INTACT CONDITION);
 EXTERIOR WINDOW COMPONENTS AND LINTELS (INTACT CONDITION);
 EXTERIOR HANDRAILS ON ROOF (POOR CONDITION); AND
 EXTERIOR PORCH CEILING (INTACT CONDITION).

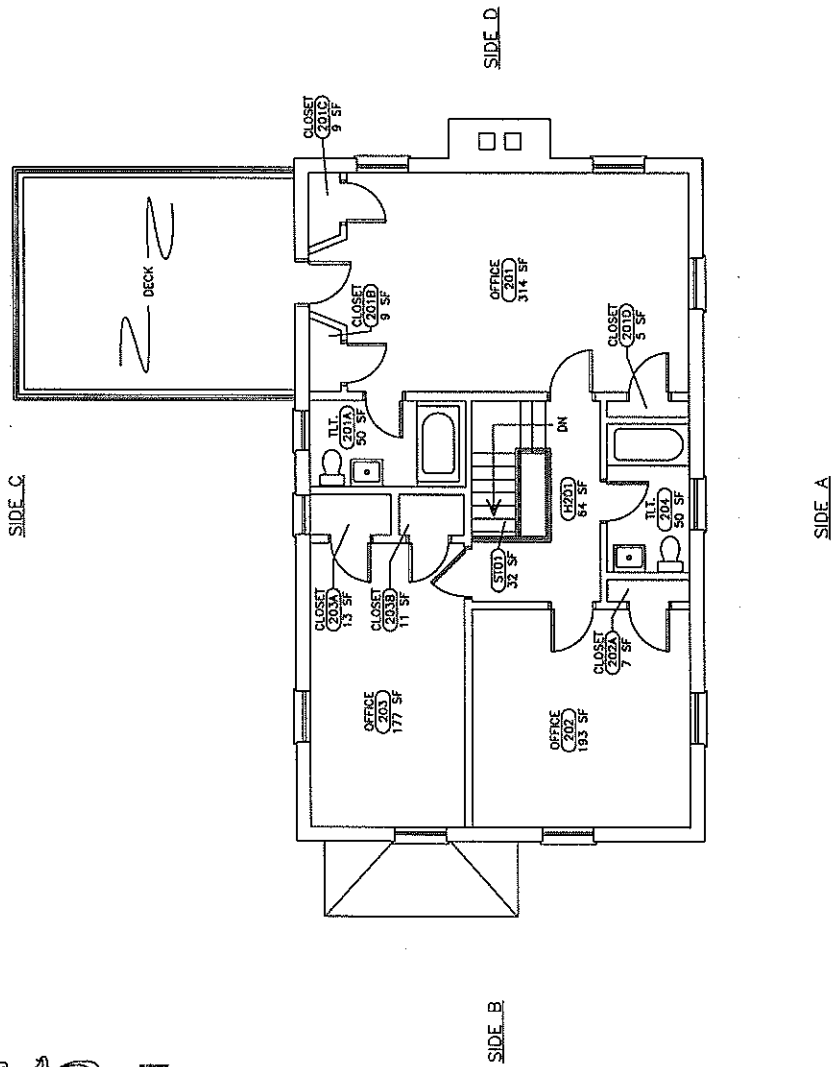
SCALE: NTS	DRAWN BY: LAJ	APPROVED BY: TR
PROJECT NO. 1125-13-464	DATE: 9-30-2013	FIGURE NO. 1.2

CONFIRMED ASBESTOS CONTAINING MATERIALS:

WINDOW GLAZING - APPROXIMATELY 490 LINEAR FEET

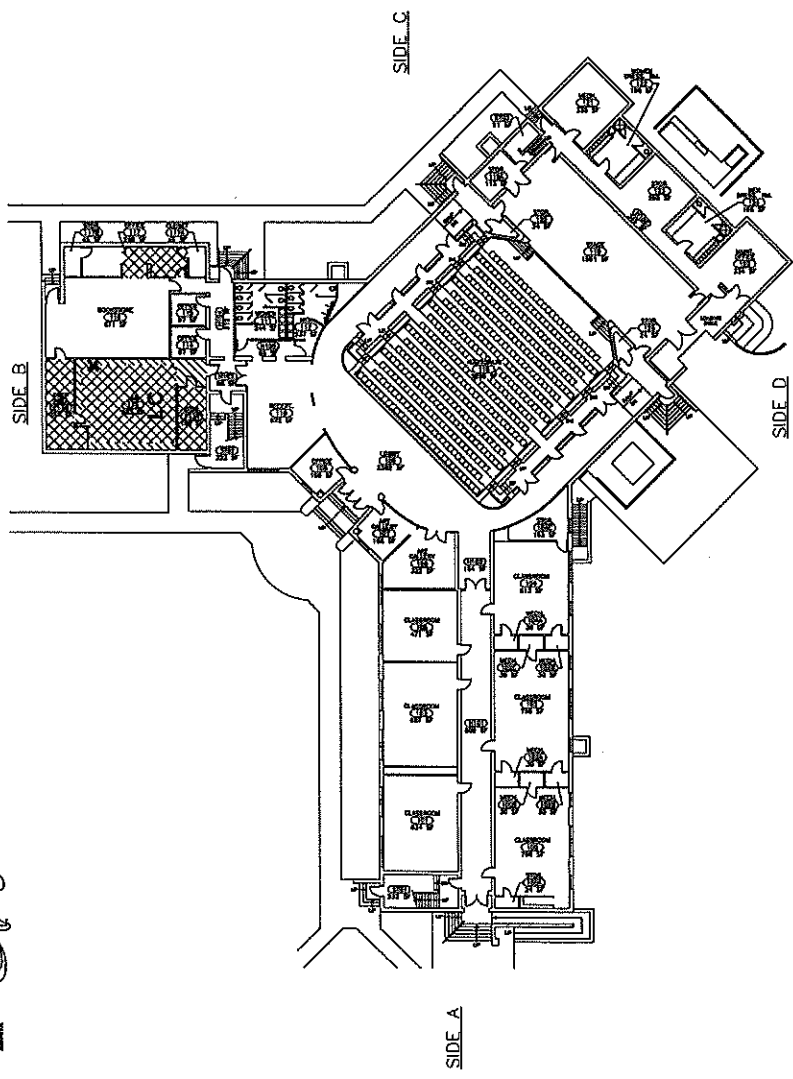
SCALE: NTS	DRAWN BY: LAJ	APPROVED BY: TR
PROJECT NO: 1135-13-464	DATE: 9-30-2013	FIGURE NO: 2.1

CONFIRMED ASBESTOS CONTAINING MATERIALS:

- MASTIC (BLACK) ASSOCIATED WITH FLOOR TILE (12" WHITE)
 - APPROXIMATELY 955 SQUARE FEET
- MASTIC (BLACK) ASSOCIATED WITH FLOOR TILE (12" BLUE)
 - APPROXIMATELY 350 SQUARE FEET
- CEMENTITIOUS PANELS ASSOCIATED WITH VENTILATION HOODS
 - APPROXIMATELY 70 SQUARE FEET
- LABORATORY COUNTER TOPS
 - APPROXIMATELY 315 SQUARE FEET

We recommend proper removal and disposal of the identified ACMs, by a South Carolina Department of Health and Environmental Control (SCDHEC) licensed asbestos abatement contractor, prior to any destructive activities that may disturb the ACMs, as required by the SCDHEC and the EPA. Onsite asbestos air monitoring must be performed by a SCDHEC licensed Air Sampler, prior to, during, and following the completion of friable abatement activities or activities rendering non-friable ACMs friable, totaling 160 square feet or greater. If additional suspect ACMs not addressed in this report are discovered during destructive activities, bulk samples should be collected by a SCDHEC licensed inspector and analyzed for asbestos content prior to disturbance or disposal of the suspect materials. This report should also be provided to the contractor(s) to assist with compliance with applicable State and Federal regulations.

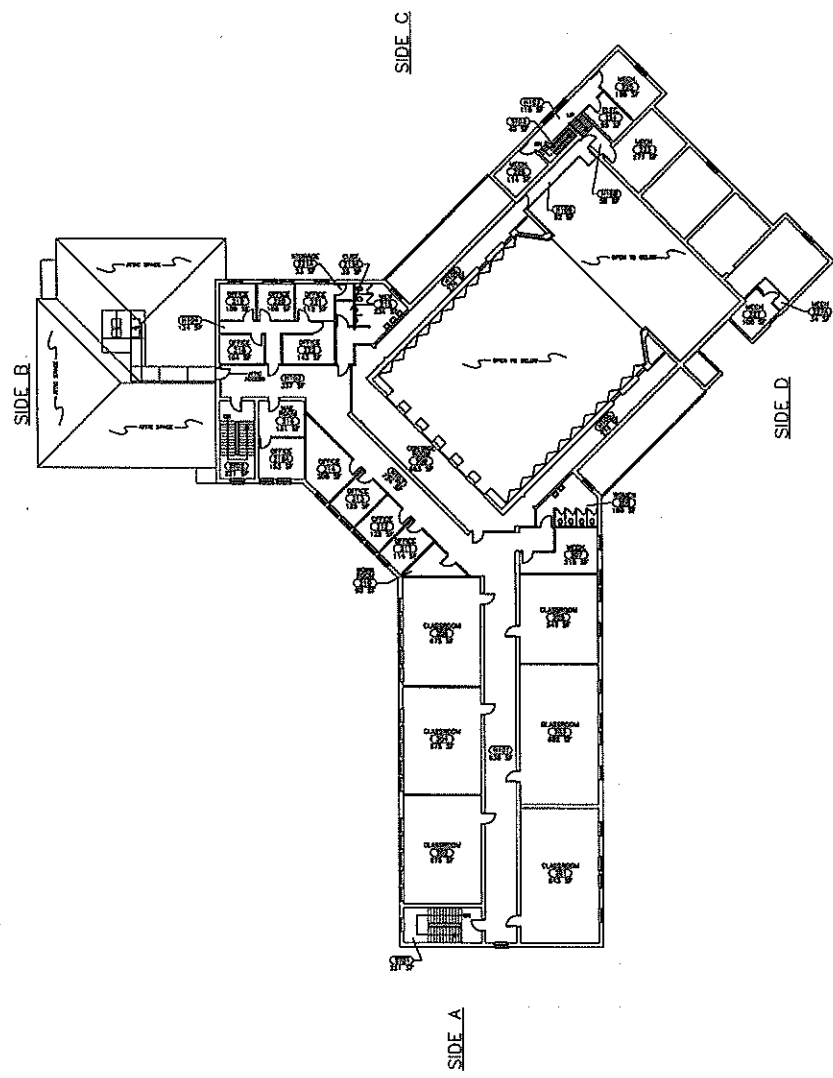
ASBESTOS AND LEAD BASED PAINT UPDATE PERFORMING ARTS CENTER - SECOND FLOOR UNIVERSITY OF SOUTH CAROLINA - BEAUFORT BEAUFORT, SOUTH CAROLINA			
SCALE: NTS	DRAWN BY: LAJ	APPROVED BY: TR	
PROJECT NO: 135-13-464	DATE: 9-30-2013	FIGURE NO: 2.2

NO ASBESTOS WAS DETECTED ON THE SECOND FLOOR.

CONFIRMED LEAD-BASED PAINT COATED COMPONENTS:
INTERIOR AND EXTERIOR DOOR LINTELS (INTACT CONDITION);
INTERIOR METAL STAIRCASE BALUSTERS (INTACT CONDITION); AND
RUBBER BUMPER AT LOADING DOCK (INTACT CONDITION).

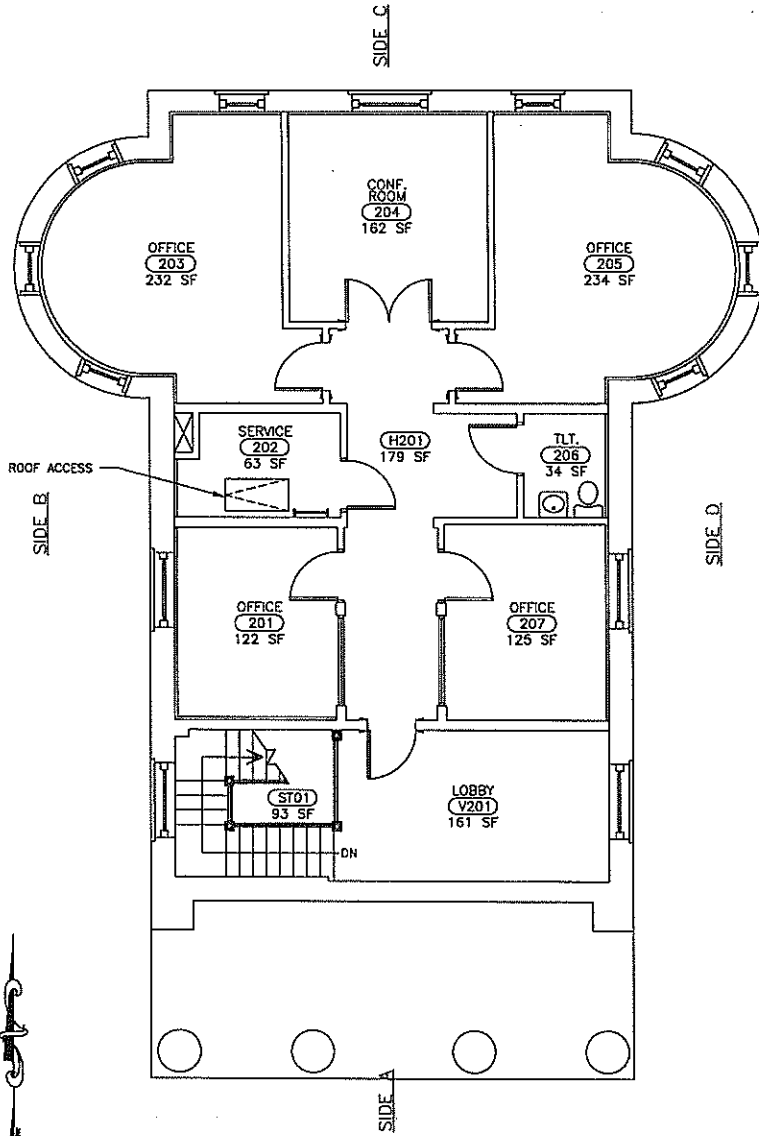
NO ASBESTOS WAS DETECTED.

CONFIRMED LEAD-BASED PAINT COATED COMPONENTS:
 INTERIOR AND EXTERIOR DOOR CASINGS (INTACT
 CONDITION); AND
 INTERIOR STAIRCASE BALUSTERS (INTACT CONDITION).

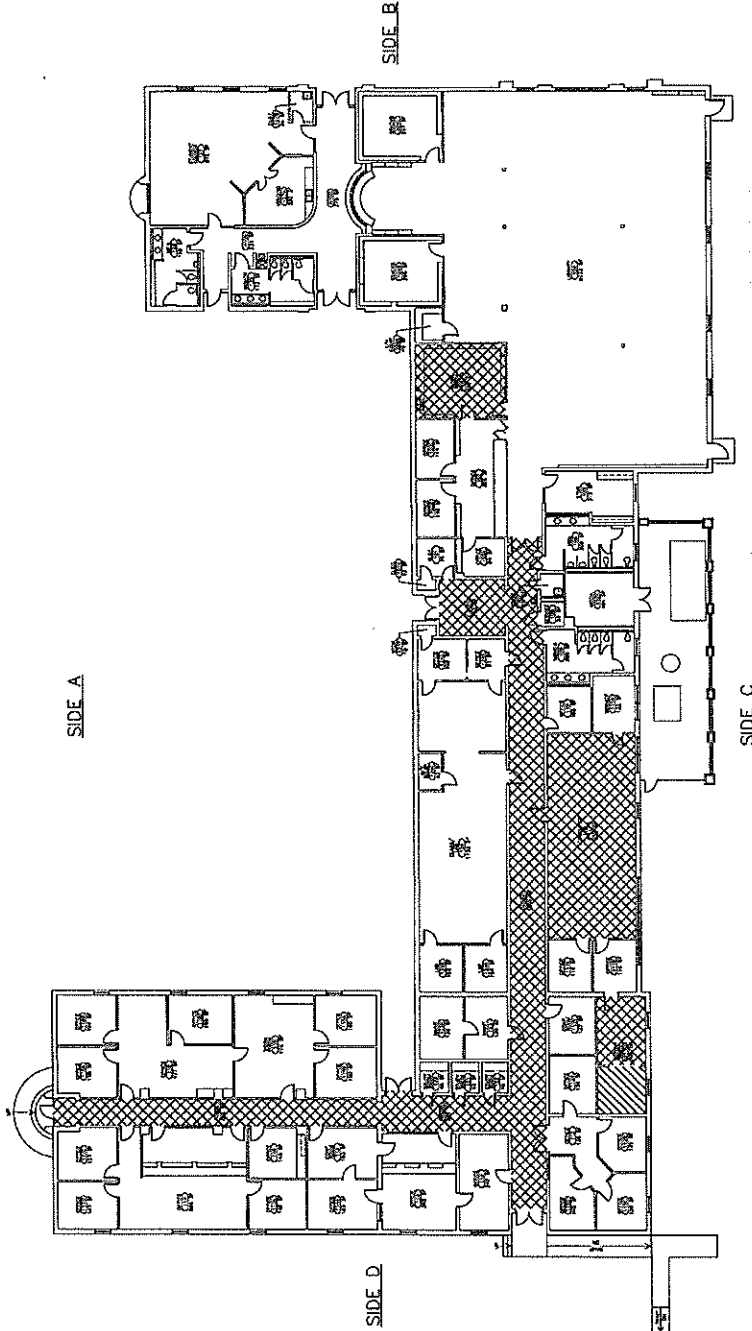
SCALE: NTS	DRAWN BY: LAJ	APPROVED BY: TR
PROJECT NO. 1135-13-464	DATE: 9-30-2013	FIGURE NO. 4.0

CONFIRMED ASBESTOS CONTAINING MATERIALS:

- MASTIC (BLACK) ASSOCIATED WITH FLOOR TILE (12" WHITE)
- APPROXIMATELY 3,960 SQUARE FEET
- MASTIC (BLACK) ASSOCIATED WITH FLOOR TILE (12" TAN)
- APPROXIMATELY 120 SQUARE FEET

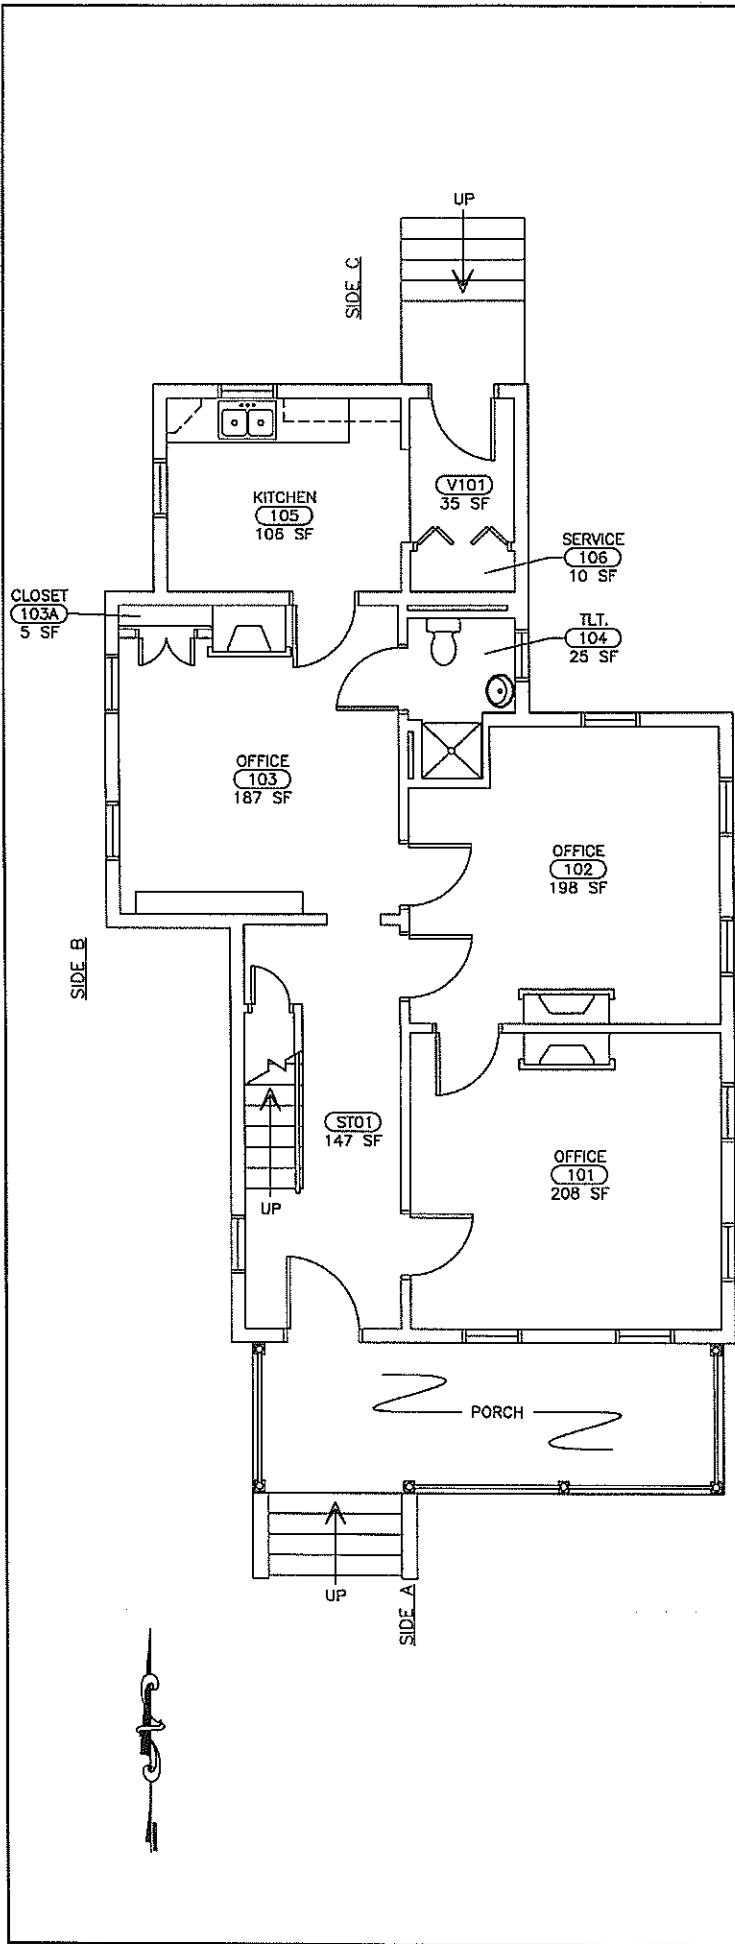
SCALE: NTS	DRAWN BY: LAJ	APPROVED BY: TR
PROJECT NO. 1135-13-464	DATE: 9-30-2013	FIGURE NO. 5.1

NO ASBESTOS WAS DETECTED.

CONFIRMED LEAD-BASED PAINT-COATED COMPONENTS:

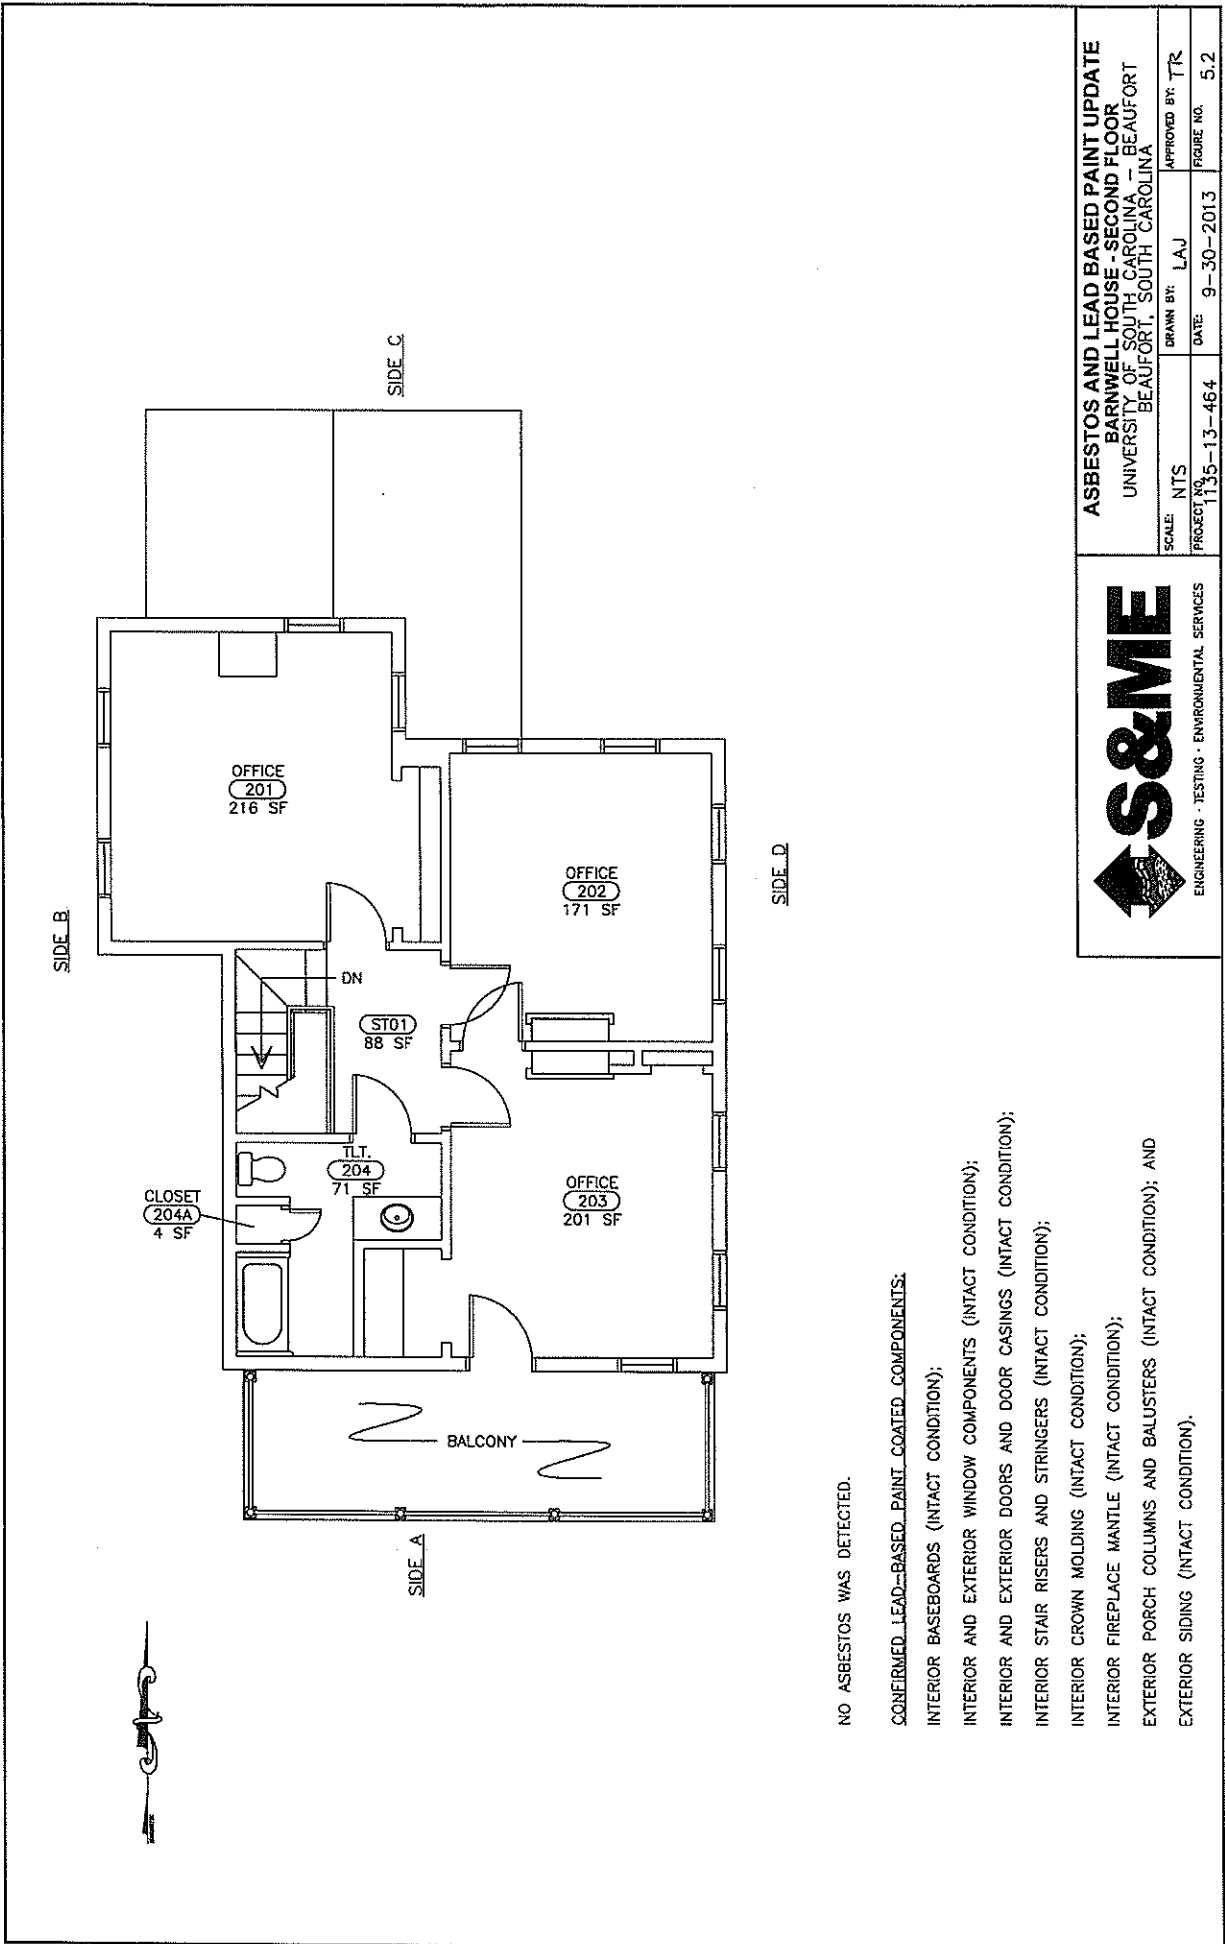
SCALE: NTS
 PROJECT NO. 1135-13-464
 DRAWN BY: LAJ
 DATE: 9-30-2013
 APPROVED BY: TR
 FIGURE NO. 5.2

NO ASBESTOS WAS DETECTED.

CONFIRMED LEAD-BASED PAINT COATED COMPONENTS:

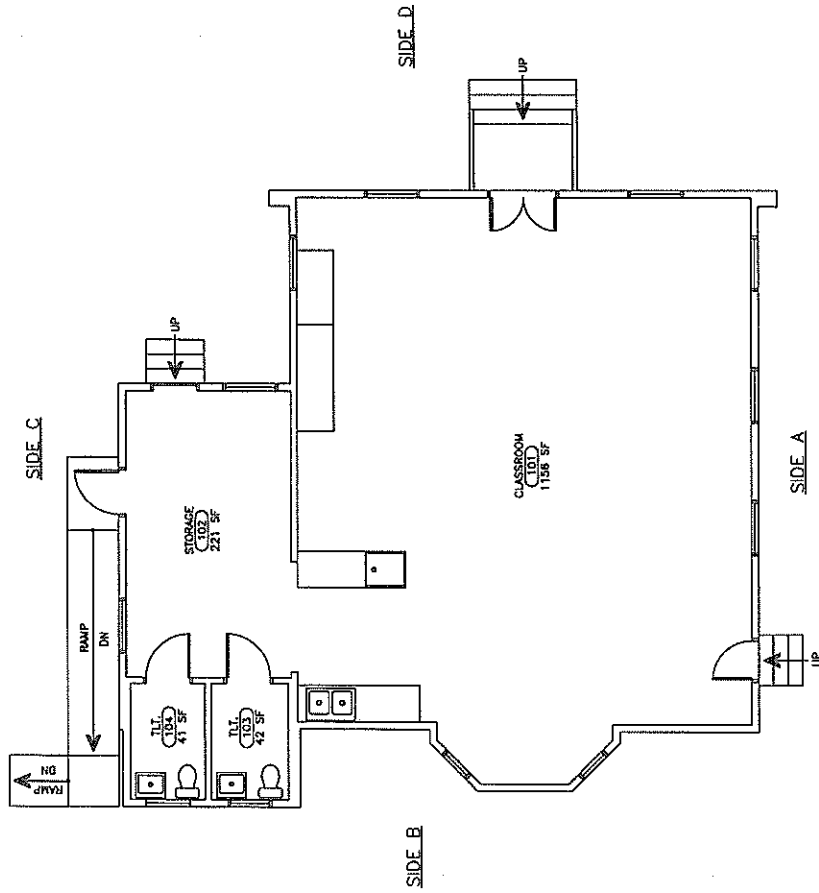
ASBESTOS AND LEAD BASED PAINT UPDATE			
ART STUDIO			
UNIVERSITY OF SOUTH CAROLINA - BEAUFORT			
BEAUFORT, SOUTH CAROLINA			
SCALE: NTS	DRAWN BY: LAJ	DATE: 9-30-2013	APPROVED BY: TR
PROJECT NO. 1135-13-464			FIGURE NO. 6.0

NO ASBESTOS WAS DETECTED.

CONFIRMED LEAD-BASED PAINT-COATED COMPONENTS:
EXTERIOR SIDING AND TRIM (POOR CONDITION);
EXTERIOR WINDOW COMPONENTS (POOR CONDITION); AND
EXTERIOR PORCH COMPONENTS (POOR CONDITION).

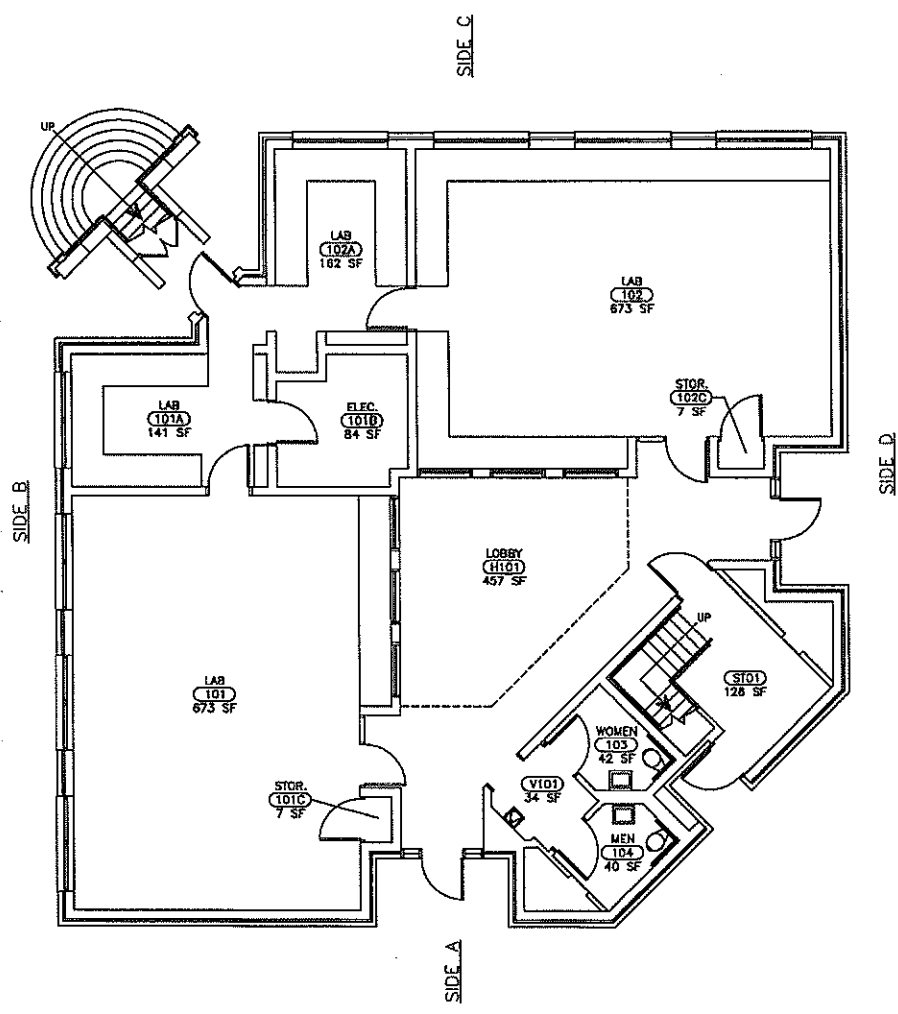
ASBESTOS AND LEAD BASED PAINT UPDATE			
MARINE SCIENCE CENTER - FIRST FLOOR			
UNIVERSITY OF SOUTH CAROLINA - BEAUFORT			
BEAUFORT, SOUTH CAROLINA			
SCALE: NTS	DRAWN BY: LAJ	APPROVED BY: TR	
PROJECT NO. 1135-13-464	DATE: 9-30-2013	FIGURE NO. 7.1

NO ASBESTOS WAS DETECTED.
 DETECTABLE LEVELS OF LEAD, APPLICABLE TO OSHA, WERE IDENTIFIED.

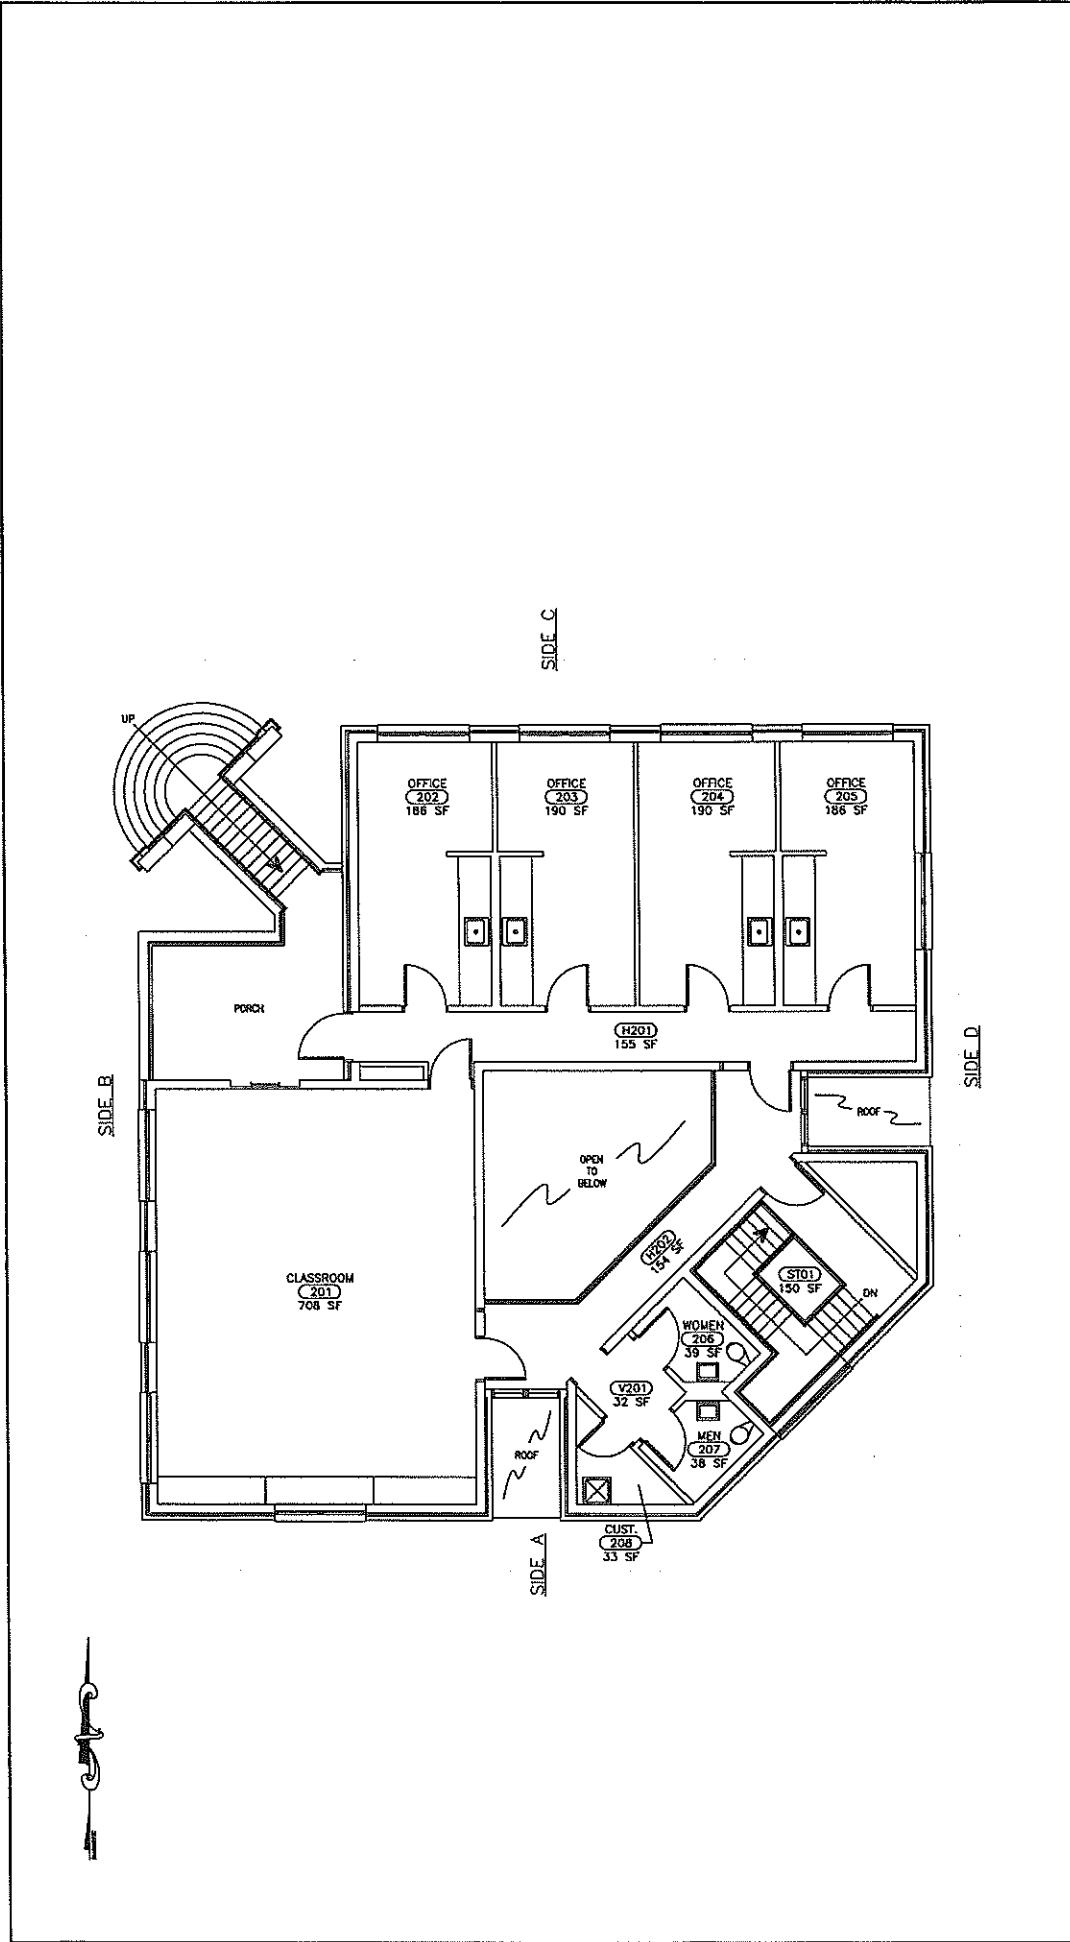
NO ASBESTOS WAS DETECTED.
 DETECTABLE LEVELS OF LEAD, APPLICABLE TO OSHA, WERE IDENTIFIED.
