PRELIMINARY REPORT
HULL CONSTRUCTION FEATURES OF THE
BROWN'S FERRY VESSEL

J. Richard Steffy
Institute of Nautical Archeology
College Station, Texas

Prepared by the
INSTITUTE OF ARCHEOLOGY AND ANTHROPOLOGY
UNIVERSITY OF SOUTH CAROLINA
February 1979

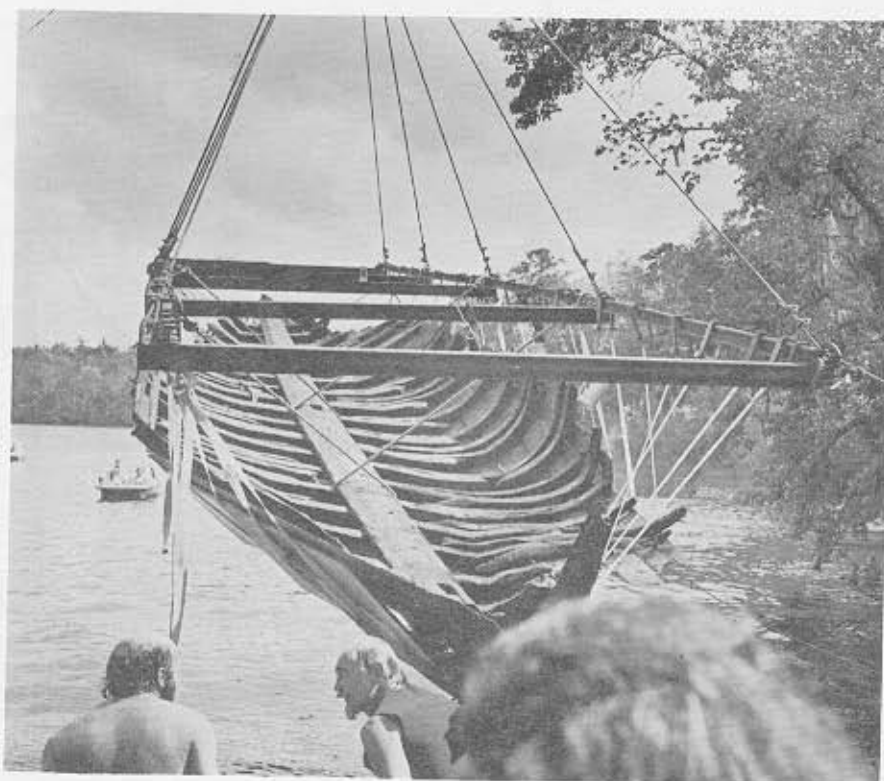
Figure 1: Raising the Brown's Ferry Vessel from the Black River (Photo by Gordon Brown).

The inclination to starboard taken by the stem during dispersion on the riverbed can be seen in Figure 1. Caused by the weight of the heavy structure above, this distortion created breakage only at the angle of the inner post.

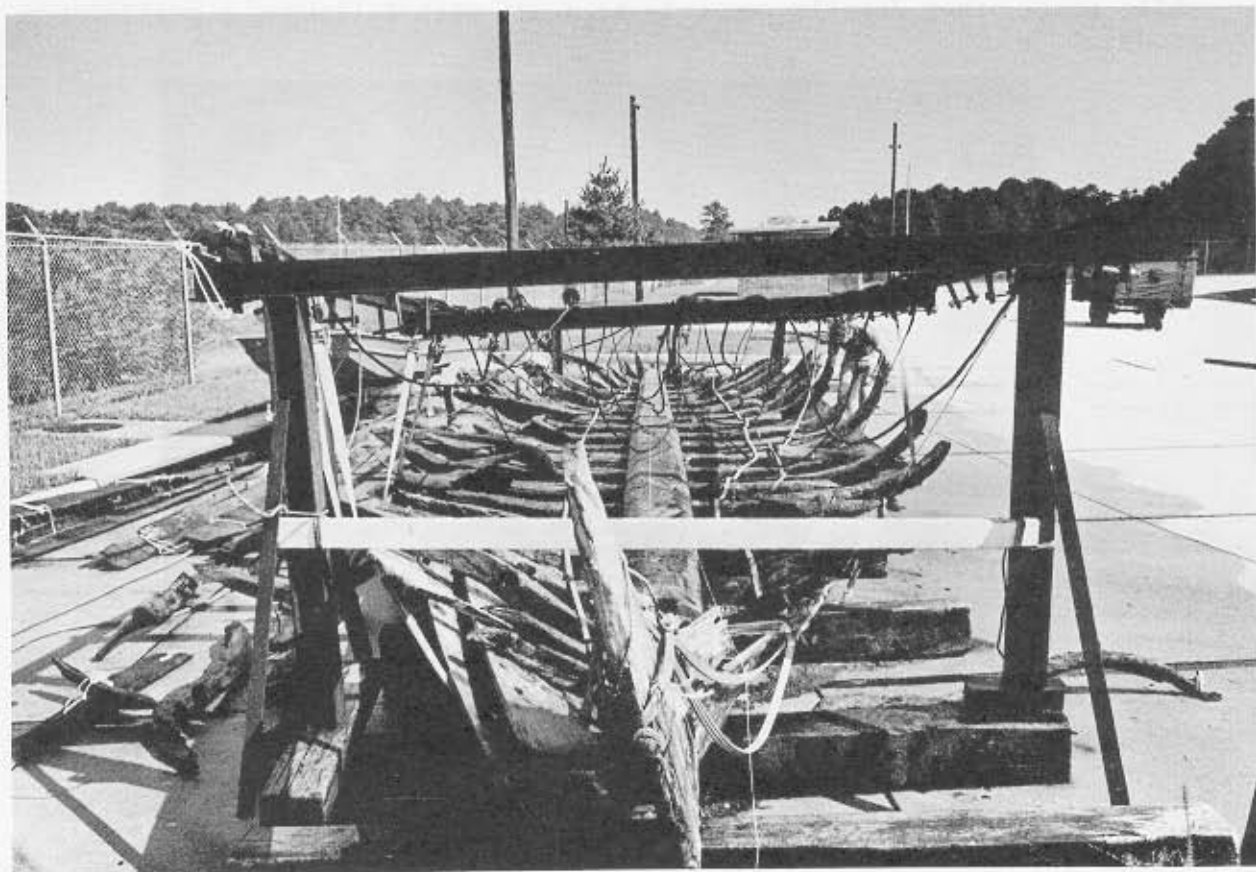
The wreck was stored along the perimeter of Fort Jackson, near Columbia, South Carolina, and was protected from human molestation. However, it was not protected from the elements, although continuous water sprays from perforated hoses and lawn sprinklers did seem to keep the timbers wet. This storage site was a temporary one as the hull has since been lowered into a storage pool to await conservation. The sprays made detailed inspection difficult and precise measurements virtually impossible. It was necessary to interrupt the water supply to perform certain duties, but such interruptions were limited to a few minutes each. Pools of water within the hull did not improve conditions.

Figure 2 illustrates the storage site. The hull was largely intact to the turn of the bilge. This section was still supported by the structure with which it was raised and transported, consisting of iron support beams, lifting cables, and cargo slings. The support structure and hull bottom rested on eight-inch sleepers. Detached hull members were stored nearby and were also under water sprays.

Figure 2: The storage site, showing the intact hull in its cradle (Photo by Alan Albright).

There remains the question of "where do we go from here" The most pressing problem is that of conservation. The hull remains continue to suffer some deterioration, even though they are soaking in fresh water. There is little advice I feel qualified to advance concerning the method of conservation, merely that it be done as quickly as possible.

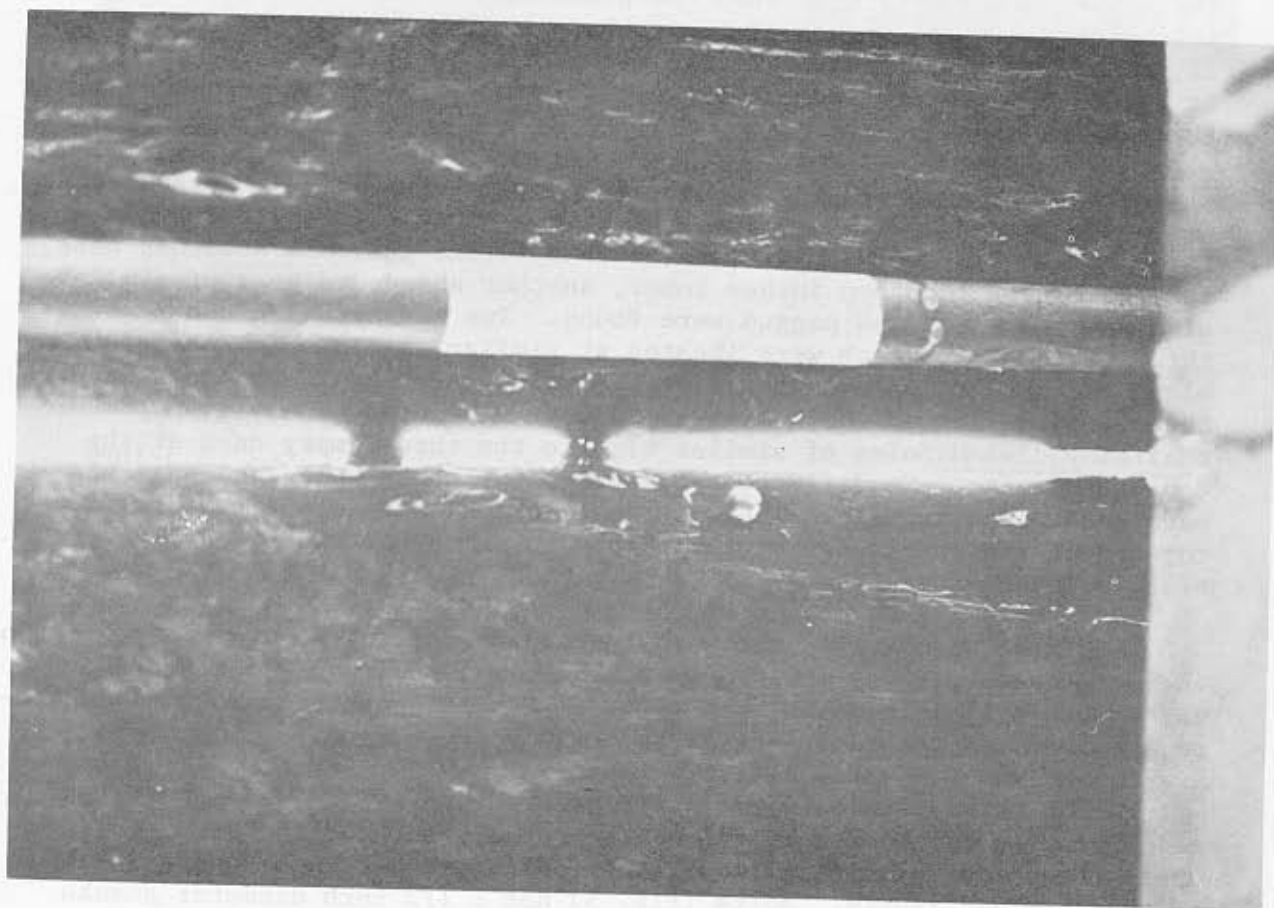
Figure 3: Two small treenails joining the edges of bottom planks (Photo by Alan Albright).

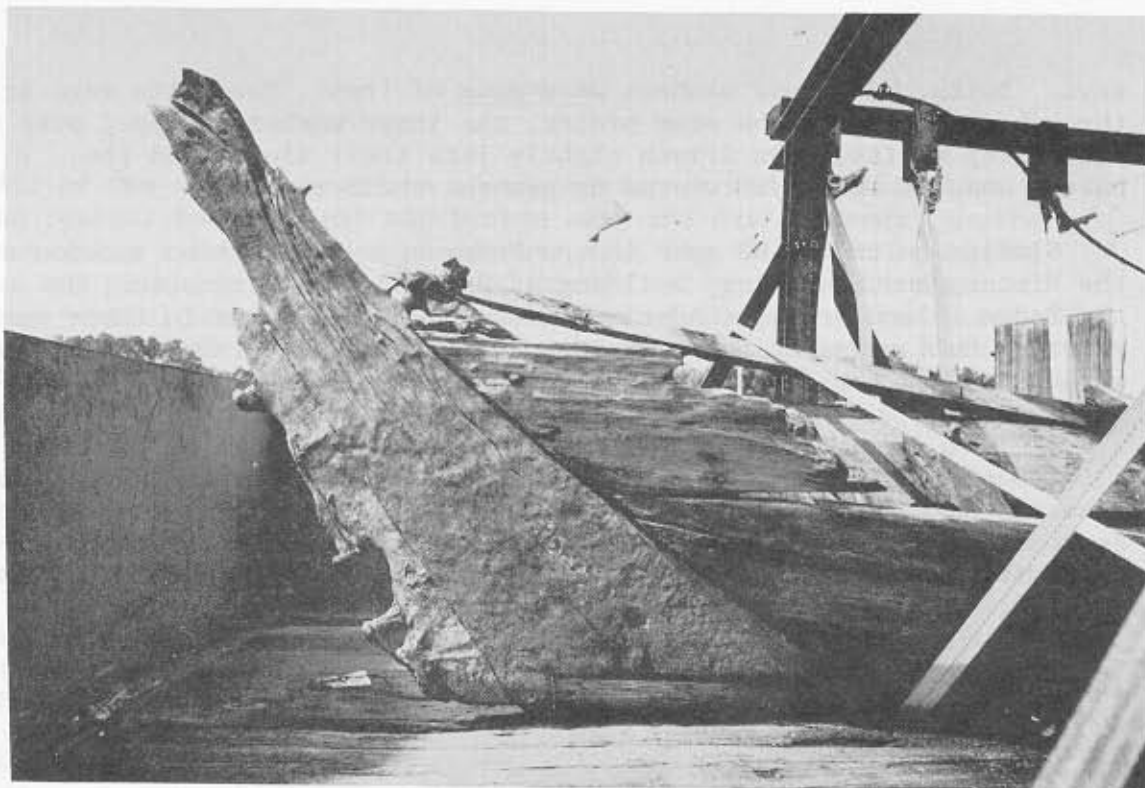
Perhaps the most interesting construction on the entire hull was that of the stem. It consisted essentially of three pieces: inner, main, and false posts. Figures 4 and 5 show the manner in which the three members were attached to the center bottom plank and each other. The main (outer) post contained the planking rabbet. Its maximum thickness was $4 \frac{1}{4}$ inches at the rabbet, tapering to $2 \frac{1}{2}$ inches where it joined the false post. Its maximum width was $23 \frac{1}{2}$ inches where it joined the center plank; the center plank was only $2 \frac{1}{2}$ inches thick here.

Approximately $4 \frac{1}{2}$ feet of the main post survived. Its upper end was quite eroded and the entire stem assembly was twisted to starboard. Three holes, $\frac{5}{16}$ inch in diameter, transpierced the main stempost near its rot line. Eighteen inches lower, another abandoned hole of similar size and one which was pegged were found. Two additional clusters of three pegged holes each were located at similar spacings and orientations along the rabbet. Although the pegs closing seven of these holes have been worn smaller at their exposed ends from erosion, there is no doubt that they closed holes of similar size to the three empty ones at the top of the stem. No definite explanation for these holes and pegs has been determined to date. The fact that each cluster was situated just forward of the upper edge of the planks entering the rabbet may be a clue, however.

Figure 4: The surviving portion of the stem (Photo by Alan Albright).

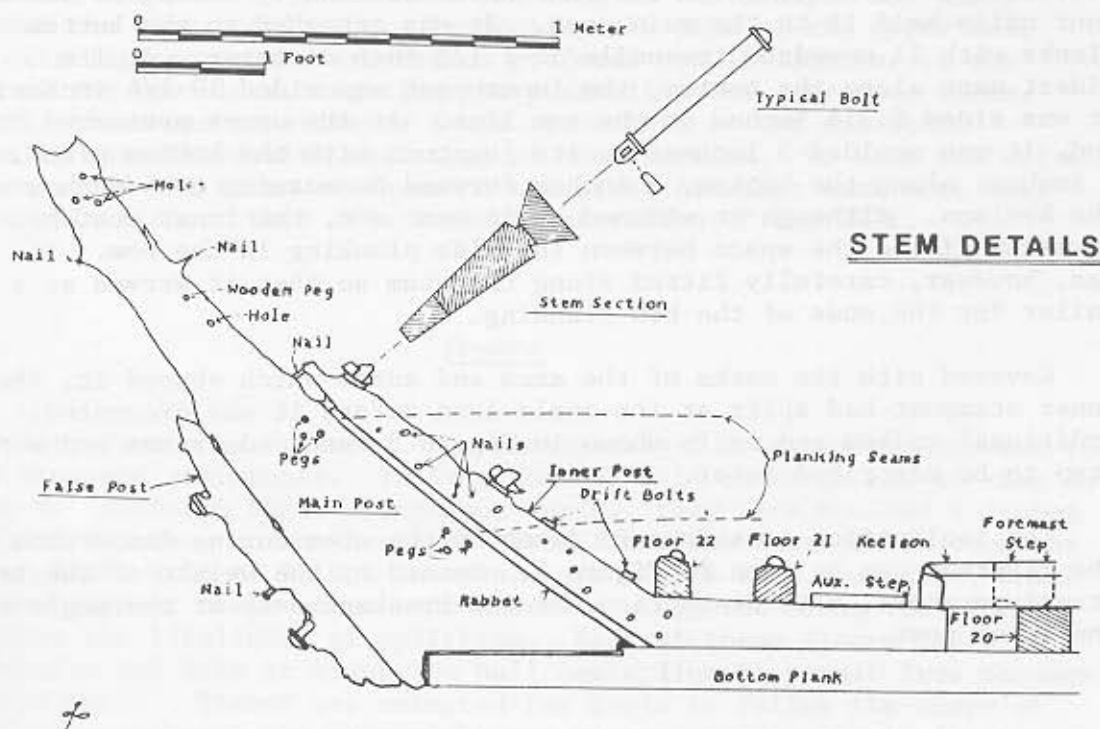
Figure 5: Stem details (Redrawn from an original by Darby Erd).

Covered with the marks of the axes and adzes which shaped it, the inner stempost had split at its angle long before it was excavated. Additional spikes and nails shown in Figure 5 fastened frames and a step to be described later.

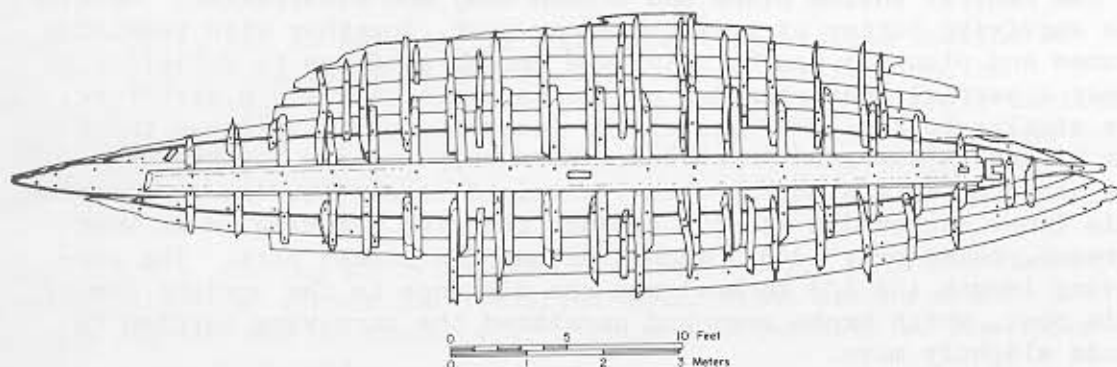
Twenty floors were spaced on approximately 2 foot centers between the inner stem and sternposts. Their extent of hull coverage can be seen in Figure 6. Although their dimensions varied, they were moulded 4 inches and sided 5 inches on the average. Each floor was fastened through the bottom planks at 6 to 8 inch intervals with 1 1/8 inch treenails, which were unwedged at their upper ends and were staggered along the floors to reduce the likelihood of splitting. Each of these floors had a watercourse cut into it along the hull centerline to permit free passage of bilge water. Timber was selected for grain to follow the shape of the floors, although the shipwright experienced difficulty in finding such grain curvature among the u-shaped floors in the ends of the hull. No metallic fastenings were used to secure these floors, nor were there any fastenings present in the floor tops to suggest the installation of permanent ceiling.

Figure 6: The intact portion of the hull (Drawing by Darby Erd).

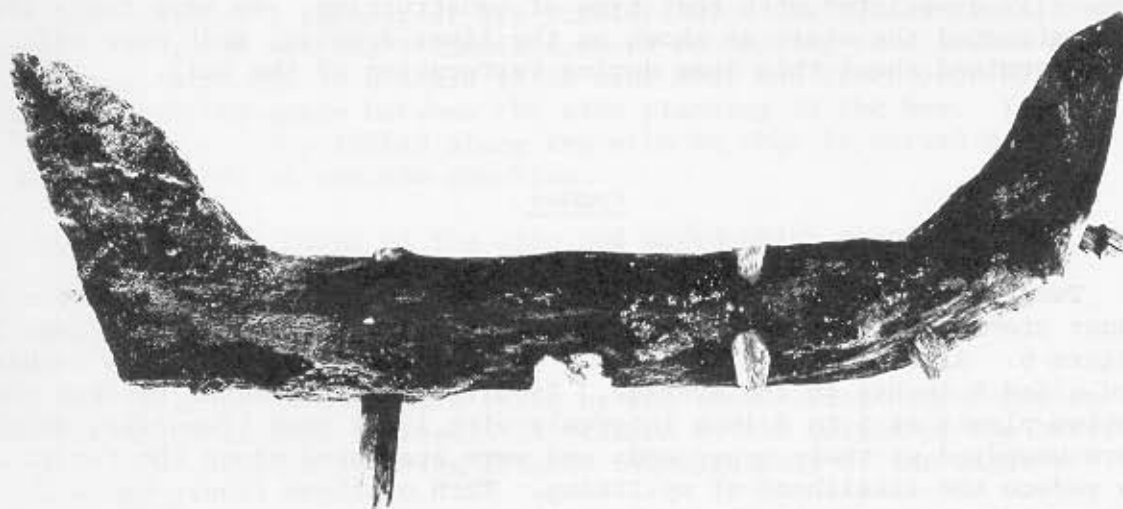
Figure 7: Floor of Frame #2 (Photo by Alan Albright).

The midship futtocks nearly abut in the center of the hull, while in the ends of the ship futtocks barely step on the bottom planks. Figures 7 and 8 illustrate a typical floor and futtock. The heel of the futtock was treenailed through the bottom plank and was also laterally treenailed through its floor (see also Fig. 9). While the heels of the futtocks were fastened to the bottom planks with at least one treenail and often 3 or 4, only a few in the fore and after sections of hull were laterally fastened.

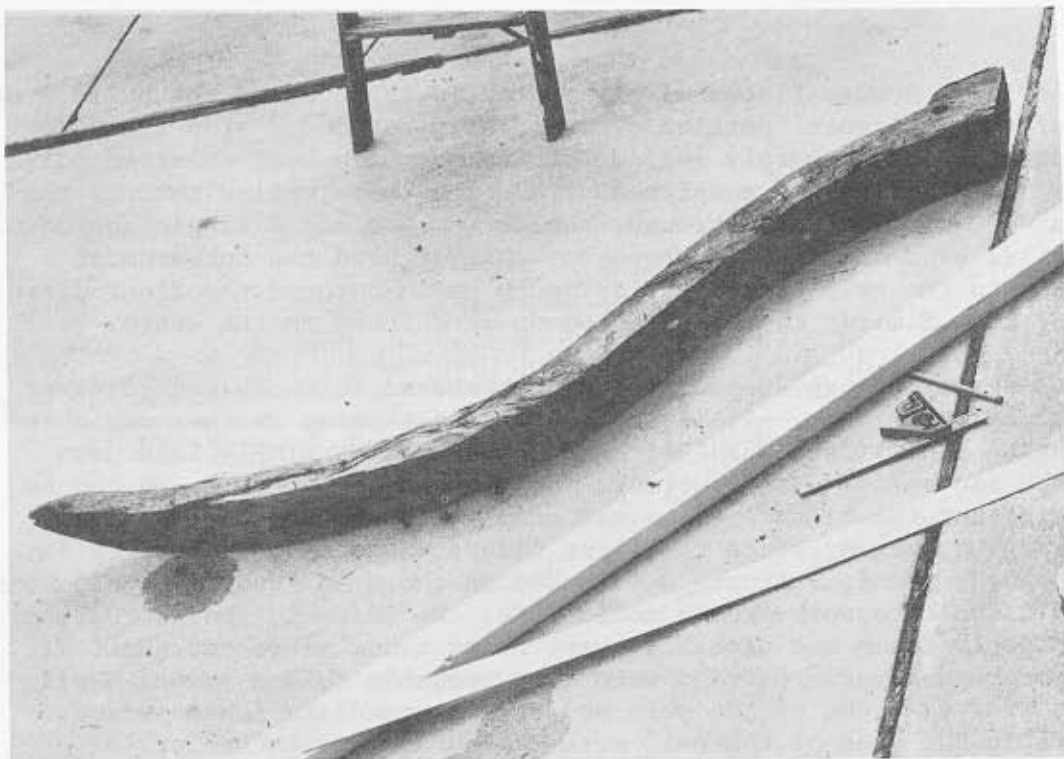
Figure 8: Starboard futtock of Frame #8 (Photo by Alan Albright).

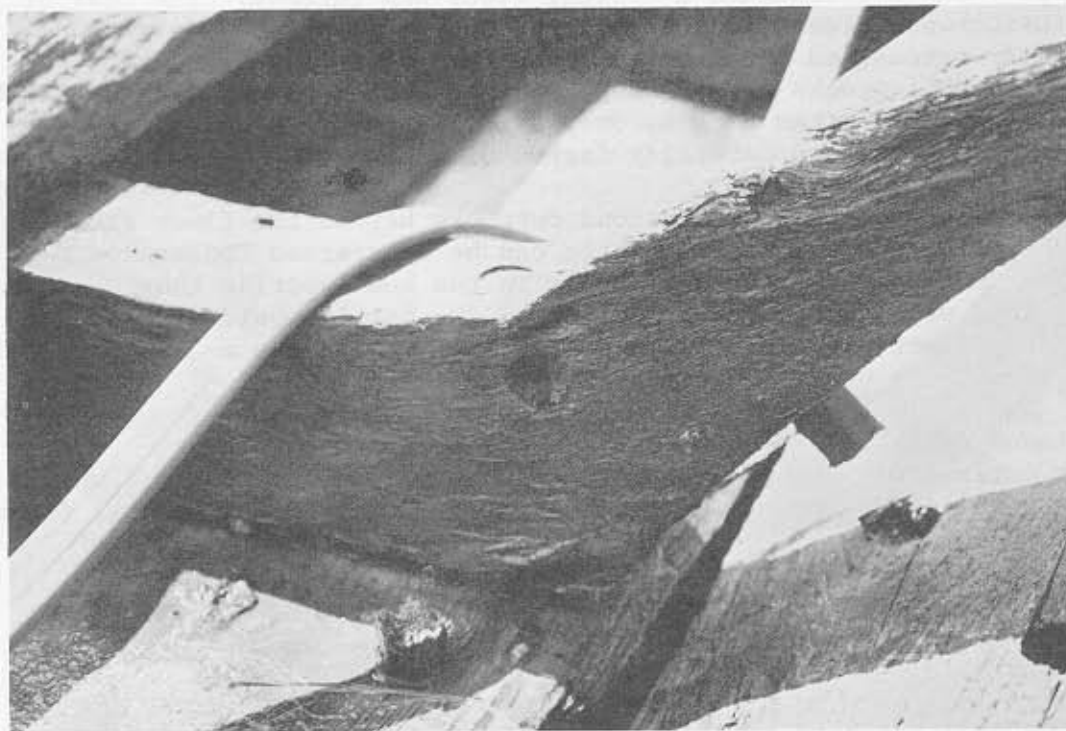
Figure 9: Floor and chine details (Photo by Alan Albright).

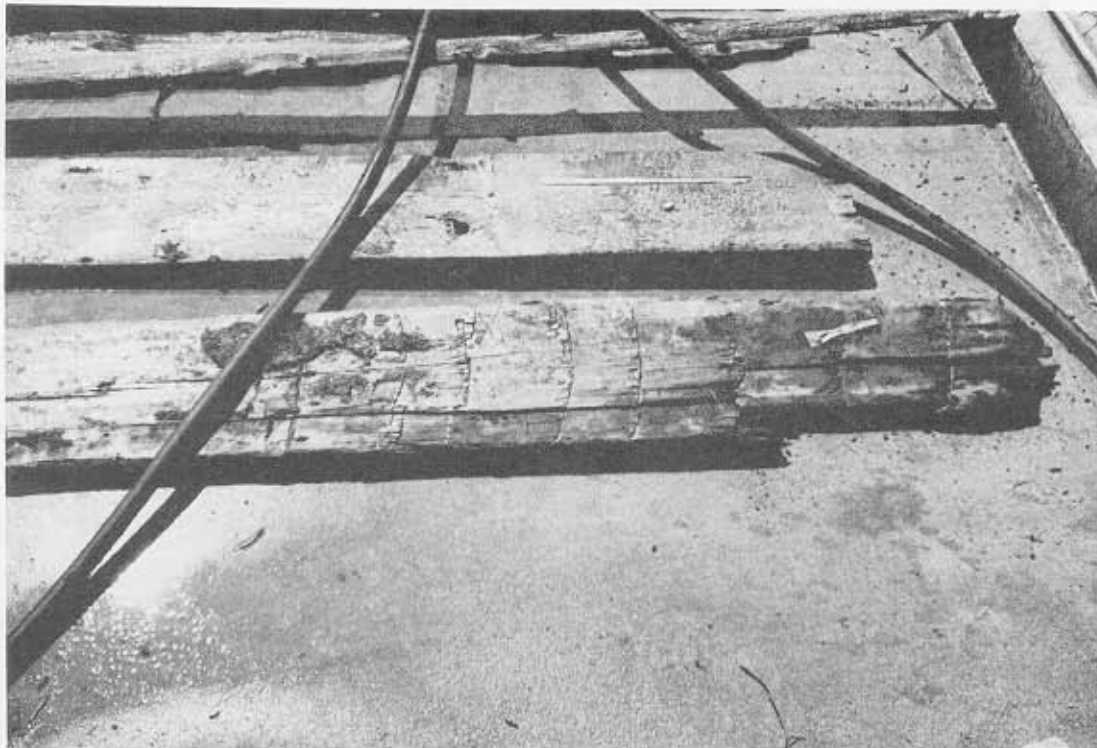
The curvature of the ends of the hull was rather severe above the fifth side strake, and considerable force was required to bend even these thin strakes into the rabbet. The shipwright made his job easier by slicing the inside surfaces of his planking (Fig. 10). We were at first surprised at this discovery and wondered whether the cuts weakened these planks. When the process was applied to our model, however, we found that much of the strength remained while the task of bending the strakes into the rabbet was greatly simplified. Not just any notch will do, of course; the secret is to make a very thin cut which is angled away from the direction of the bend.

Figure 10: End of plank cut on inside face for bending into rabbet (Photo by Alan Albright).

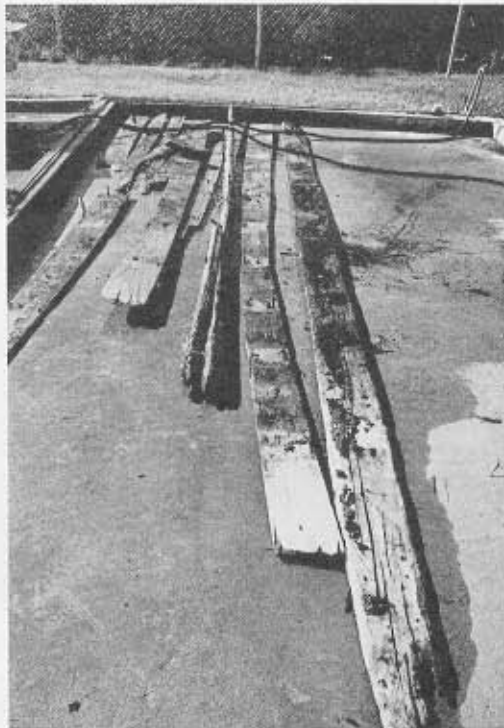
Figure 11: A sample of planking strakes. Surviving wale fragments in center of photo (Photo by Alan Albright).

already detached on the bottom has two eroded ends and will have to be fitted to the nails of similarly detached frames (Fig. 11). Planking was in relatively good condition, however, and no problem is anticipated in accomplishing a precise and convenient restoration.

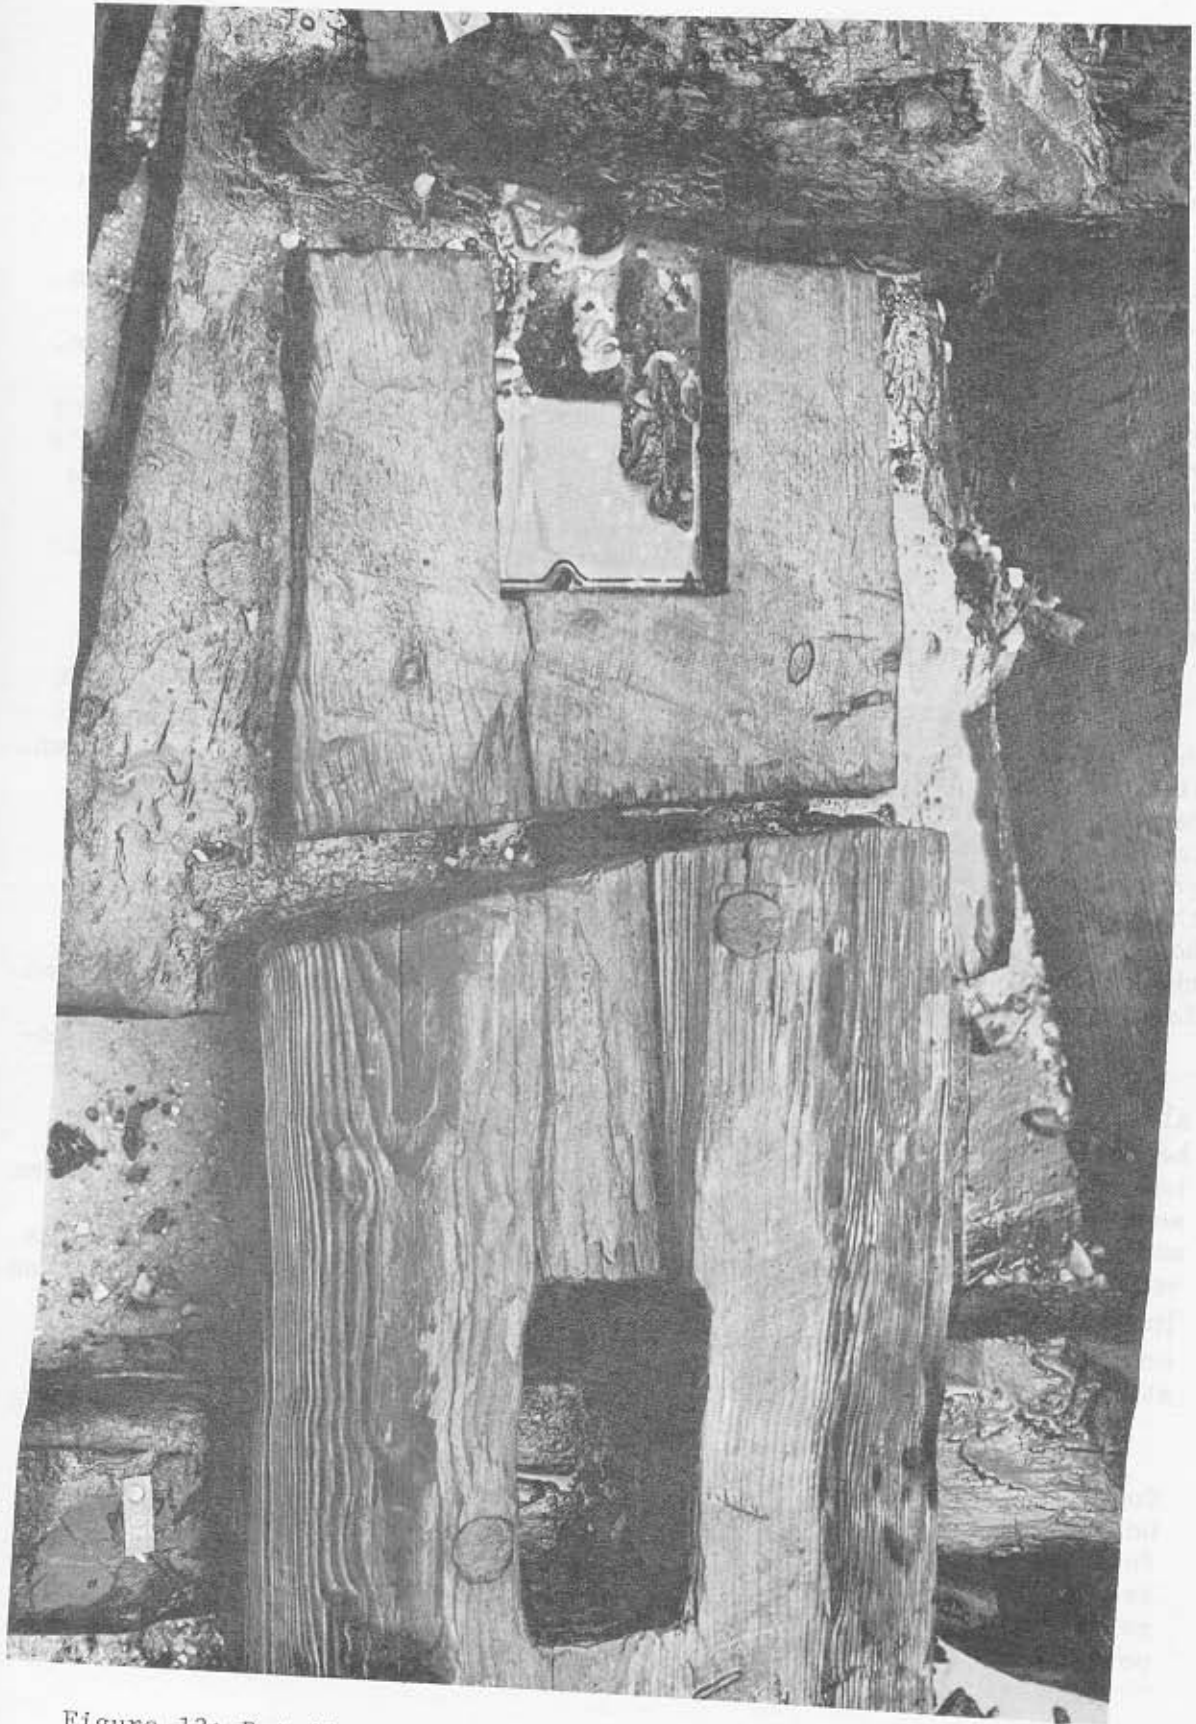
This timber served functions other than that of a keelson. It contained steps for both main and foremast. The main step was cut 12 by 4 inches, while the forestep (Fig. 12) was 5 3/4 by 3 1/8 inches. Both steps pierced the keelson. Surprisingly little wear was evident around either step.

A small auxiliary step (Fig. 12), cut from a plank 11 inches broad and 1 1/2 inches thick, was located just forward of the keelson and was nailed into the inner post with two iron nails. Floor 21 served as the fourth side of this step, perhaps supporting a bit. Its proximity to the stem and the height of floor 21 do not support the theory that it was the bowsprit step.

Figure 12: Details of small auxiliary step (Photo by Alan Albright).
