CBM COMPONENT TESTING AT THE UNIVERSITY OF SOUTH CAROLINA: AH-64 TAIL ROTOR GEARBOX STUDIES

Nicholas Goodman^a, Abdel Bayoumi^a, Vytautas Blechertas^a, Ronak Shah^a, Yong-June Shin^b

Condition-Based Maintenance Research Center

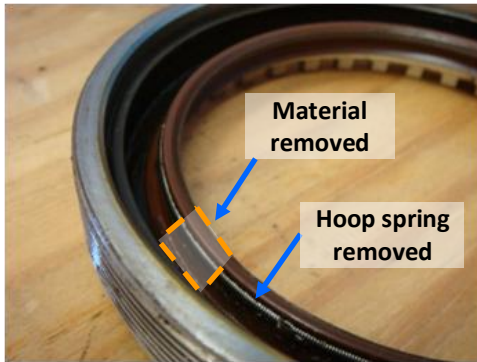
The intent of the test plan was to create a worst-case scenario for the two ball bearings that support the gearbox output shaft assembly by inducing a leak in the output seal and allowing grease to drain from the static mast. This was accomplished by removing approximately 0.5 inches of seal material on the bottom of the output seal and removing the hoop spring which compresses the seal against a rotating portion of the output assembly spline (Figure 4). The procedure was repeated for three separate gearboxes, and each gearbox was specified to run for 500 hours in the seeded fault condition.

Figure 4 – Seeding procedure utilized to induce an output seal leak

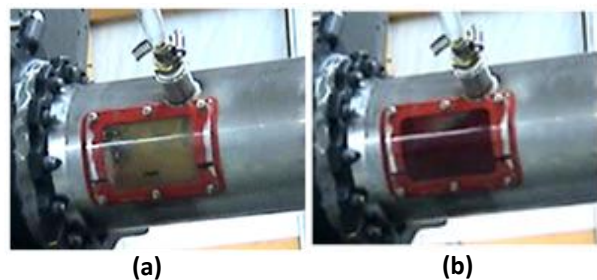
Prior to cutting the output seal on Article 3, it was allowed to run for approximately 50 hours to observe grease movement rates. After 120 minutes of operation a red discoloration was evident in the static mast grease, and by 145 minutes, it had been thoroughly mixed with the dyed grease from the main compartment (Figure 5). During this pre-seeding phase, grease levels were also observed to rise within the static mast.

Figure 5 - Grease mixing observed through the static mast window of Article 3 after (a) 120 minutes and (b) 145 minutes of operation

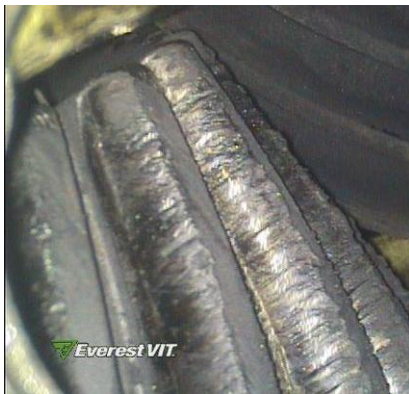
Video analysis of these events shows the gearbox was venting either a mist or smoke through the breather port immediately prior to shutdown on both occasions. Post run inspection found the teeth on the input gear to be noticeably textured, and the output gear was found covered with a layer of coarse carbon deposits.

Further inspection using a borescope revealed catastrophic wear nearly every tooth on the input gear and discoloration of the metal surfaces (Figure 6). The damage is consistent with failures caused by high friction and high heat metal-to-metal contact.

Figure 6 - Article 1 input gear after catastrophic failure

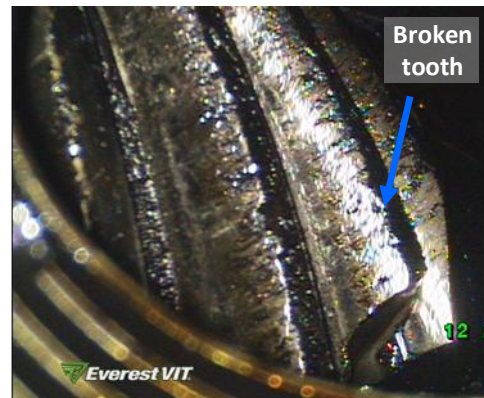
Article 2 never experienced a complete loss of lubricant on the gear tooth surfaces. When an unexpected tooth breakage occurred after 487 testing hours, the gear teeth, although severely worn, maintained a thin layer of grease, and temperatures showed no instability (Figure 7).

Figure 7 - Article 2 input gear after gear tooth breakage

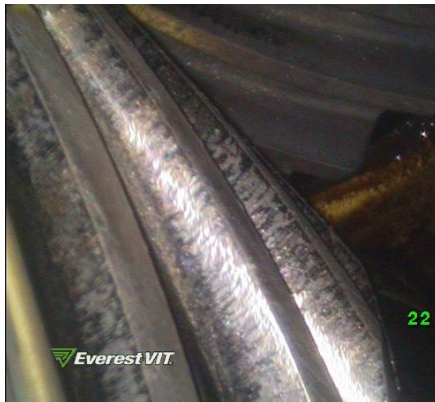
It should be noted that neither the input duplex bearing nor the output roller bearing thermocouple locations exceeded the safety limit, and during the final run, differences as great as 150 °F were recorded between the gearbox core and the originally recorded output roller bearing. This may indicate that during the failure of Article 1, the gearbox core temperatures may have reached as high as 450 °F. As a result, the damage caused to the gear teeth of Article 3 is significantly less severe than the previous two articles (Figure 8).

Figure 8 - Article 3 input gear after gearbox core temperature instability

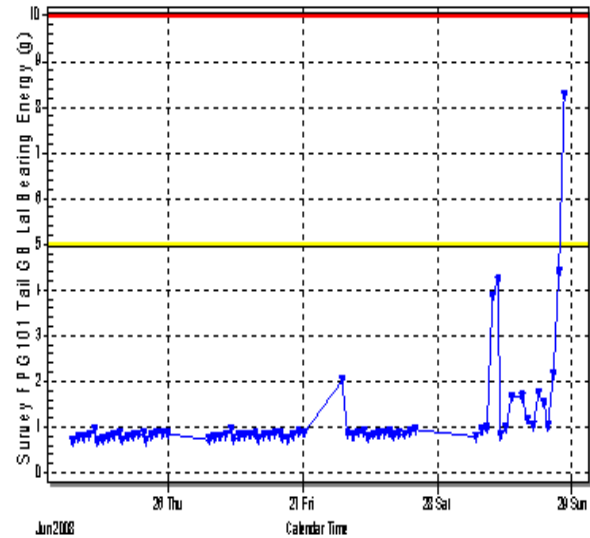
As Article 1 began failing, one of the MSPU condition indicators transitioned from a normal to a caution level. This indicator, denoted as the TRGB Lateral Bearing energy, showed notable changes during the two thermal excursions (Figure 9). Whether this is indicative of actual changes in vibration signature or is merely a reflection of the influence of temperature on vibration energies has yet to be determined.

Examination of the Lateral Bearing Energy prior to the observed thermal events shows a consistent magnitude of 1 g or less. Typical values for this CI on actual aircraft are less than 2 g, and it is likely that reducing the threshold levels for the Lateral Bearing Energy caution and exceedance will result from these findings. Several other indicators were observed to have changed on the day of the failure, none of which had experimentally determined

Figure 9 - Article 1 MSPU TGB Lateral Bearing Energy Condition Indicator prior to failure

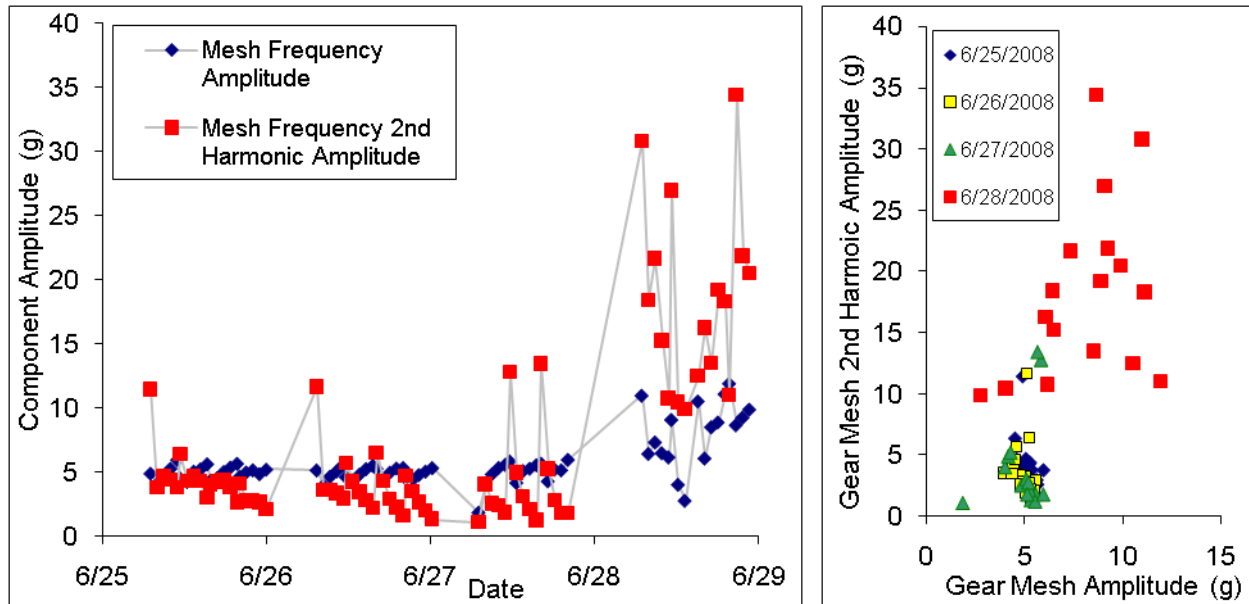
Extracting the gear mesh harmonic amplitudes from the frequency domain data as Article 1 approached failure reveals the transition from stable operation to imminent catastrophic failure occurred relatively rapidly. Plotting the first and second harmonics over the final four days of testing illustrates a regular cyclic pattern of mesh amplitudes, possibly indicating a strong dependency of component amplitudes on system temperature (Figure 10). Local amplitude maxima are also observed to occur during the first measurement survey of a given run, and steadily increasing as the gearbox approaches failure.

Plotting the amplitudes of the two harmonics against each other reveals strong data clustering prior to the failure and wide dispersion on the date of the failure. There is presently no physical interpretation of these results, particularly the large increase in the second harmonic of the gear mesh frequency amplitude. Gearbox tooth wear is not conventionally diagnosed through simple frequency domain analysis, therefore warranting the need to investigate more advanced processing techniques such as joint frequency time domain analysis.

Figure 10 – Article 1 gear mesh harmonic amplitudes immediately prior to failure

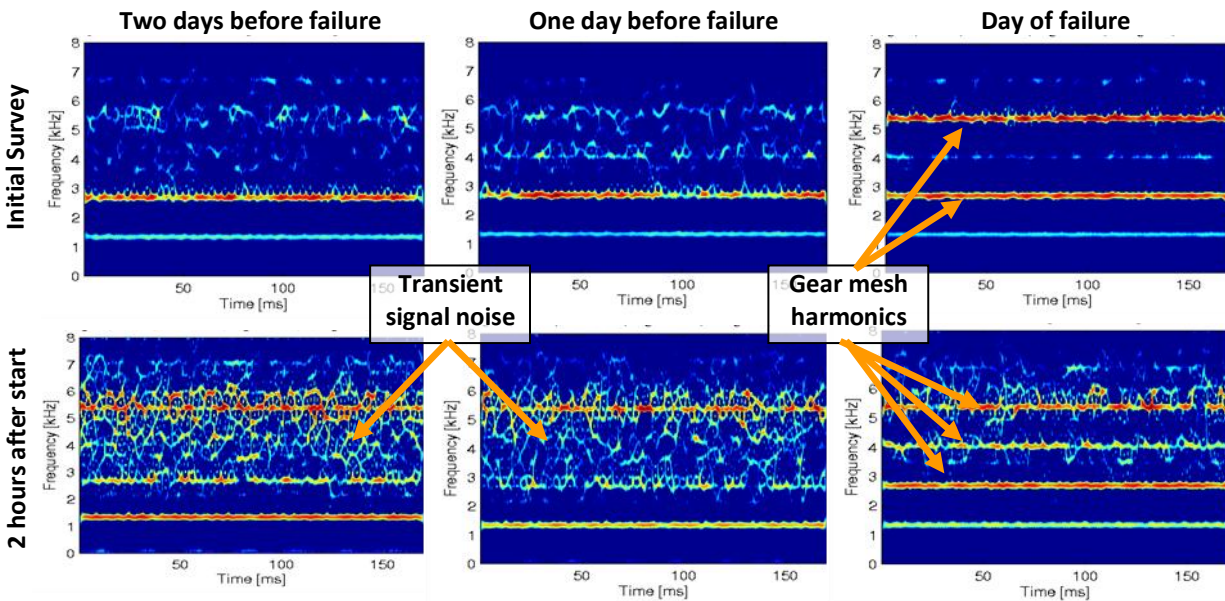
These results confirm the oscillating behavior of signal characteristics observed in the gear mesh frequency plots. The first surveys taken on the days before the failure show a reduced signal noise in the 3 to 6 kHz range when compared to samples taken later in the day (Figure 11). On the day of gearbox failure, higher-order gear mesh harmonics become prominent, and the noise band is reduced.

Figure 11 – Time frequency domain analysis of Article 1 lateral accelerometer as it approached failure

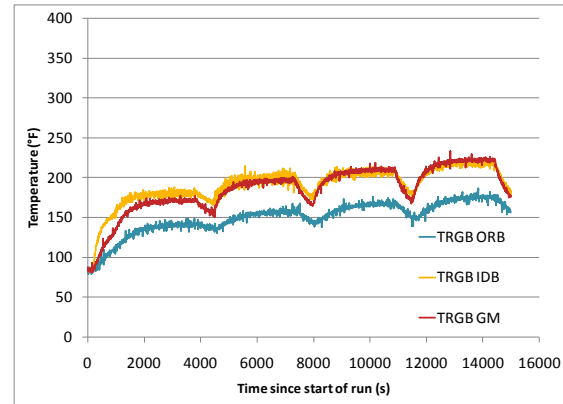
After 216 hours of seeded fault operation, the majority of the total grease had been purged from the gearbox. This corresponded with an overall reduction in temperature measured at the output roller bearing location (Figure 13). Since the primary heat generation occurs on the input gear mesh surface, this indicates that heating at the output roller bearing is partially due to convective heat transfer of the lubricant within the gearbox. Infrared imaging confirms that large temperature gradients occur on the surface of the gearbox when there are insufficient levels of grease within the main compartment (Figure 14).

Figure 13 - Temperatures of Article 3 after main compartment grease loss through the output seal

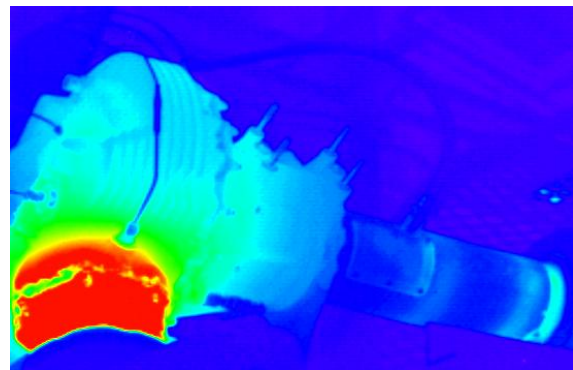
Figure 14 - Infrared thermal imaging of Article 3 after main compartment grease loss through the output seal

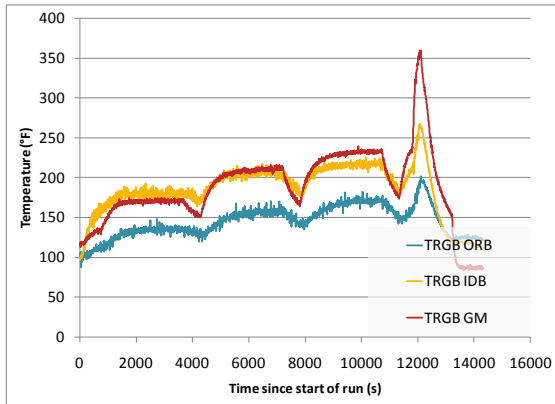
The greatest temperature gradients were observed at the end of the gearbox life. During the second thermal runaway event, the gearbox core suddenly began rising at approximately 10 °F per minute, peaking at 350 °F before the test was suspended (Figure 15). This was 150 °F hotter than the output roller bearing and 90 °F hotter than the input duplex bearing, which is the hottest measurable region on the actual aircraft. It is predicted that low lubrication conditions have the potential to generate gear surface temperatures in excess of 425 °F without detection, risking lubricant breakdown or tooth material degradation.

Figure 15 - Temperature of Article 3 as it experienced rapid heating from gear mesh lubrication starvation
