CBM COMPONENT TESTING AT THE UNIVERSITY OF SOUTH CAROLINA: AH-64 GEARBOX GREASE STUDIES

Nicholas Goodman^a, Abdel Bayoumi^a, Vytautas Blechertas^a, Ronak Shah^a, Yong-June Shin^b

Condition-Based Maintenance Research Center

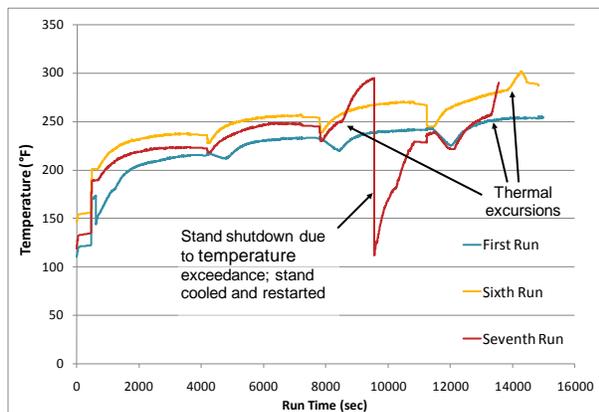
An intermediate gearbox which had been removed from an aircraft due to unidentified vibration signatures was installed on the USC test stand for further analysis. Initially, the gearbox indicated no abnormal behavior, and the vibrations which were generated were inconclusive. At the end of the sixth test run during the 330 hp load interval, however, an unexpected rapid change in gearbox temperature was observed (Figure 3). Although, the over-temp condition of 300 °F occurred, the stand was not stopped since the test run was near completion.

Figure 3 - Temperature-time plots of a thermally unstable intermediate gearbox

During the following run, near the beginning of the 252 hp load interval, a similar thermal excursion occurred, resulting in an emergency stop of the test stand due to the over-temp condition. The stand was then allowed to cool to ambient temperature and the run was resumed in the 252 hp load interval. Steady state temperature conditions had not yet occurred when the stand load profile was cycled to an FPG101 configuration. Almost immediately after the 330 hp load was applied, a third thermal event was

observed, which also warranted the shutdown of the test and the removal of the gearbox as a test article.

This gearbox would be the first of many in which rapid changes of temperature at increasingly cooler starting conditions was observed. The sudden change in slope on the temperature plot indicates that an additional heat source beyond the normal effects of gear meshing may have been present.

Following its removal, the gearbox was disassembled and studied to identify the source of the problem. The teardown analysis findings were inconclusive and found no major damage to gear teeth surfaces or rolling element bearings. It is therefore theorized that the cause of the sudden heat generation was not due to mechanical phenomena such as friction or wear, but rather due to an exothermic chemical decomposition of the grease.

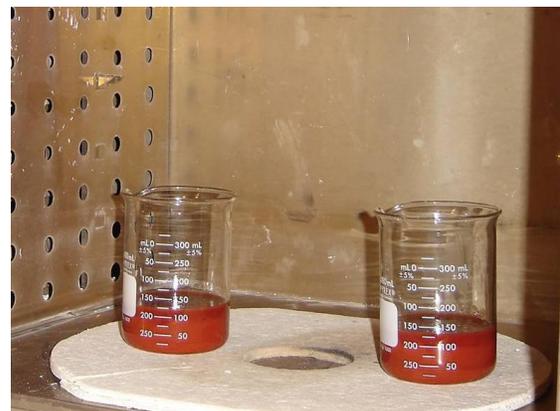
Further ongoing follow-up studies are being performed at USC to characterize NS-4405-FG when heated beyond its specified operating limits. In one experiment, unused grease samples were placed in a 300 °F oven at ambient air pressure for a period of four weeks. During that time, it was observed that the grease began to change color from tan to red and finally to black (Figure 4). In its final condition, it was further observed that the grease no longer maintained a uniform semi-solid viscosity, and had separated into solid and liquid regions.

Figure 4 - Changes in grease coloration when exposed to 300 °F temperatures

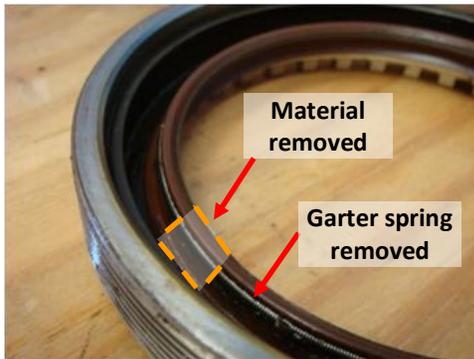
The output seals were seeded to represent a worst-case scenario leak for the gearboxes, so a large amount of seal material and the compression garter spring were removed (Figure 6). When the first attempted article was tested, it was unexpectedly found that following a sufficient ejection of grease from the output seal, the main compartment service levels were also low. Immediately following a servicing of the main compartment, the grease flow from the output seal increased in volume.

Figure 6 - Seeding procedure utilized to induce an output seal leak

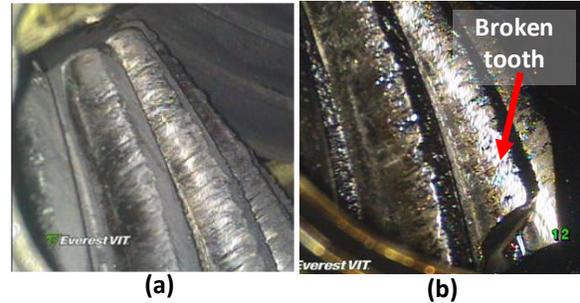
Since it was thought that this behavior was impossible, the gearbox was disqualified and three more gearboxes, identified as Articles 1, 2, and 3, were selected. Article 1 showed similar behavior, causing the test plan to be modified such that the main compartment would only be serviced with the correct amount of grease at the beginning of each article test life. For all three articles, it was observed that a persistent grease leak through the output seal resulted in a loss of lubricant in the main gear

compartment. Consequently, this condition ultimately resulted in lubricant starvation on the gear meshing region and catastrophic gear tooth failures (Figure 7). For Articles 1 and 3, the failure was accompanied by large thermal excursions, while Article 2 incurred a broken input gear tooth.

Figure 7 - Article 1 (a) and Article 2 (b) input gears after catastrophic failure

The most practical conclusion that results from the findings presented is that unit-level replacement or repair of AH-64 tail rotor gearbox output seals is feasible. Since grease has been observed to mix and transfer freely between the two gearbox compartments, there is no longer an immediate need to ground aircraft with minor output seal leaks. Since the observed rate of ejection was relatively low compared to the flight duration on an actual aircraft, properly servicing the main gear compartment is sufficient for maintaining static mast grease levels.

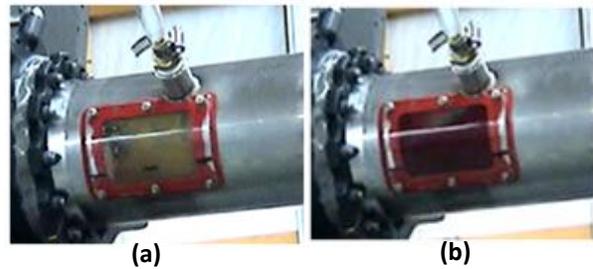
The experiment for Article 3 included a specially modified static mast, which allowed visual inspections to be made of the static mast grease levels. A special red dye was added to the main compartment, and prior to cutting the output seal, the test stand was run to observe any grease mixing. Within 120 minutes of starting the test stand, the static mast window began to show a slight red coloration and by 145 minutes, grease from the two compartments had become thoroughly mixed (Figure 8).

Figure 8 - Grease mixing observed through the static mast window of Article 3 after (a) 120 minutes and (b) 145 minutes of operation

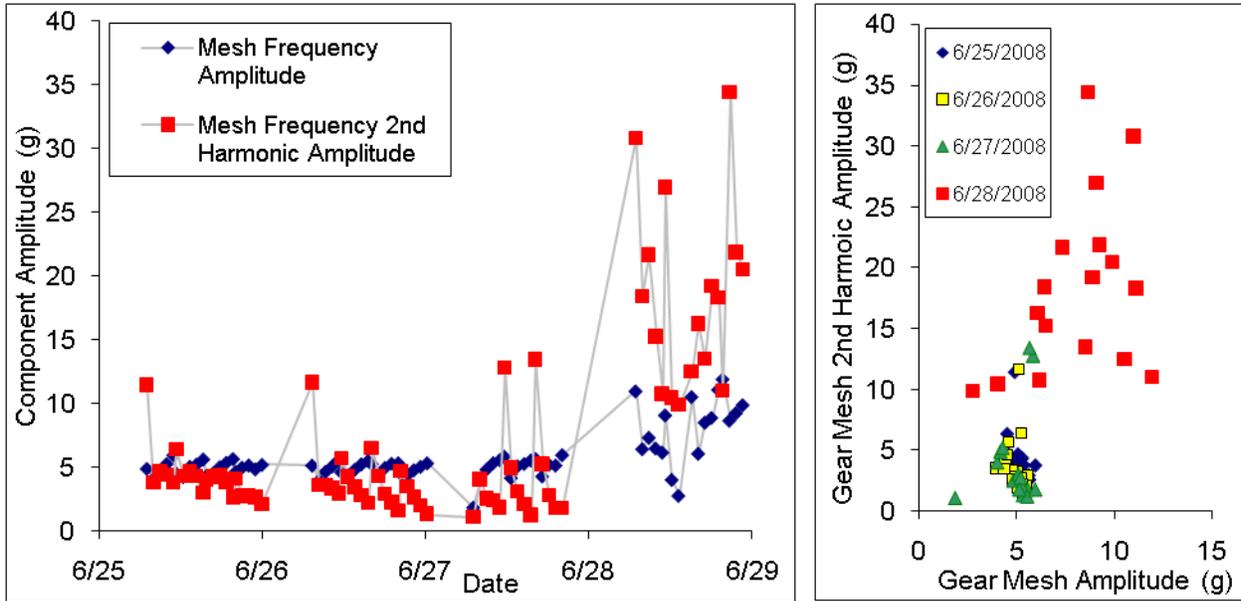
From this study, various vibration signatures were collected that give some insight into the effects of lubricant condition on component vibrations. Examining the first and second harmonics of the gear mesh frequencies of Article 1 as it approached failure (Figure 9) shows noticeably cyclic behavior, despite the fact that all data points were collected in the same loading condition, namely FPG101. It is theorized that the cyclic behavior is strongly related to the gearbox temperature at the time of the Survey, and that accompanying viscosity changes in the lubricant cause the vibration signals to be affected.

Figure 9 – Article 1 gear mesh harmonic amplitudes in the final four days of testing

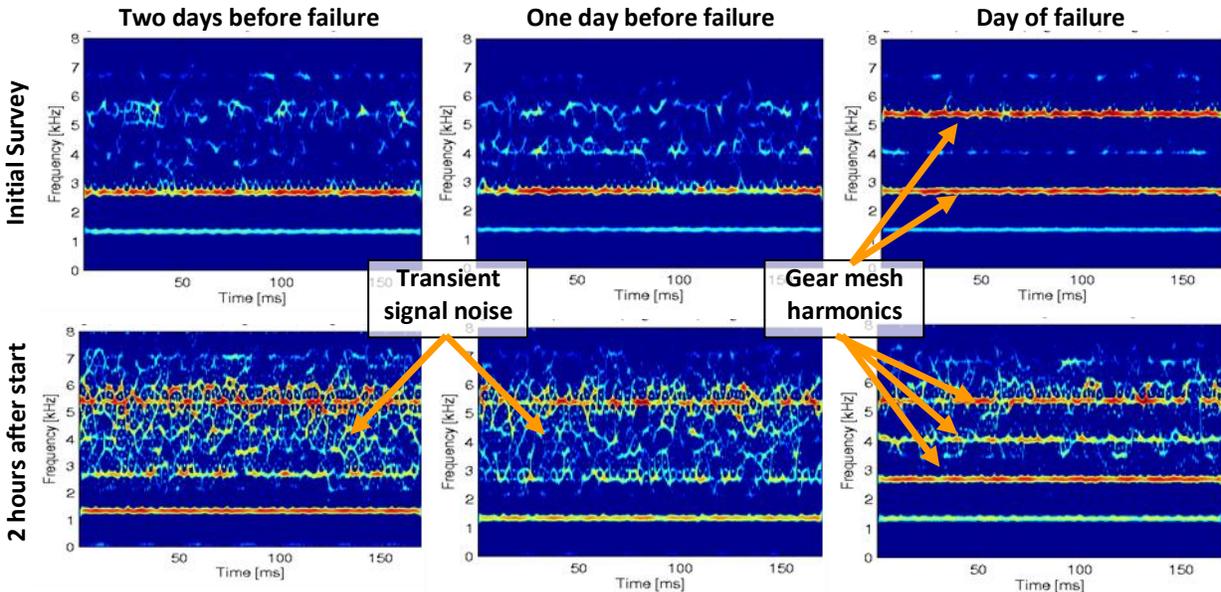
This is evidenced even more when utilizing joint time-frequency domain analysis of the vibration signals for the same gearbox (Figure 10). In the days leading to the failure, the cold-start conditions show significantly less high-frequency noise than two hours into the run. Such noise is often associated with shock energy and indicates that in a lubricant-deficient gearbox, high temperatures cause a final protective layer of grease to become thinner and less effective.

Figure 10 – Time frequency domain analysis of Article 1 lateral accelerometer as it approached failure

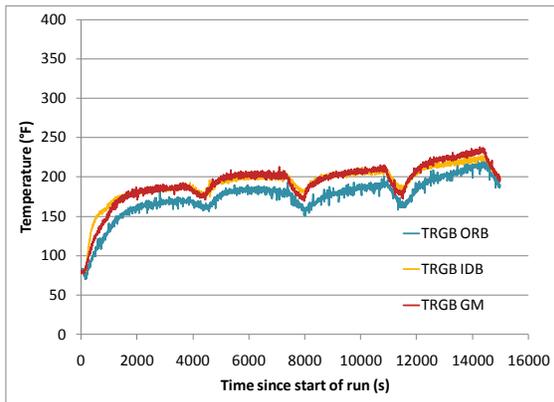
Comparing the temperature profiles of Article 3 in original fully serviced condition with its imminent-failure condition, it can be observed that two of the locations saw no significant changes in thermal behavior while the output roller bearing actually experienced a decrease in temperature (Figure 11 and Figure 12). It is theorized that this effect is due to the loss of a convective transfer mechanism which distributes gear mesh heat throughout the gearbox. It is predicted that gearboxes experiencing low-lubricant conditions will typically exhibit large thermal gradients, as illustrated by the use of infrared imagery ().

Figure 11 - Temperatures of the three measured locations on Article 3 prior to fault seeding

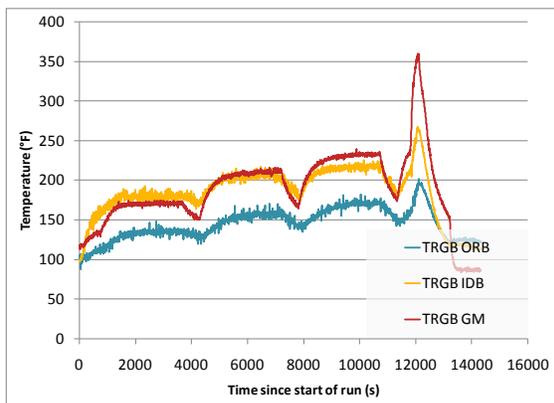
Figure 12 - Temperature of Article 3 as it experienced rapid heating from gear mesh lubrication starvation

As observed previously, Article 3 experienced three over-temp conditions each at successively cooler initial temperatures. Examining the first of these events, it is clear that the magnitude of the thermal gradients increases severely during the thermal transients, and that the gear mesh region can reach temperatures approximately 100 °F hotter than the highest monitored location on the actual aircraft (Figure 12). This indicates the possibility that in certain scenarios, a gearbox may reach

temperatures beyond the operational limits of the grease without indicating this information to the flight crew.

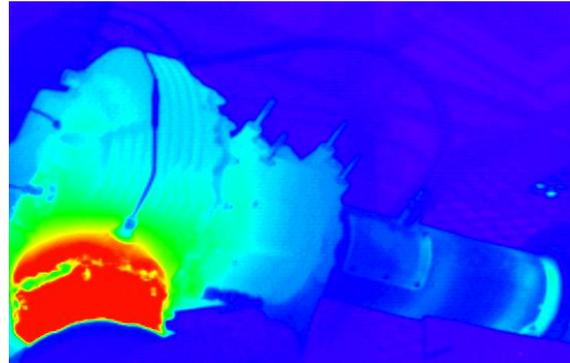
Figure 13 - Infrared thermal imaging of Article 3 after main compartment grease loss through the output seal

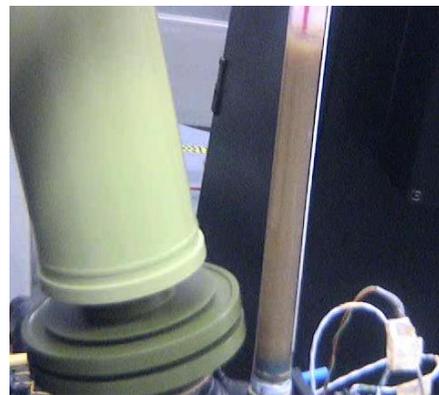
The first step in characterizing this fault was to attach a transparent pipe to the breather port so that the static pressure head of the grease could be determined. During the first 4 hour test run, grease was ejected out of the breather to a maximum height of approximately 14 inches (**Error! Reference source not found.**). Based upon the density of the grease at room temperature, this would indicate an internal gearbox pressure of approximately 0.5 psi. The source of such a relatively low pressure has not yet been verified, but may be the result of centrifugal fluid dynamics of the grease or by thermal expansion of trapped air within the gearbox.

Figure 14 - Ejected grease column observed on intermediate gearbox test article

Another interesting observation is that the grease ejection only occurred during the first day of testing. At the end of the day, the grease settled back into the gearbox, and since then no further ejections have been observed coming from the breather. It is theorized that this may be due to rapid changes in grease properties such as a decrease in viscosity, thus changing the dynamics of air pocket and foam generation.

Future work will seek to quantify if such changes are, in fact, occurring and to determine what implications it may have on the operational practices of the intermediate gearbox. Other possible follow-up investigations may attempt to modify the breather such that grease ejections are less severe.
