ADDENDUM 01

Project: Upstate – Hodge Athletic Storage Renovations

LIMITED ASBESTOS INSPECTION REPORT
FOR

Re: Limited Asbestos Inspection Report
Hodge Building (Athletic Storage Renovation)
CRE Project Number: 16733-IN

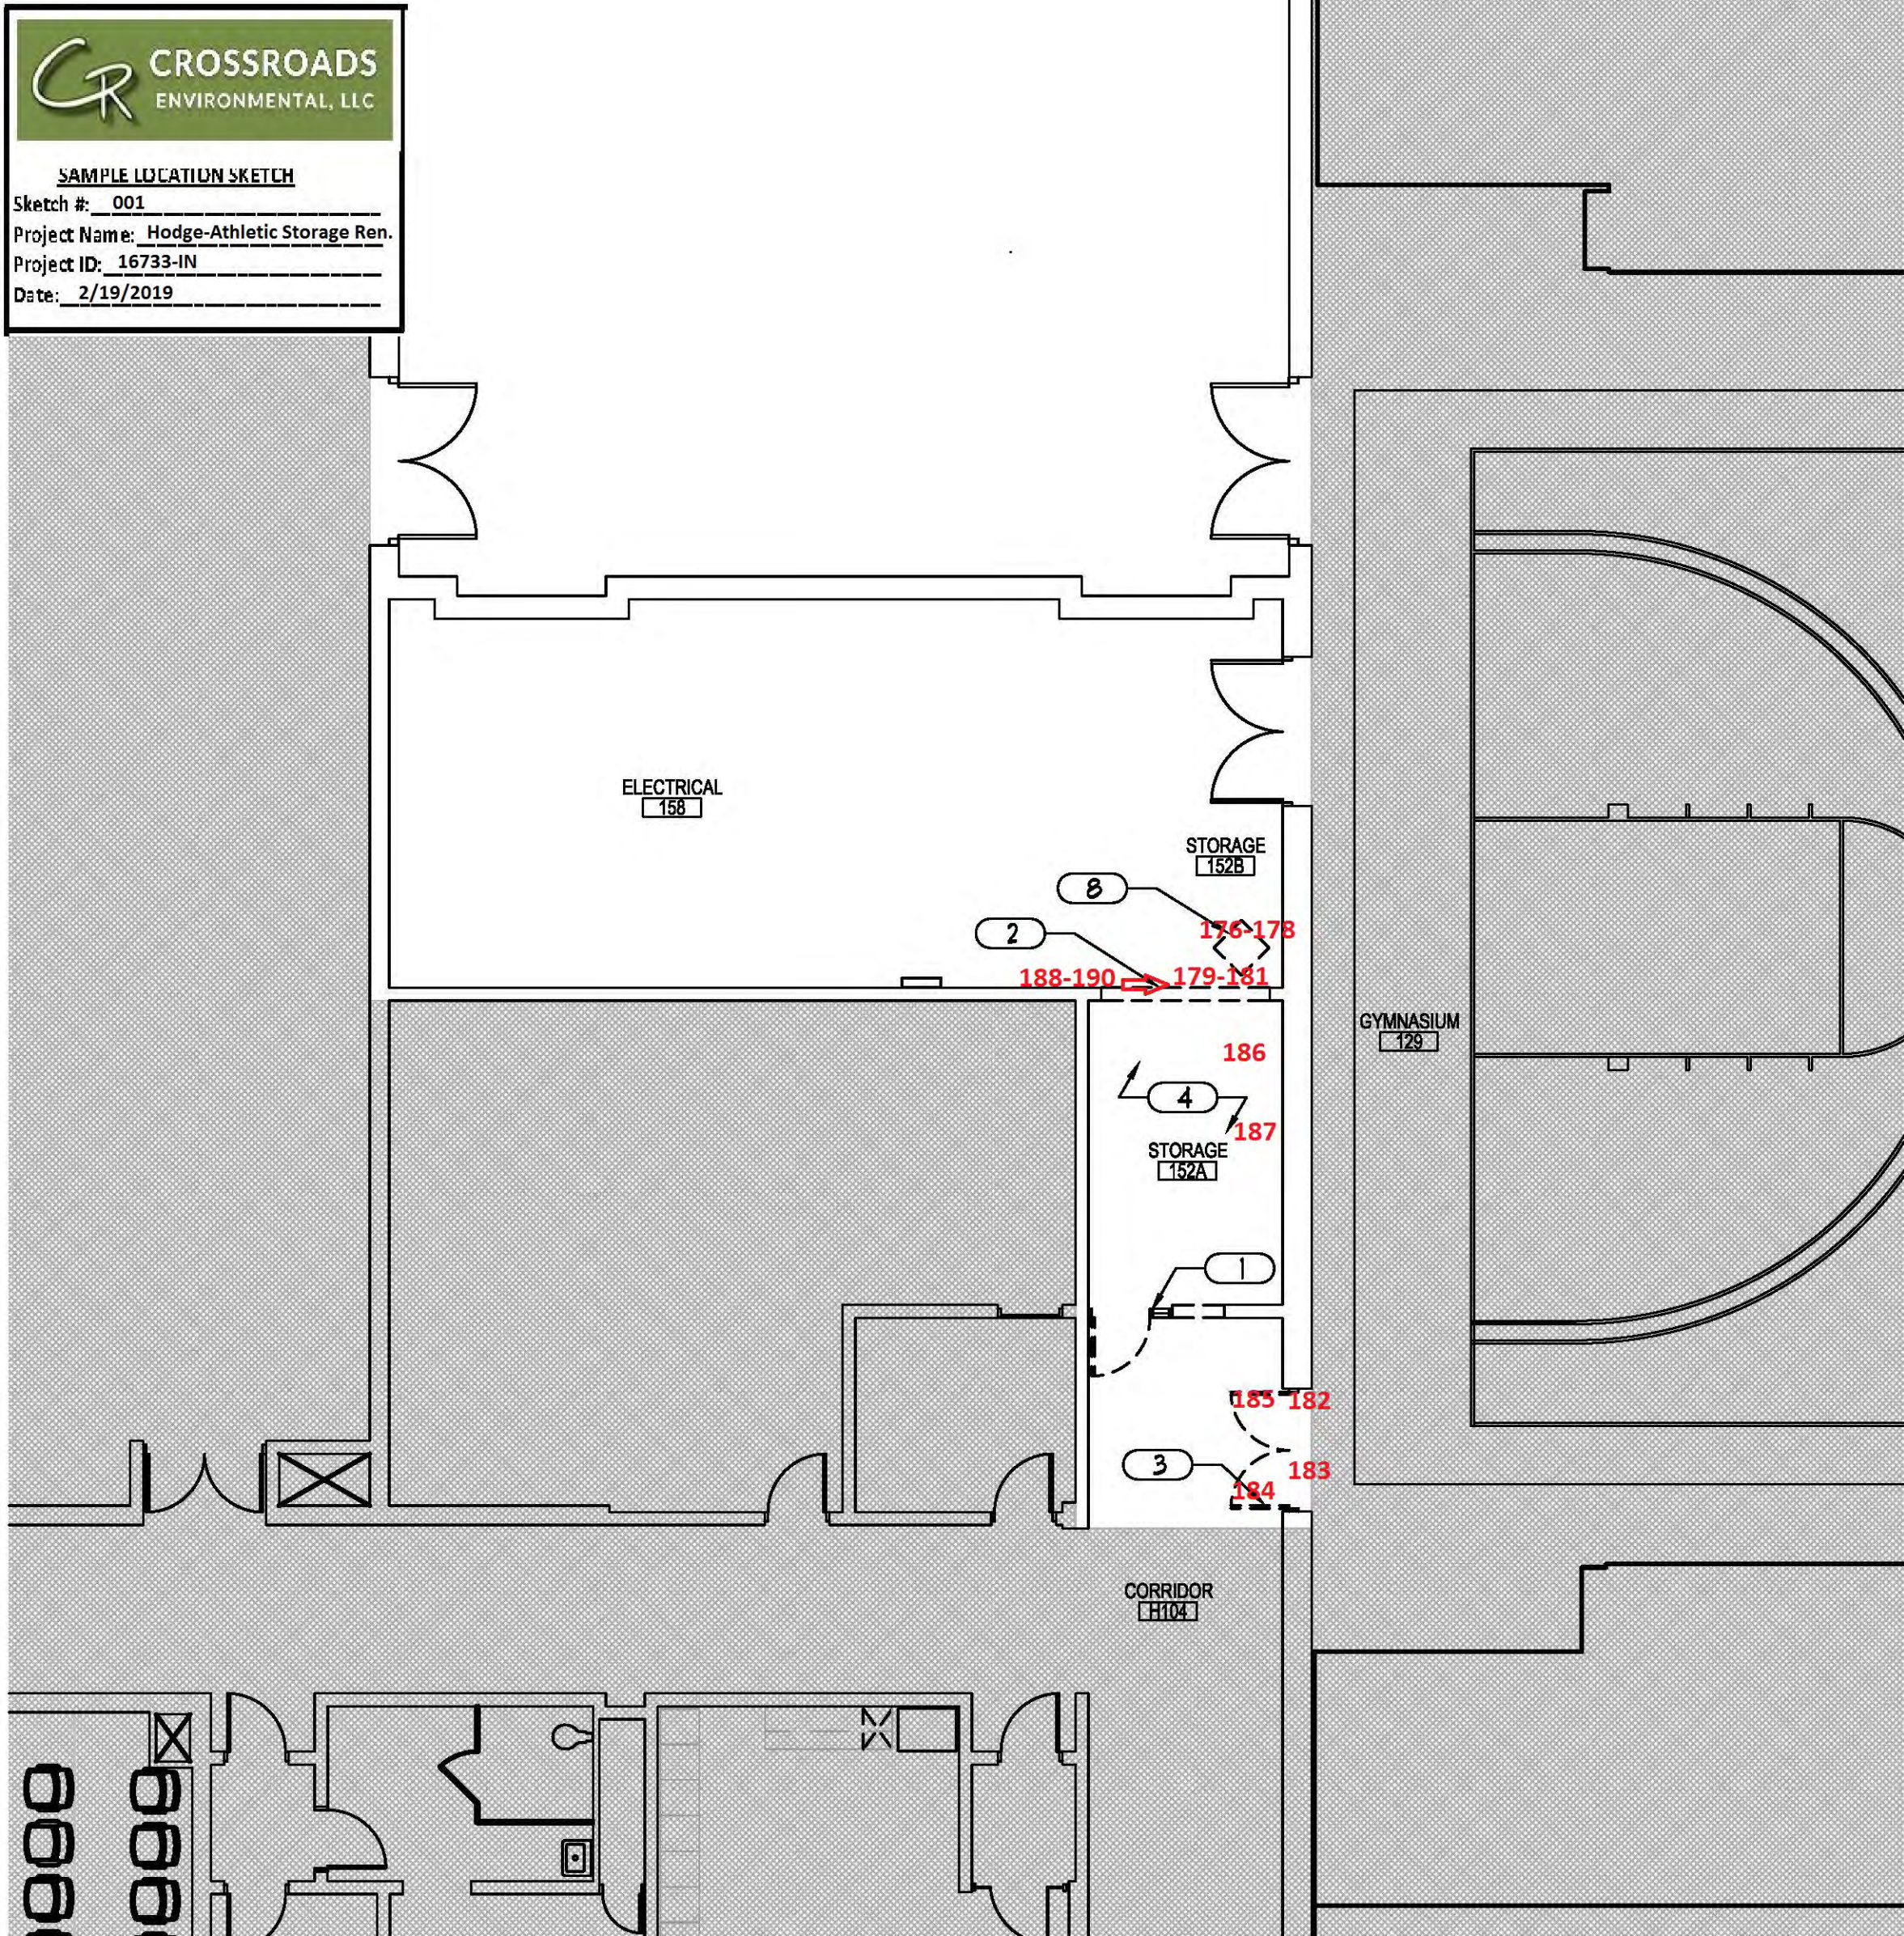
Sketch #: 001
Project Name: Hodge-Athletic Storage Ren.
Project ID: 16733-IN
Date: 2/19/2019

SAMPLE LOCATION SKETCH
