HVAC Equipment Replacement and Repairs USC Humanities Office Building University of South Carolina H27-Z417 / 50003395-2

Addendum Number One

## ASBESTOS CONTAINING MATERIAL INVESTIGATION REPORT

USC – WELSH HUMANITIES OFFICE BLDG. 4<sup>TH</sup> – 9<sup>TH</sup> FLOORS MECHANICAL AND WATERPROOFING RENOVATIONS 1620 COLLEGE STREET COLUMBIA, SOUTH CAROLINA

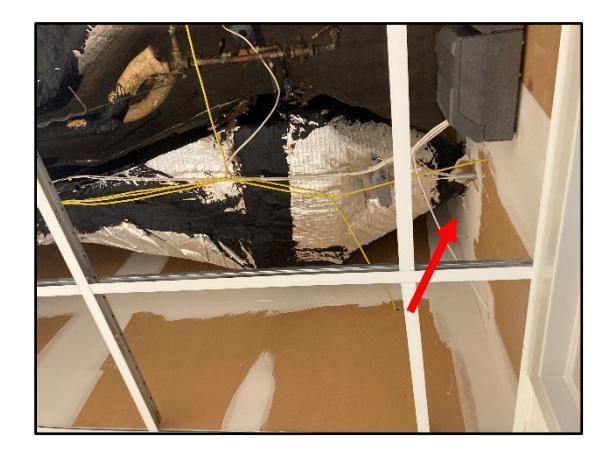
HA-1 – Joint Compound associated with drywall above suspended ceilings (>5,000 SF) - Asbestoscontaining joint compound associated with drywall wall and ceiling systems was noted throughout the Building. It was also noted above the suspended ceilings and interacting with the mechanical fan coil units in to be impacted by the planned renovations. This material was found in an intact non-friable condition, with no damage noted. However, this material will be rendered friable during the abatement process and therefore must be removed under full containment means and methods. If the planned renovations are to impact this material, it must be removed, handled, and disposed of by a licensed abatement contractor prior to the start of renovation activities.

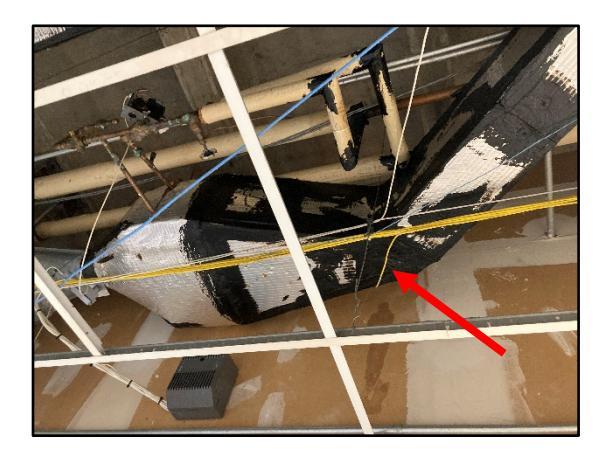
HA-2 – Black Mastic on non-ACM fiberglass insulation over metal HVAC ductwork (~1,000 SF) -Asbestos containing black mastic was found on non-ACM fiberglass duct wrap above the suspended ceilings throughout the areas to be impacted by the planned renovations. This material appears intact, and in a non-friable condition with no damage noted. If the planned renovations are to impact this material, it must be removed, handled, and disposed of as ACM by a licensed abatement contractor prior to the start of renovation activities.

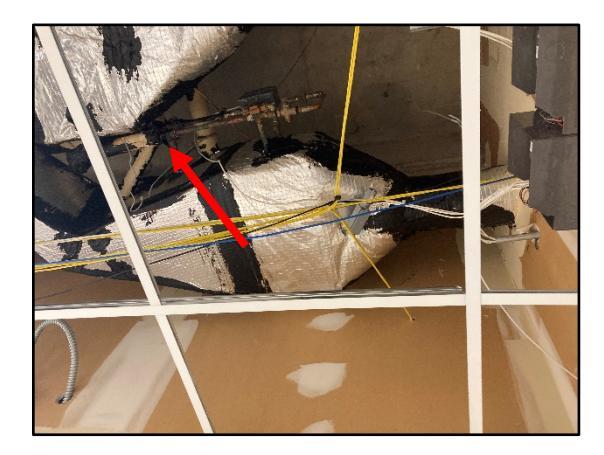
HA-3 – Black Mastic on non-ACM fiberglass pipe wrap insulation (~200 SF) - Asbestos containing black mastic was found on non-ACM pipe wrap insulation above the suspended ceilings throughout the areas to be impacted by the planned renovations. This material was noted to be in an intact, and in a non-friable condition with no damage being noted. If the planned renovations are to impact this material, it must be removed, handled, and disposed of as ACM by a licensed abatement contractor prior to the start of renovation activities.

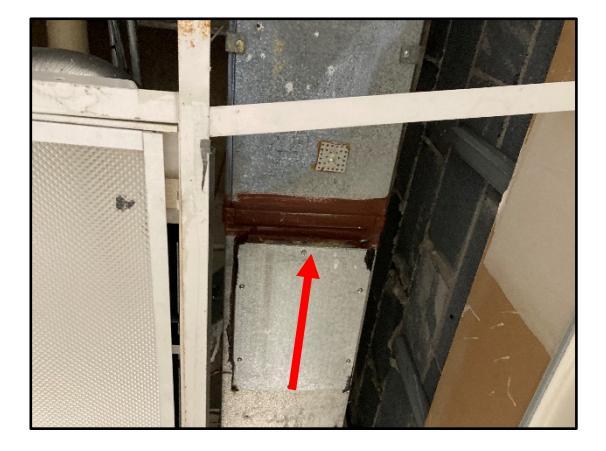
HA-4 – Brown/Red mastic on metal ducts (~500 SF) Asbestos containing black mastic was found above the suspended ceilings on the seams metal HVAC duct underneath non-ACM fiberglass duct wrap insulation. This material was found to be intact, and in a non-friable condition with no damage being noted. If the planned renovations are to impact this material, it must be removed, handled, and disposed of as ACM by a licensed abatement contractor prior to the start of renovation activities.
