WILLIAMS BRICE STADIUM

Waterproofing (Upper East Deck)

H27-Z057

University of South Carolina

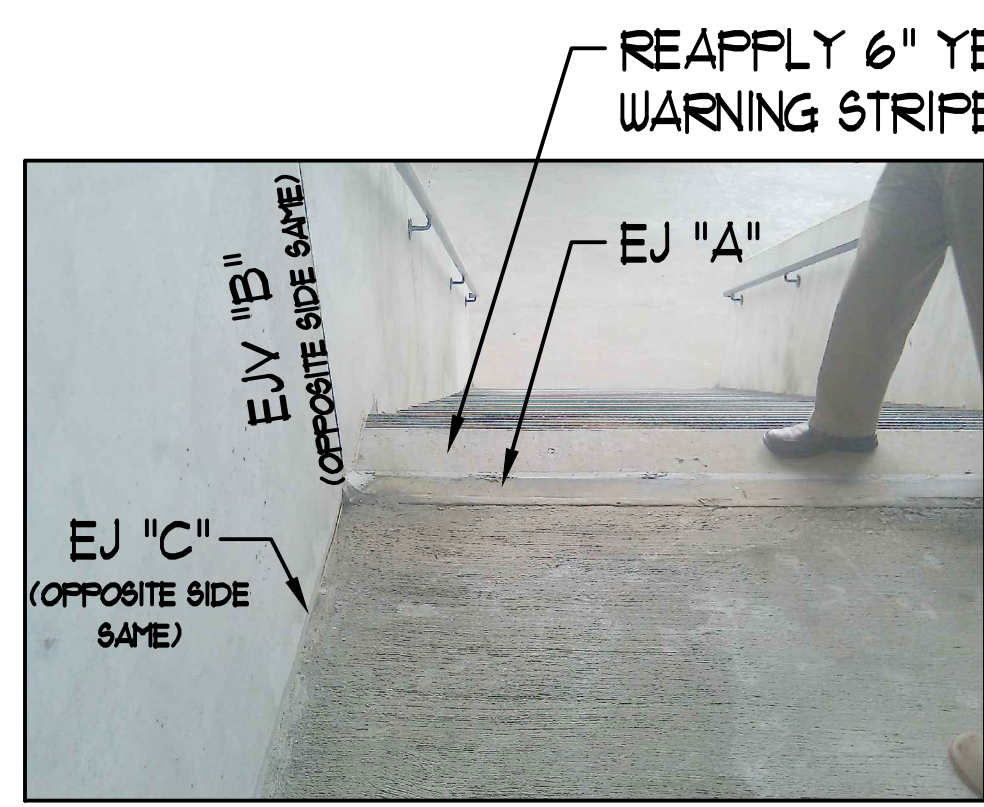
1 VOMITORY WALL HORIZONTAL JOINT, TYPICAL.

- THE WATERPROOF SYSTEM AT THE VOMITORY TUNNELS SHALL EXTEND TO THE REAR OF THE TUNNEL, AS INDICATED. REAPPLY THE 6" YELLOW STRIPES (2 PER TUNNEL). SEE PHOTOS # 1, 3.

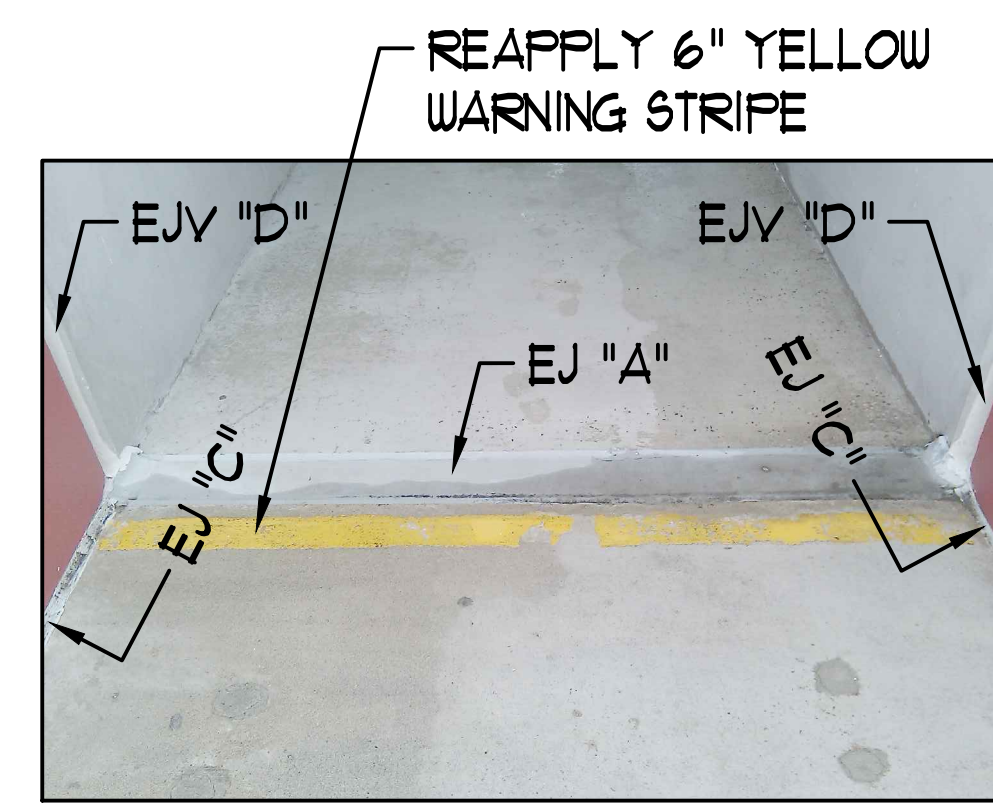
3 HORIZONTAL JOINT @ VOMITORY, TYPICAL.

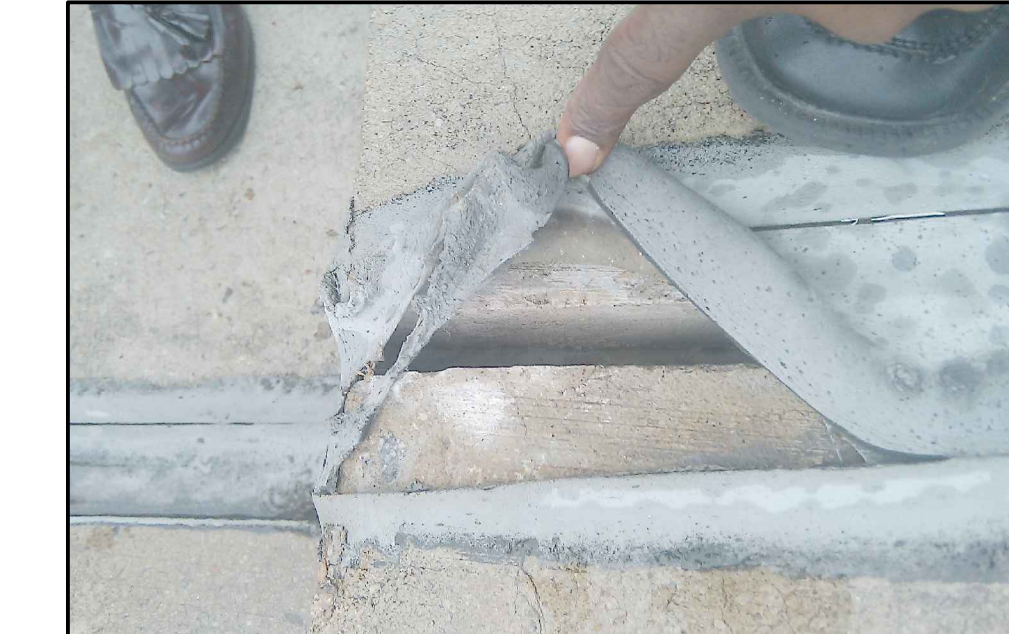
9 EXIST. EX. OF EJ @ TREAD/RISER CONDITION REQUIRING MINOR CONC. REPAIR EFFORTS, TYP.

- MINIMAL CONCRETE REPAIR AT EDGES OF SOME JOINTS, BLEACHER CLIPS AND TREAD EDGES, IS EXPECTED AND SHALL BE PROVIDED. REMOVE LOOSE CONCRETE, SAIL CUT, CHIP AND CLEAN, 4 APPLY BONDING AGENT 4 CONCRETE REPAIR MORTAR. PROVIDE SIKA 211 FOR DEEP CONDITIONS AND FORM. USE SIKA TOP 122 PLUS FOR SHALLOW CONDITIONS. FOLLOW REPAIR MORTAR MANUFACTURER'S WRITTEN INSTRUCTIONS 4 PER ACI RAP BULLETIN 1. EQUAL PRODUCTS BY BASF 4 EUCLID ARE ACCEPTABLE. SUBMITTAL TO ARCHITECT IS REQUIRED. SEE PHOTO # 9.

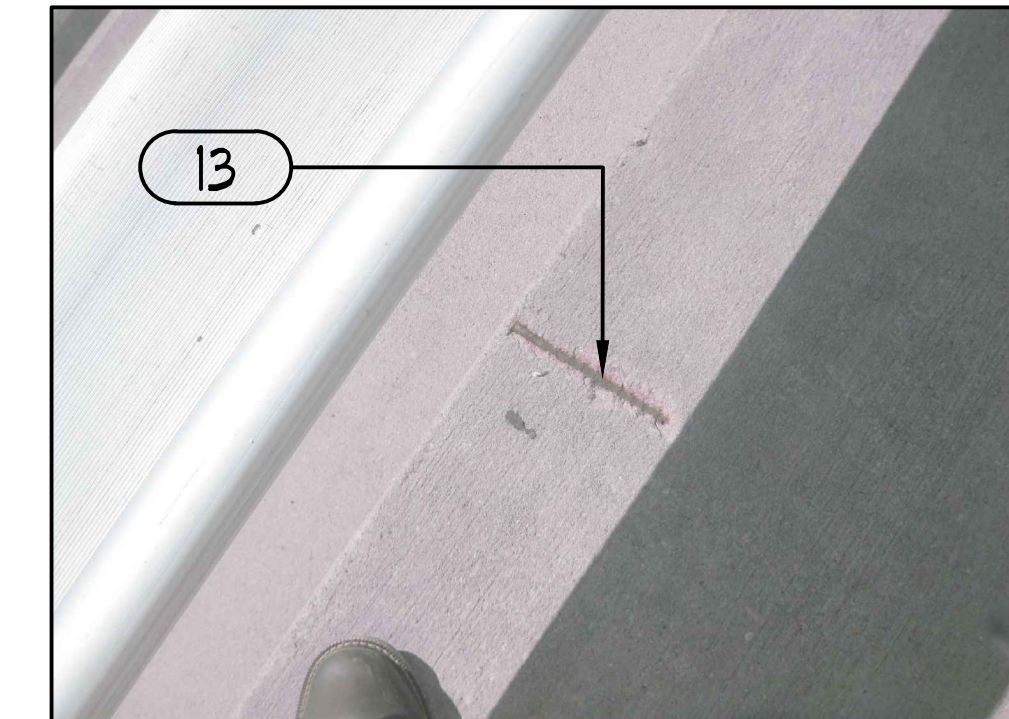
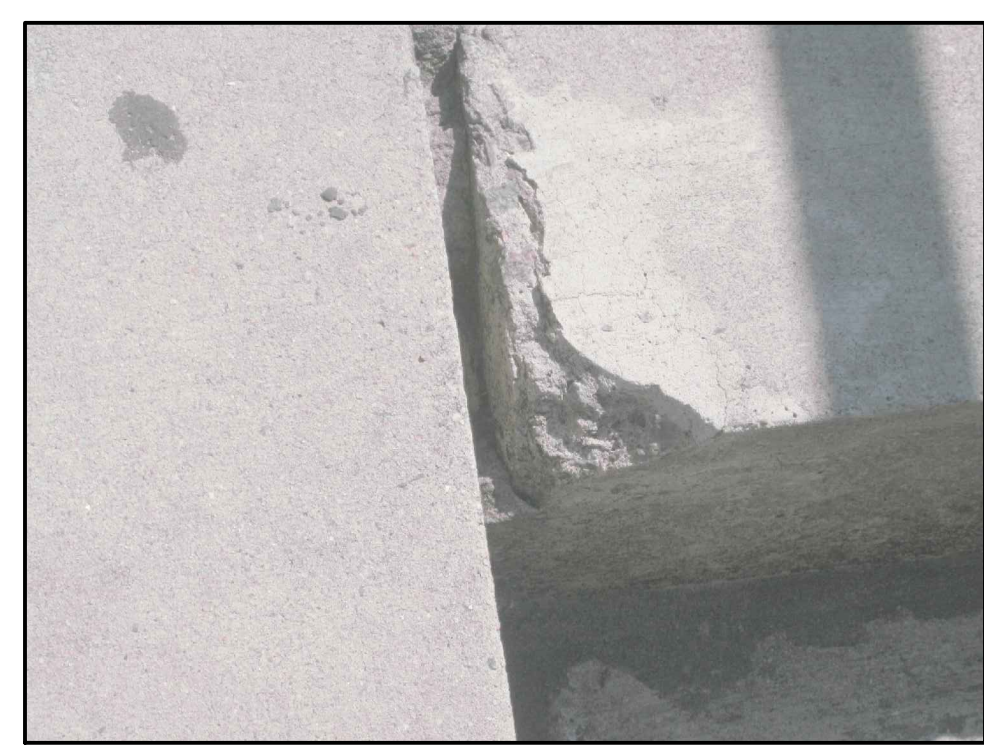
- EXPOSED STEEL REBAR SEE PHOTOS # 10 4 23/A203. NOTE THAT THESE ARE WORST CASE PHOTOS AS THE DEGREE OF EXPOSURE VARIES. CONTRACTOR IS TO REPAIR AND TREAT AS REQUIRED PER WATERPROOF DECK COATING MANUFACTURER'S WRITTEN RECOMMENDATIONS PRIOR TO COATING. REPAIR CONCRETE WHERE REQUIRED PRIOR TO COATING PER KEYNOTE 1 BELOW.

10a MISCELLANEOUS EXAMPLES OF CONCRETE REPAIRS

10b MISCELLANEOUS EXAMPLES OF CONCRETE REPAIRS

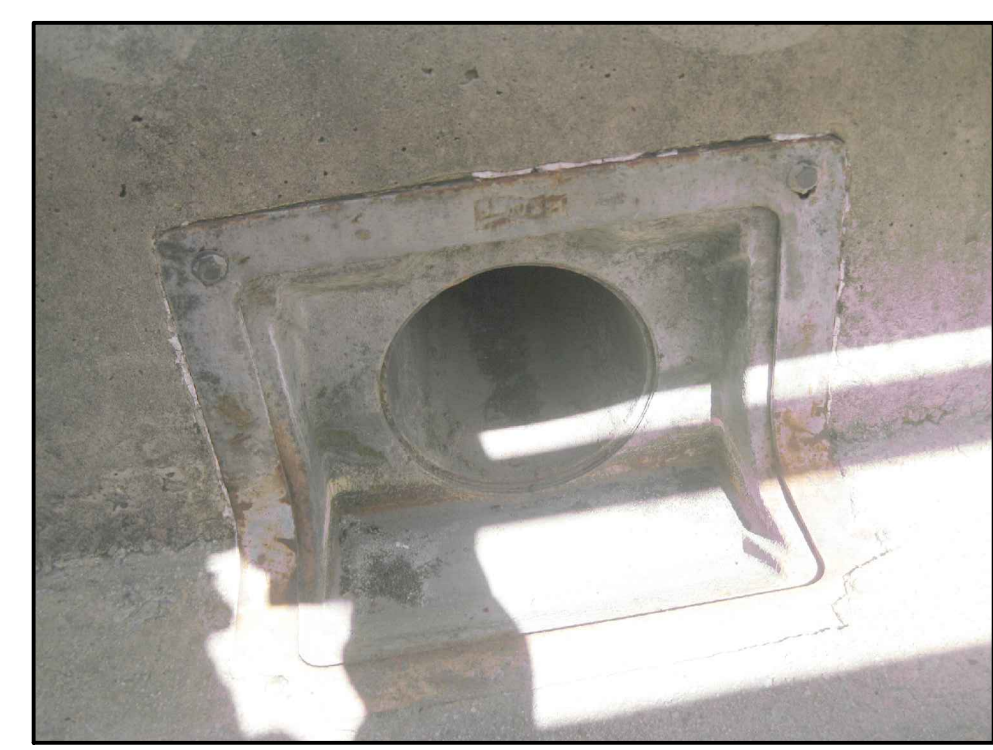
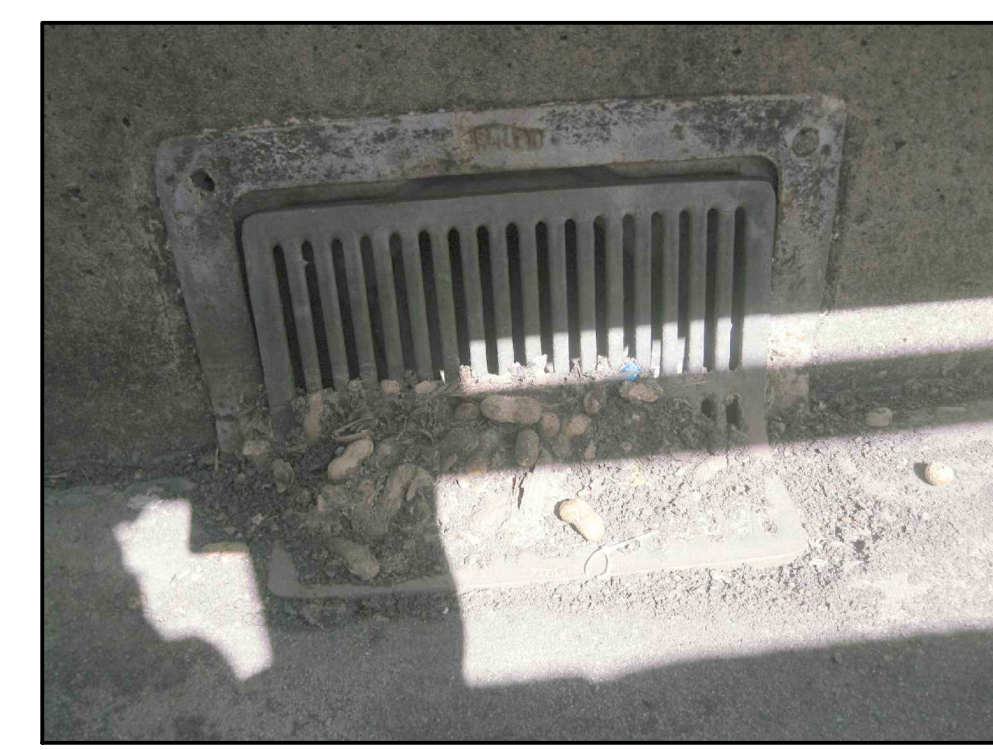
11a EXISTING FLOOR DRAIN

11b EXISTING FLOOR DRAIN (W/ COVER)

- WATER PROOF TO EDGE OF ALL FLOOR AND FLOOR/WALL GRATES. SEE PHOTO # 11/A202.
- NOT USED.
- CONTRACTOR SHALL TAKE MEASURES NOT TO DAMAGE EXISTING PAINTED SURFACES. CONTRACTOR IS TO TOUCH UP PAINT AT JOINT LOCATIONS AROUND VOMITORIES OR WALL SLAB PAINTED SURFACES. PAINT MUST BE SAME AS EXISTING AND OBTAINED FROM SHERWIN WILLIAMS IN "5C GARNET" COLOR.

- REAPPLY GARNET AT AREA SHOWN IN PHOTO # 11 ALONG WITH BLACK TEXT.
 - DIETERIORATED OR RUTTED DIETERIORATED SLAB CRACK. GRIND OUT AND EPOXY FILL PRIOR TO WATERPROOFING PER WATERPROOFING MANUFACTURER'S INSTRUCTIONS. SEE PHOTO # 20. NOTE: SOME ARE NOT THIS BAD, BUT MUST BE REPAIRED. FIELD VERIFY QUANTITY 4 REPAIR ALL.

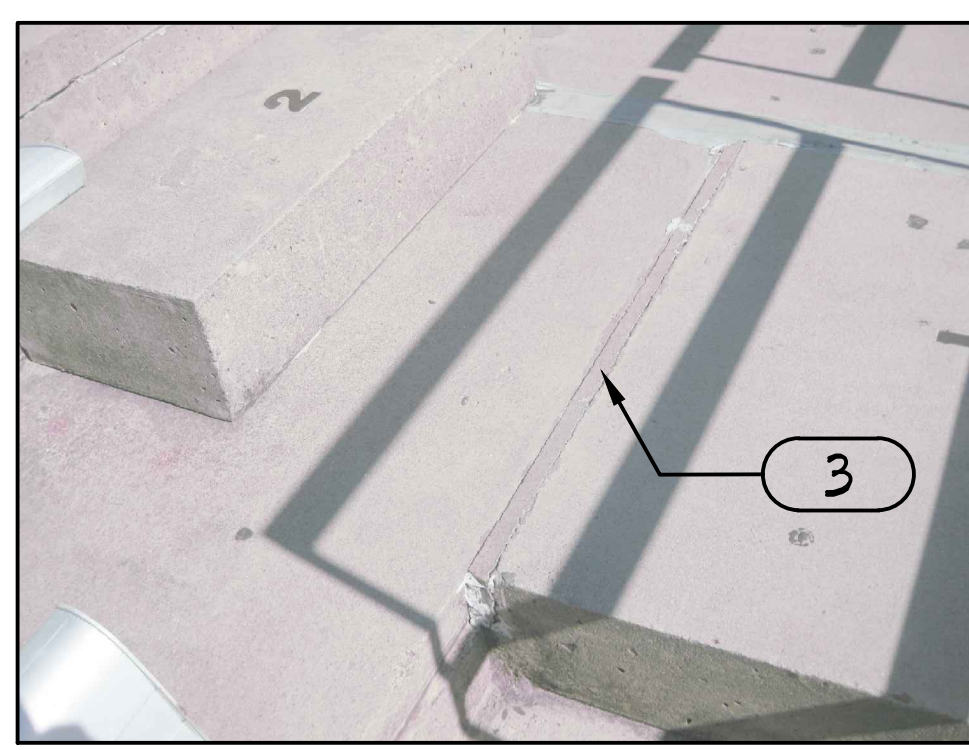
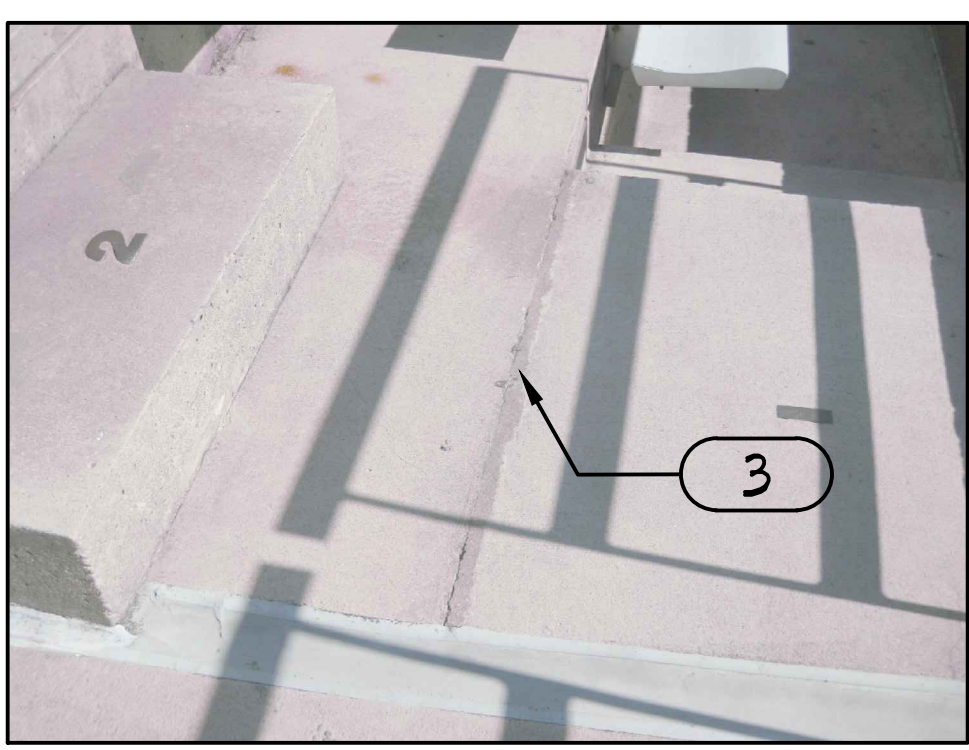
12 EXISTING JOINTS AT BOTTOM OF VOMITORY STEPS

- REMOVE LOOSE GROUT AT JOINT AND REGROUT IN ACCORDANCE WITH WATERPROOFING MANUFACTURER'S RECOMMENDATIONS. SEE PHOTO # 12.
 - REPLACE EXISTING BACKER ROD AND SEALANT AT EACH VOMITORY OR PROVIDE IF MISSING. PROVIDE CANT BEAD. SEE PHOTO # 13.

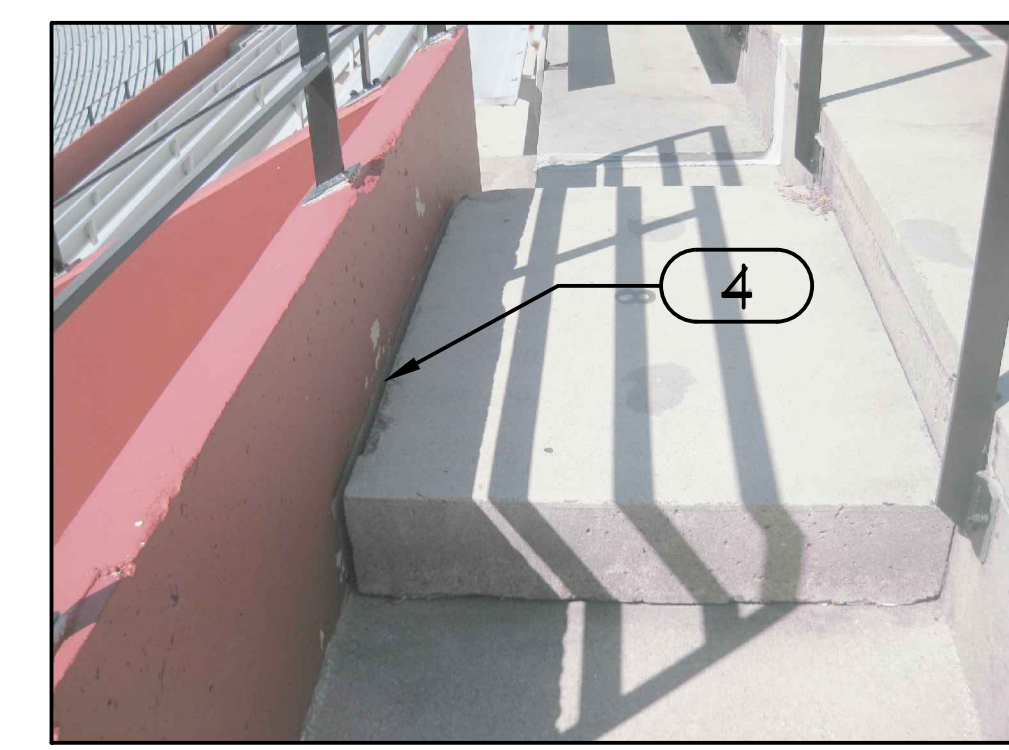
13 STEP AT TOP OF VOMITORIES

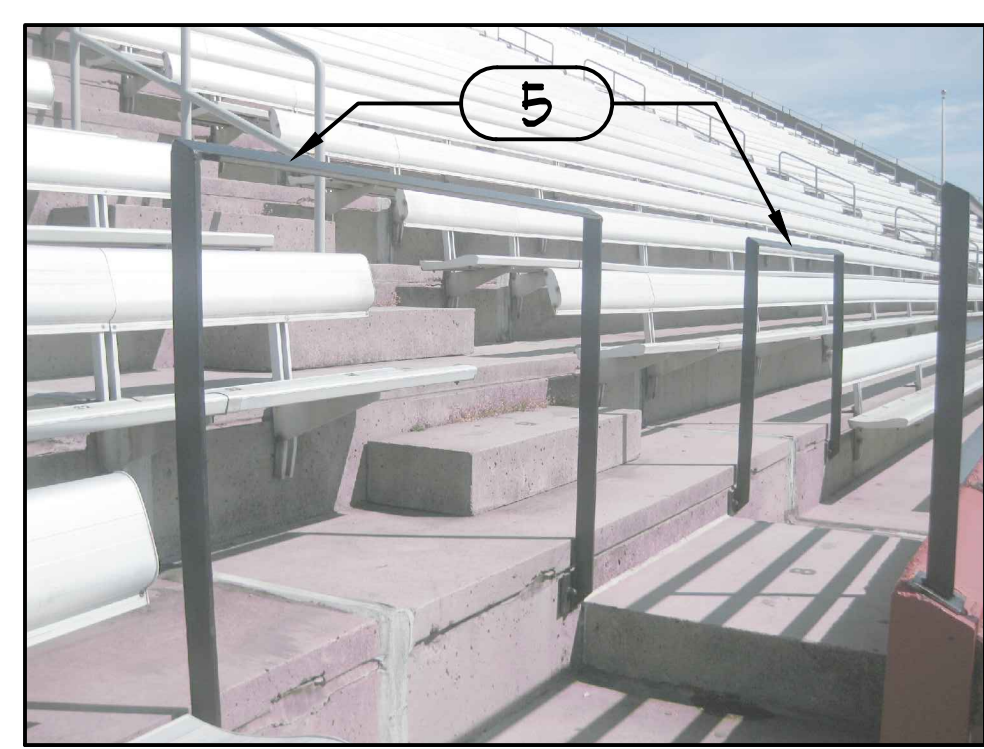
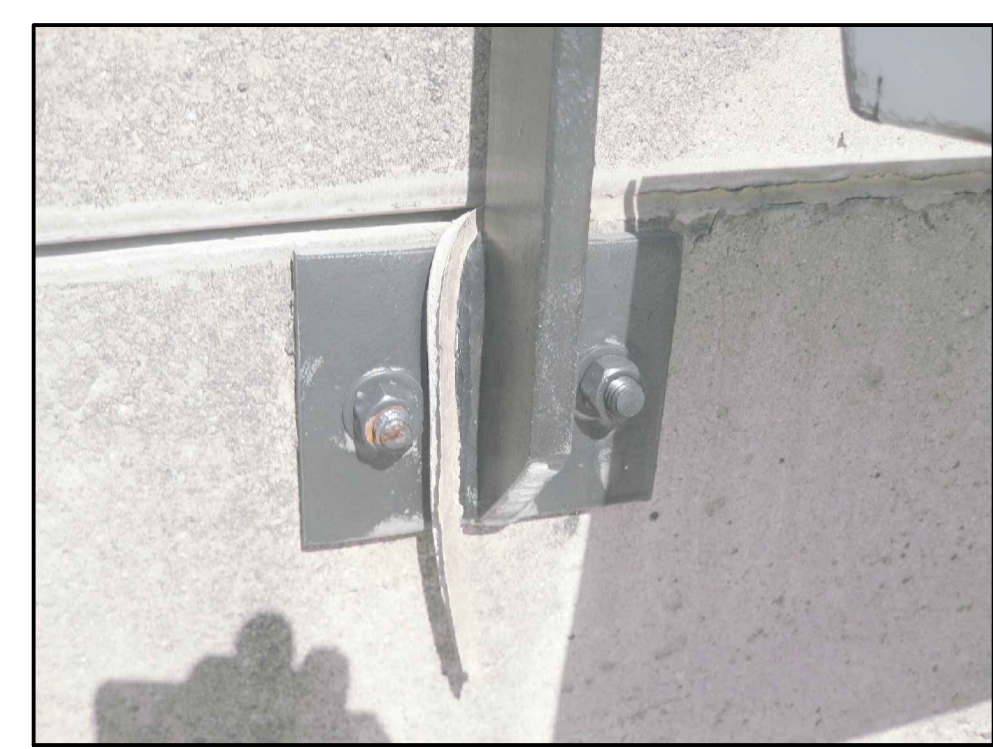
14a RAILINGS AT TOP OF VOMITORY

14b VOMITORY RAILINGS MOUNTS

- REMOVE EXISTING STEEL GUARD RAILS AT EACH VOMITORY AND REINSTALL UPON COMPLETION OF WATERPROOFING. SEE PHOTO # 14.
 - EXISTING STEEL RAILINGS AT WATERPROOFING SURFACE TO REMAIN IN PLACE. WATERPROOF 4 SEAL AT SLAB.

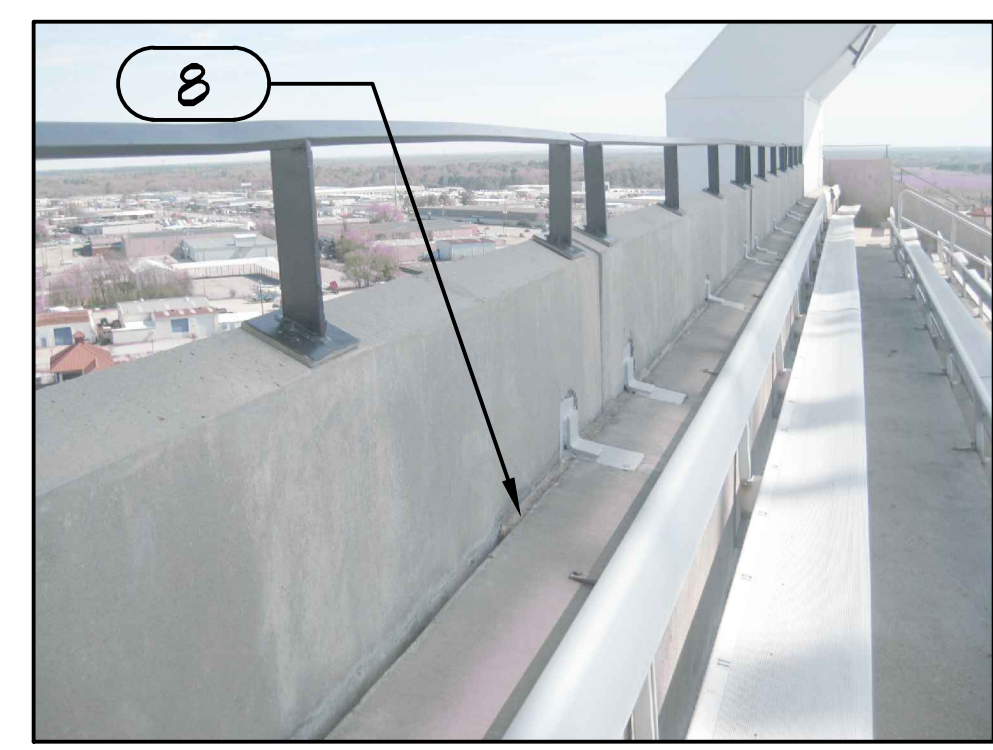
19 JOINT REPLACEMENT AT TOP WALL (HORIZONTAL)

- VERTICAL CONTROL JOINT AT TOP WALL. REPLACE. SEE PHOTO # 19/A203.
 - PROVIDE CONCRETE REPAIR AT SLOPED TOP WALL EDGE. TYPICAL FOR 5 LOCATIONS ALONG TOP WALL. SEE PHOTO # 32/A203.

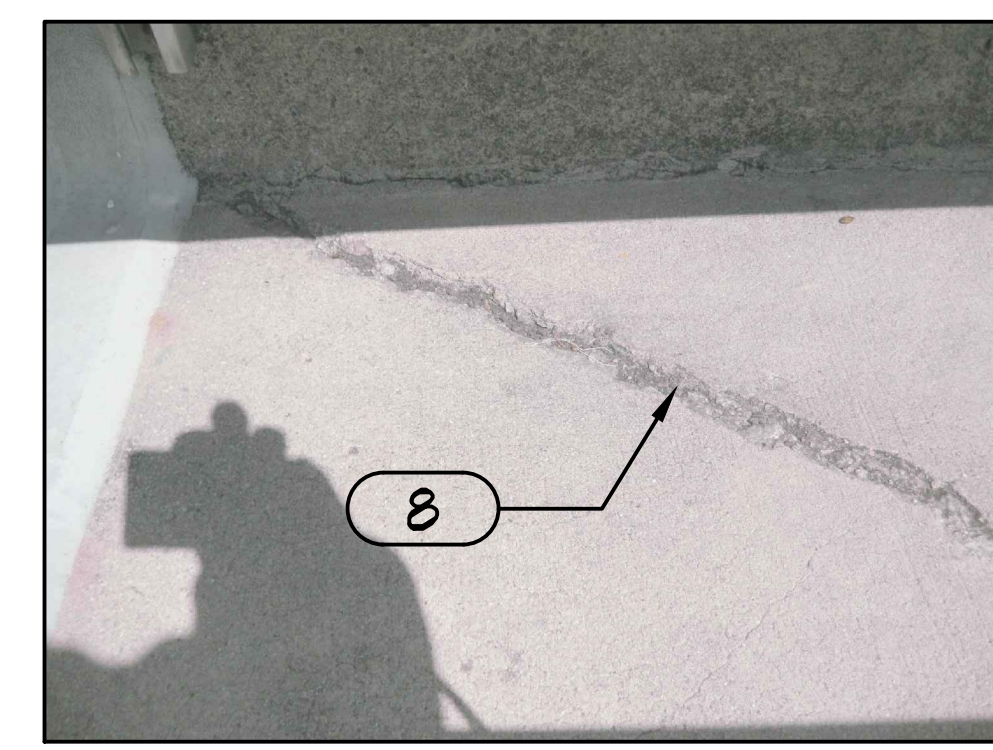
20 SLAB FRACTURE EXAMPLE

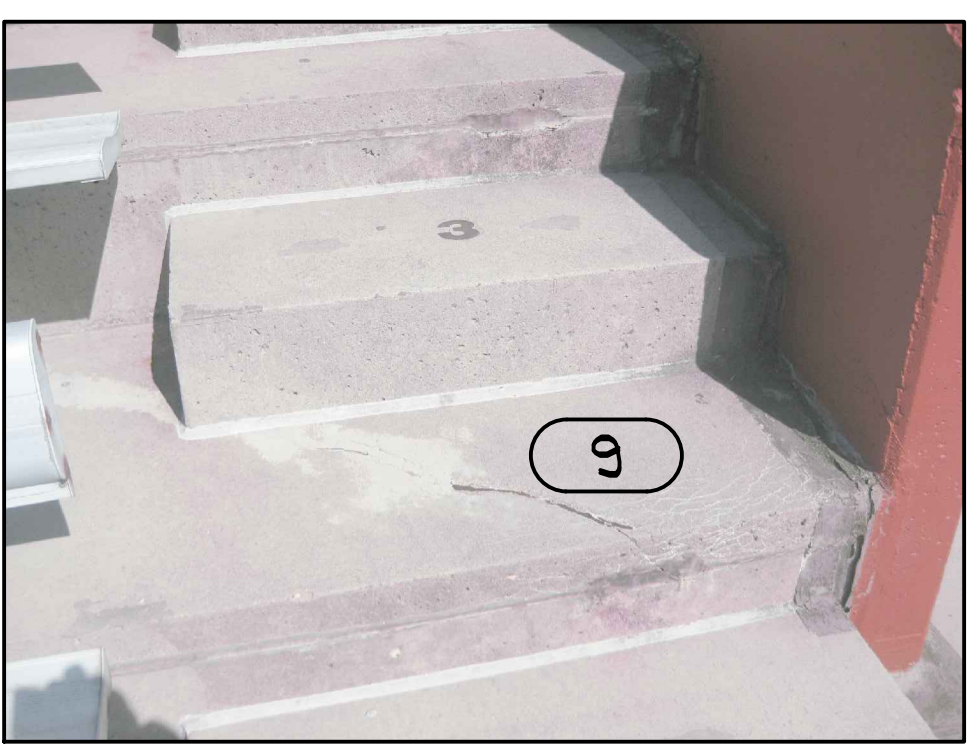
21 SPALDING TREAD

- EXISTING SPALDING TREAD. REMOVE BAD CONCRETE AND RE-POUR TREAD. CLEAN AND RE-POUR STEP CORNER. DRILL ANCHOR PINS INTO EXISTING CONCRETE USING THE "HYA ADHESIVE SYSTEM" BY HILTI WITH AN EMBEDMENT DEPTH OF 3" OR APPROVED EQUAL. SEE PHOTO # 21/A202. ASSUME 5 SIMILAR CONDITIONS FOR REPAIR. SEE PHOTO # 21.

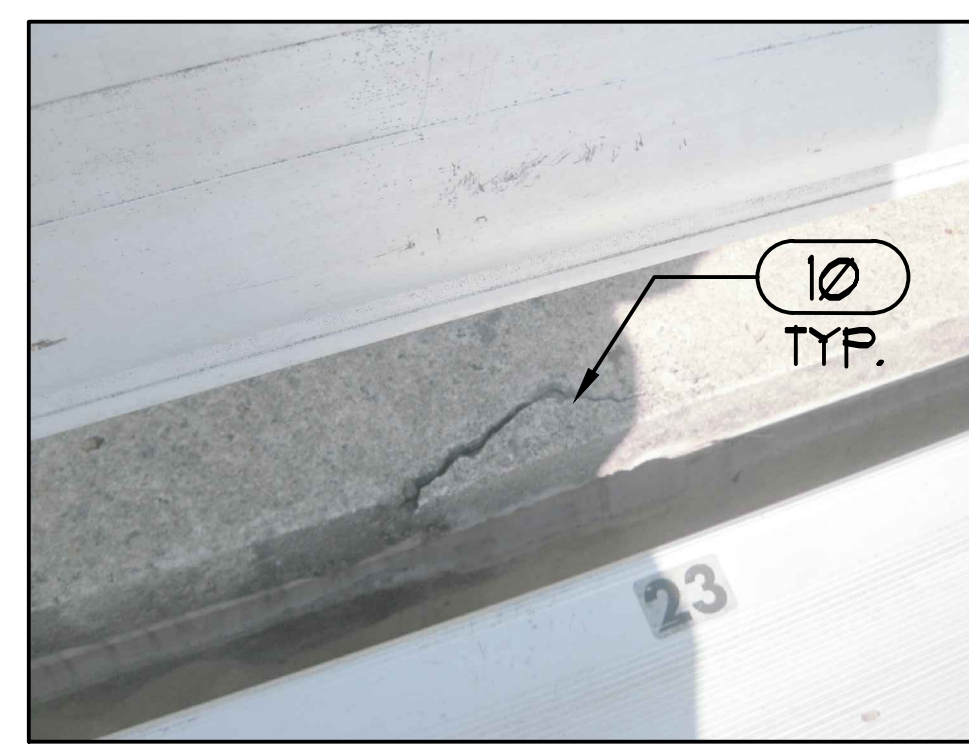
22 TYPICAL TREAD EDGE FRACTURE

- REPAIR FRACTURED CONCRETE EDGES. SEE PHOTO # 22 FOR EXAMPLE. FIELD VERIFY QUANTITY.
 - EXPOSED ABANDONED STUDS, PIPE OR OTHER METAL GRIND TO BELOW CONCRETE SURFACE. REPAIR PER GENERAL NOTE # 19 PRIOR TO WATERPROOFING. VERIFY THESE AND SIMILAR CONDITIONS AND REPAIR ALL. SEE PHOTO # 23.

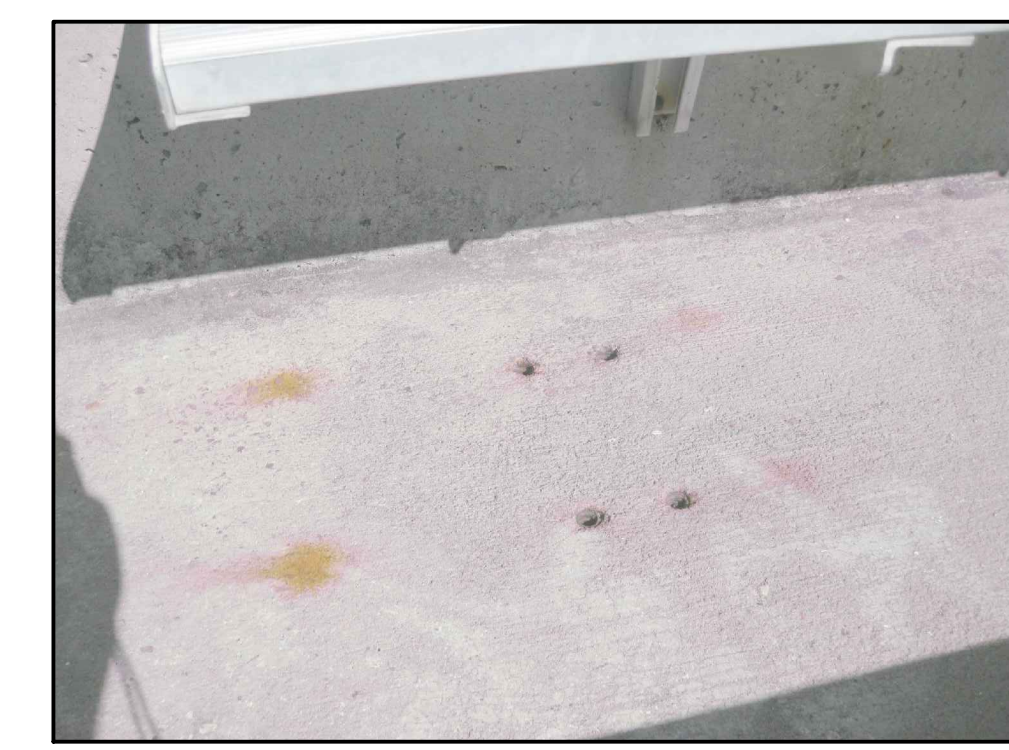
23 EXPOSED ABANDONED METAL CONDITION

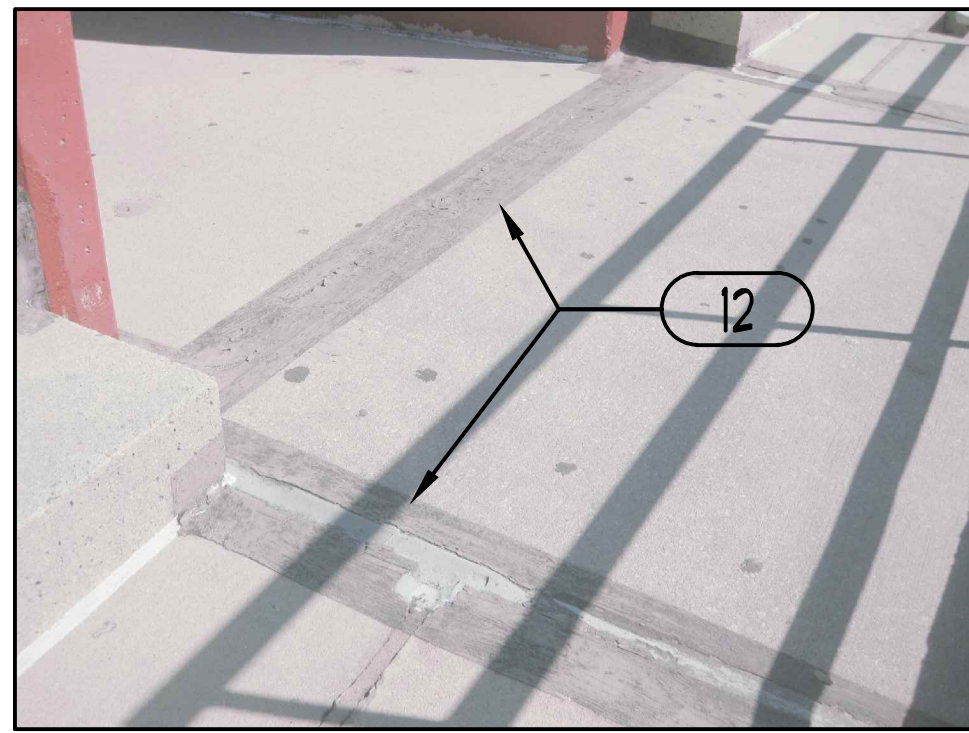
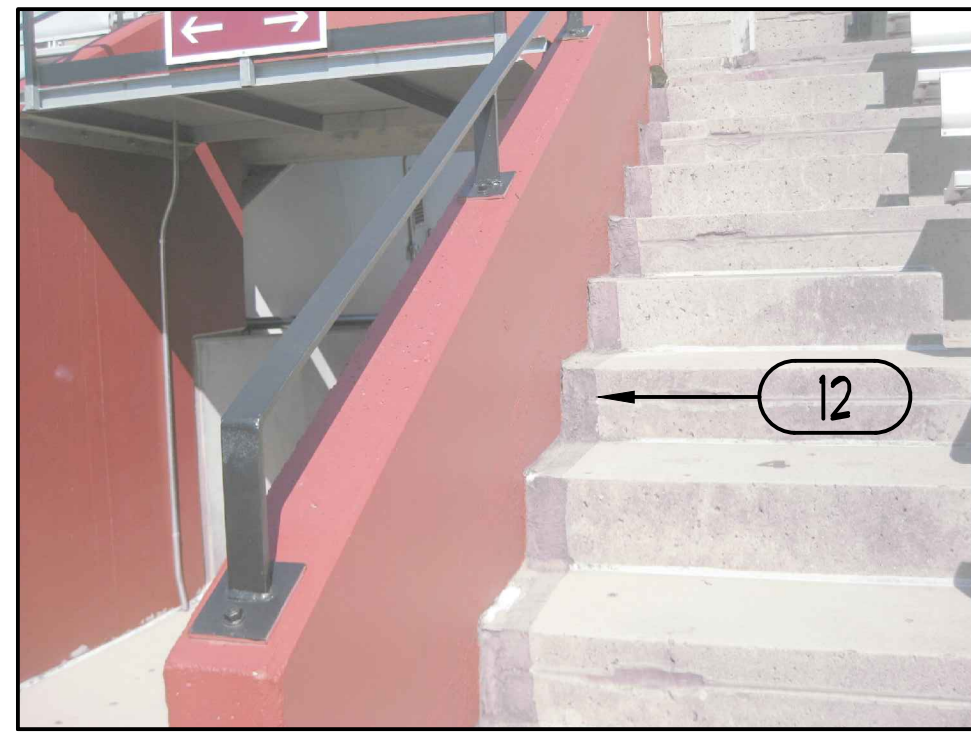
24a PREVIOUS VOMITORY LEAK REPAIR ATTEMPTS

24b PREVIOUS VOMITORY LEAK REPAIR ATTEMPTS

- PREVIOUS MESH 4 MASTIC ATTEMPT TO REPAIR LEAKS AT VOMITORY. REMOVE ALL MATERIAL 4 PREPARE SURFACES FOR JOINT REPLACEMENT 4 WATERPROOFING PER MANUFACTURER'S INSTRUCTIONS. SEE PHOTO # 24/A203.

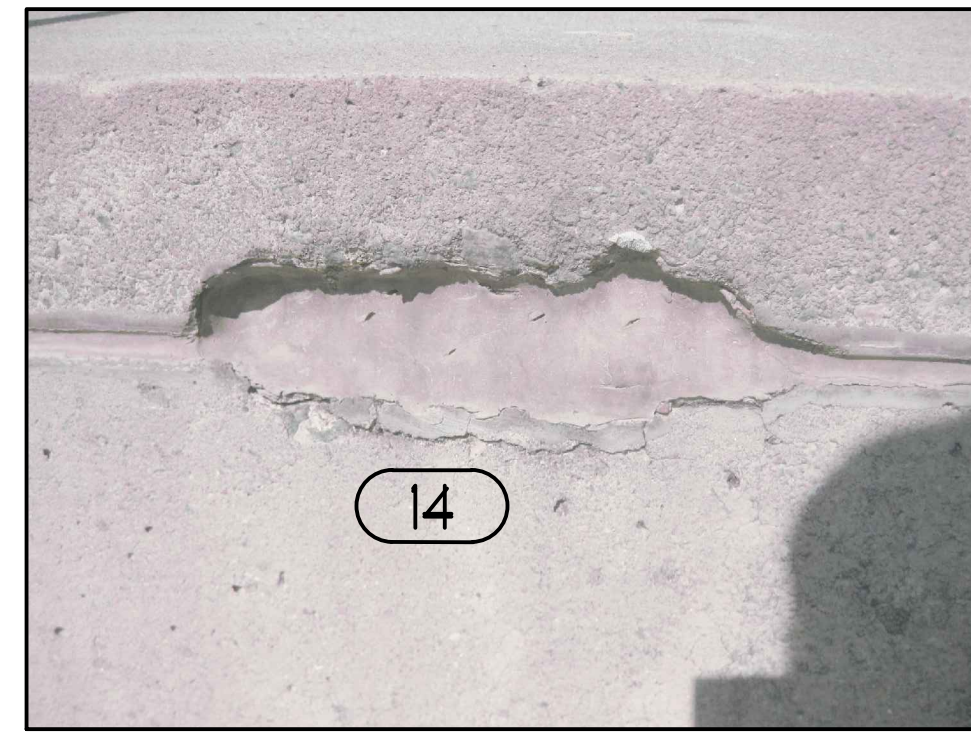
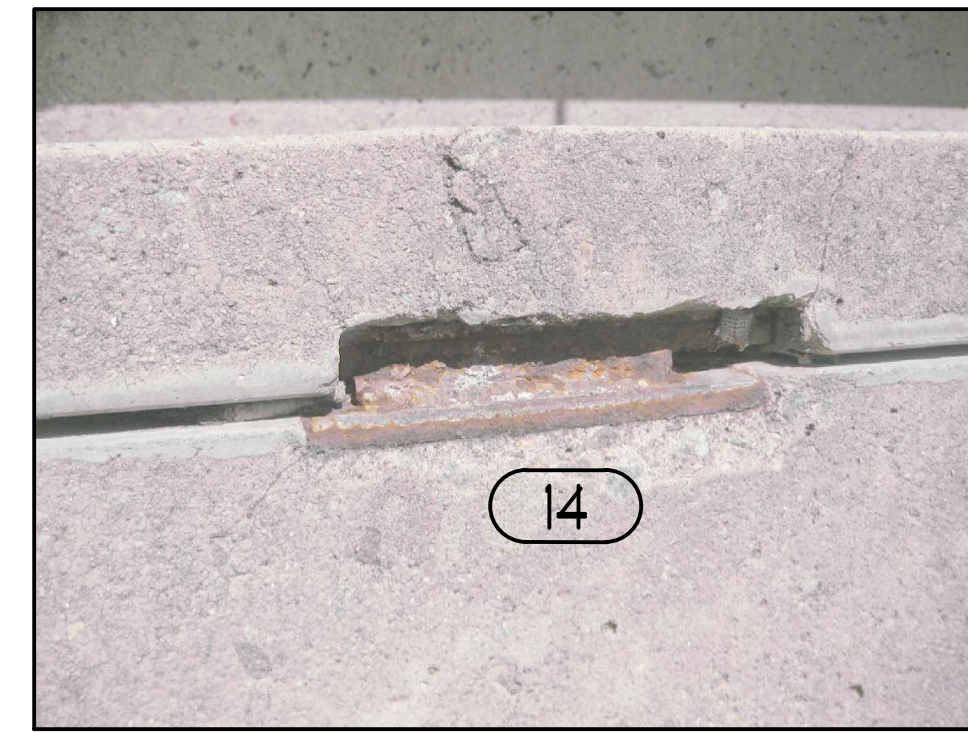
25a STEEL CLIP CONDITION

25b STEEL CLIP CONDITION

- EXPOSED AND SEMI-EXPOSED STEEL CLIP AT RISER. REMOVE ALL FRACTURED GROUT 4 SEALANT COVERING AND REPAIR PER REPAIR PRODUCT MANUFACTURER'S WRITTEN RECOMMENDATIONS AND IN ACCORDANCE WITH WATERPROOF COATING MANUFACTURER'S WRITTEN INSTRUCTIONS. SEE PHOTO # 25/A203. CONTRACTOR IS TO FIELD VERIFY PRIOR TO BID THE FOLLOWING NUMBER OF EXPOSED OR SEMI-EXPOSED CLIPS PER SECTION TO BE REPAIRED PRIOR TO APPLICATION OF WATERPROOF DECK COATING SYSTEM (UPPER EAST) ESTIMATED AT 365 CLIPS PER SECTION. FIELD VERIFY.

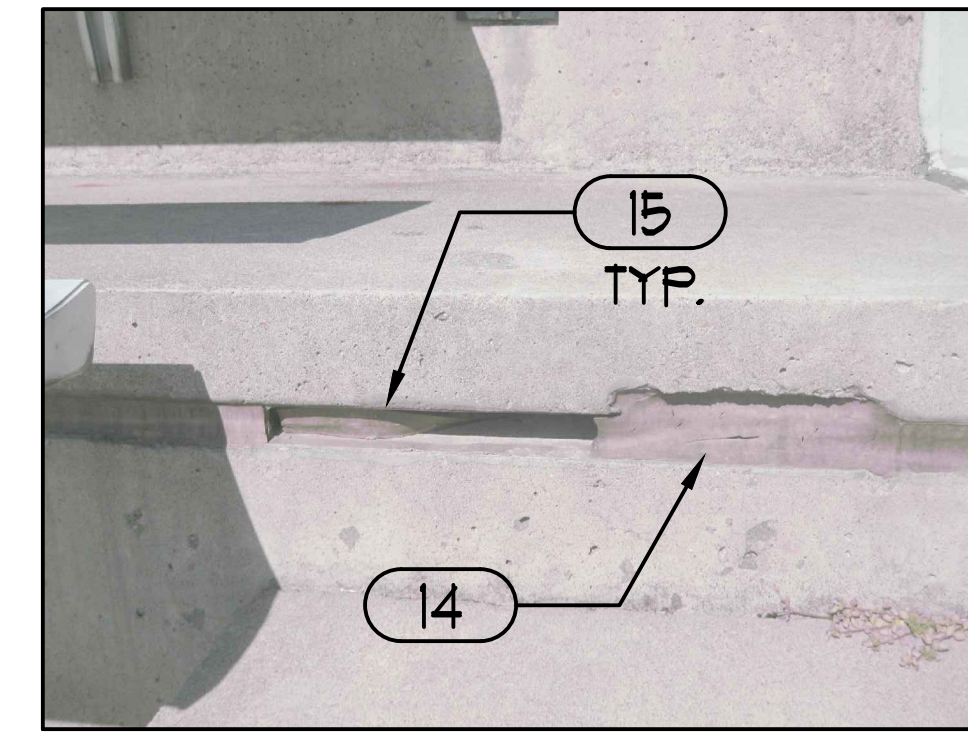
26 TREAD/RISER JOINT CONDITION

- REPLACE ALL HORIZONTAL SEALANT JOINTS WITH IN THE VERTICAL FACE OF THE TREAD/RISER CONDITIONS CONTINUOUS FOR THE ENTIRE UPPER EAST STANDS. SEE PHOTO # 26/A203.

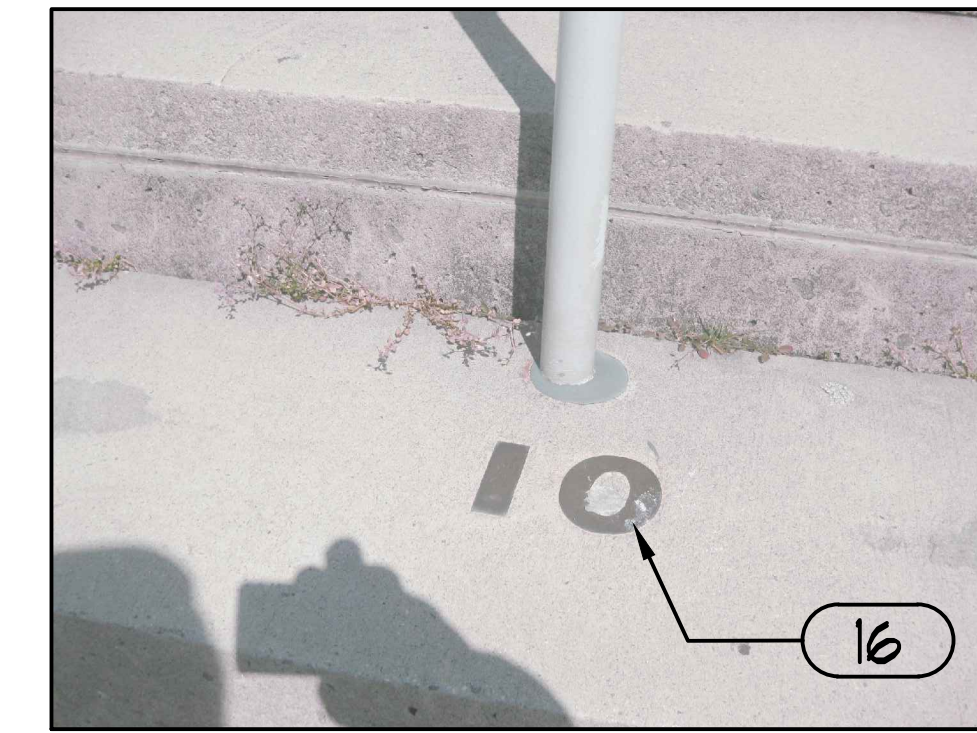
27 INLAID BRASS IDENTIFICATION

- INLAD BRASS ROW IDENTIFICATION MASK OFF AN APPROXIMATE 4" SQUARE (FIELD VERIFY SIZE WITH ARCHITECT) AREA OVER THE NUMBERS AND PROVIDE DECK COATING UP TO THIS SHAPE. SEE PHOTO # 27/A203.

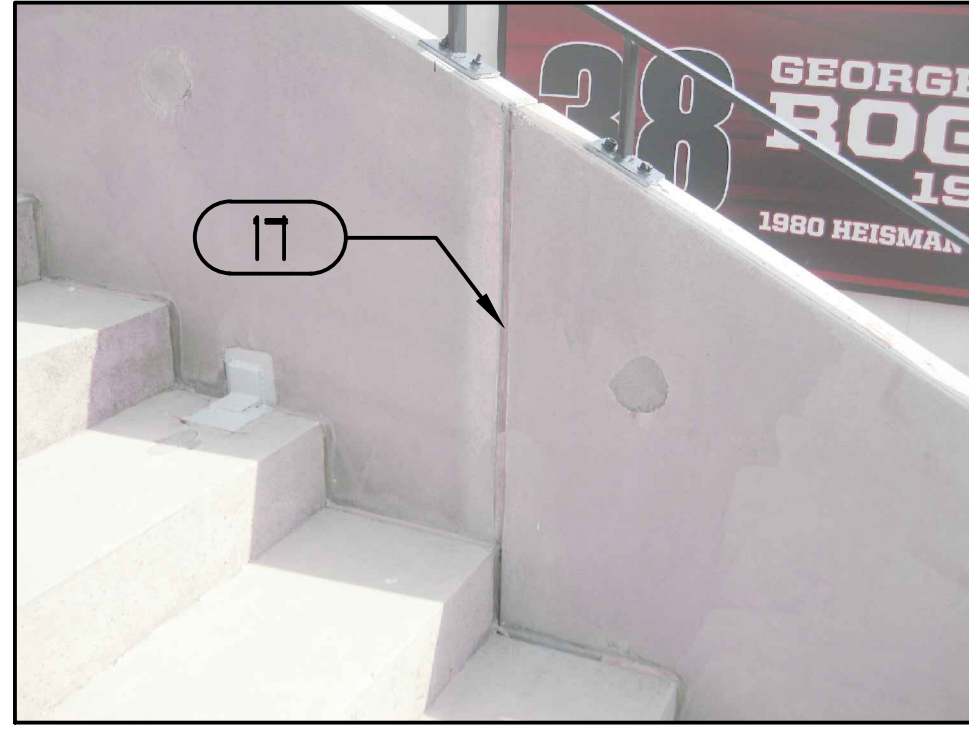
28 VERTICAL CONTROL JOINT (CJV) AT END PANELS

- VERTICAL CONTROL JOINT (CJV) AT END PANELS. REPLACE AT TOP AND BLEACHER SIDE ONLY. SEE PHOTO # 28/A203.
 - REMOVE EXISTING JOINT COVER. APPLY WATERPROOF DECK COATING AND RE-INSTALL JOINT COVER. SEE PHOTO # 29.

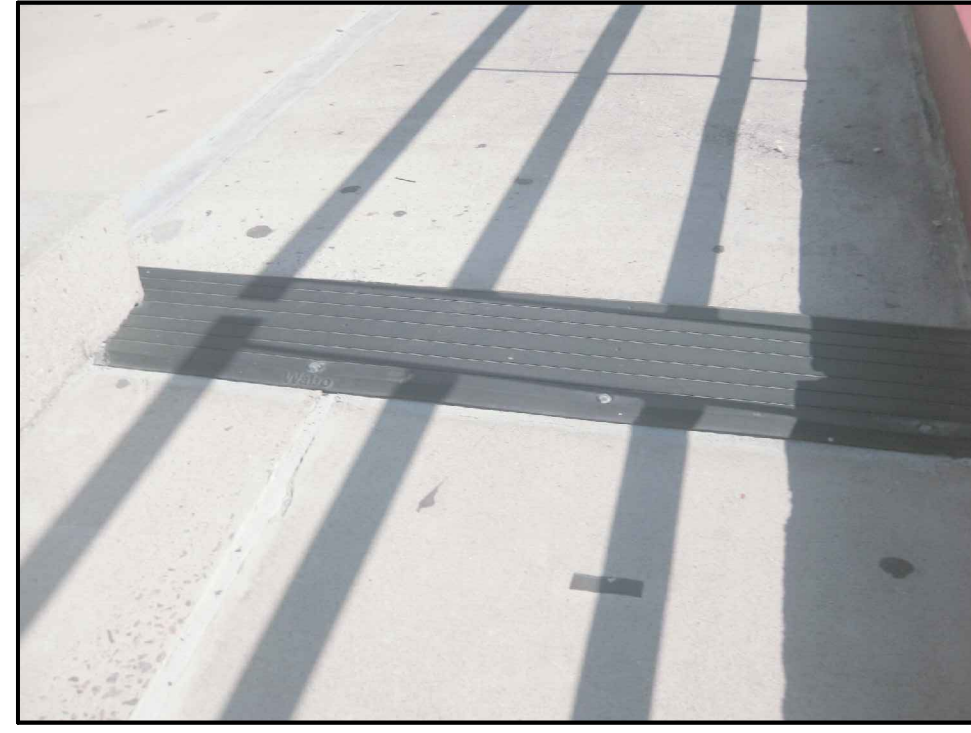
29 EXISTING WABO SAFETY FLEX JOINT COVER

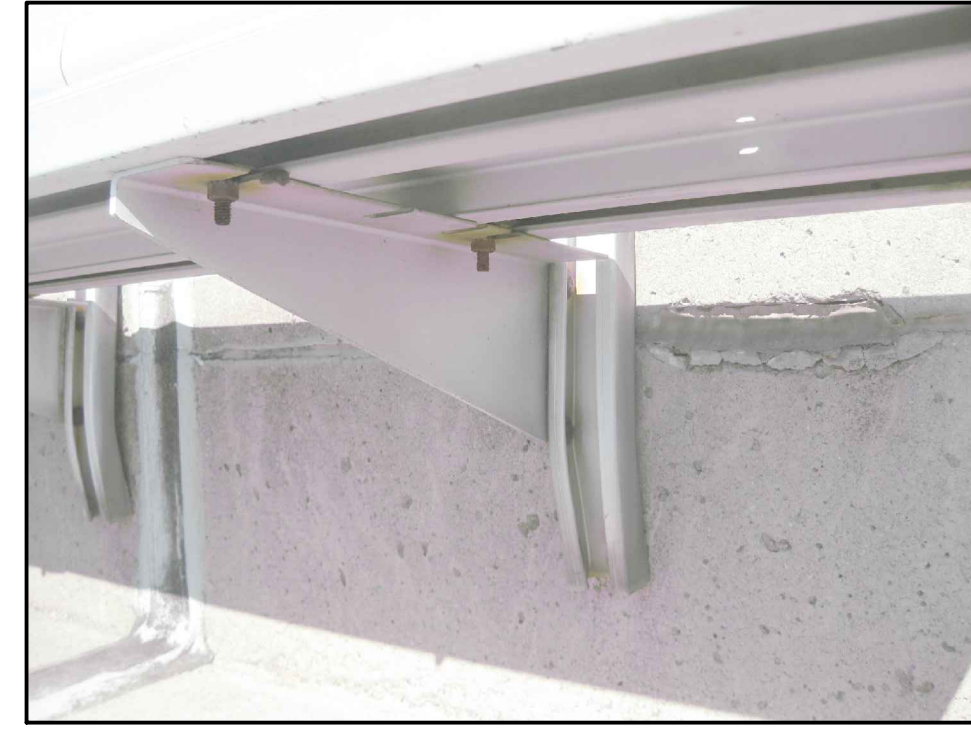
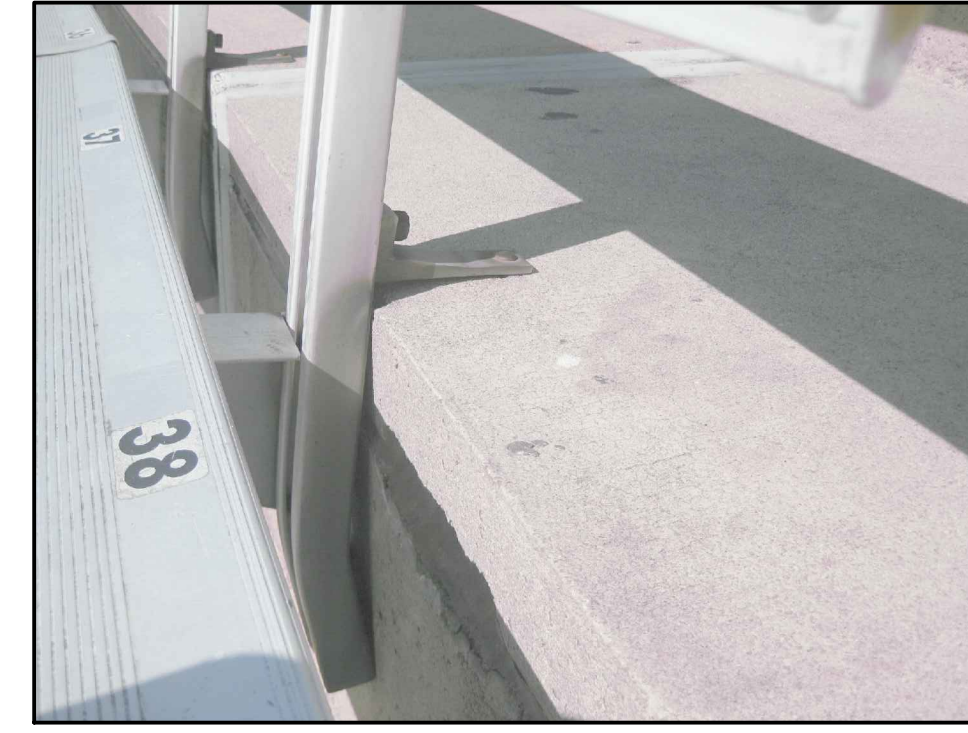
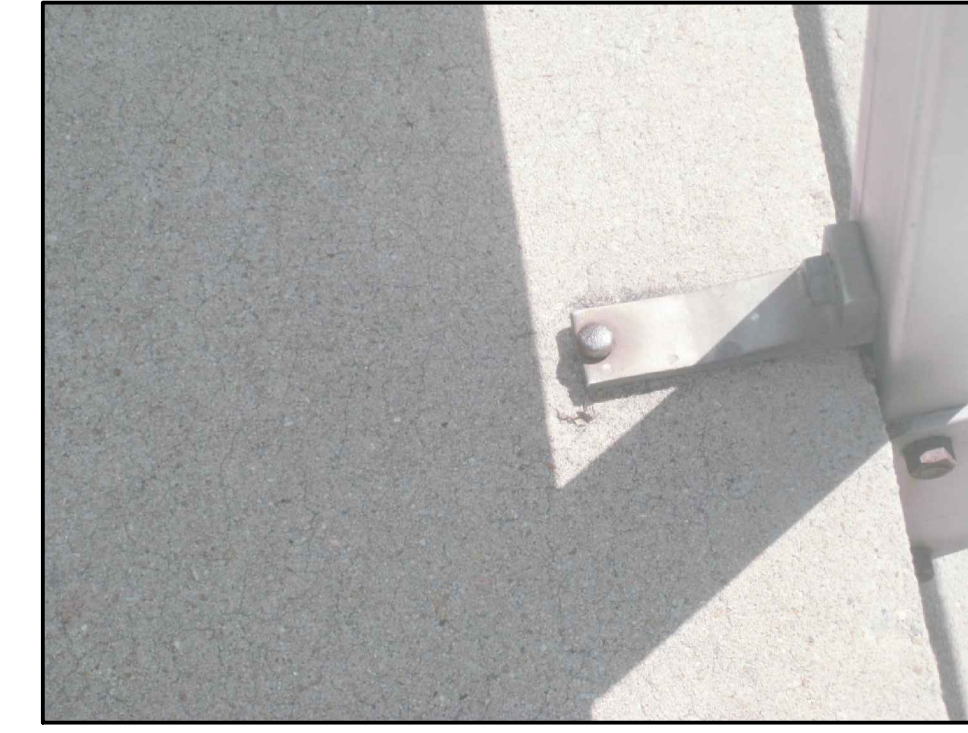
30a BLEACHER BRACKET CONDITION

30b BLEACHER BRACKET CONDITION

30c BLEACHER BRACKET CONDITION

- SEE PHOTO # 30/A203 FOR TYPICAL BLEACHER BRACKET CONDITION.
- KEY NOTES:**
- EXISTING UREFLEX SLAB RECESS AT THIS TREAD.
 - EXISTING UREFLEX SLAB RECESS AT THIS LOCATION.

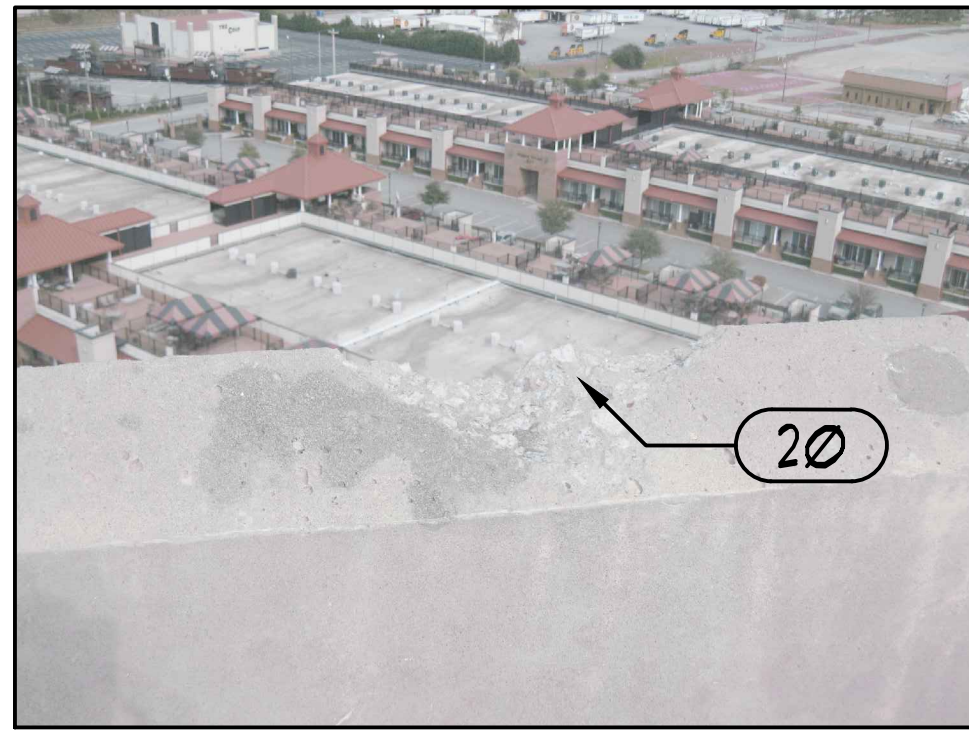
32 CHIP AT SLOPED TOP WALL
