ADDENDUM NUMBER 1
Friday, September 30, 2016

PROJECT: **USC Lancaster Starr Hall Renovation – Phase II**
 USC PROJECT NO. H37-9517
 GMC PROJECT NO. AGRE160038

LIMITED ASBESTOS AND LEAD INSPECTION REPORT

USC Lancaster, Starr Hall (limited areas)

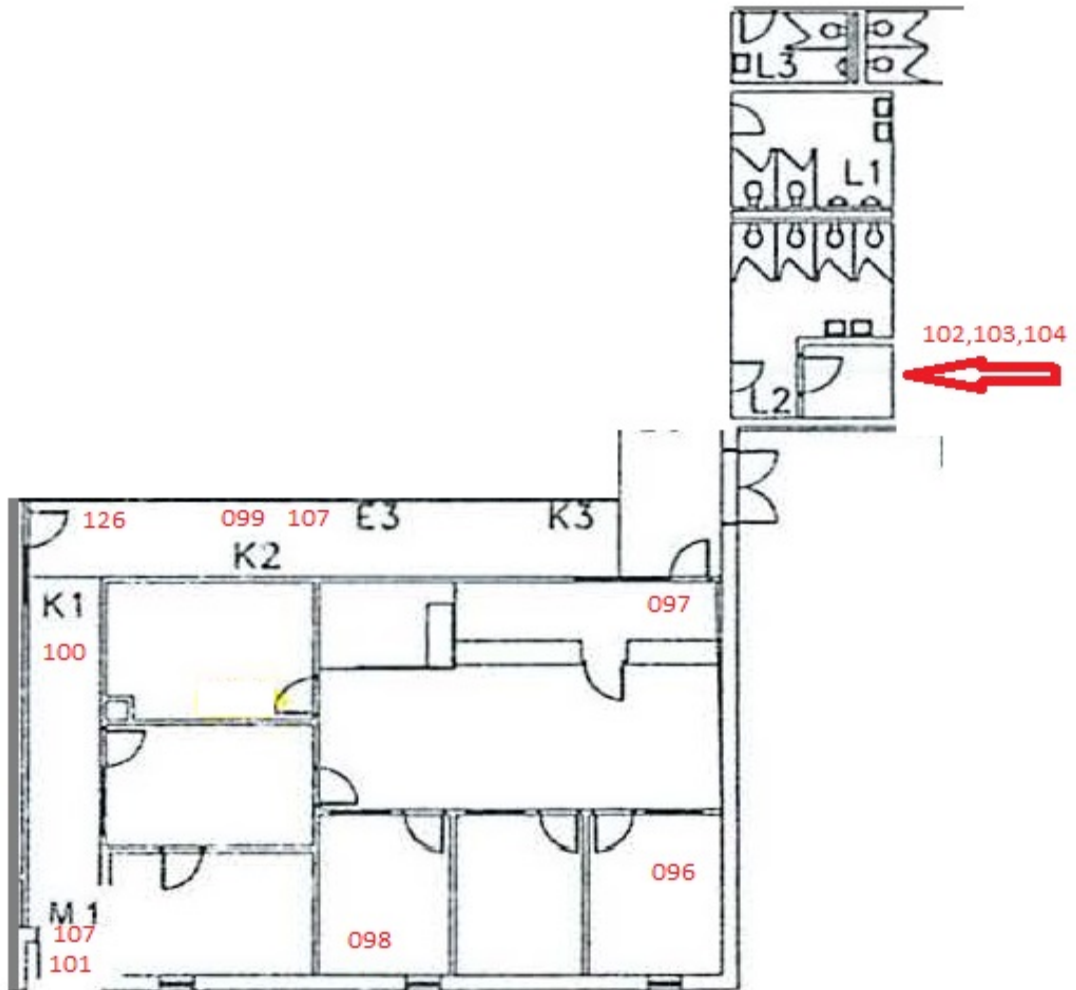
SAMPLE LOCATION SKETCH

Results indicated that greater than one percent asbestos was detected in the 12"x12" tan vinyl floor tile and black mastic. The ceiling tiles located in the restrooms were previously sampled and found to contain greater than one percent asbestos.

Results indicated that lead was detected in the ceramic tiles located on the walls in all four sampled restrooms.
