Replace General Notes, Plan and Elevation
Blossom Garage East Stair Replacement
Prepared For:
University of South Carolina, Columbia, SC

Replacement Sections and Details
 Blossom Garage East Stair Replacement
 Prepared For:
 University of South Carolina, Columbia, SC

Alternative Stair Replacement
Blossom Garage East Stair Replacement
Prepared For:
University of South Carolina, Columbia, SC

Replacement Sections and Details
Blossom Garage East Stair Replacement
 Prepared For:
University of South Carolina, Columbia, SC

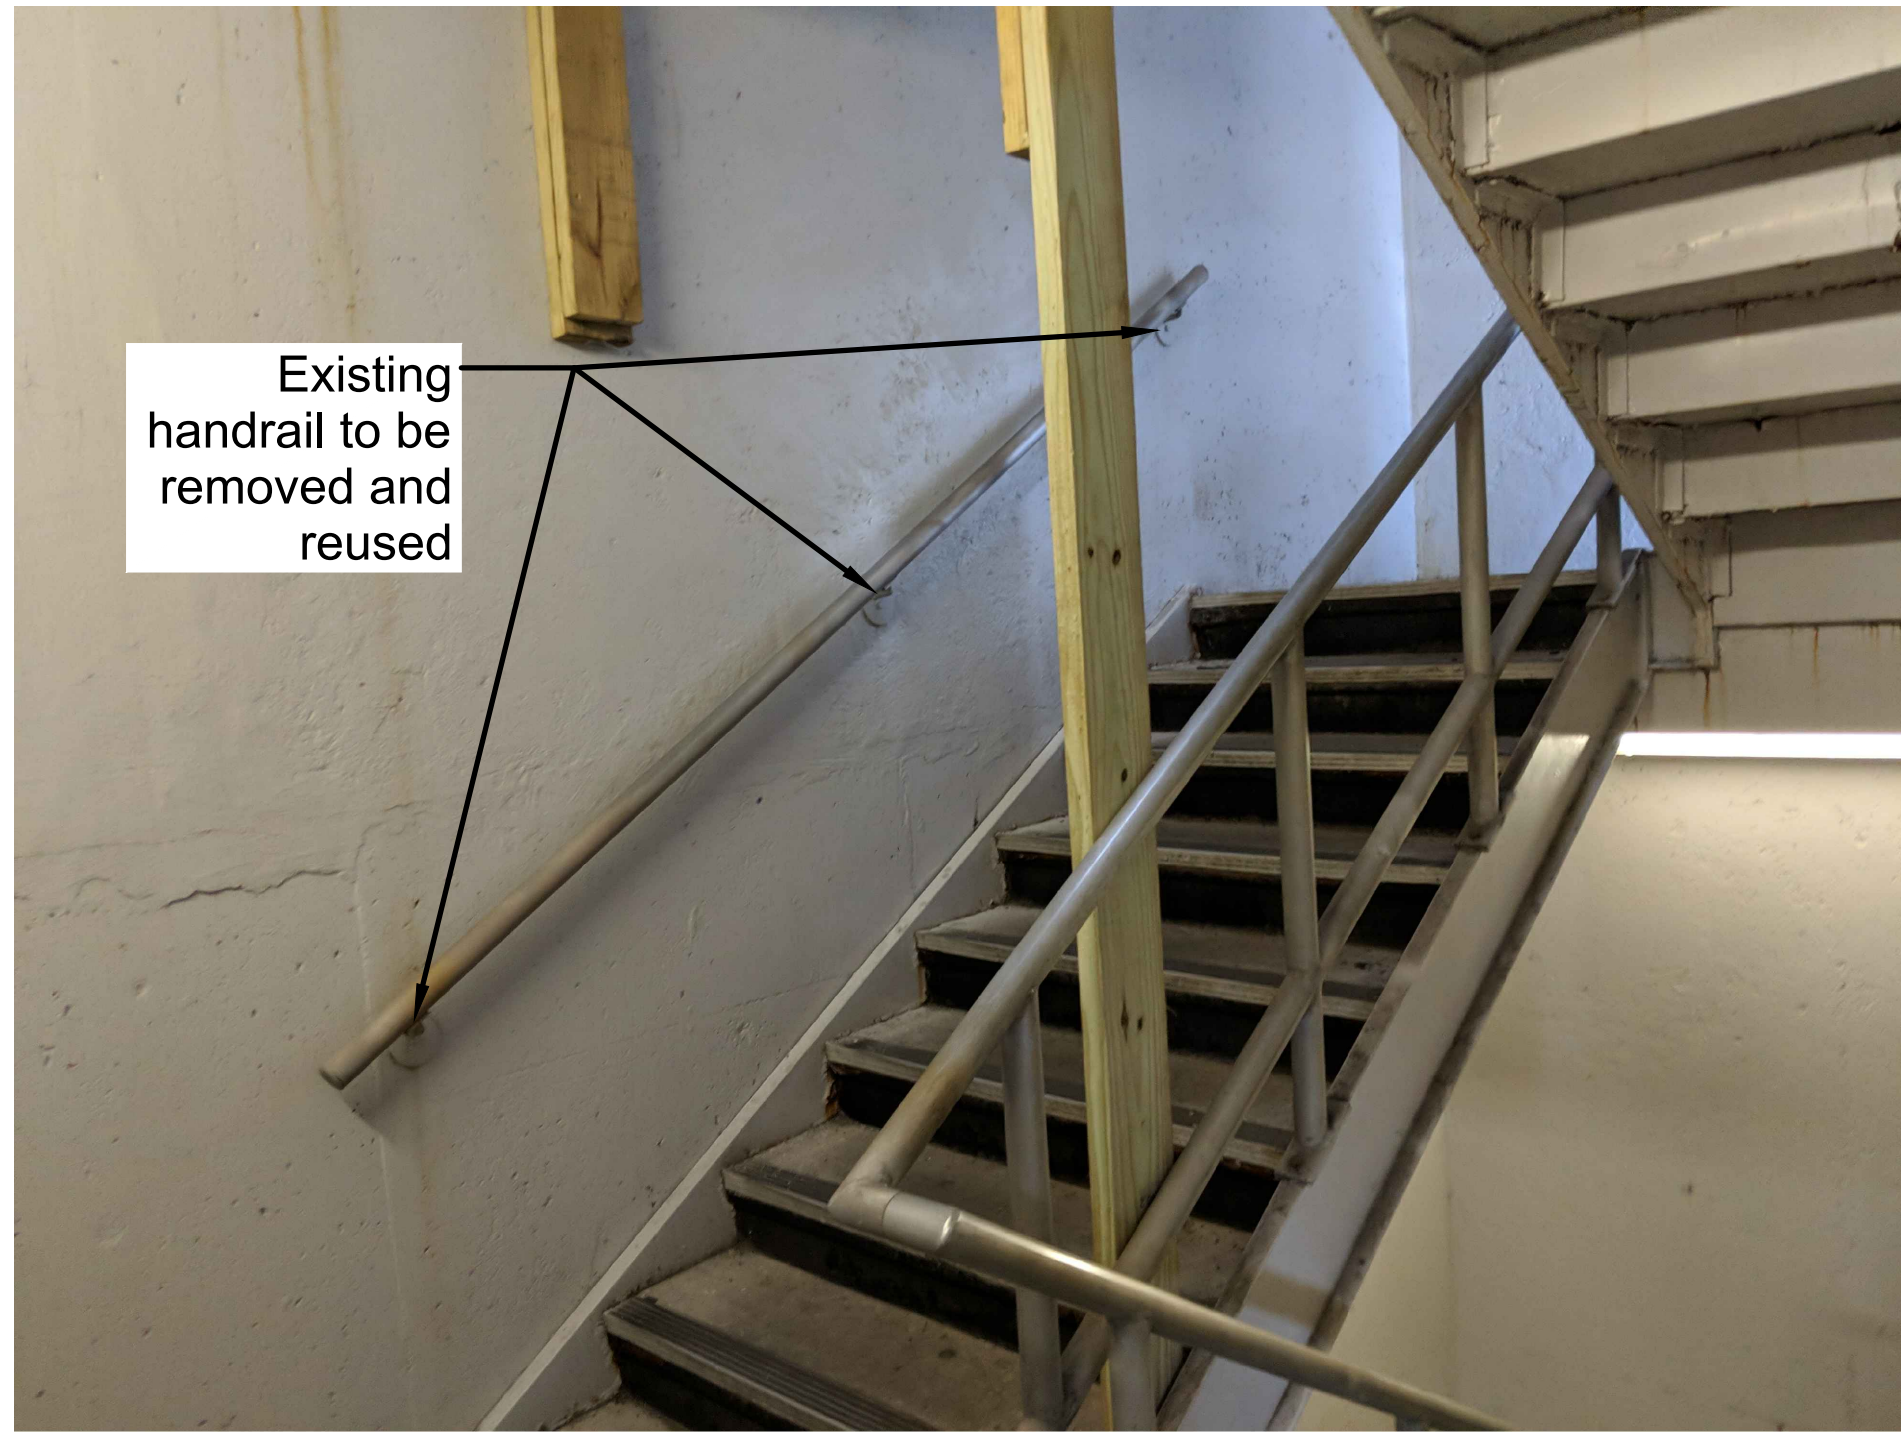
G.C. shall remove all temporary wood reinforcement shoring, see photo (1) and (2) on S2.1. Photos are for informational purposes only. Total quantities shall be evaluated by the contractor.

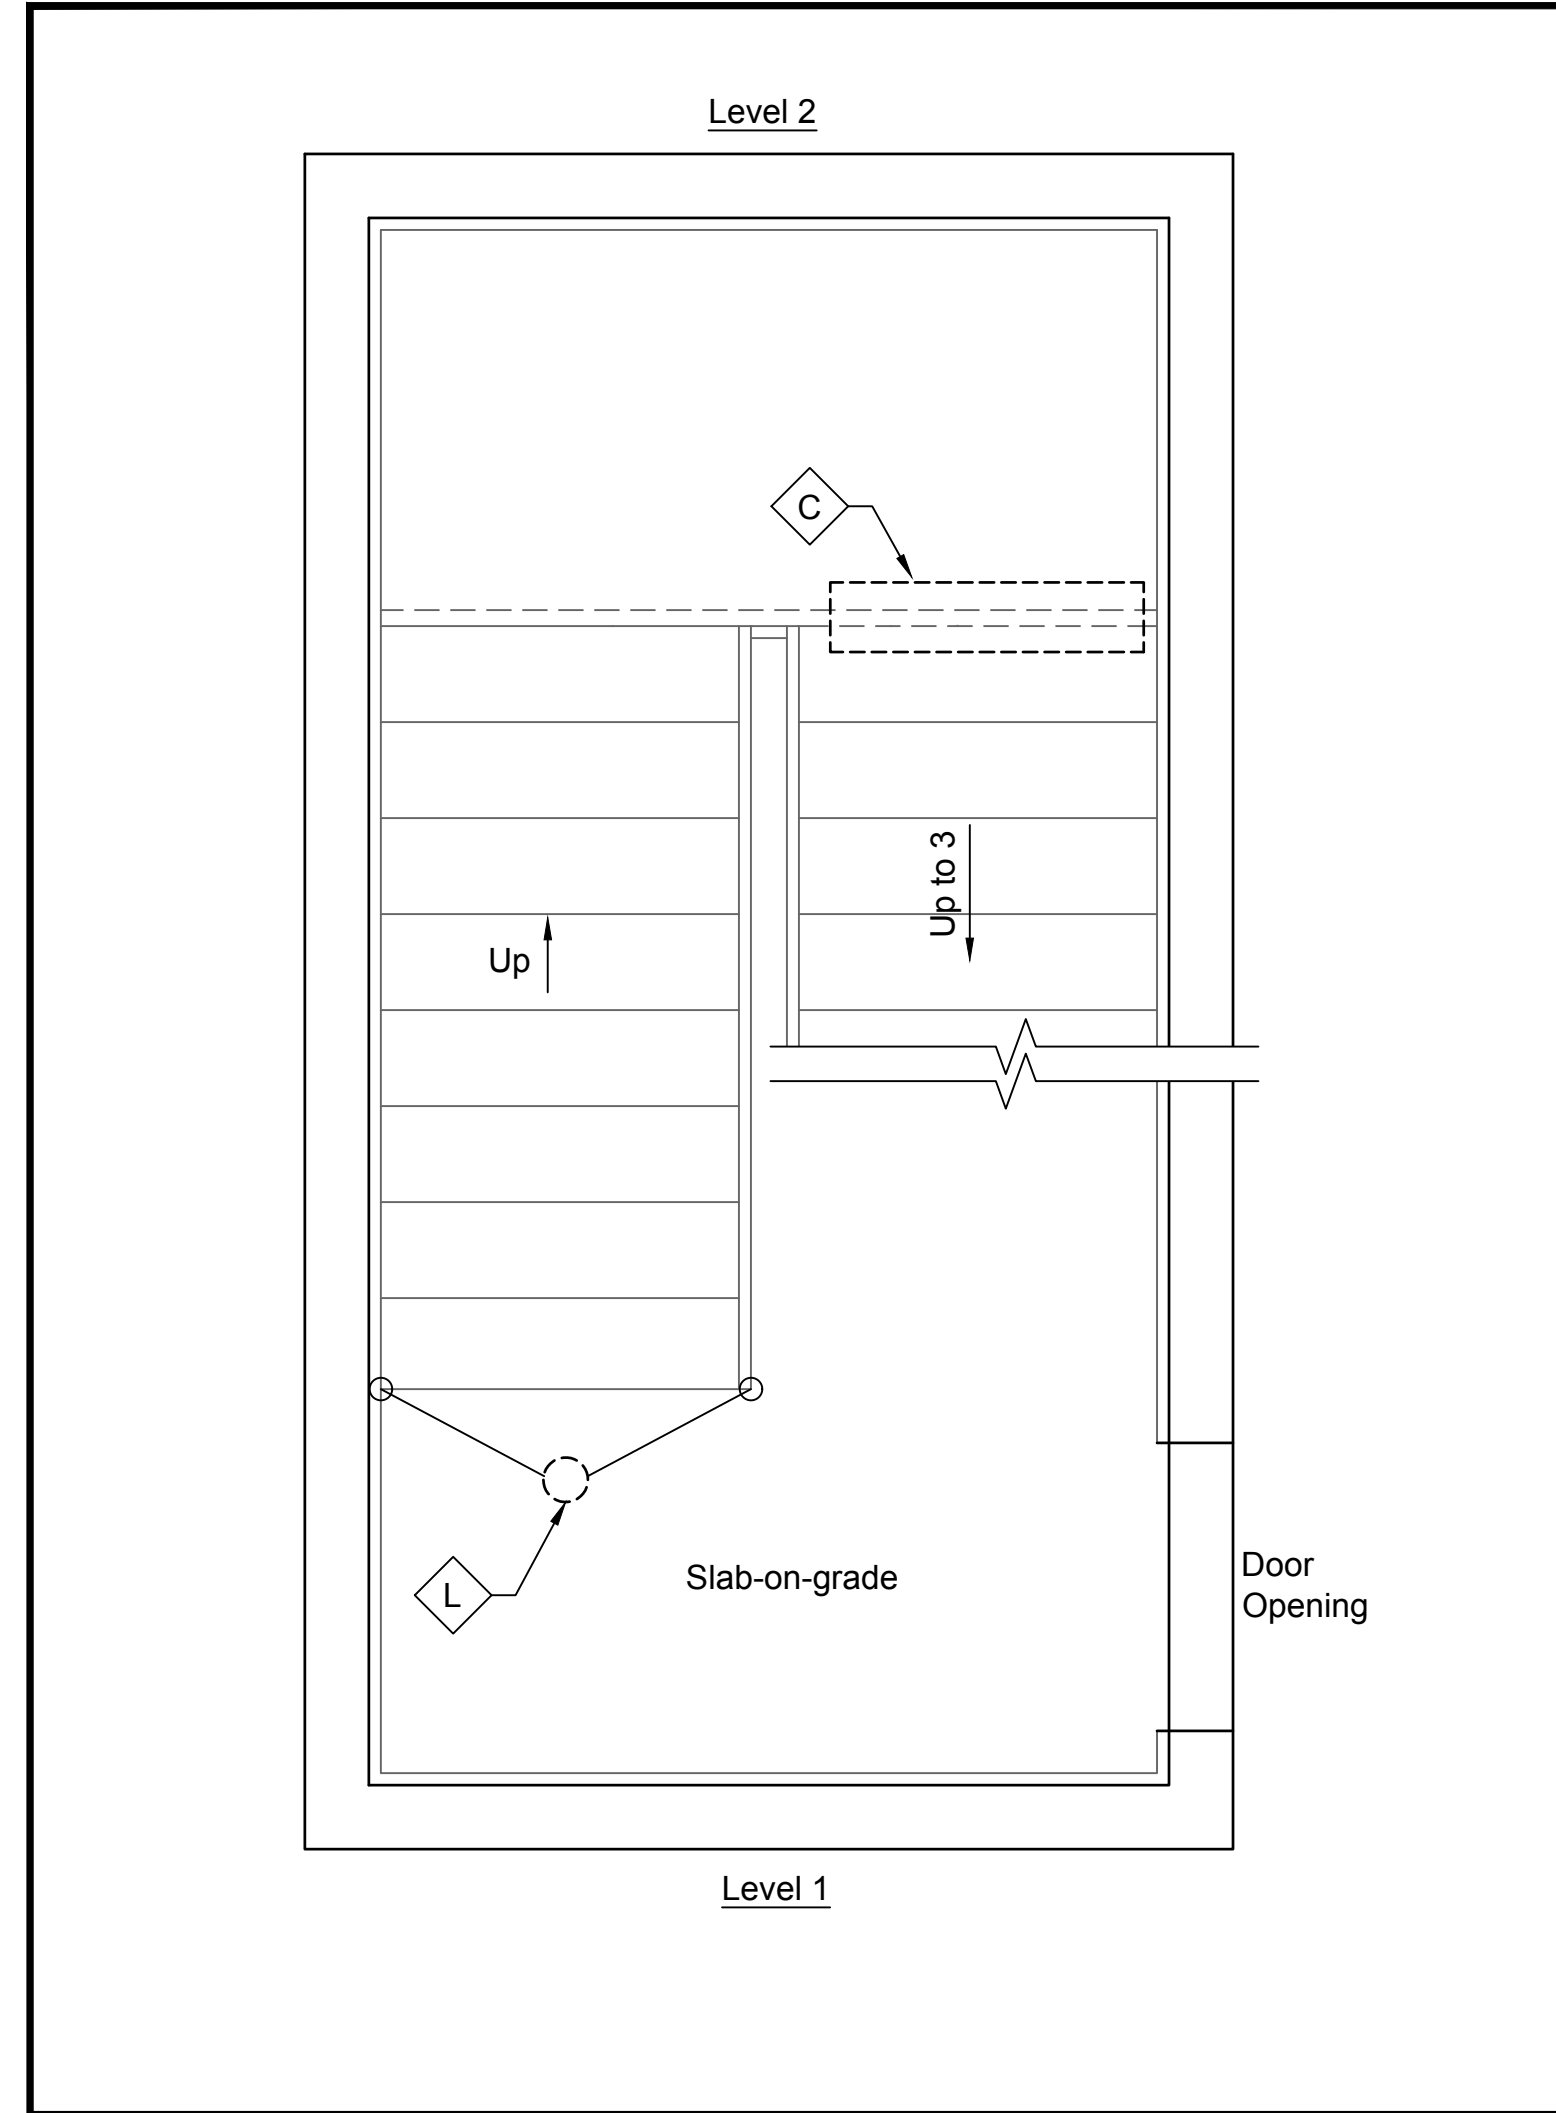
1 - Level 1 - 2 Plan Scale: 1/2" = 1'-0"

Deficiency Reference Schedule			
Tag	Deficiency	Applicable Levels	Repair Action
A	Standing water noted (After rain event).	1, 2, 3, 4, 5, 6, 7	Noted For Reference.
B	Riser plate severely corroded.	1, 5, 6	Remove heavily corroded portions of riser plate, clean all additional corrosion and reinforce/ replace riser plate with additional plate material (3/16" plate material)(min. weld 3/16" fillet, 2" in 6" full length, each side, typ.)
C	Tread plate severely corroded.	3, 4, 5, 6	Remove heavily corroded portions of tread plate, clean all additional corrosion and reinforce/ replace riser plate with additional plate material (3/16" plate material)(min. weld 3/16" fillet, 2" in 6" full length, each side, typ.)
D	Landing plate severely corroded.	3, 4, 5, 6, 7	Remove heavily corroded portions of landing plate, clean all additional corrosion and reinforce/ replace tread plate with additional plate material (3/16" plate material)(min. weld 3/16" fillet, 2" in 6" full length, each side, typ.)

E	Steel channel severely corroded.	2, 5	Remove heavily corroded portions of channel. (Supplementary support of landings to be provided by addition of C6x10.5 beam.)
F	Steel channel moderately corroded.	2	Clean corrosion and provide for re-evaluation of the corroded condition by the structural engineer. (Supplementary support of landings to be provided by addition of C6x10.5 beam.)
G	Bent plate cover plate severely corroded.	2, 3, 4, 5, 6	Remove all bent plate cover plating and provide for re-evaluation of the presently concealed conditions by the structural engineer. (Additional work anticipated.)
H	Exposed reinforcement in concrete slab.	5, 6	Future repair is recommended.
I	Support angle severely corroded.	2, 3, 4, 6	Remove corroded support angle, clean substrates and replace support angle with L1-1/2x1-1/2x3/16.
J	Tread plate support angle severely corroded.	1, 2, 3, 4, 5, 6, 7	Remove corroded support angle, clean substrates and replace support angle with L1-1/2x1-1/2x3/16.

K	Wall crack noted at beam bearing.	5	Not part of scope. (Future repair is recommended)
L	Rust on stringer.	1	Clean corrosion repair per 6/S2.0.
M	Slab cracking noted.	1, 2, 3, 4, 5, 6, 7	Noted for reference, does not require repair.
