**1800 Gervais Street Renovation -
Demolition - Phase I**

Project # H27-Z008 - A

Project Name: 1800 Gervais Street Renovation – Demolition – Phase I

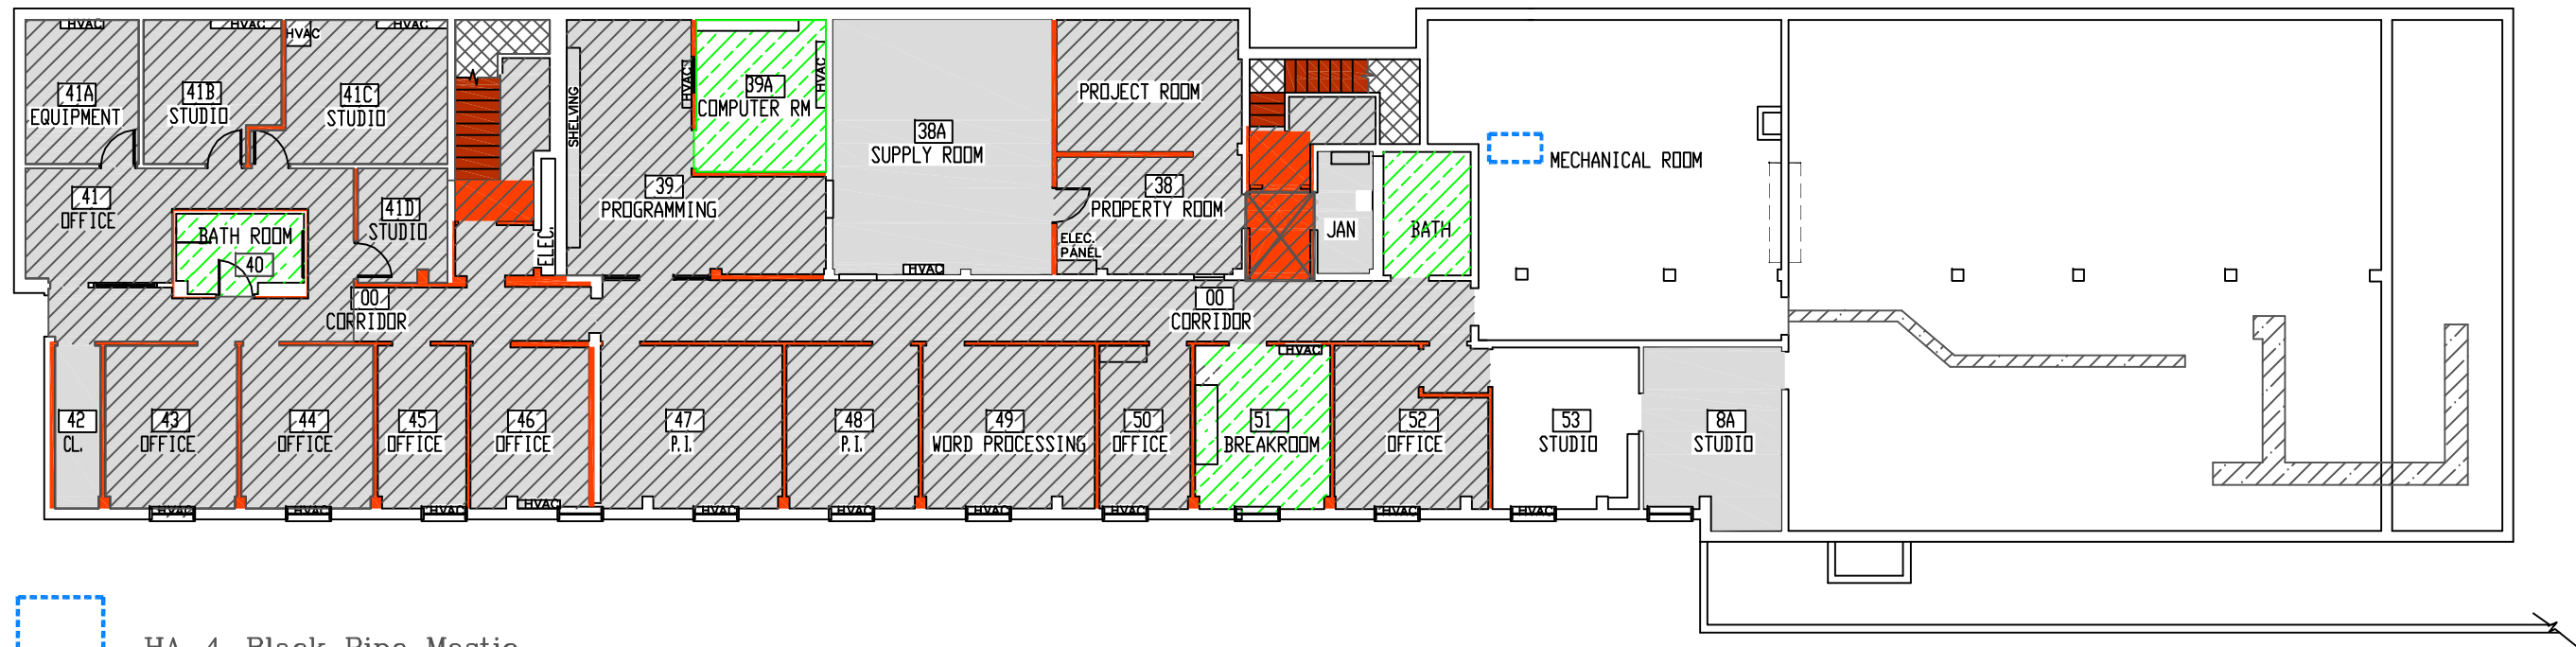
HA-9 Unidentified Spray Applied Fibrous Material

-   HA-4 Black Pipe Mastic
-   HA-5 Floor Tile Mastic Under Non-ACM Floor Tile
-   HA-6 Joint Compound
-   Carpet
