Project Manual:: Appendix B Mortar & Brick Analysis

Contract Documents Historic Horseshoe Wall Restoration Phase 2

Characterization of Masonry Mortar
Historic Campus Wall
University of South Carolina

Engineering Assessment of Bricks
Historic Campus Wall
University of South Carolina

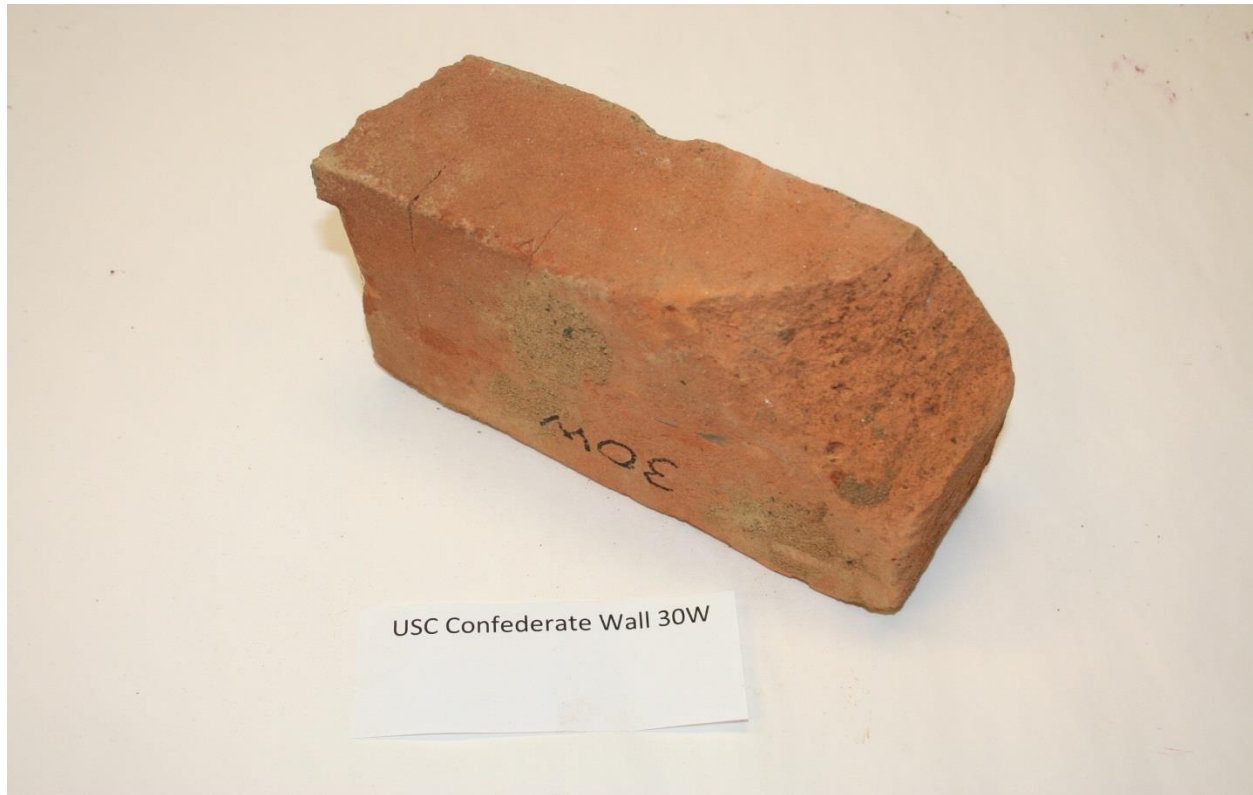
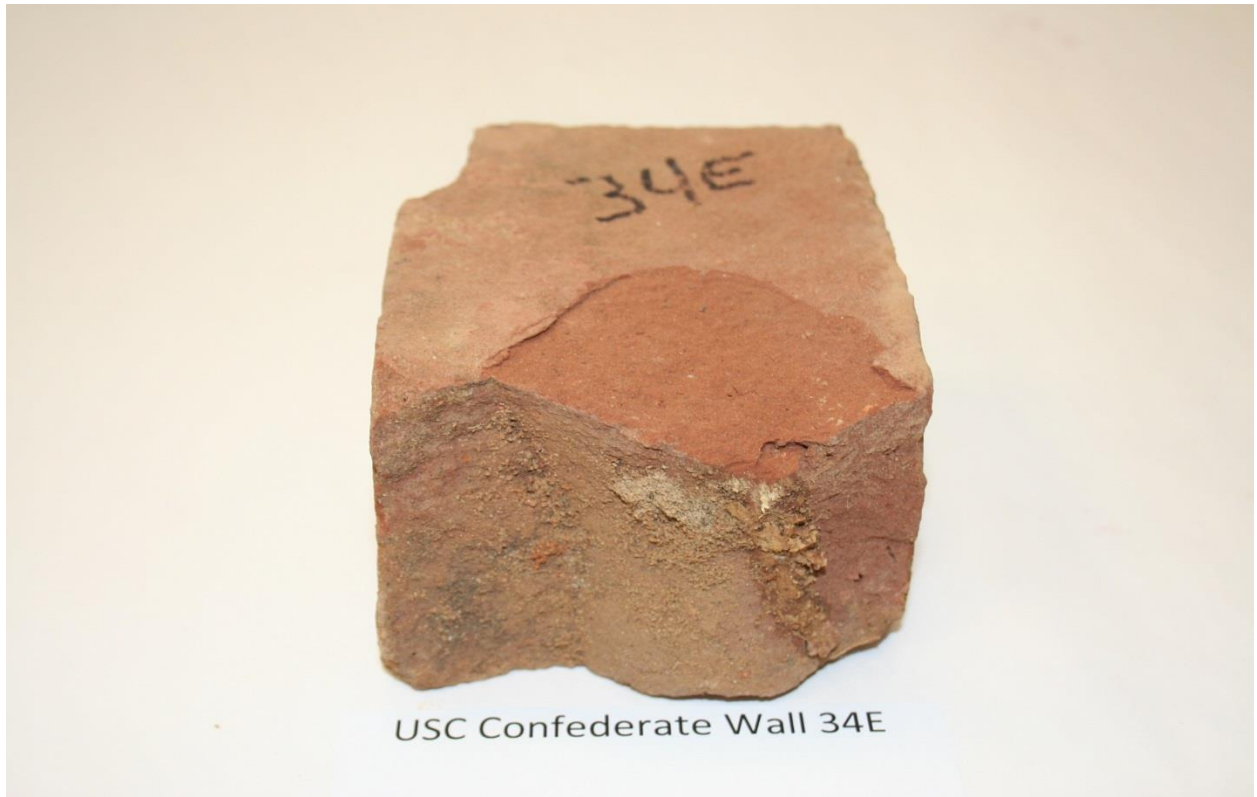
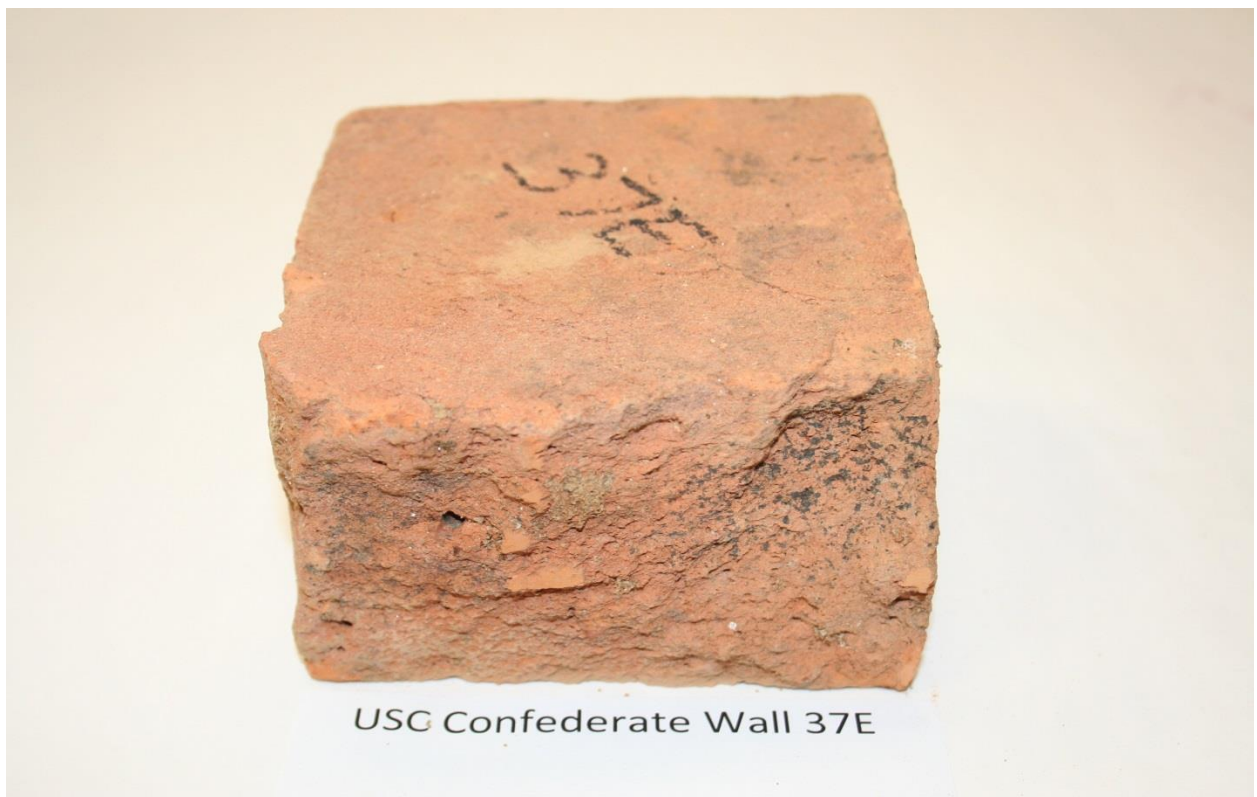
As-Received Photographs – No Brightness or Contrast Adjustment
No photograph available for Specimen 4W

Photographs of three of the as-received bricks are shown in the Appendix. All appear to be molded bricks based on the weathered shale commonly found in the Columbia area. The three brick were all red to red-yellow in color with typical “porous texture” for molded bricks as shown on fracture surfaces on the as-received photographs.

Color data is given in Table 3, and it may be compared to as-received photographs of three of the four bricks. Brick 37E exhibits the largest yellow hue (highest b* value), consistent with the fact that this brick exhibits the lowest predicted firing temperature (Table 4). It is noted that brick 37E was previously classed as durable by the absorption and Maage methods despite a “lower” firing temperature.

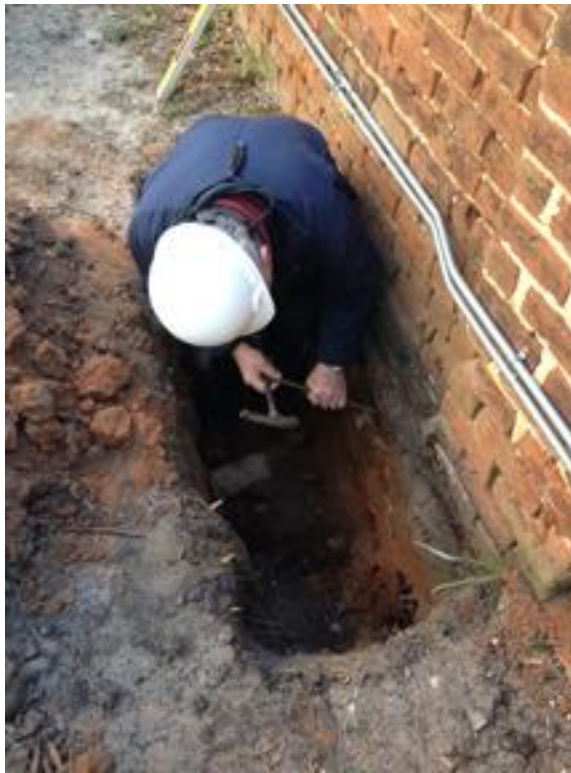
Obtaining Greene 2

(Note mortar recession in the lower wall to the left of a pointed area.)

- Mortar recession was observed in lower courses, generally to 24" above ground level, suggesting mortar interaction with salt-laden water in rising damp. The source of salts is the naturally occurring salt in the soil plus environmental sources.

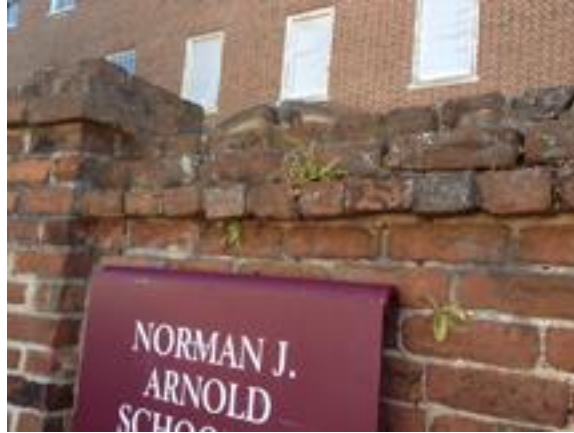
Top Course of Wall by Sumter near Greene
(Note mortar recession and vegetation in coping courses.)

- Many bricks were loose in coping courses where mortar and bricks were discolored by organic matter from overhanging tree growth. Biological growth in mortar joints attested to the wet conditions in the upper courses of the wall. The mortar was solid or not in a powdered condition in upper courses in the wall.

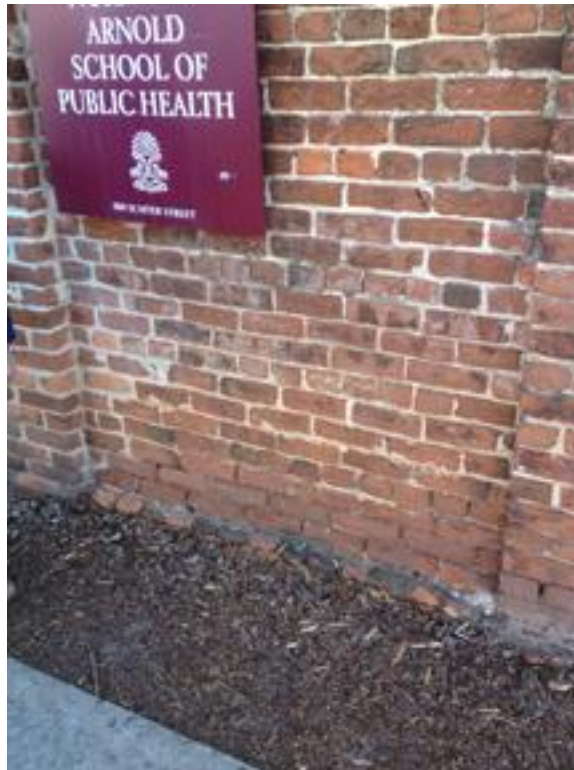
Lower Courses of Wall by Sumter near Greene
(Note mortar recession in lower wall.)

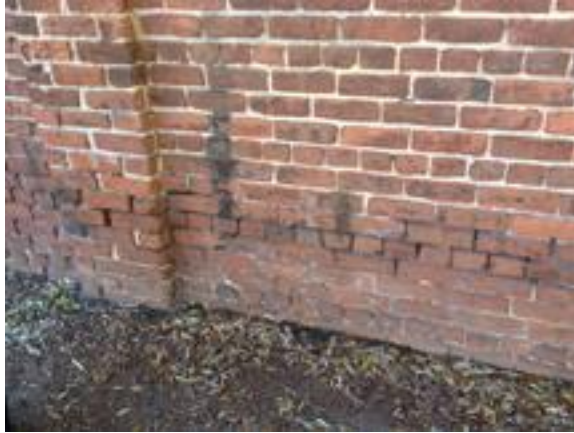
Lower Courses of Wall by Sumter near Pendleton
(Note mortar recession in lower wall.)

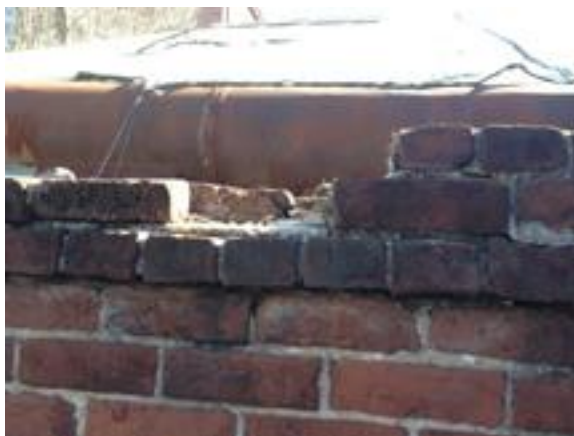
Missing Bricks in Coping on Sumter

- The bricks in original construction were in good structural or sound condition exhibiting only infrequent damage from freezing and thawing or salt exposure. Some bricks were missing in areas of the coping courses, and others were damaged in areas of wall impacts or physical alterations of the wall.

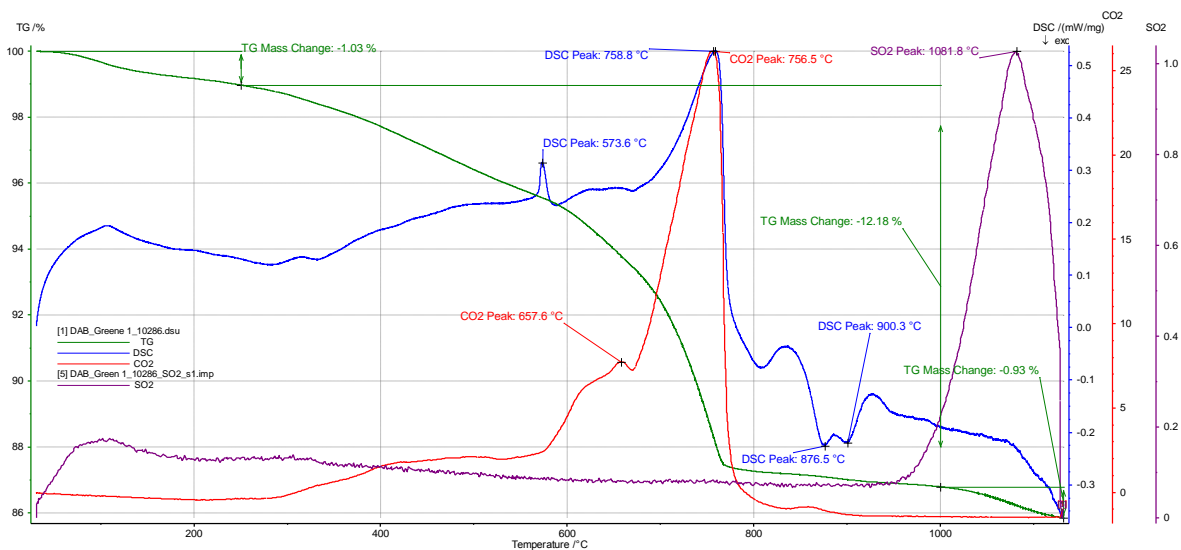
Greene 1

Key: Greene trace is the weight loss (thermogravimetric); Blue trace is the energy change (differential scanning calorimetry, downward peak is exothermic); Red trace is the CO₂ evolution (FTIR detection); and Black trace is the SO₂ evolution (if shown, by FTIR).

- All specimens exhibit the endothermic quartz inversion near 574°C reflecting the sand content of the mortar.
- All specimens exhibit a large endothermic peak with CO₂ evolution near 750-800°C reflecting the carbonate binder decomposition.
- The weight loss below 200°C is likely due to ettringite decomposition. This phase is commonly found in mortars.
- All mortars exhibit CO₂ evolution in the area of 350-400°C reflecting oxidation of organic matter forming CO₂.

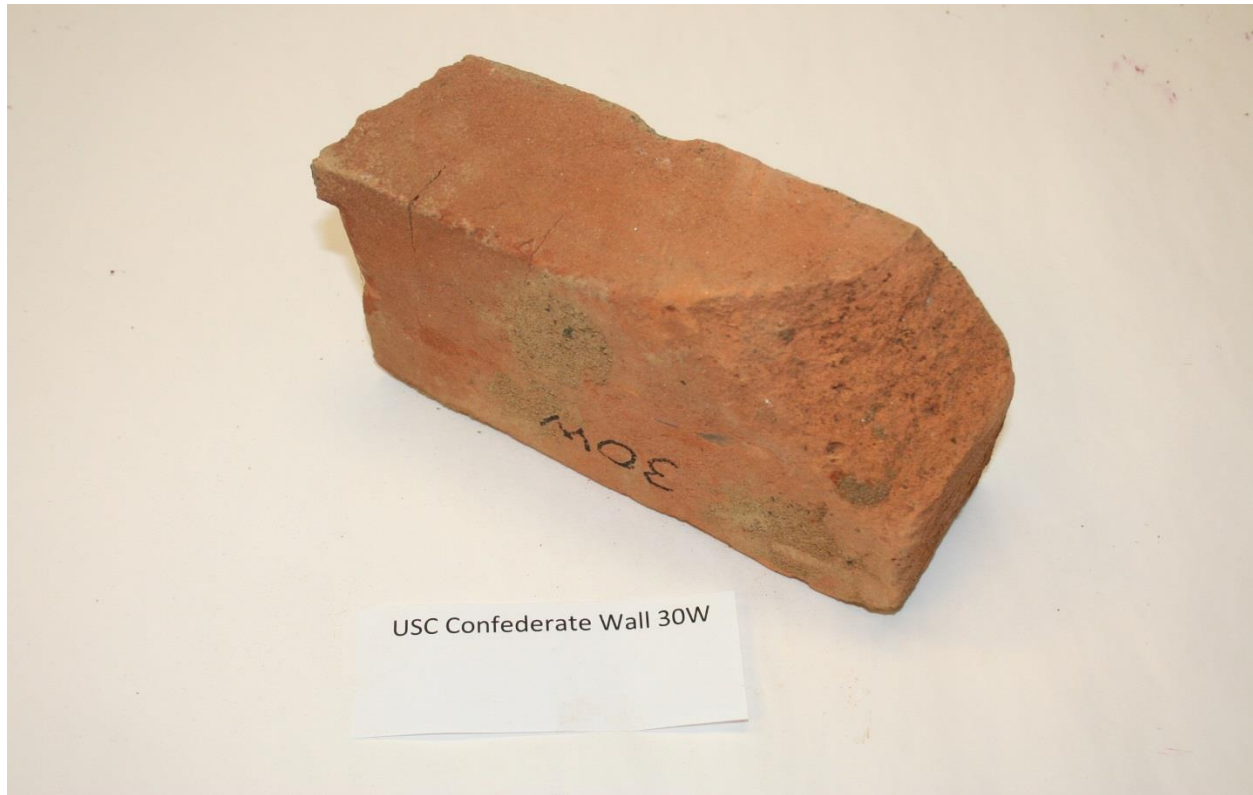
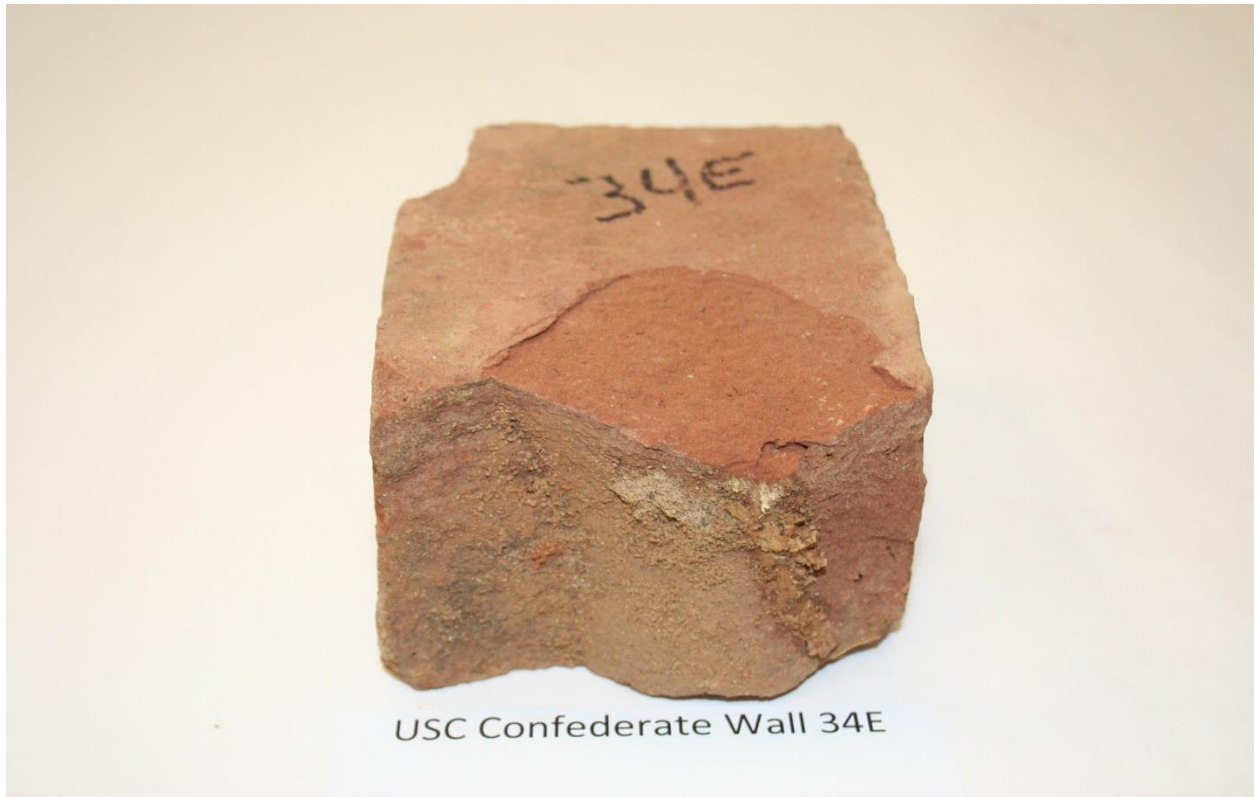
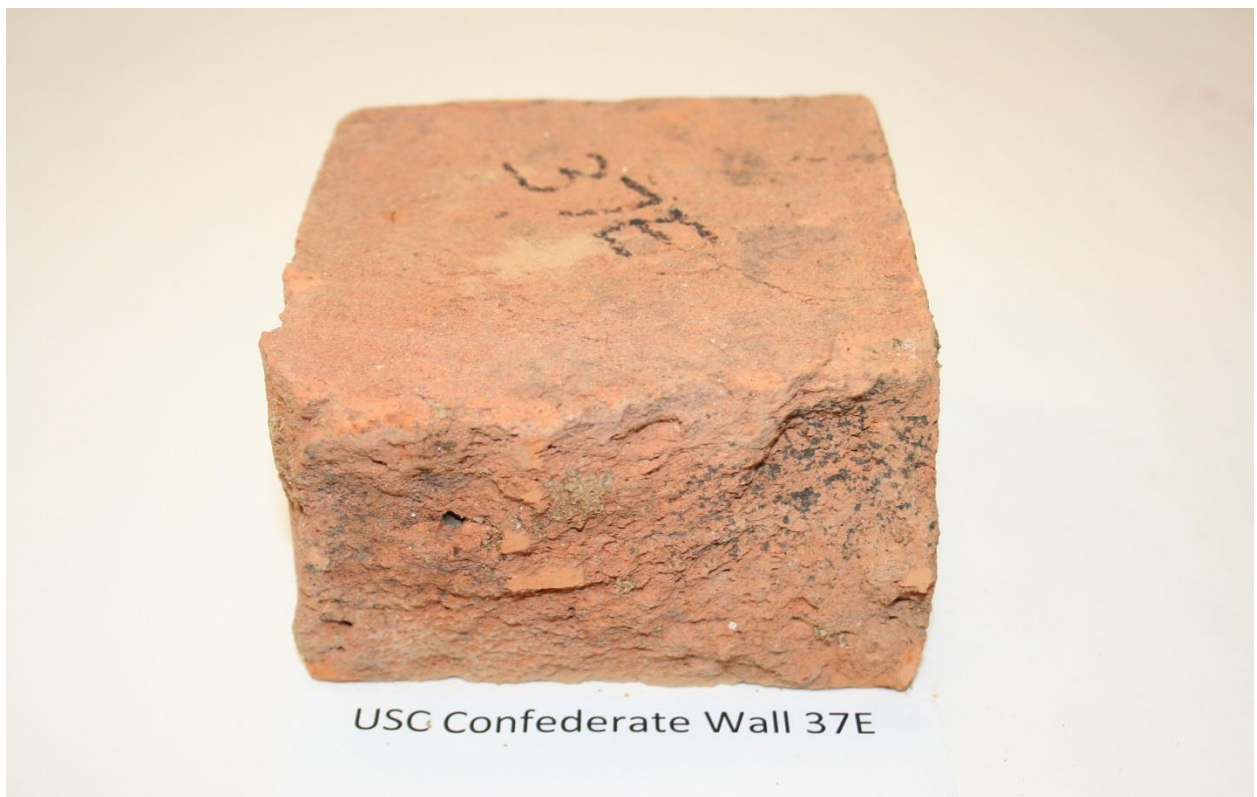
As-Received Photographs – No Brightness or Contrast Adjustment
No photograph available for Specimen 4W

Photographs of three of the as-received bricks are shown in the Appendix. All appear to be molded bricks based on the weathered shale commonly found in the Columbia area. The three brick were all red to red-yellow in color with typical “porous texture” for molded bricks as shown on fracture surfaces on the as-received photographs.

Color data is given in Table 3, and it may be compared to as-received photographs of three of the four bricks. Brick 37E exhibits the largest yellow hue (highest b* value), consistent with the fact that this brick exhibits the lowest predicted firing temperature (Table 4). It is noted that brick 37E was previously classed as durable by the absorption and Maage methods despite a "lower" firing temperature.
