## Addendum No. 1

Project: USC Upstate Media Building Roof Replacements  
USC Upstate, 800 University Way  
Spartanburg, South Carolina, 29303

## **LIMITED ASBESTOS INSPECTION REPORT**

**Media Center Roof  
USC Upstate  
Spartanburg, South Carolina**

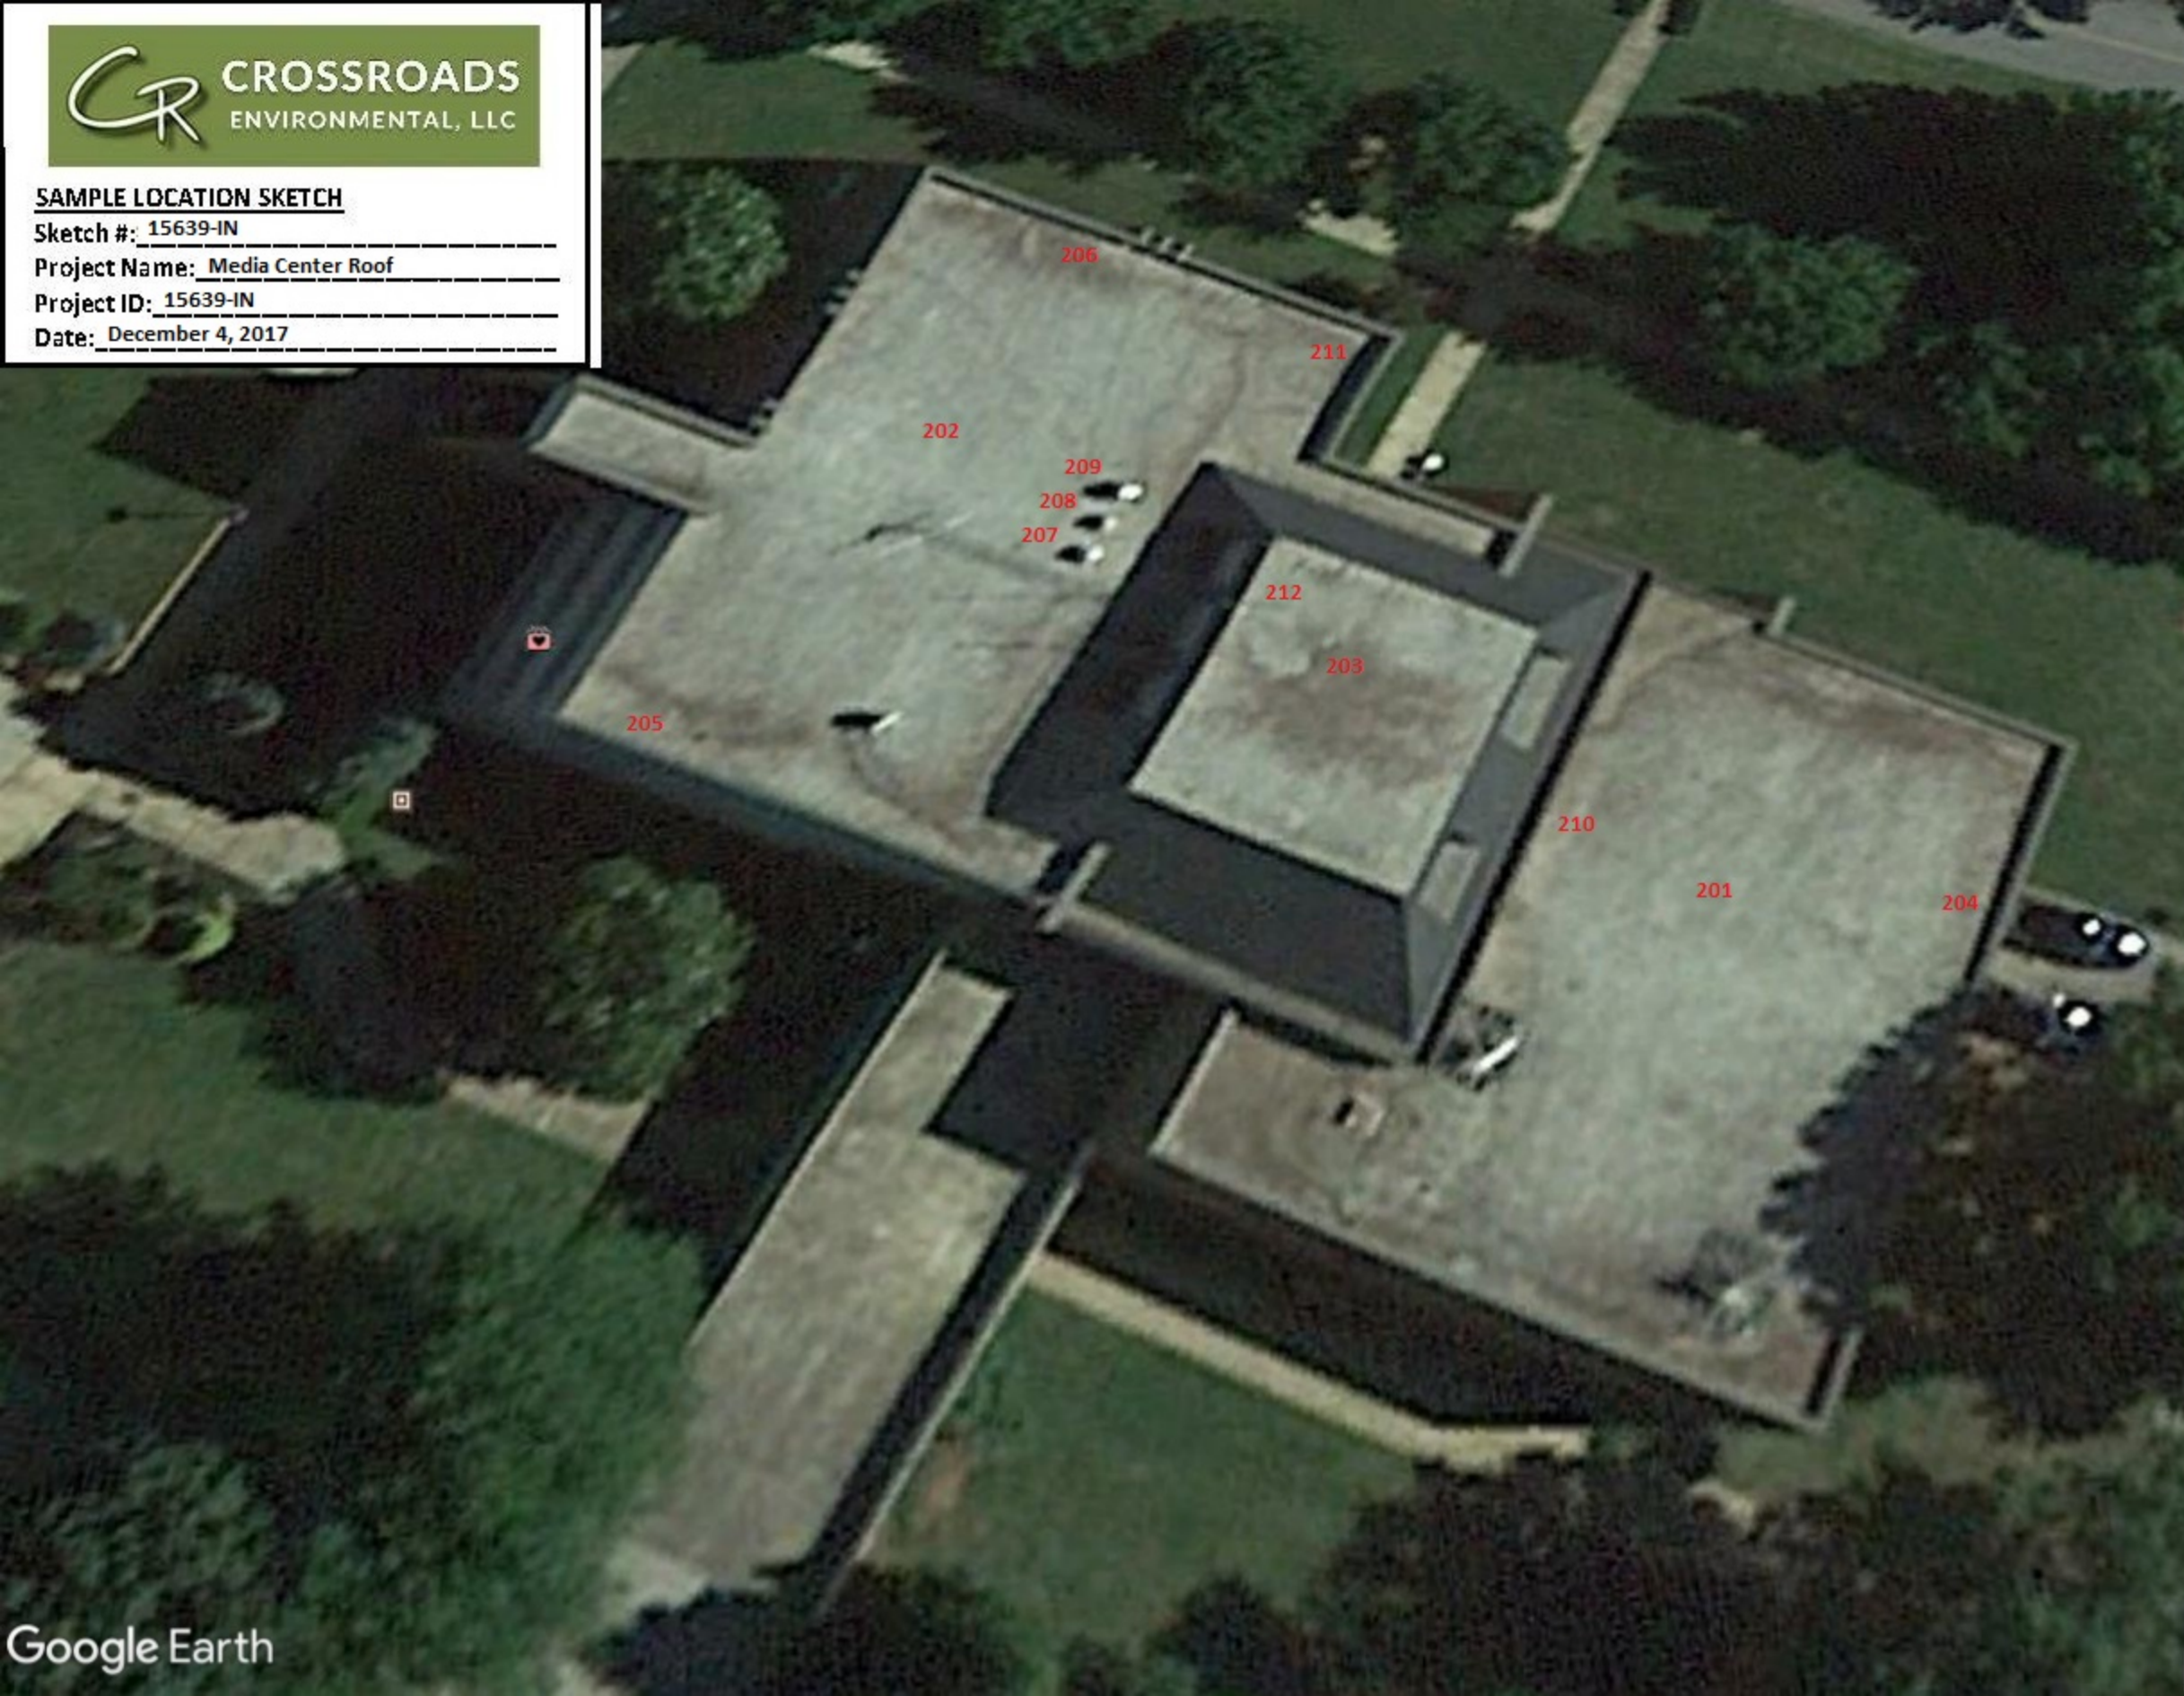
**SAMPLE LOCATION SKETCH**

Sketch #: 15639-IN  
Project Name: Media Center Roof  
Project ID: 15639-IN  
Date: December 4, 2017
