# Dependence of Vibration Characteristics on Grease Service Levels in an AH-64D Intermediate Gearbox

Presented at the AHS 70th Annual Forum, Montréal, Québec, Canada, May 20–22, 2014. Copyright © 2014 by the American Helicopter Society International, Inc. All rights reserved.

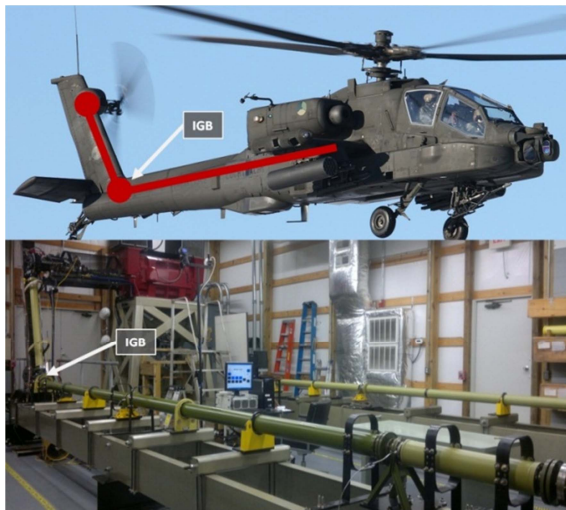
**Figure 1. Comparison of USC test stand to actual aircraft**

National Guard (SCARNG). Combined efforts between two parties led to a fully developed Condition-Based Maintenance (CBM) Research Center within the USC Department of Mechanical Engineering that hosts several aircraft component test stands in support of CBM objectives. At the USC test stands, different CIs have been tested and validated to detect faults that occur over the lifetime of various drivetrain articles including such components as the AH-64D forward hanger bearing, aft hanger bearing, IGB, tail rotor gearbox (TGB), and tail rotor swashplate (TRSP) (Figure 1).

The test stand emulates the complete tail rotor drivetrain (TRDT) from the main transmission to the tail rotor swashplate assembly. The TRDT is comprised of actual aircraft hardware and is capable of handling drive shafts installed at the maximum allowable misalignment of two degrees. Structure, instrumentation, data acquisition systems, and supporting hardware are installed according to military standards. The test stand's two 800 horsepower motors are capable of exceeding 150% of the actual aircraft drivetrain loading. The test stand was designed and built to accommodate the use of various Health and Usage Monitoring Systems (HUMS) and is currently equipped with a Honeywell modern signal processing unit (MSPU). USC's own data acquisition results have been validated with data obtained from actual airframes. The testing facility is also capable of being modified to test new and existing drivetrain components of military and civilian aircraft, including the ARH-70, CH-47, and UH-60 drivetrains (Ref. 1).

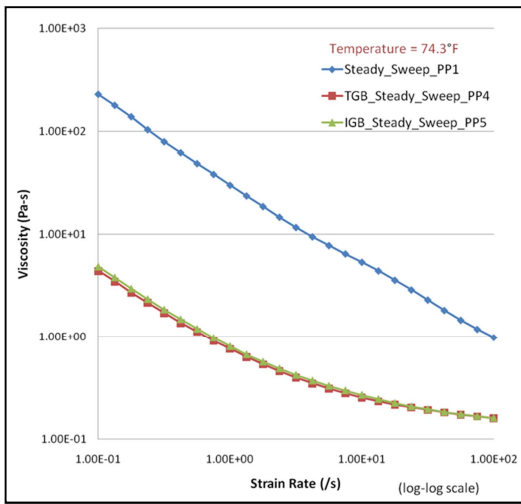
**Figure 4. Sweep test results for IGB and TGB**

A common belief is that the ejection occurs when the grease exposed to the in-flight operating conditions. The physical and rheological properties of the grease change after a certain period of time even when the temperatures are within operating limits (Ref. 3). One possible mechanism responsible for this phenomenon is the simultaneous application of mechanical and thermal loads. Rheological characterization of the IGB grease samples revealed reduction in their apparent viscosities when compared to the virgin grease at shear rates tested (Figure 4).

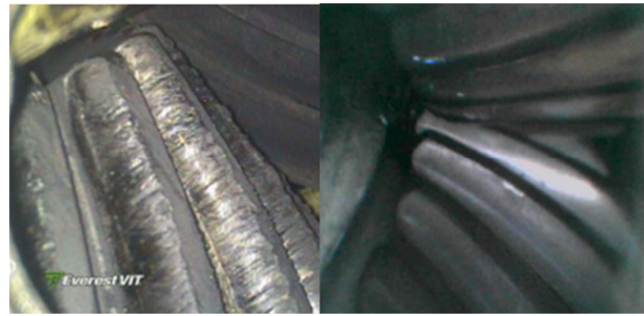
**Figure 7. A comparison, from a previous experiment, of worn gear teeth (left) to healthy teeth (right)**

After every fifth test in Table 1 the IGB was removed and flushed of grease. To ensure these levels are consistent the gearbox was flushed twice, first with an oil-based solution and then a second time with denatured alcohol. After being filled with the liquid the gearbox was left to sit overnight and then drained for another eight hours. To verify that an acceptable amount has been removed, the gearbox internals were checked using a borescope (Figure 7). During this part of the procedure, any damage to the gearbox could be noted.

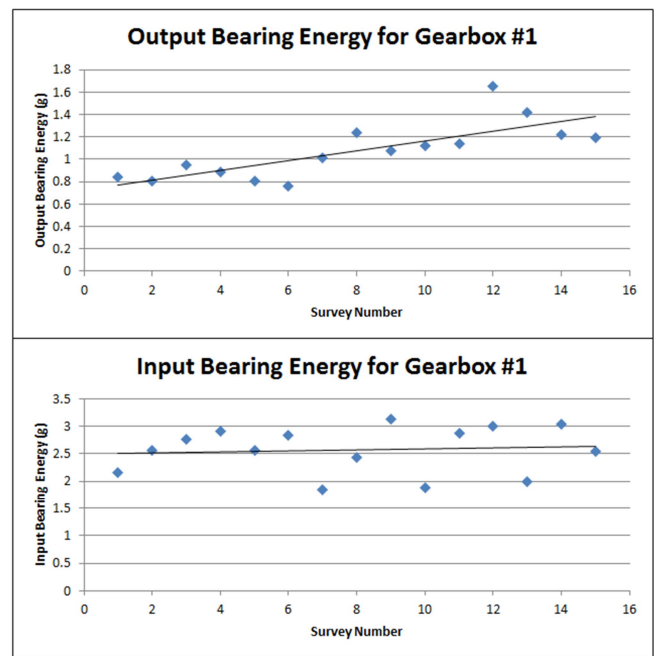
**Figure 9. CI values for Gearbox #1**

In gearbox #1 this expected trend in the input bearing energy is only seen in the 25% grease run, and only in the 25% and 100% runs is it noticeable in the output bearing energy. In the overall trend graphs the increase in grease was expected to lead to a decrease in vibration, due to less friction in the gears leading to a downward trend. This trend is not evident in most of the graphs (Figure 9).

The vibration plots are displayed to put emphasis on the trend for each gearbox through all the grease level changes. The figures below (Figure 9-Figure 11) each show the data for one run broken up by CI. These plots show the overall trend across runs. During the course of a run, the vibration is expected to decrease because the grease has a break-in period and then after that time the changing conditions will not affect the grease performance. For reference, the graph labeled IBE denotes input bearing energy and the plot with OBE is output bearing energy.

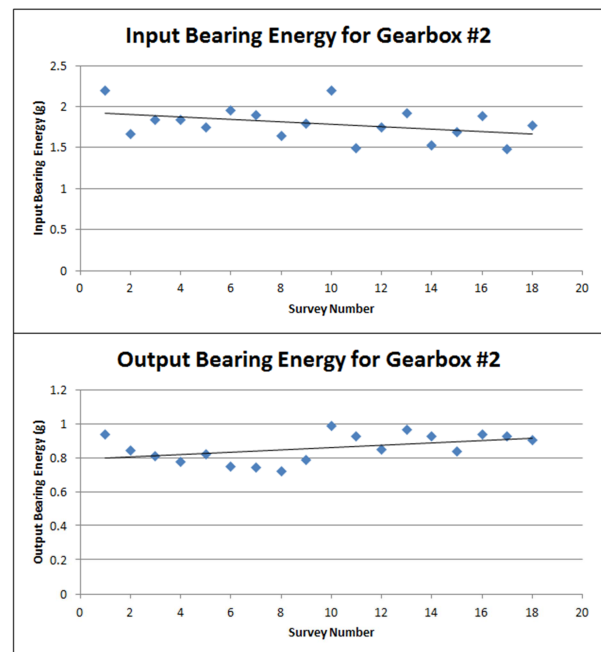
**Figure 10. CI values for Gearbox #2**

The vibration magnitude of gearbox #2 is closer to the expected trend but there are still some unexpected qualities (Figure 10). There was only one grease level for both the input and output bearing energy that had a positive trend. When all of the runs were graphed together the trend was negative for the input bearing energy and positive for the output bearing energy.

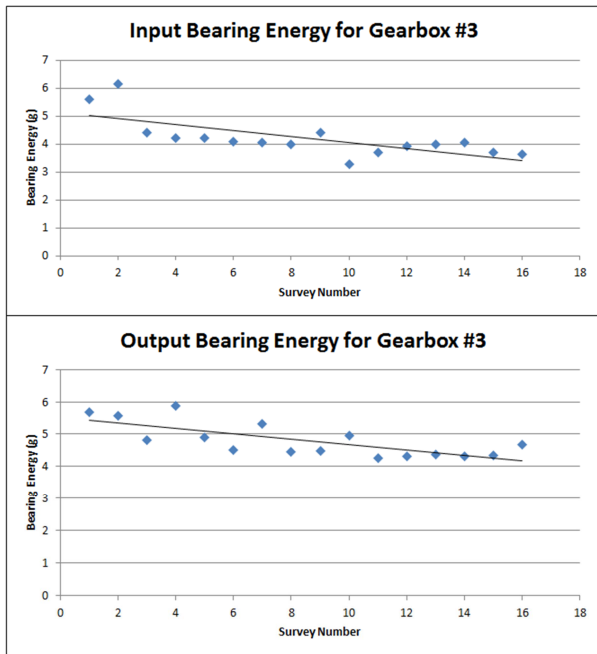
**Figure 11. CI values for Gearbox #3**

The final gearbox exhibited nearly all of the expected characteristics in this experiment (Figure 11). When changing grease levels from run to run all of the resulting

trends from the input and our bearing energy had negative trends. Although the gearbox mostly matches all of the expectations when conducting vibration analysis it is still unclear if a trend that can be applied to this type of data right now.

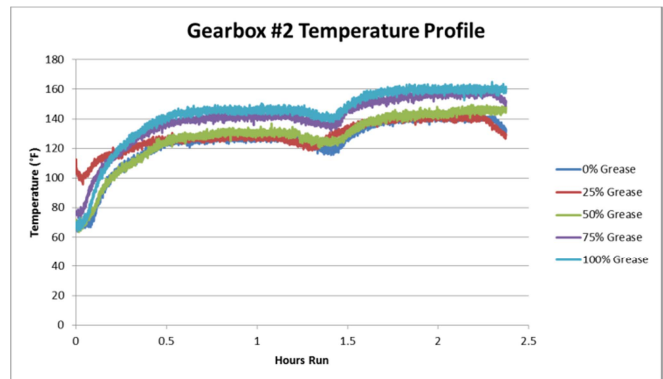
**Figure 13. Temperature results for the different runs conducted on Gearbox #2**

The temperature profile for gearbox #2 shows similar results to the first test article. The gradient increases with the service level, but it is not by a great amount (Figure 13). The average temperature for the 0% grease run was 125.1°F and for 100% it was 143.8°F.

On the aircraft, temperature plays an important role as an indicator for the health of a component. The purpose of temperature readings throughout testing were to make sure that the article was not being damaged due to running in a state with a low grease service level. Like vibration qualities, each gearbox has a different standard operating temperature. When that value starts to increase rapidly, it is a good indicator that the component is going to fail shortly. Since there is more friction on the internal components of the gearbox, it is thought that the 0% grease run will have the greatest temperature average. There are four places on the IGB where thermal readings are taken: input duplex bearing, input rolling bearing, output duplex bearing, and output roller bearing. For visual purposes these values where averaged together and plotted for each run conducted on a gearbox (Figure 12-Figure 14).
