ADDENDUM NUMBER TWO

REBID - Taylor House Phase II Renovations

Project No.: U-899-18

DATE OF ISSUE: May 7, 2019

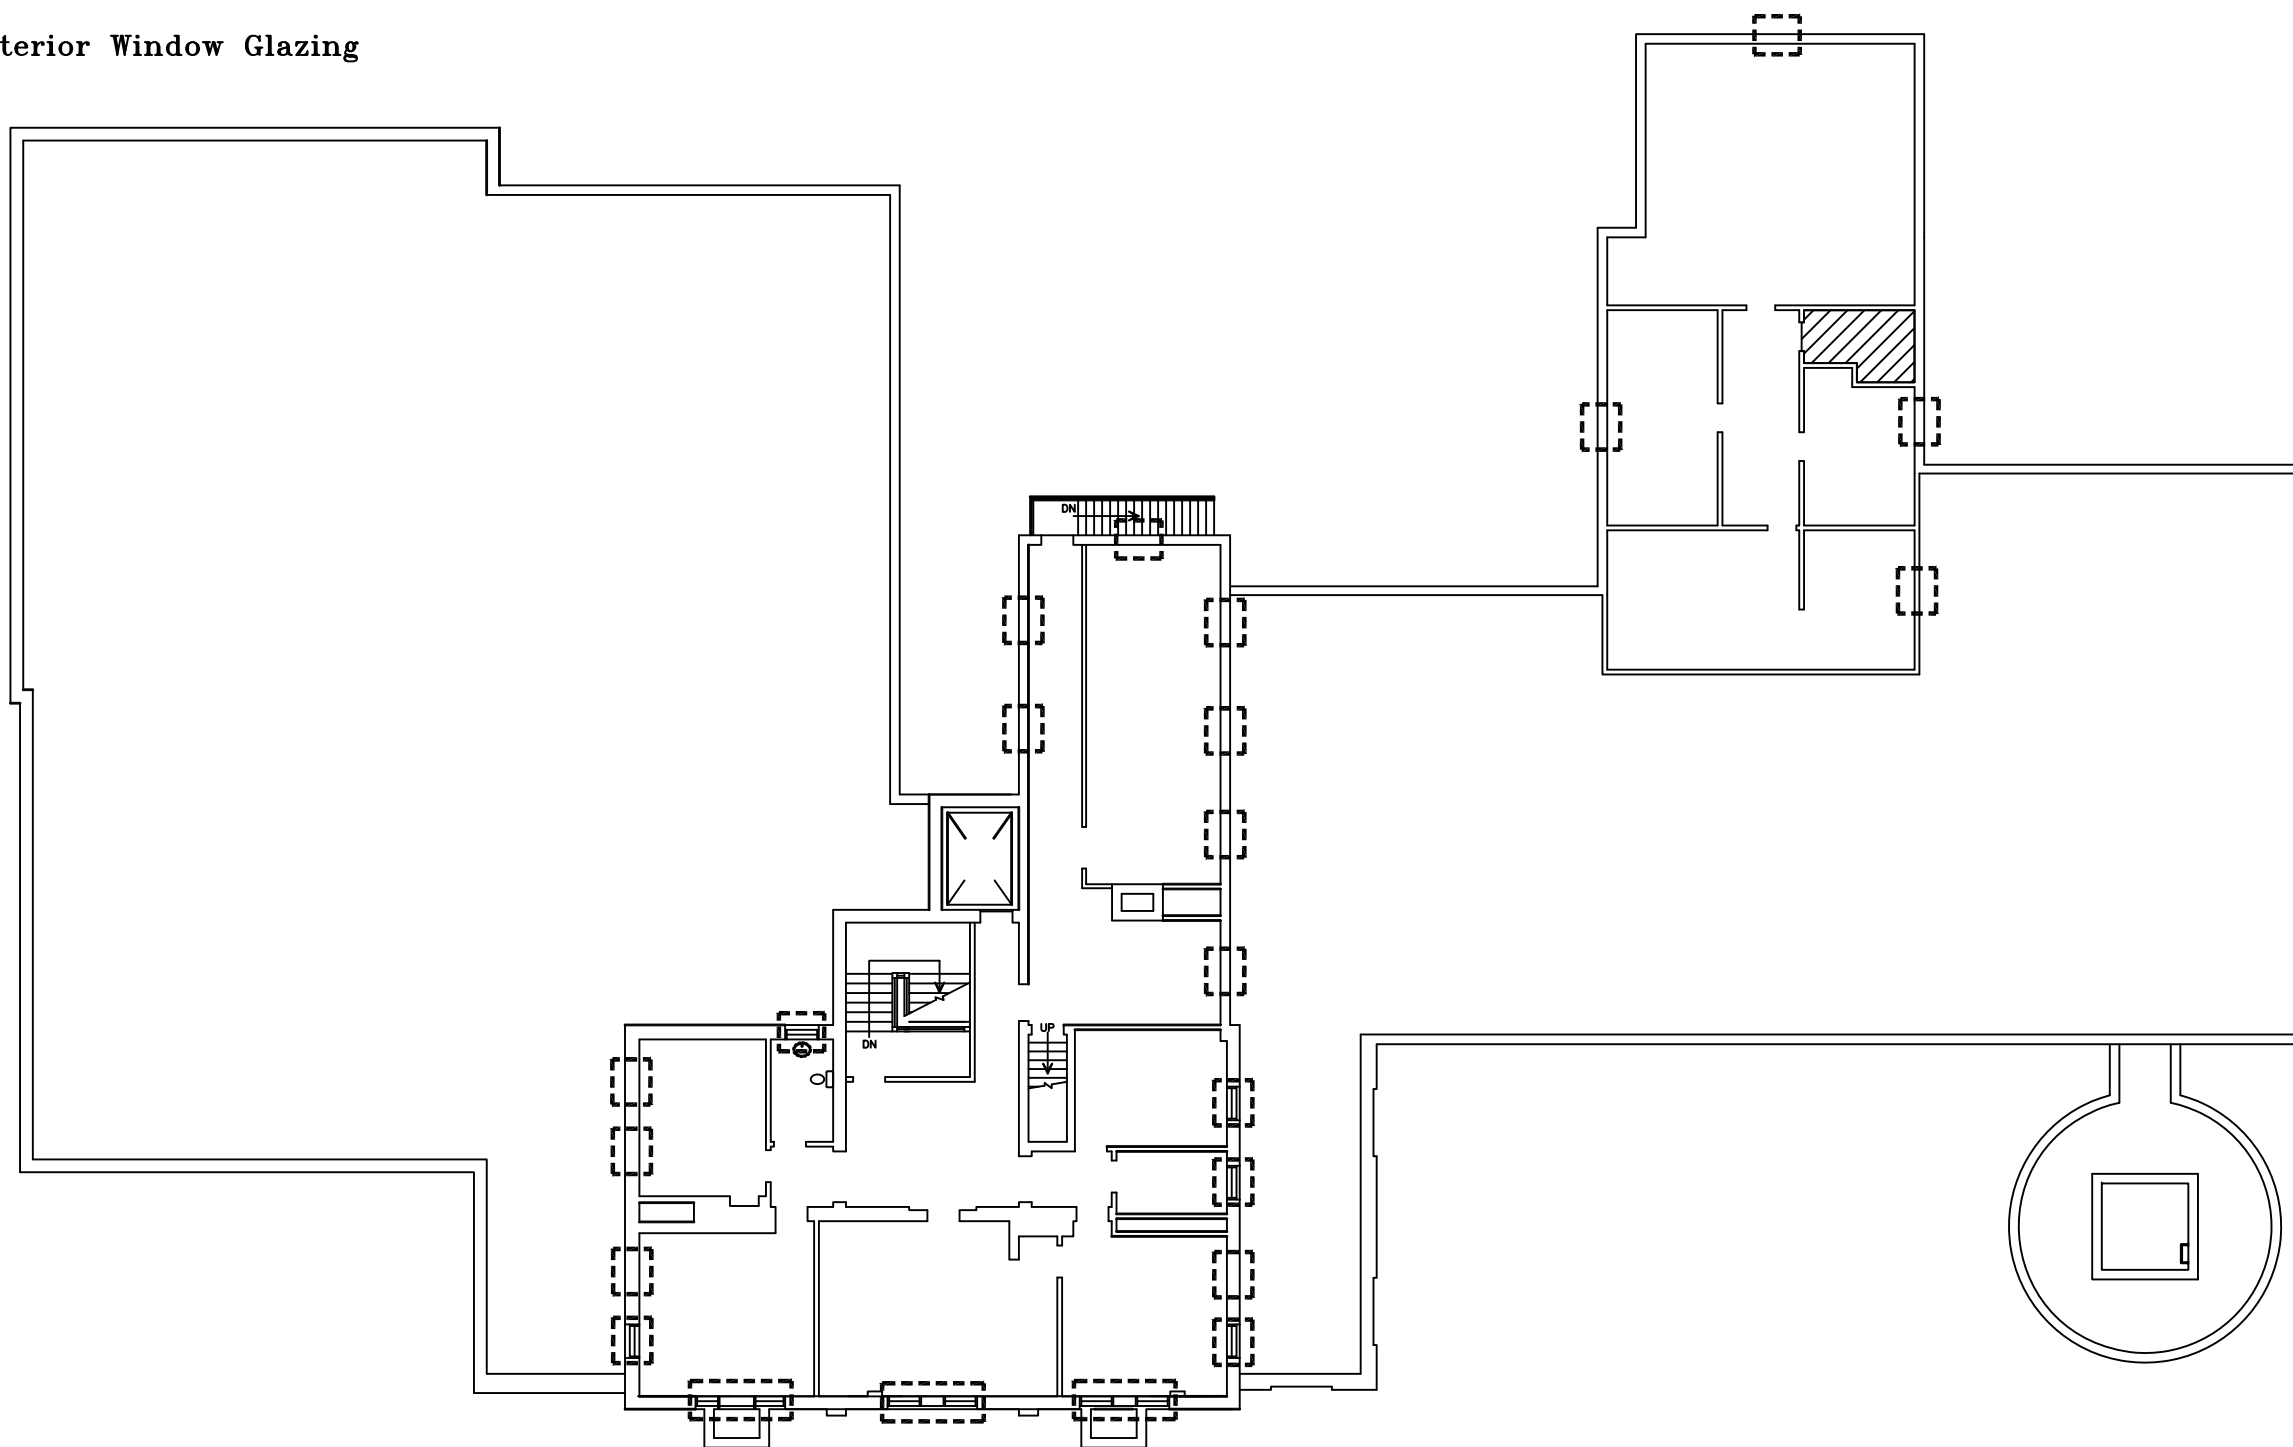
HOMOGENEOUS AREA PLAN
FUTURE USC LAW SCHOOL - BLD. #028 - 2ND FLOOR
COLUMBIA, SOUTH CAROLINA

HA-11 - Exterior Window Glazing

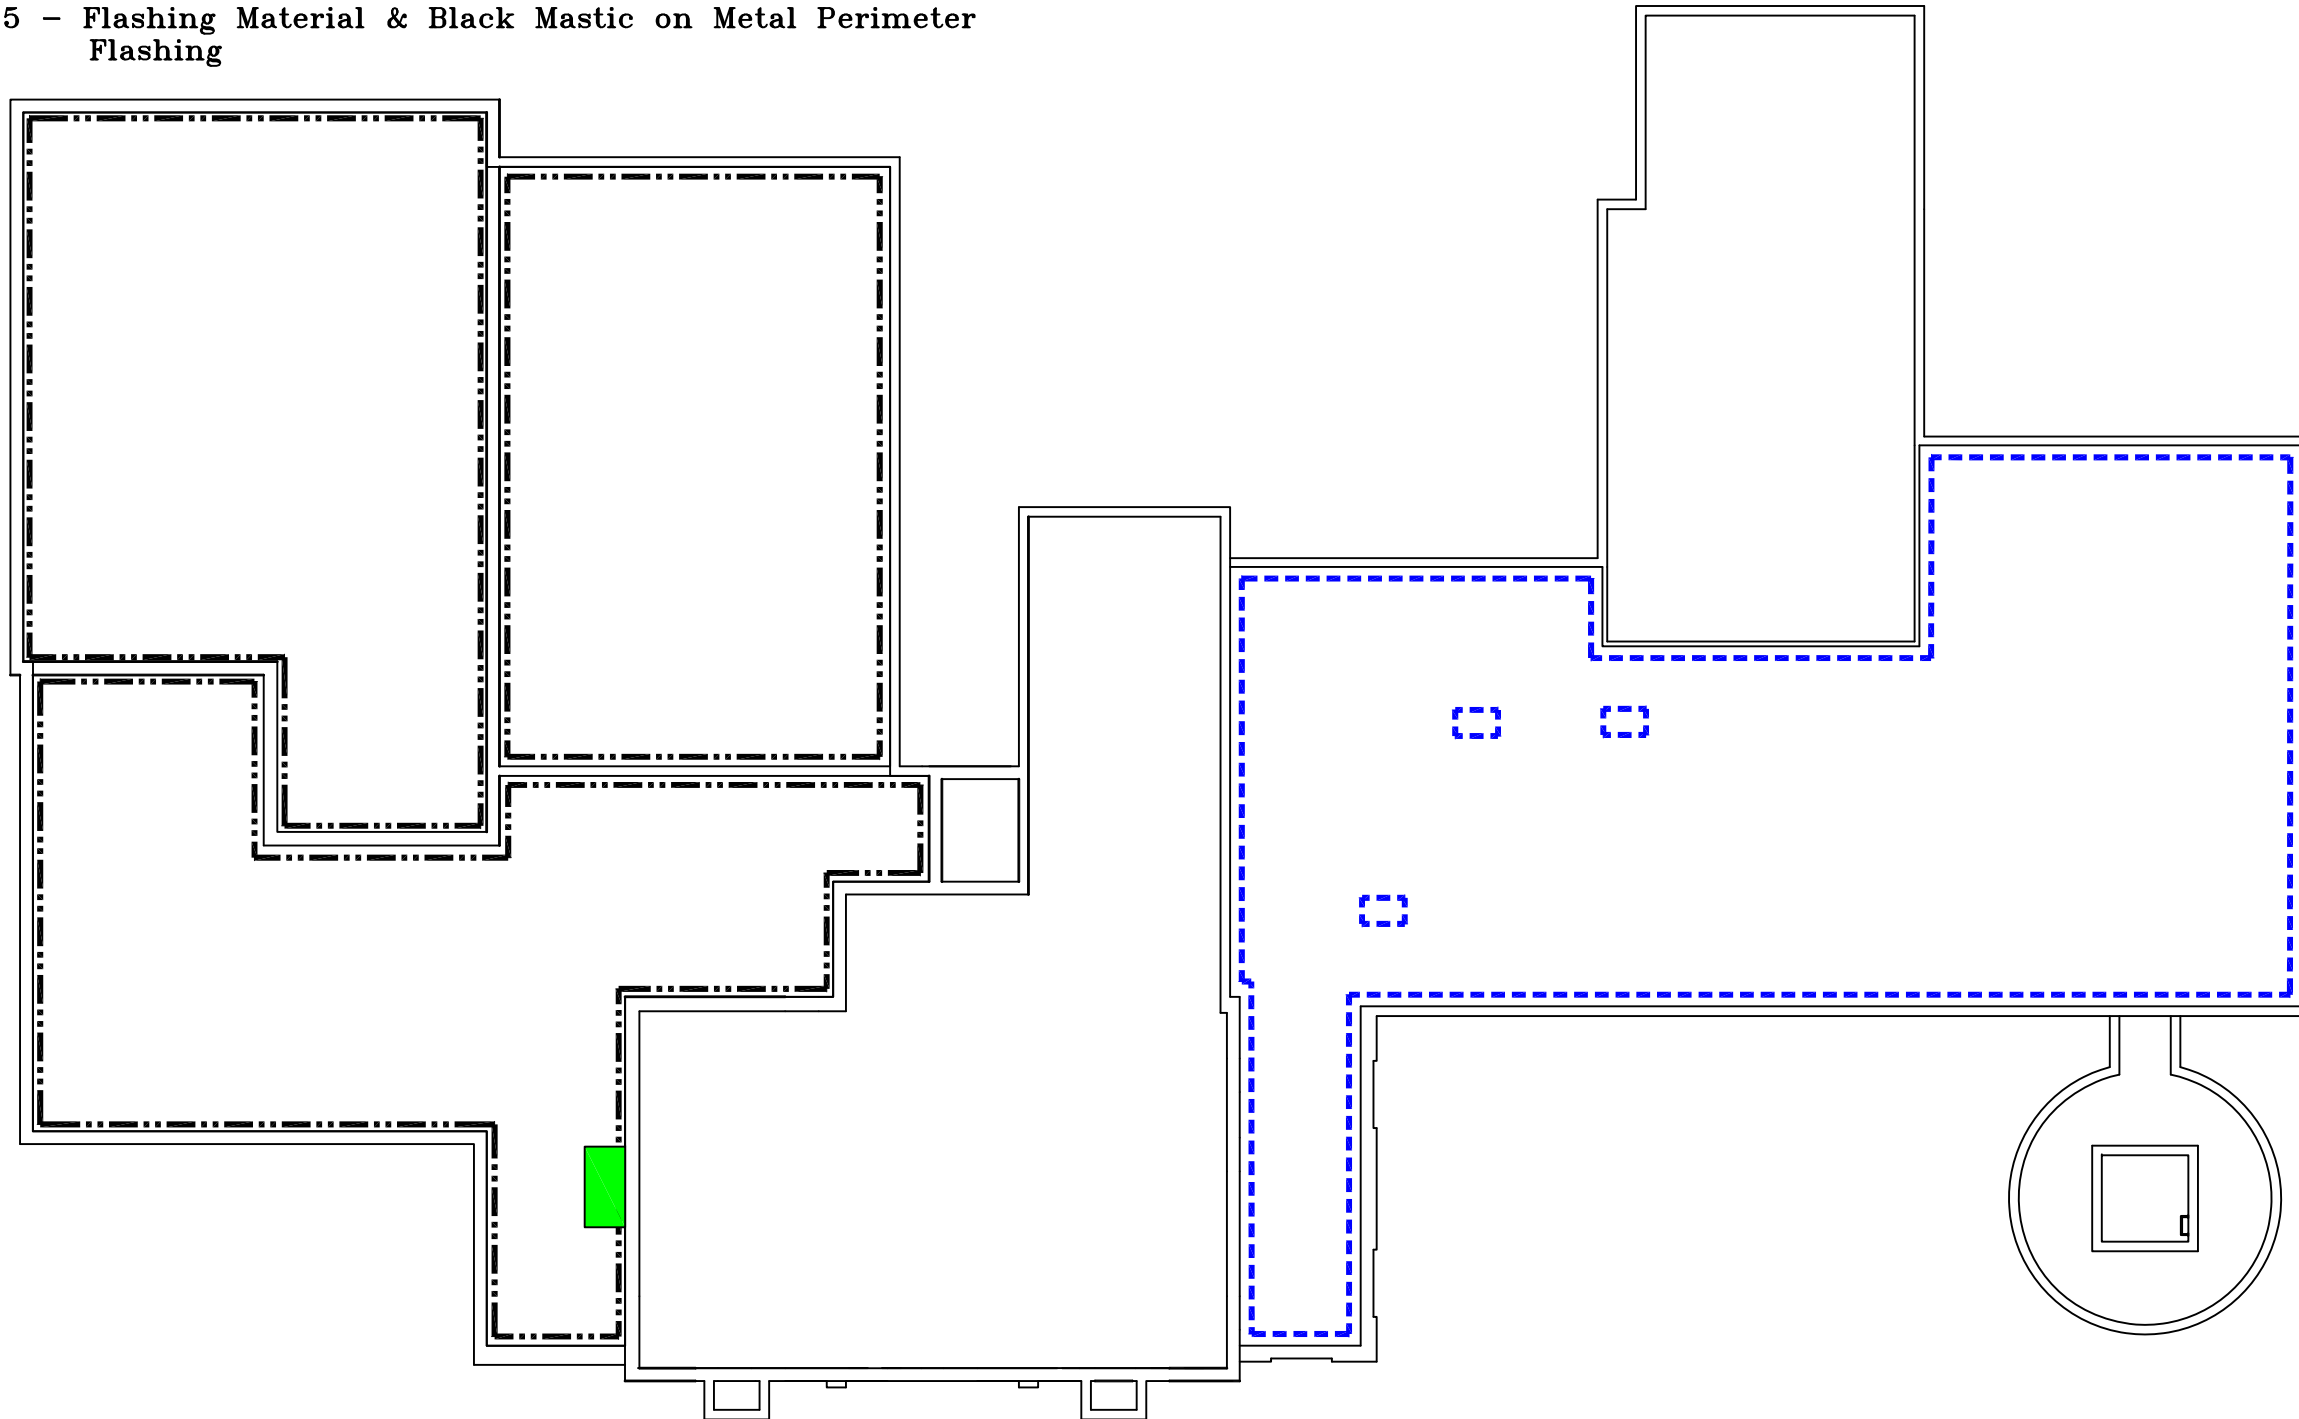
HA-14/HA-15 - Flashing Material & Black Mastic on Metal Perimeter Flashing

HA-16 - Black Flashing Mastic
