March 28, 2019

Re: Asbestos Containing Materials Re-inspection/Report Update
Bates West Residence Hall
1405 Whaley Street
Columbia, South Carolina 29208
F&ME Project No.: E6200.010

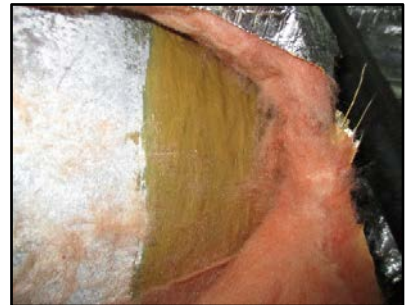
HA-20 – Olive Mastic on Metal Duct (20 SF). Asbestos-containing olive mastic found on the seams of a metal duct in mechanical room 124 under non-ACM fiberglass wrap insulation. This material was found in a good, intact non-friable condition.
