WILLIAMS BRICE STADIUM

Waterproofing (Upper East Deck)

H27-Z057

University of South Carolina

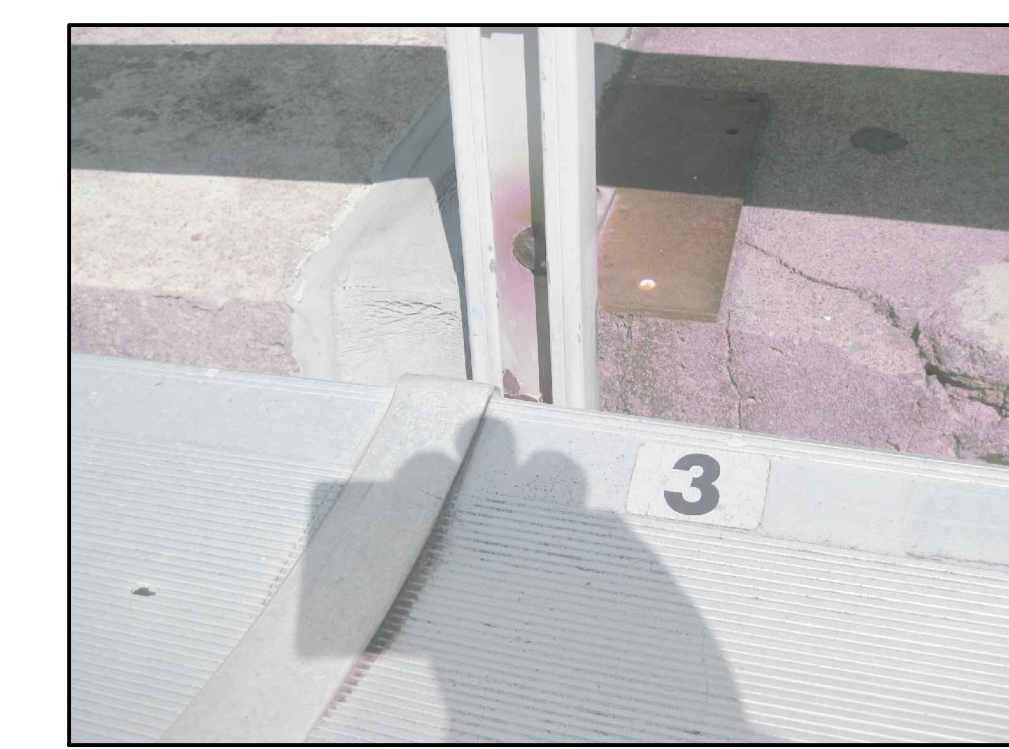
18a TYPICAL STEEL PLATE CONDITION (SOME VARY)

- SEAL ALL INSIDE CORNERS / OPEN JOINTS OF ALL STEPS FOR A WATER TIGHT CONDITION PRIOR TO WATER PROOFING.
 - REMOVE STEEL PLATES 4 PINS. REPAINT CONC. PER GENERAL NOTE # 18. APPROXIMATELY 25 CONDITIONS. FIELD VERIFY QUANTITY.

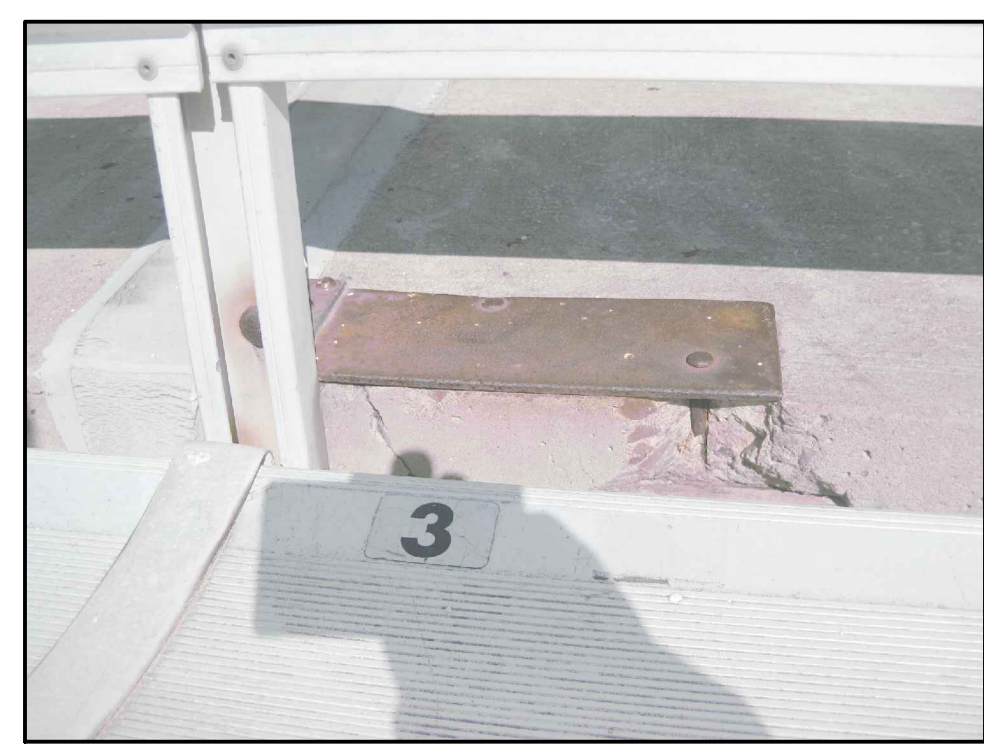
18b TYPICAL STEEL PLATE CONDITION (SOME VARY)

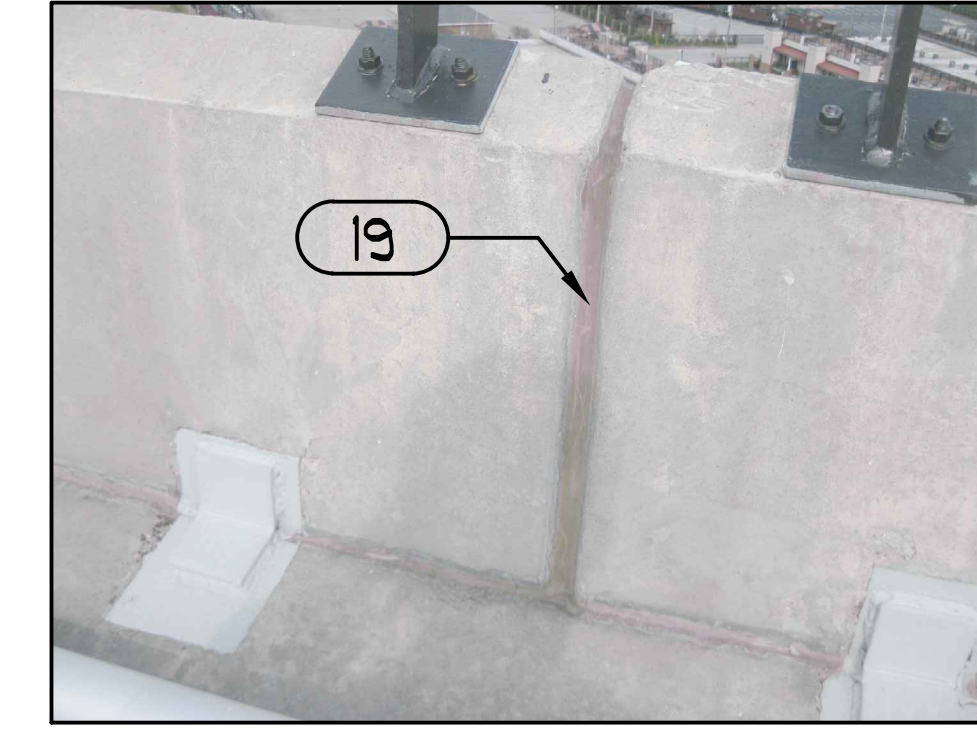
31 VERTICAL CONTROL JOINT (CJV) AT TOP WALL

- VERTICAL CONTROL JOINT AT TOP WALL. REPLACE. SEE PHOTO # 19/A203.
 - PROVIDE CONCRETE REPAIR AT SLOPED TOP WALL EDGE. TYPICAL FOR 5 LOCATIONS ALONG TOP WALL. SEE PHOTO # 32/A203.
