## Report of Eddy Current Inspection

Manufacturer: Carrier

Model: 30HXC261RZ

Location: UNIVERSITY OF SOUTH CAROLINA  
HEALTH ED CENTER  
SPARTANBURG, SC 29301

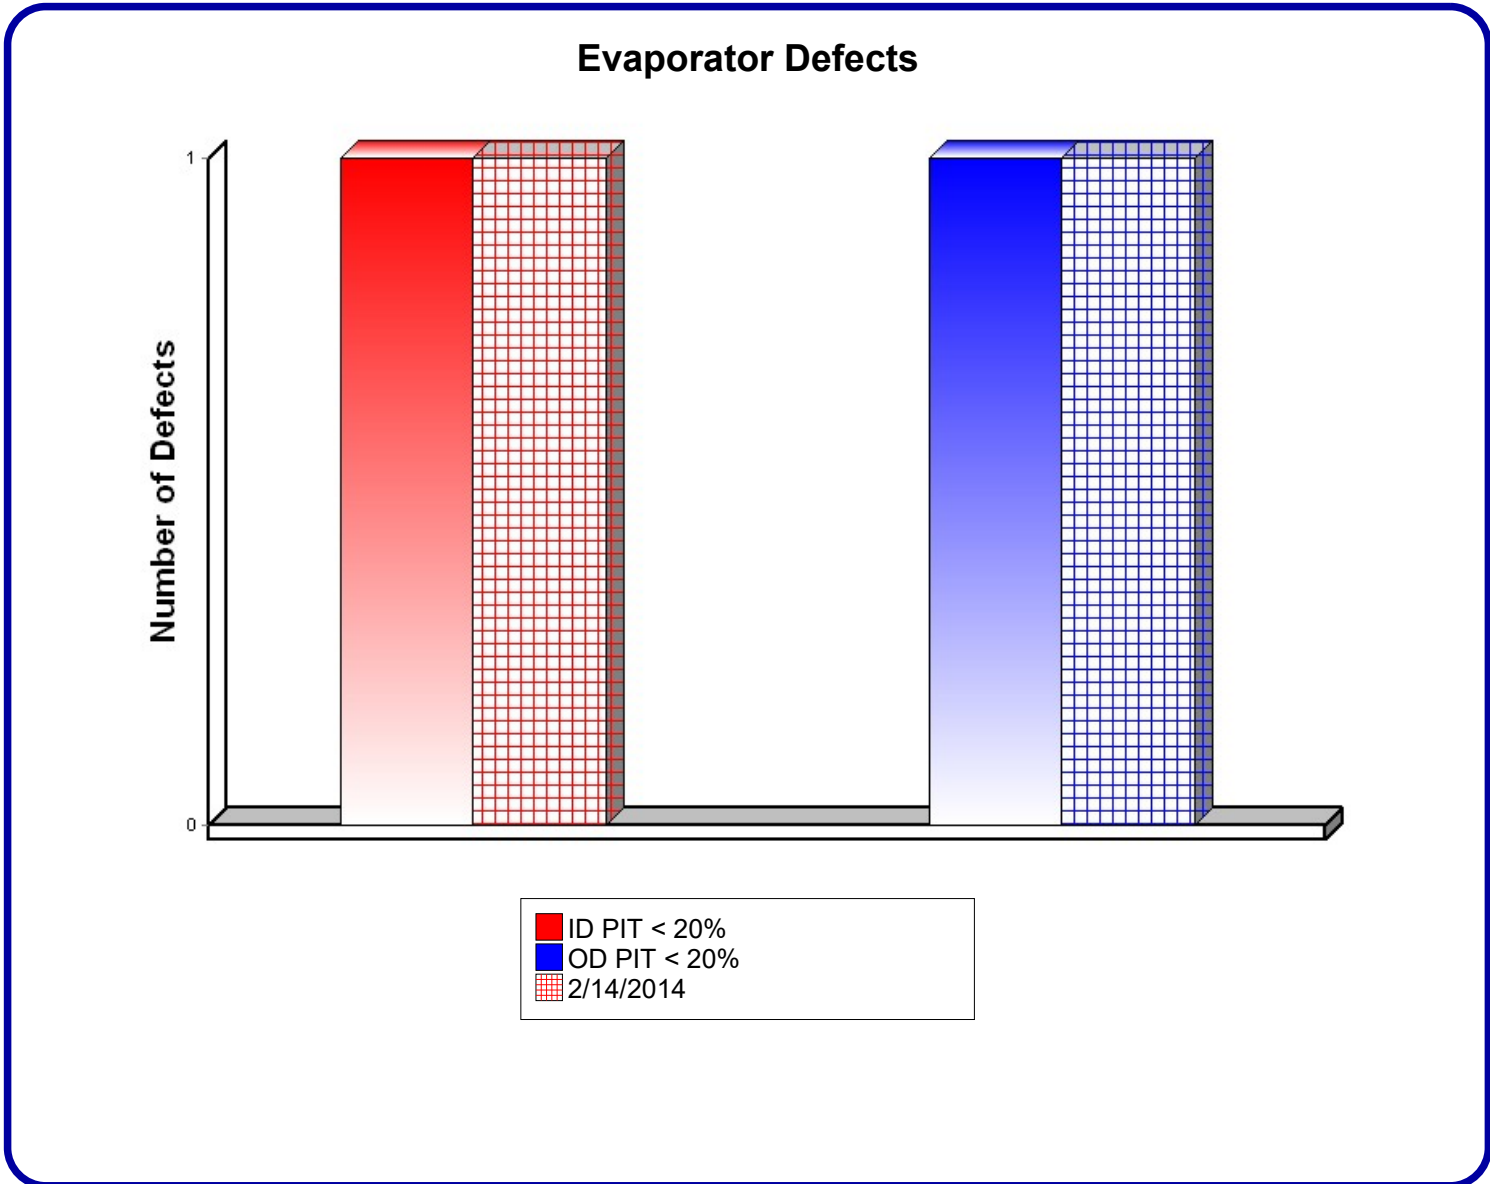
Comparison of Tests Performed

Note: A graph indicating the number of tubes marked for each category will be generated when tubes are marked. Indications from previous inspections will be displayed as cross hatch bars.

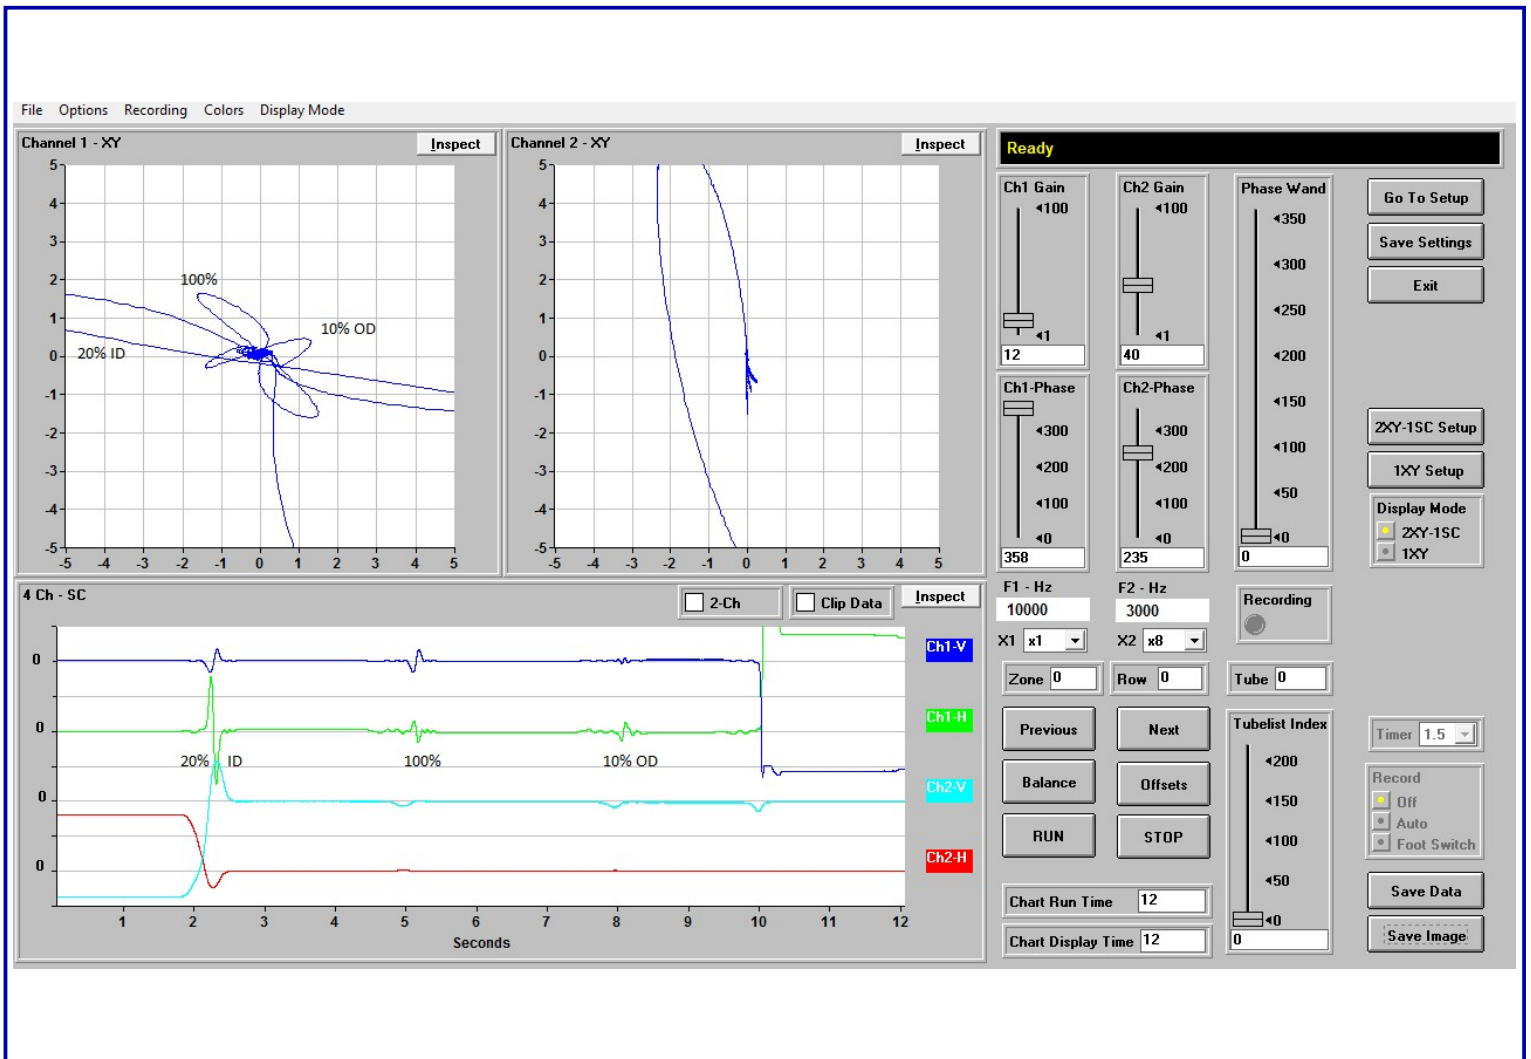
Condenser

There were no measurable defects noted during this inspection.

Note: Defects are compared to machined standards.  
Actual Defect Geometry may differ.

NO SIGNIFICANT DEFECTS (Row 1 Tube 1)

NO SIGNIFICANT DEFECTS (Row 5 Tube 2)

NO SIGNIFICANT DEFECTS (Row 8 Tube 8)

NO SIGNIFICANT DEFECTS (Row 12 Tube 12)

NO SIGNIFICANT DEFECTS (Row 15 Tube 5)

NO SIGNIFICANT DEFECTS (Row 17 Tube 14)

Condenser: 29 March 2022

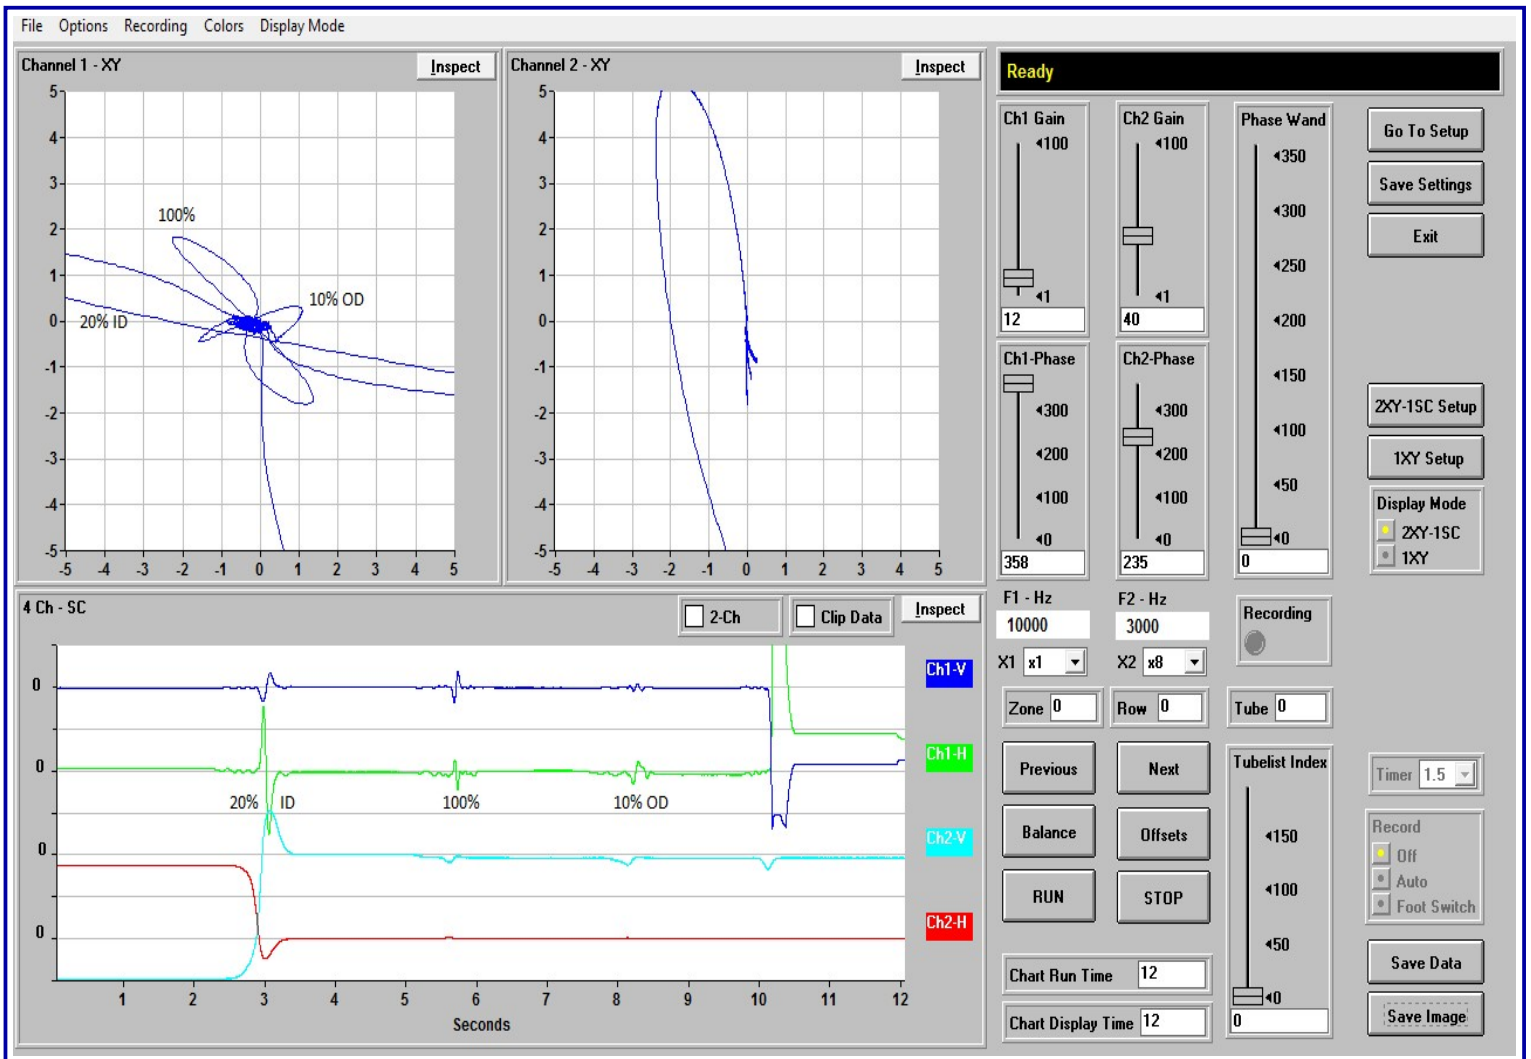
Evaporator

Tubes indicating ID Pits require no immediate corrective action. However, this type damage is usually progressive and should be monitored.

The OD Pits detected are considered minor and require no immediate corrective action, but should be monitored for defect growth.

Note: Defects are compared to machined standards.  
Actual Defect Geometry may differ.

NO SIGNIFICANT DEFECTS (Row 1 Tube 1)

NO SIGNIFICANT DEFECTS (Row 4 Tube 2)

NO SIGNIFICANT DEFECTS (Row 8 Tube 4)

NO SIGNIFICANT DEFECTS (Row 12 Tube 6)

Evaporator: 29 March 2022
