PRELIMINARY REPORT
HULL CONSTRUCTION FEATURES OF THE
BROWN'S FERRY VESSEL

J. Richard Steffy
Institute of Nautical Archeology
College Station, Texas

Prepared by the
INSTITUTE OF ARCHEOLOGY AND ANTHROPOLOGY
UNIVERSITY OF SOUTH CAROLINA
February 1979

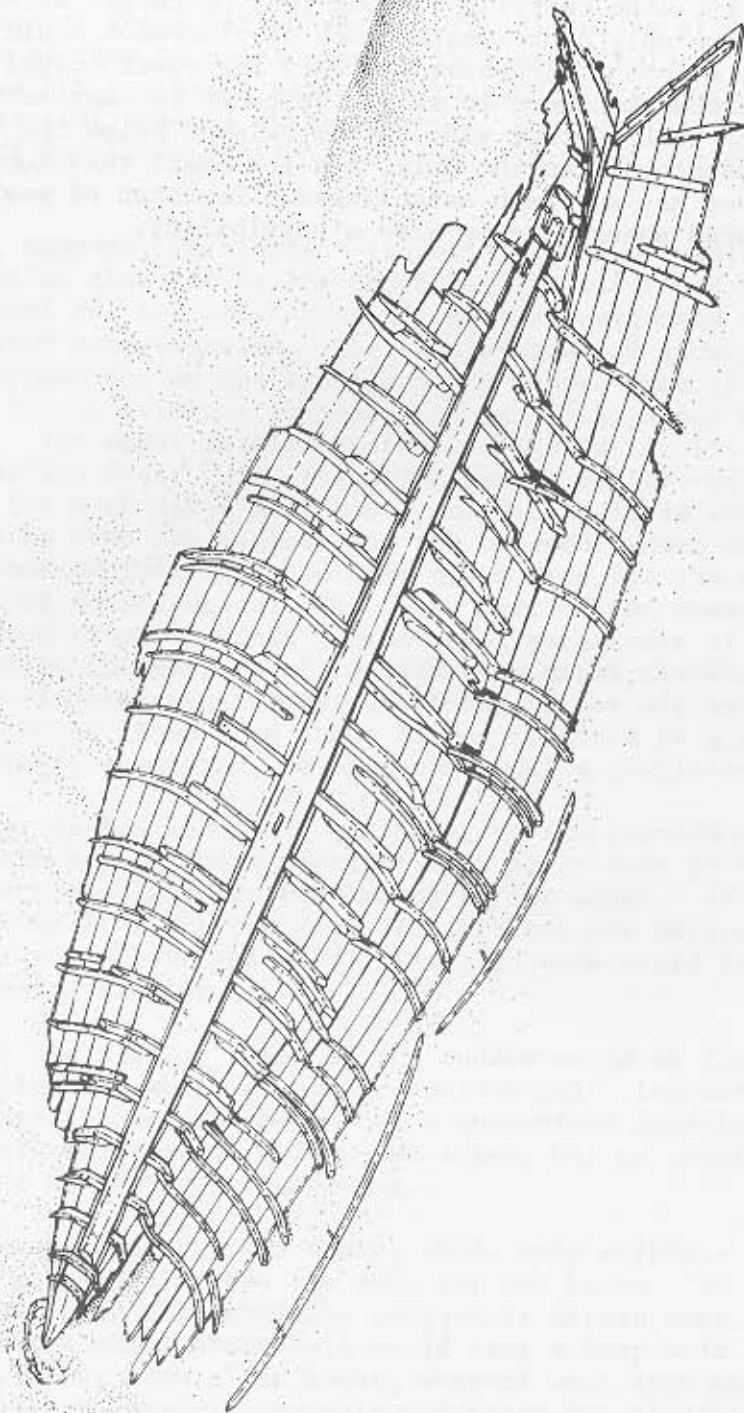
Figure 13: A reconstruction of the sternpost, sheer and upper bow
(Drawing by Darby Erd).

Thus, the hull was shallow enough to operate in shoal waters but full enough in the hold to accommodate a sizeable cargo. Even the keelson was laid flatwise to increase hold volume. The drawing indicates a hull with a little over three feet of hold depth, and less than three feet of draft when carrying 25 long tons of cargo. Although our calculations are only approximate, such displacement would give the vessel only about a foot of freeboard--plenty for river travel but a bit slight if this merchantman were to skirt the coast to Charleston. There is a possibility that another side strake existed below the wale, since the wale was detached from the hull, and its exact relationship to other side strakes has not been established. Erection of weatherboards above the indicated sheer line is also a possibility.

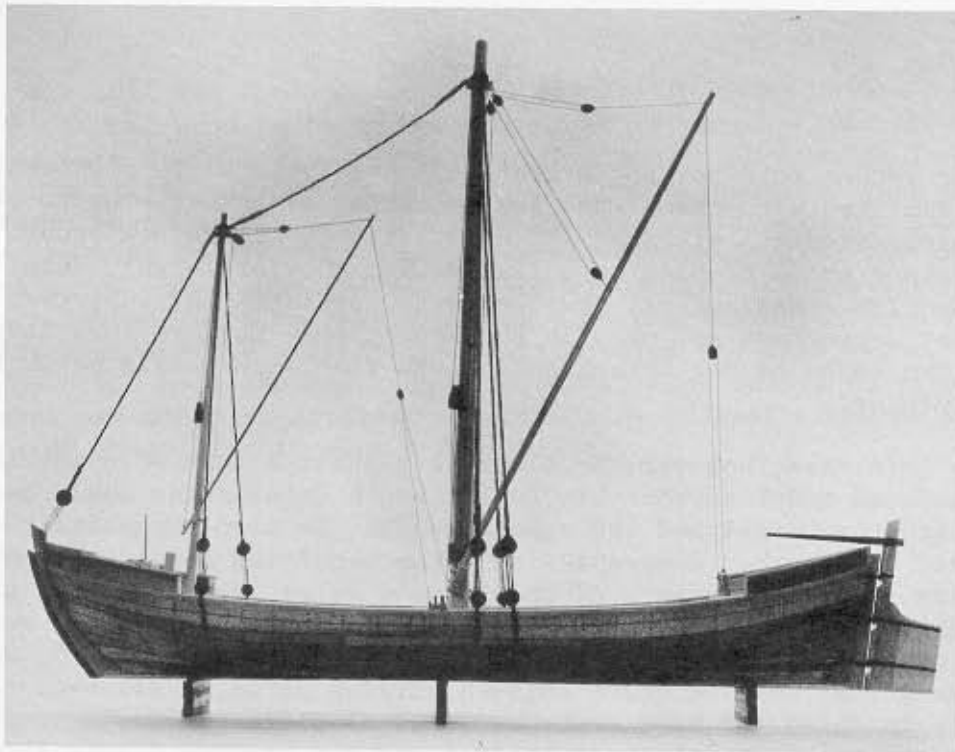
Not a hint for the size or shape of the rudder could be found, so that we have installed one which is purely conjectural. Leeboards have often been suggested and may have been a convenient addition, especially if the rig was that of a fore-and-after, but we considered such an installation to be too presumptuous.

Decks were installed at bow and stern, while only walkways covered the hold along the sides and across the main partner beams. It seems unlikely that so shallow a hold would be completely decked over, and equally unlikely that a shoal draft hull would have a deep hold. A single shelf clamp, along with a few knees, support what deck beams were necessary. Weather boards, removable amidships for loading, offered additional freeboard for coastal travel. A small galley stove, made of brick and situated under the foredeck, supported culinary efforts.

Figure 14: The completed model. Rigging, rudder, and topside details are conjectural (Photo by Gordon Brown).

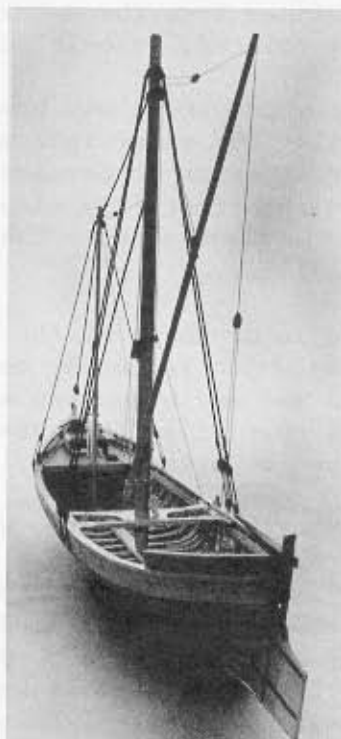
Figure 15: Stern view, port side (Photo by Gordon Brown).

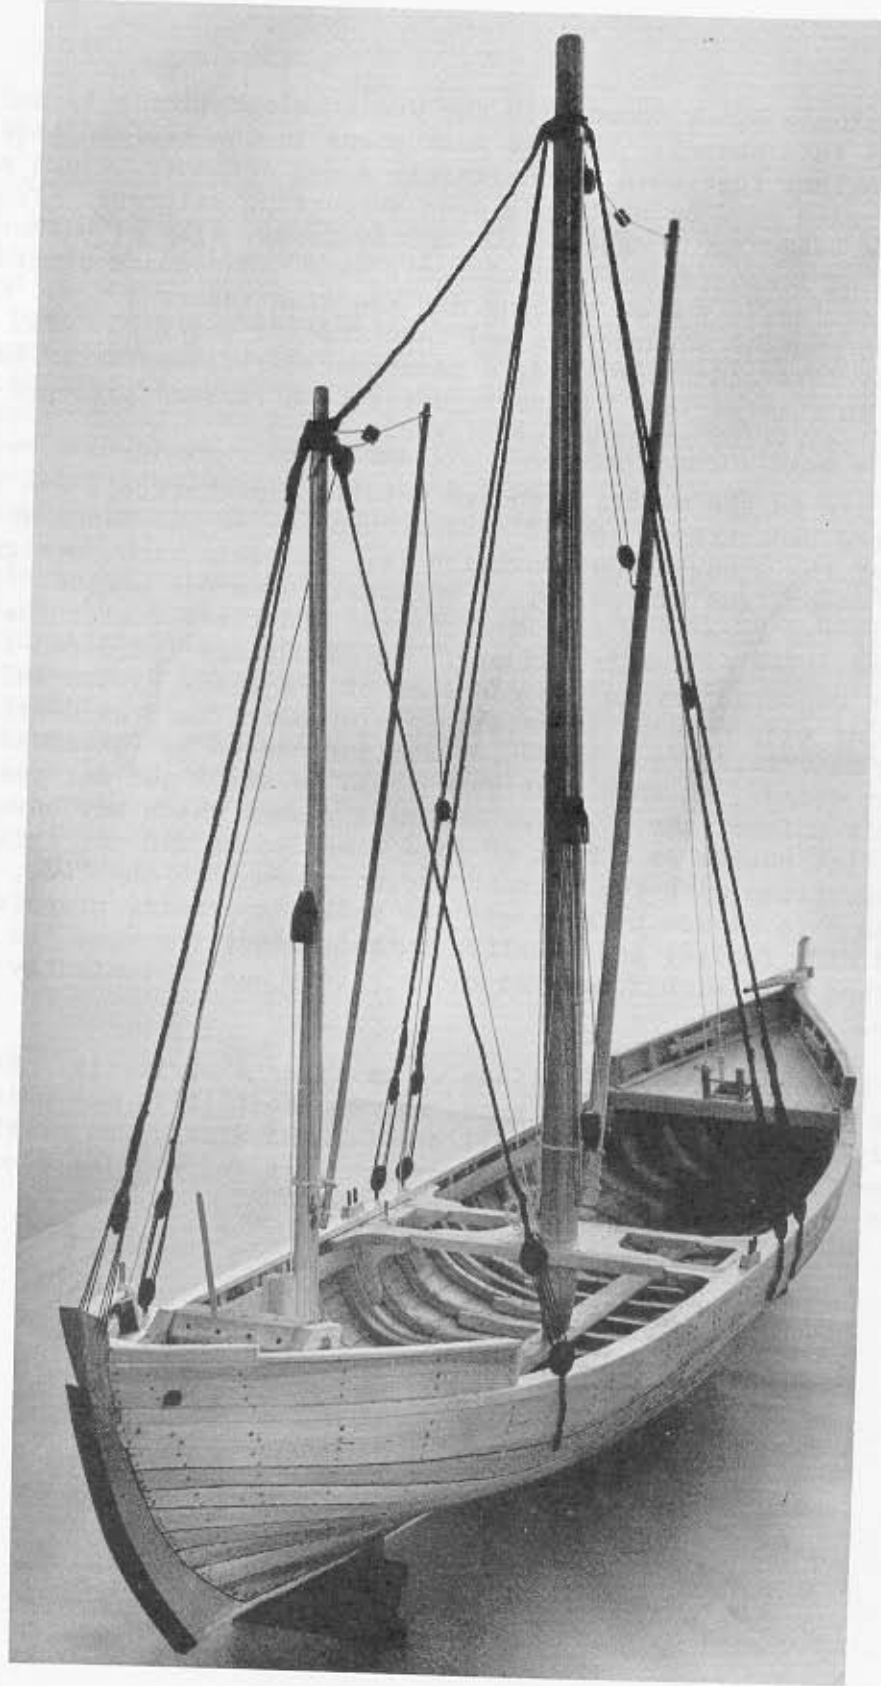
Figure 16: Bow view, port side (Photo by Gordon Brown).
