CBM COMPONENT TESTING AT THE UNIVERSITY OF SOUTH CAROLINA: AH-64 TAIL ROTOR GEARBOX STUDIES

Nicholas Goodman^a, Abdel Bayoumi^a, Vytautas Blechertas^a, Ronak Shah^a, Yong-June Shin^b

Condition-Based Maintenance Research Center

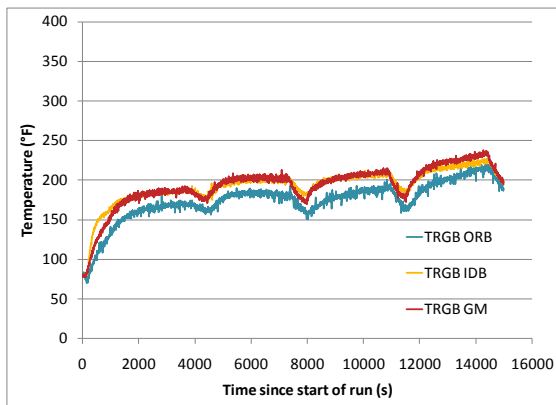
Figure 12 - Temperatures of the three measured locations on Article 3 prior to fault seeding

Temperature readings taken from Article 3 prior to fault seeding show that even in a properly serviced gearbox, slight thermal gradients exist between various regions in the assembly (Figure 12). Plotting these values over the course of the four-hour run intervals illustrates the effect that torque loading has on overall gearbox temperatures. The four wide regions of increasing temperatures correspond with the approximately 50 minutes of loading, while periods of cooling are caused by the 10 minute load reduction during MSPU survey measurements.
