CBM COMPONENT TESTING AT THE UNIVERSITY OF SOUTH CAROLINA: AH-64 GEARBOX GREASE STUDIES

Nicholas Goodman^a, Abdel Bayoumi^a, Vytautas Blechertas^a, Ronak Shah^a, Yong-June Shin^b

Condition-Based Maintenance Research Center

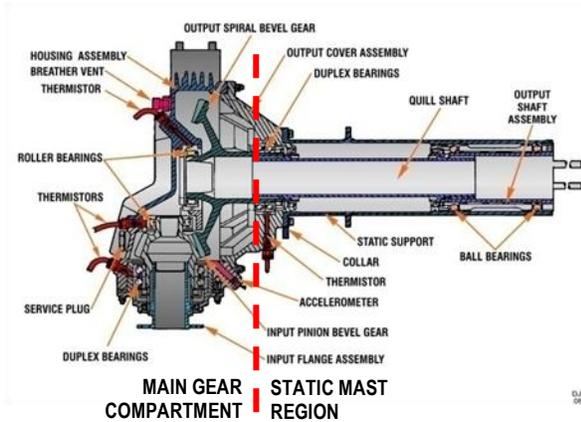
Figure 5 - Internal components of an AH-64 tail rotor gearbox

In a separate study, three AH-64 Tail Rotor Gearboxes were tested to identify the survivability of the output shaft assembly ball bearings in a seeded-fault leaking output seal condition. Motivating this study was the Army required practice of replacing Tail Rotor Gearboxes at the first sign of an output seal leak. This was due to the perception that the

static mast of the gearbox was sealed from the main compartment, meaning that static mast grease levels could not be observed or serviced (Figure 5).
