ADDENDUM NO. 1

PROJECT: USC BARNWELL COLLEGE FIRE ALARM

STATE PROJECT NO.: H27-I851

LIMITED ASBESTOS AND LEAD INSPECTION REPORT

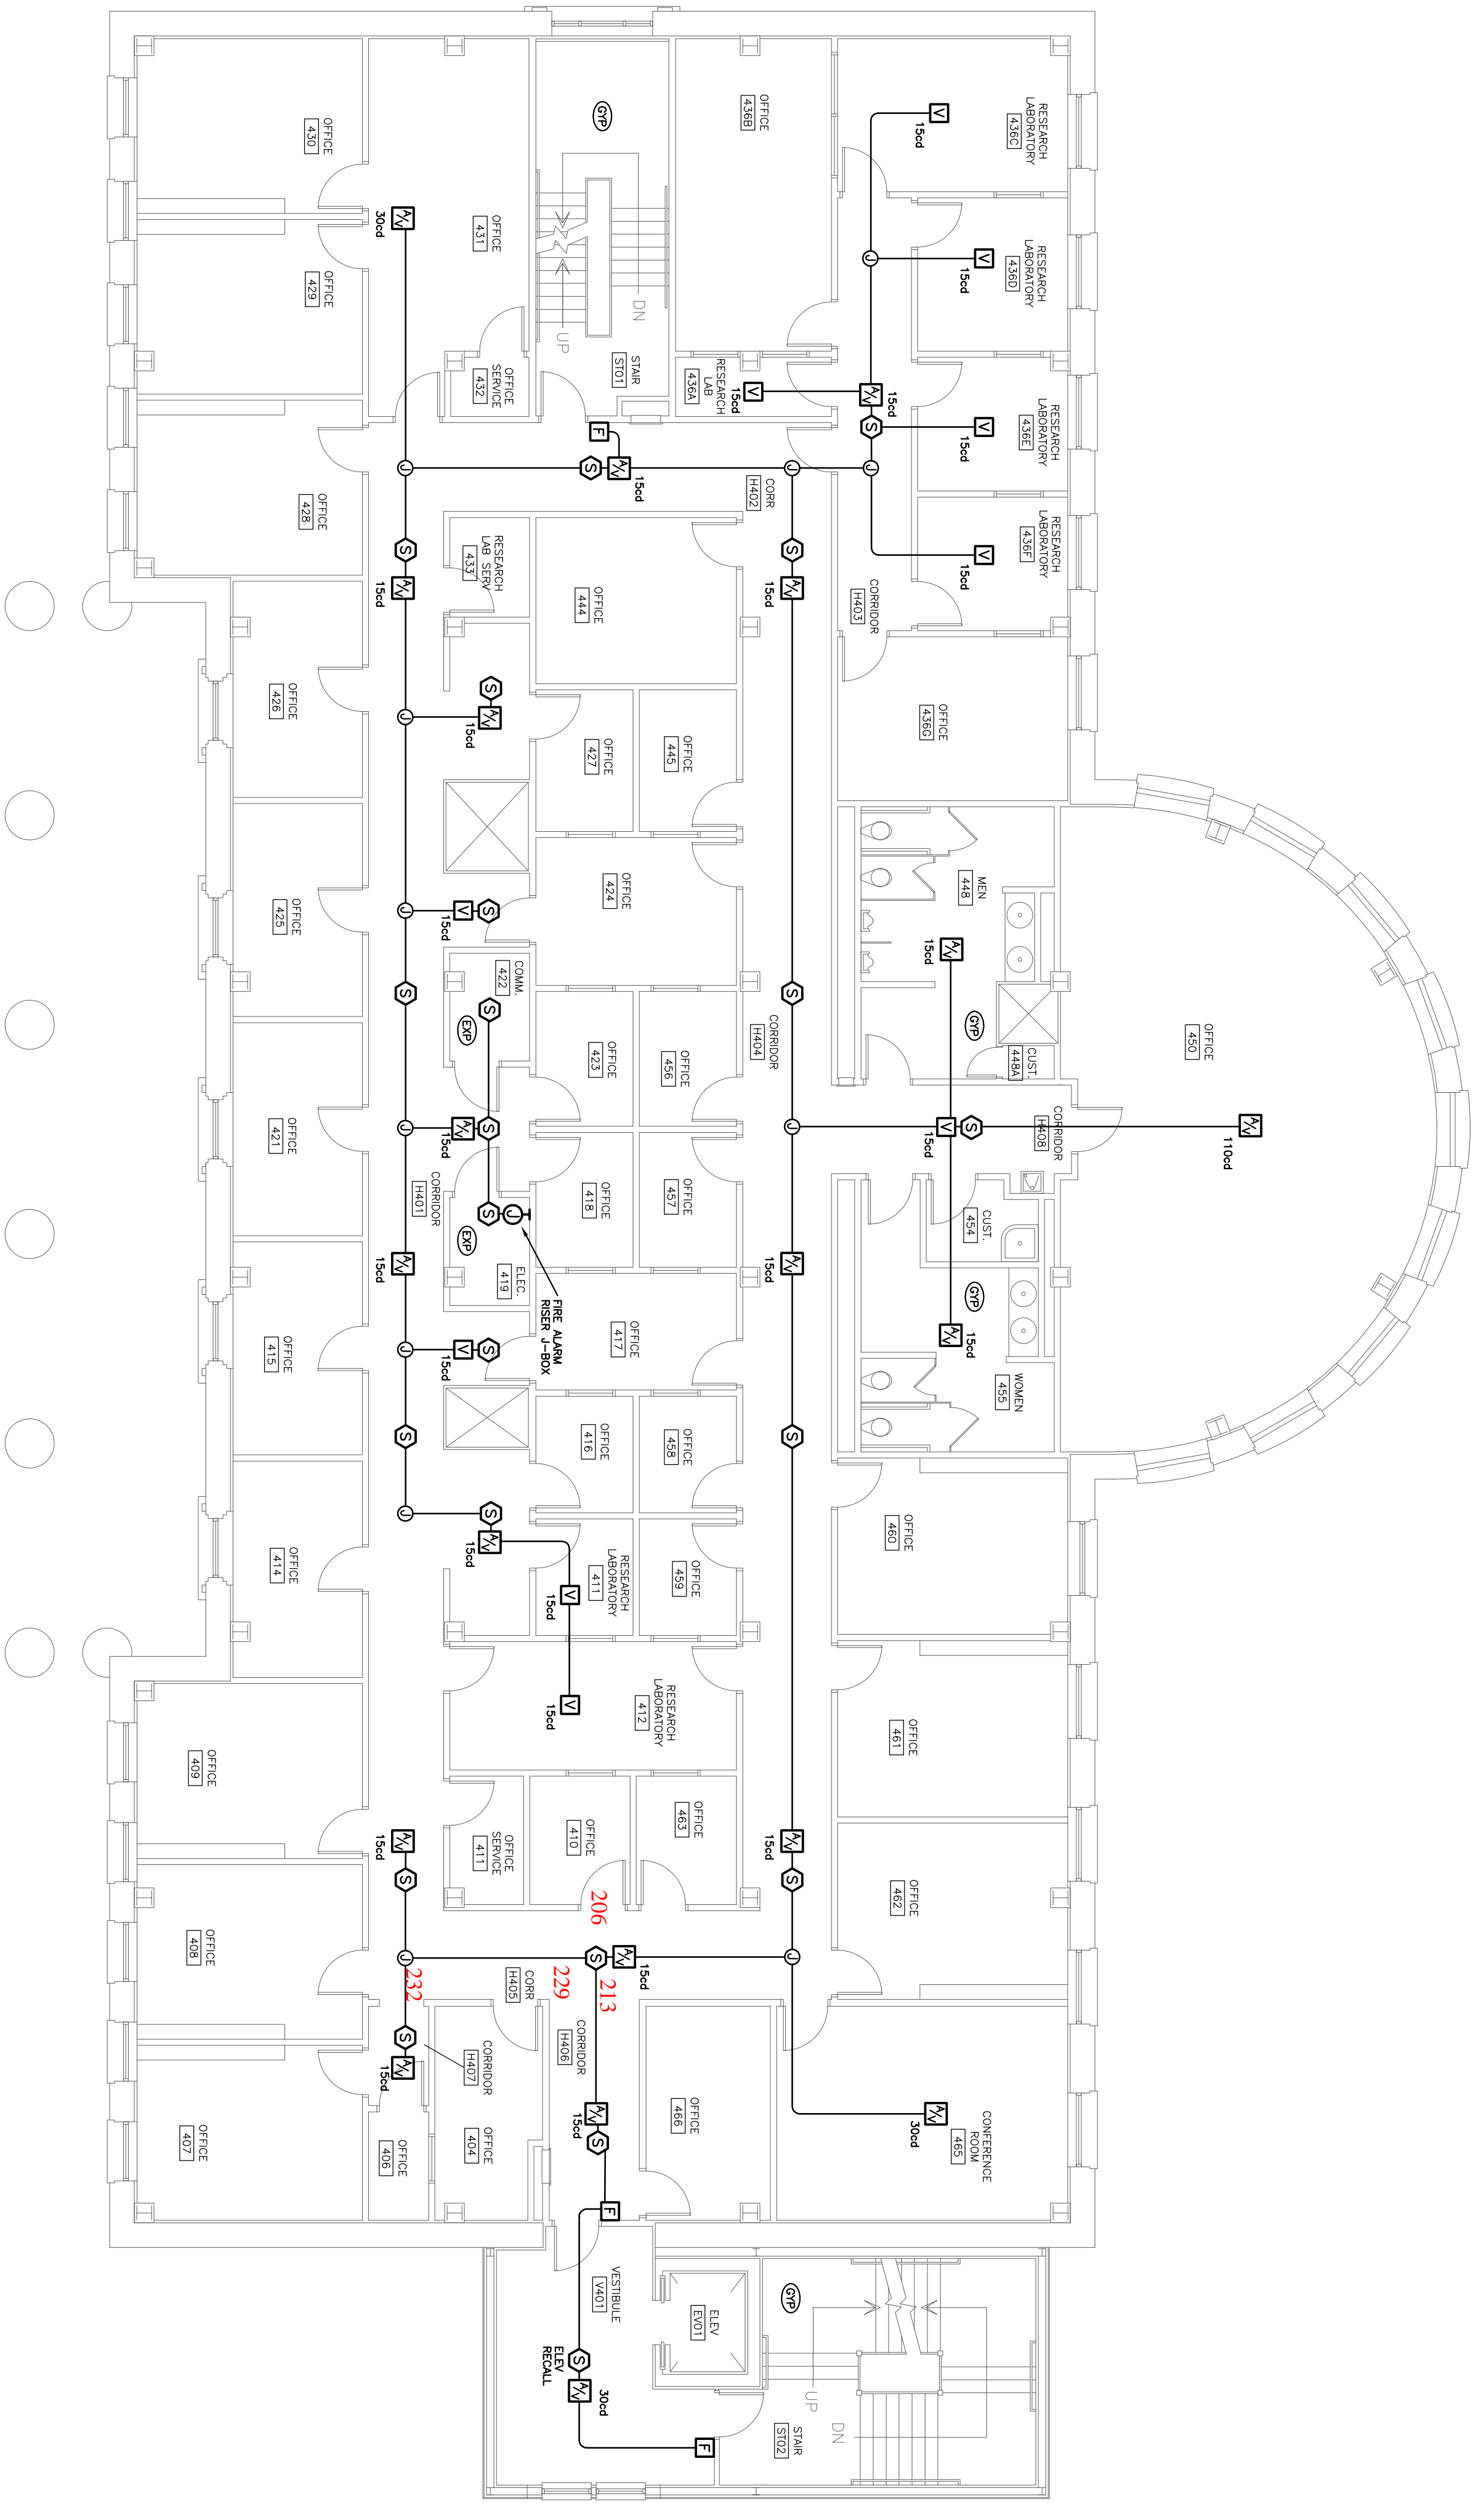
FOURTH FLOOR FIRE ALARM PLAN

1
E2.4
