THE PIMLICO SHIPWRECK PROJECT (PART I)

By Lynn Harris

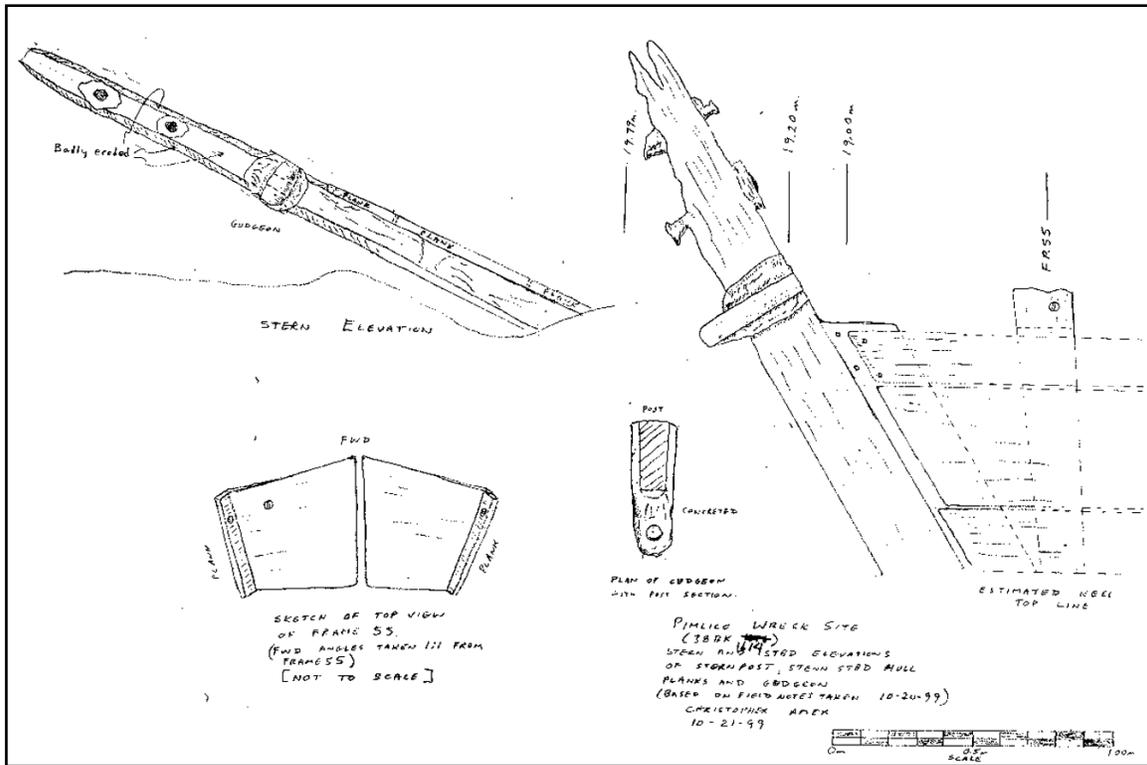
Figure 1: Sketch drawing of stern section of Pimlico Wreck (drawn by Christopher Amer).
