CHRISTOPHER F. AMER

The Malcolm Boat: A Preliminary Report

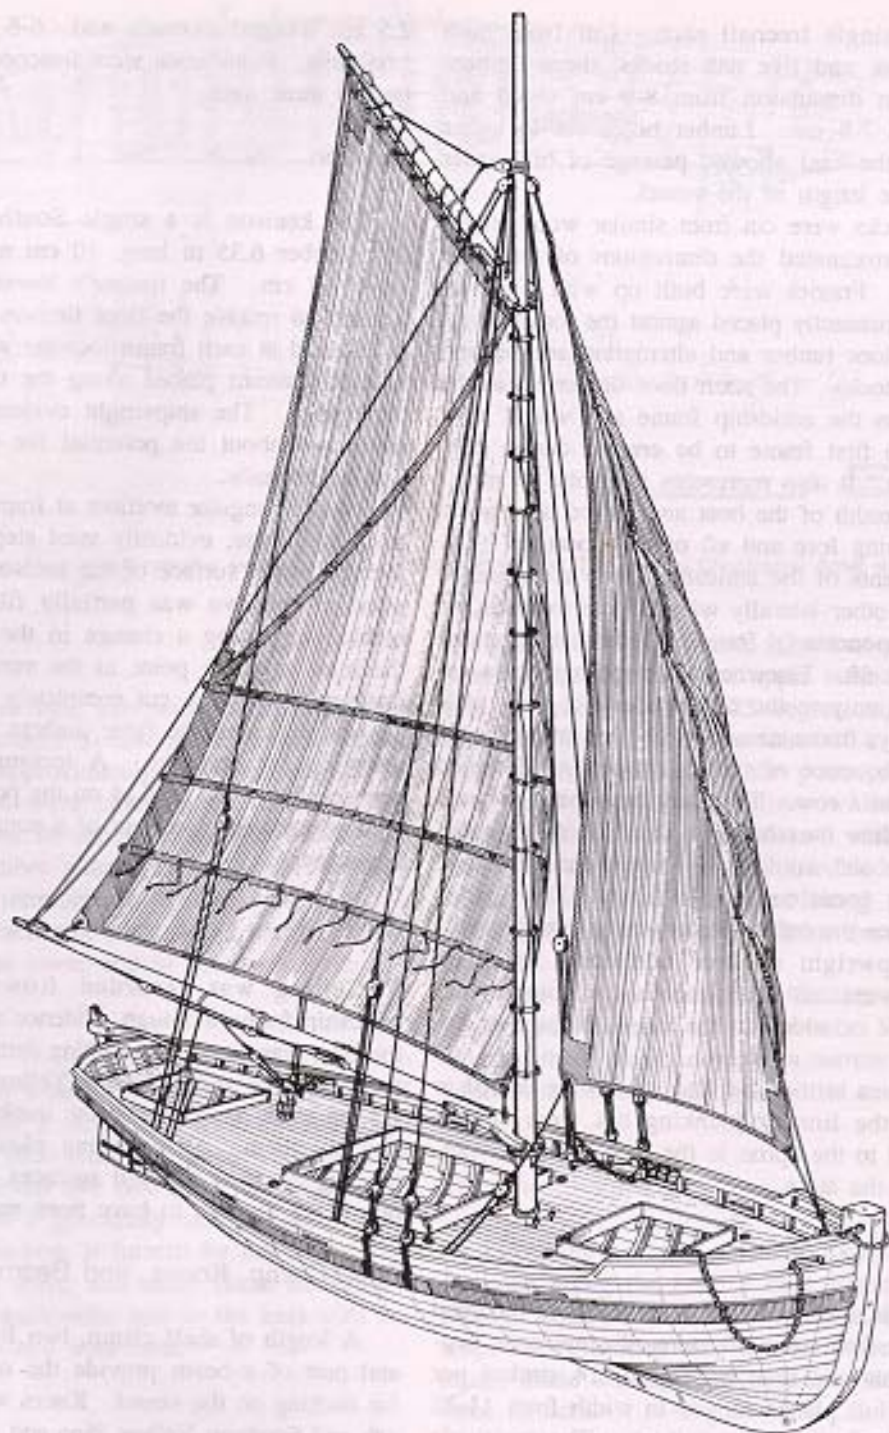
FIGURE 3. Preliminary reconstruction of the Malcolm Boat. Drawing by William Judd.

Analysis of the remains reveals a round hulled, keeled vessel with a transom stern (Figure 3). The reconstructed hull is 12 m long has a beam of approximately 4 m and an estimated depth of hold of 1.7 m. A displacement of approximately 23 tons is suggested. The vessel had a fairly sharp entry below the waterline. She had a full bodied midsection that carried aft to the transom. The construction features observed on the hull, numerous made frames along the cargo area of the hull and flexible end timbers, additional futtocks installed and a keelson notched over and fastened to each frame, suggest a boat designed with the ability to carry heavy loads. Yet the hull would have had a graceful shape and was no doubt pleasing to the eye.
