Report of Soil Gas Assessment

USC FOOTBALL PRACTICE FACILITIES NATIONAL GUARD ROAD, COLUMBIA, SC

December 30, 2013 Terracon Project No. 73137036

Prepared For: University of South Carolina Campus Planning and Construction Columbia, SC

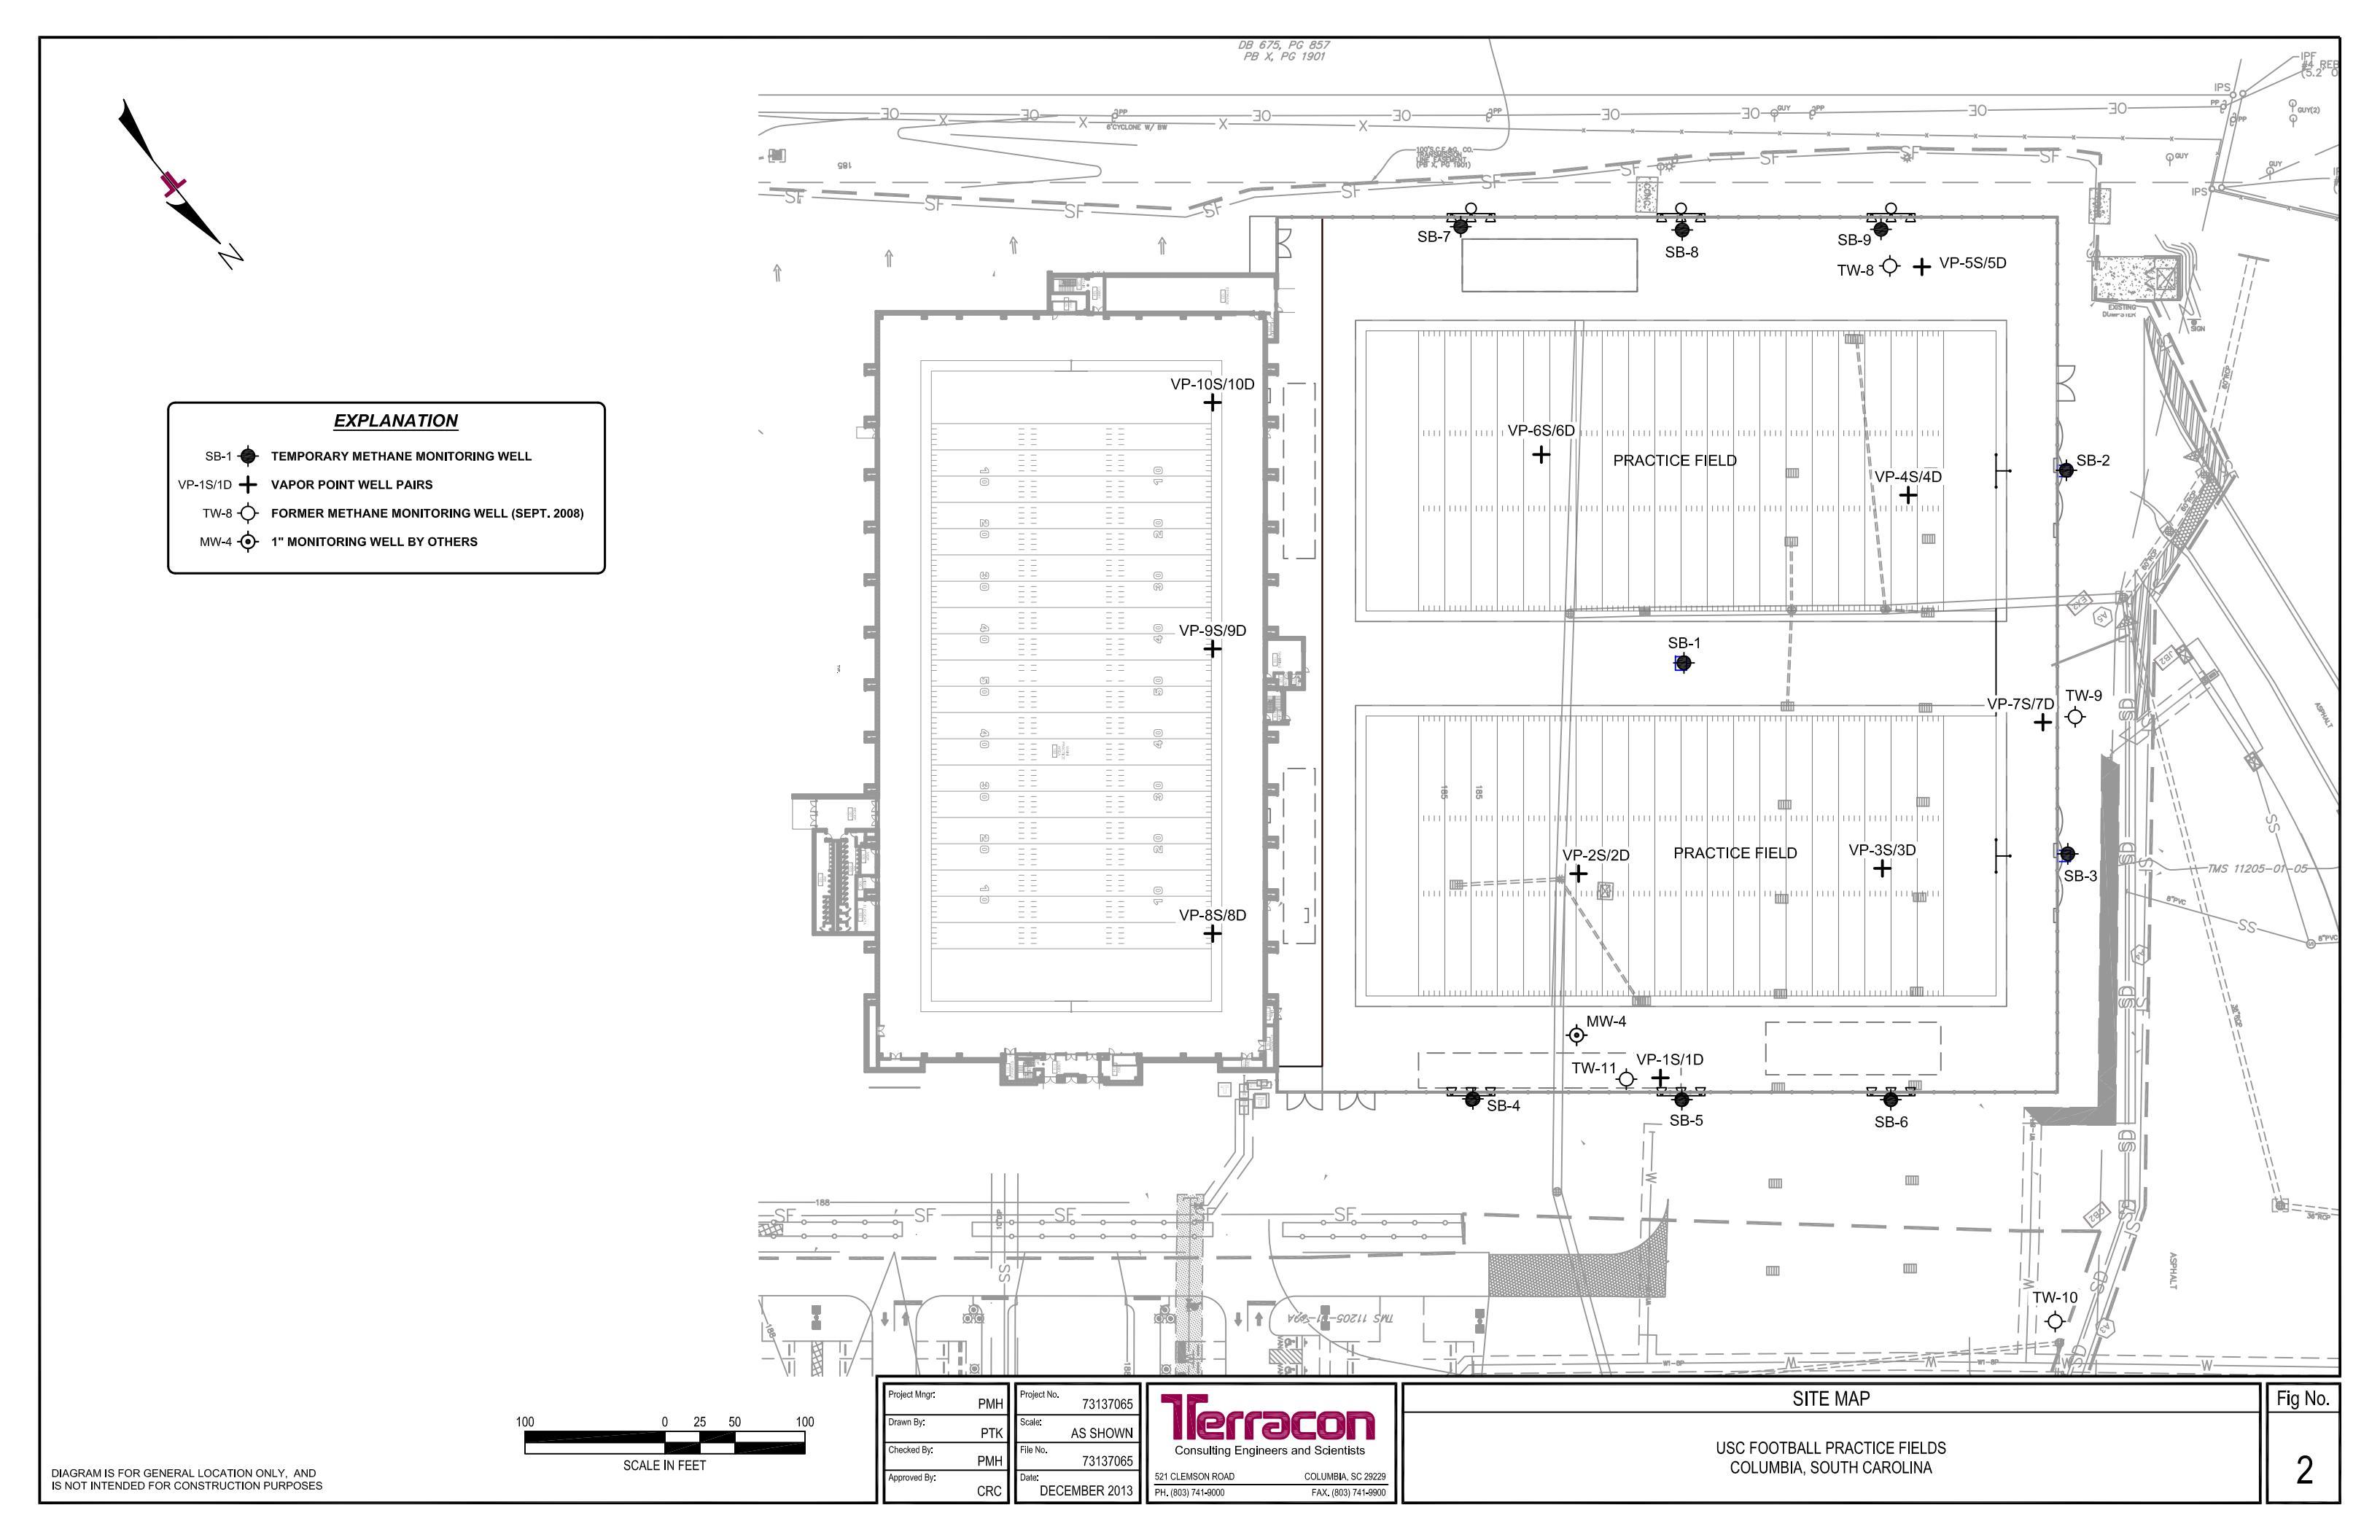
The shallow/deep vapor points were installed as separate borings, approximately five-feet apart. Figure 2 is a site plan that indicates the approximate locations of the vapor points relative to the proposed construction area.

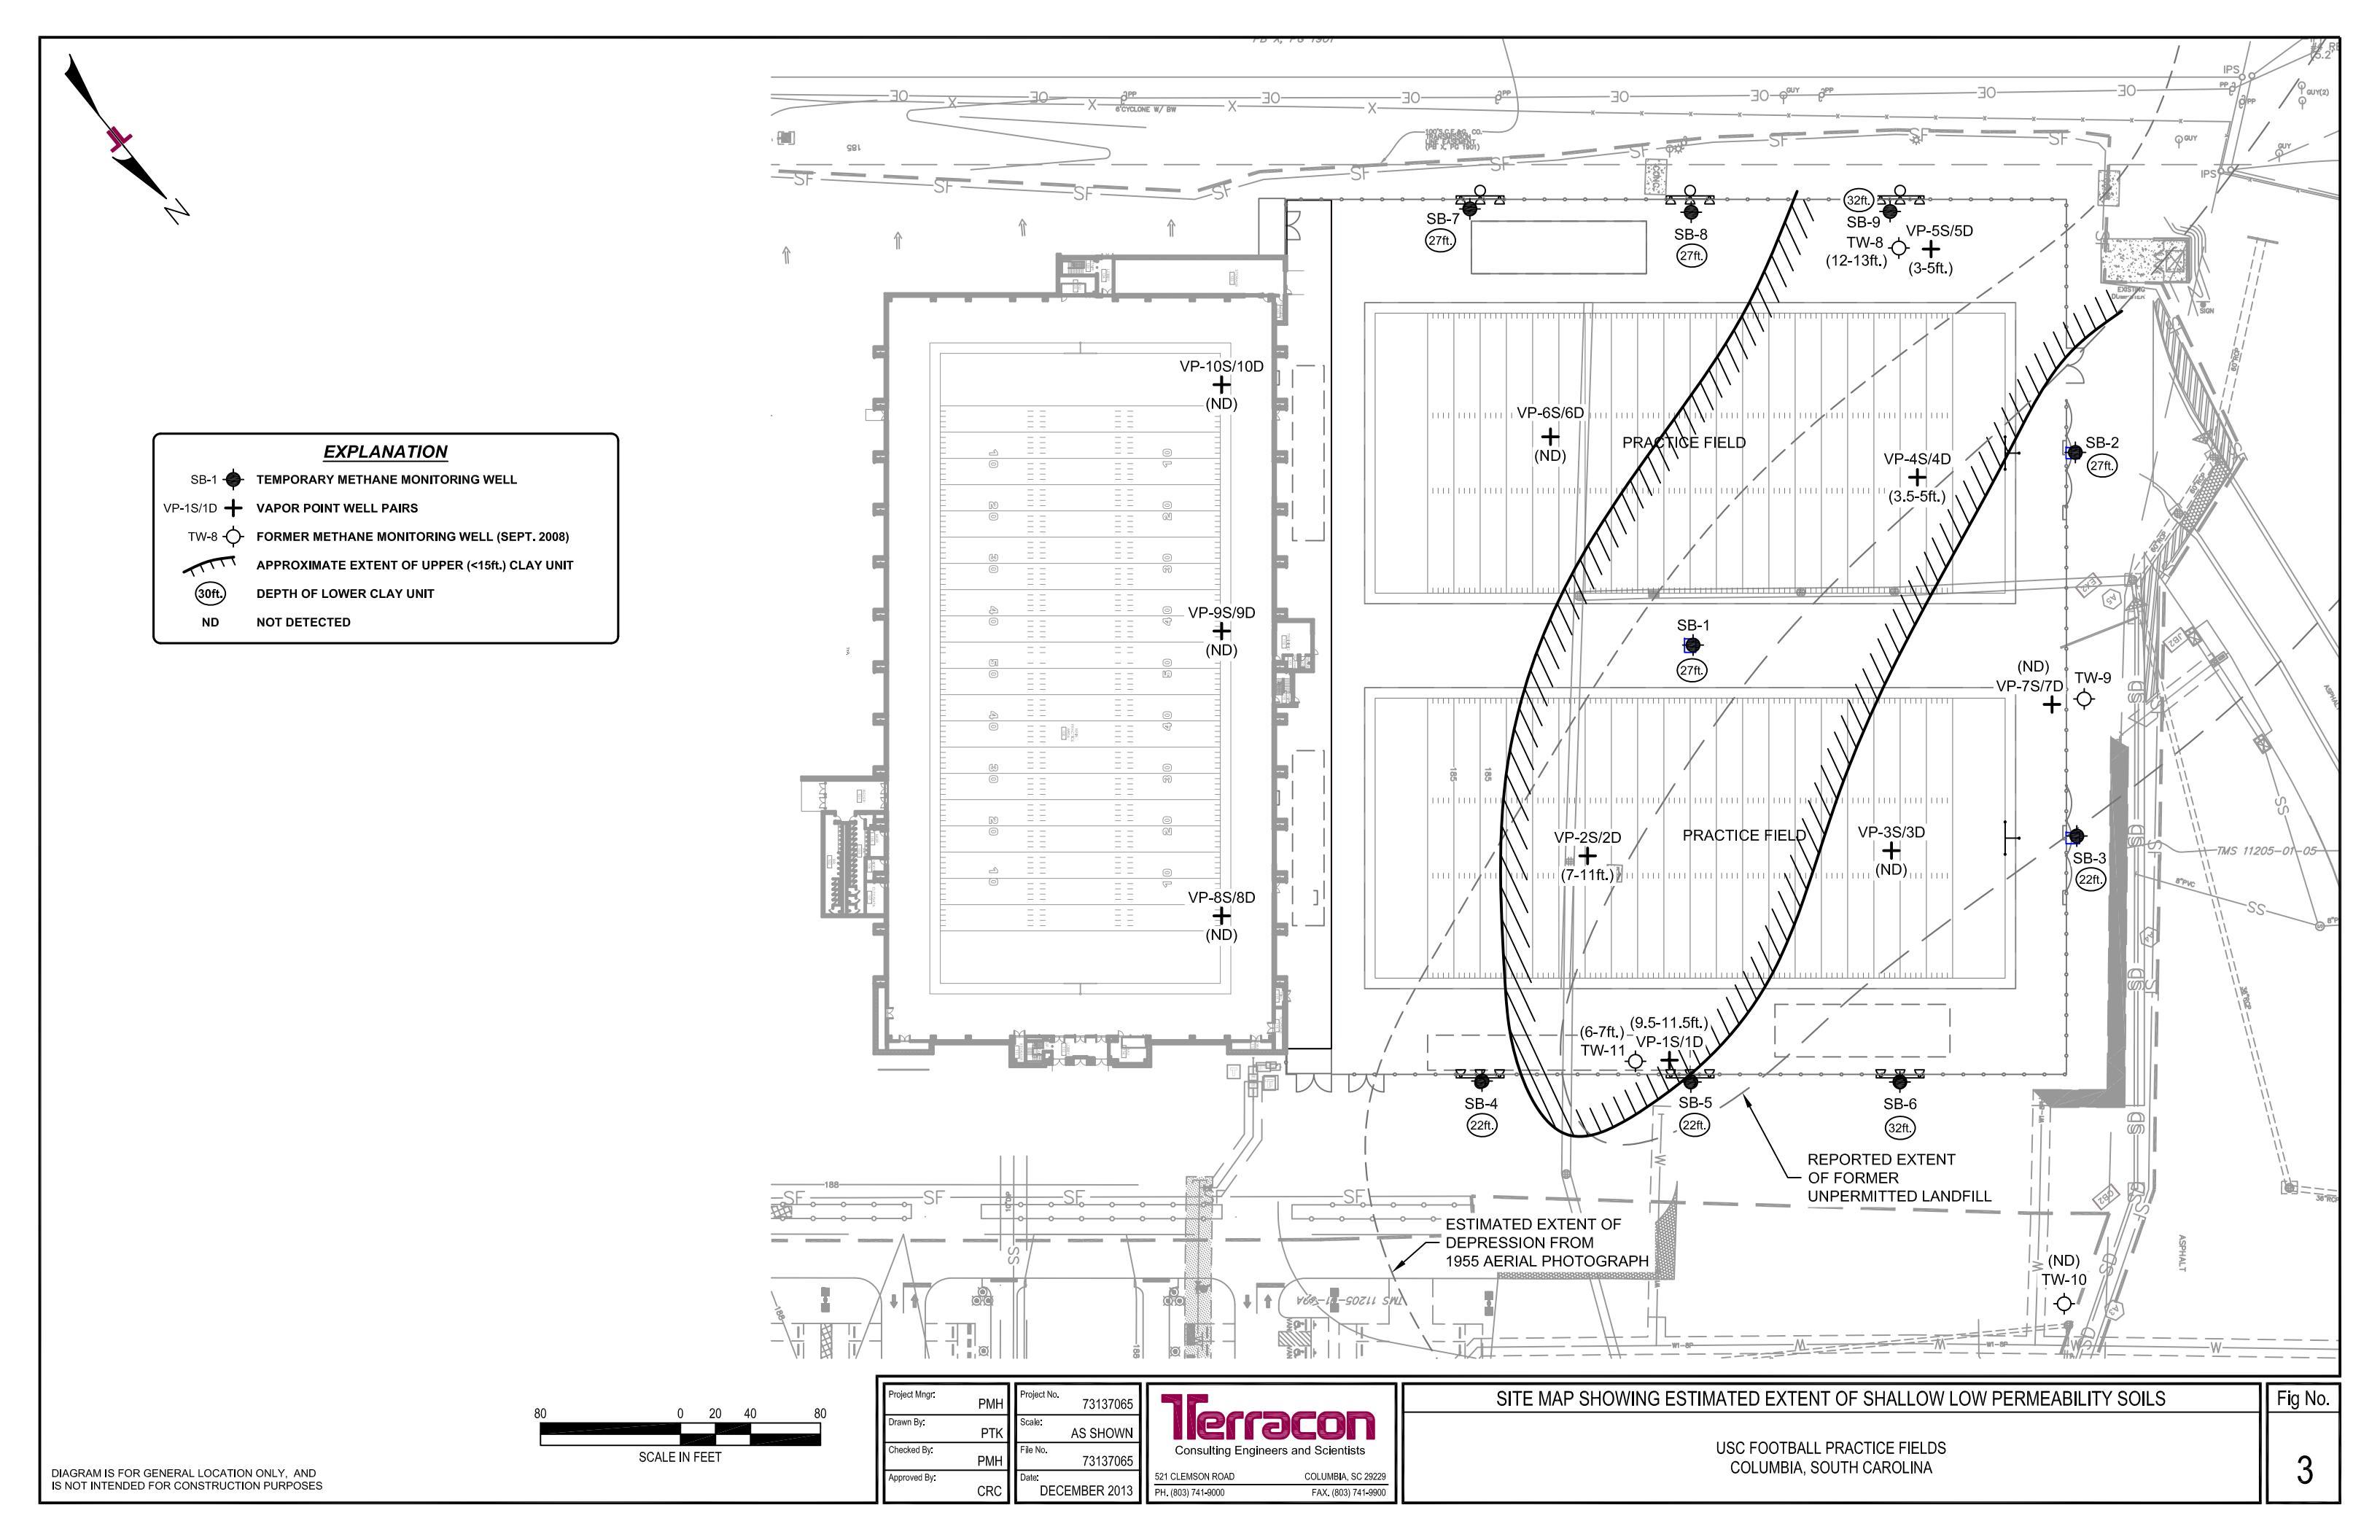
Figure 3 - Site Map Showing Extent of Low Permeability Soils

No buried debris or trash was encountered in the borings performed for this assessment. Detailed lithologic descriptions are presented on the vapor point boring logs and geotechnical boring logs included in Appendix C. The approximate extent of the low permeability soils encountered within the upper soils is depicted on Figure 3.

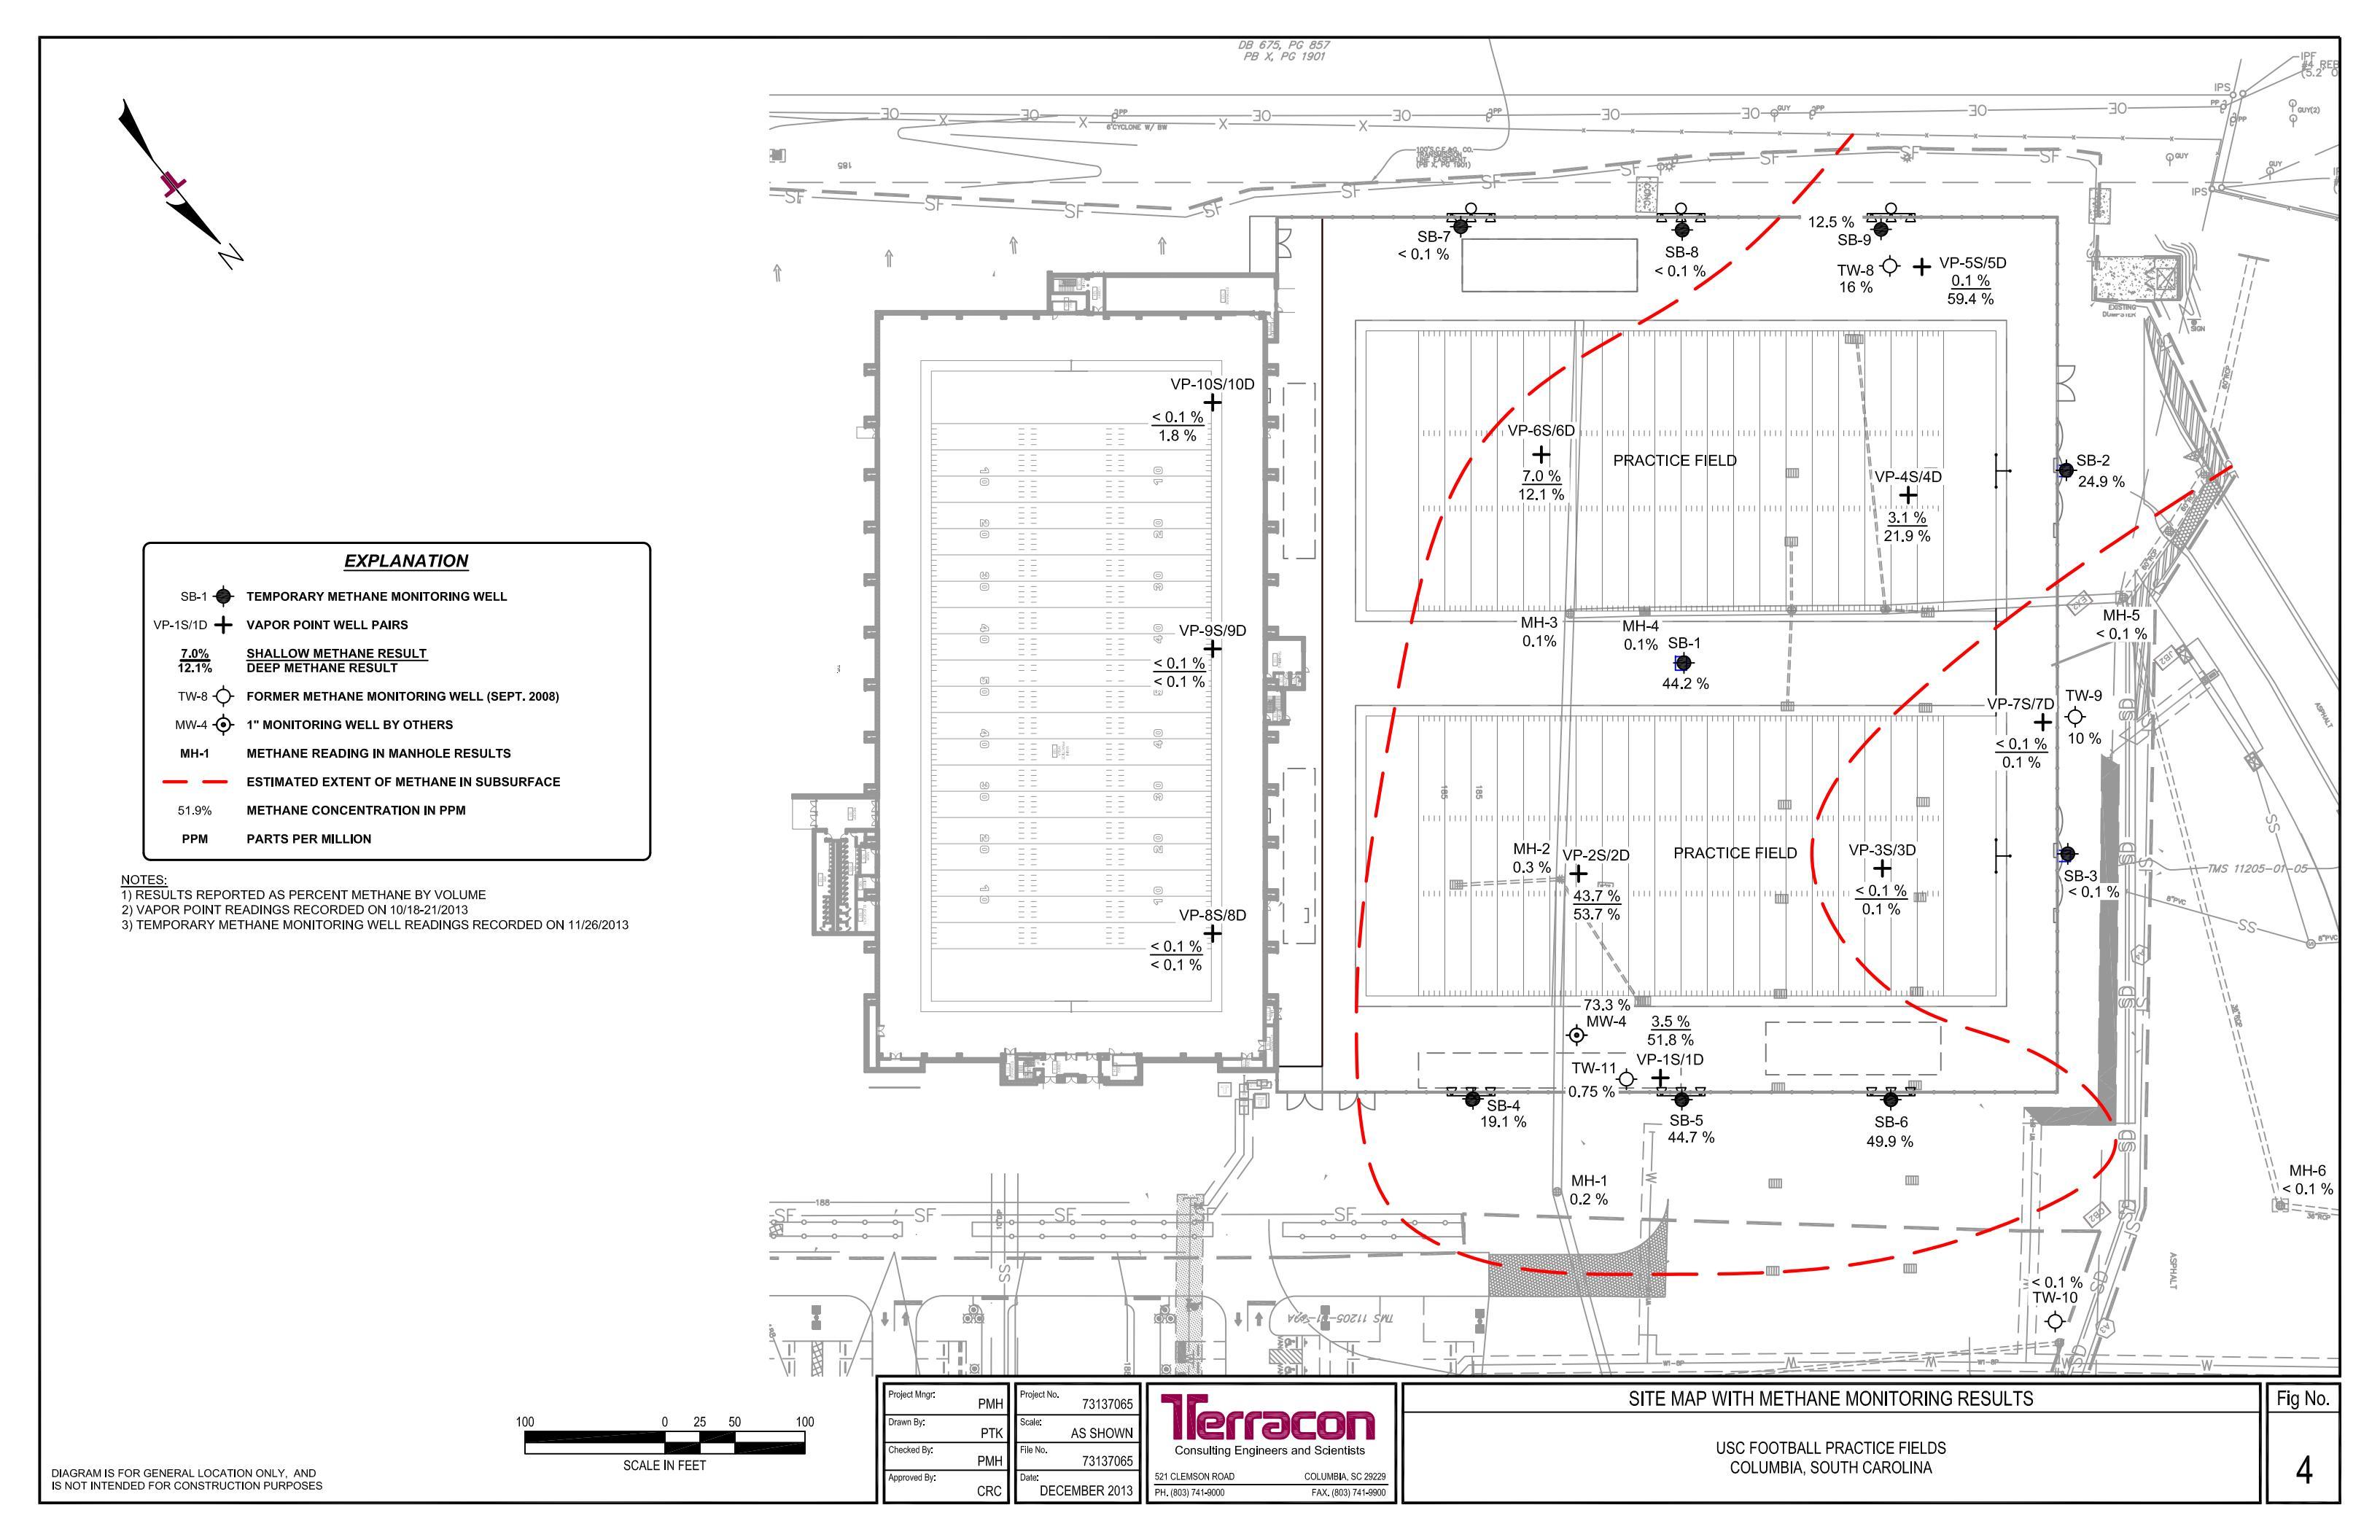
Figure 4 - Methane Concentration Map

A site map showing the methane monitoring results is included as Figure 4. Inspection of Figure 4 indicates methane was detected in the shallow and/or deep soils beneath the two outdoor football practice fields and beyond the eastern project boundary. No methane was detected above 5% LEL in the borings located in the proposed indoor football practice facility; however a methane concentration of 1.8% was detected above the regulatory limit of 1.25% at deep vapor point VP-10D, located near the northwest portion of the proposed indoor facility.

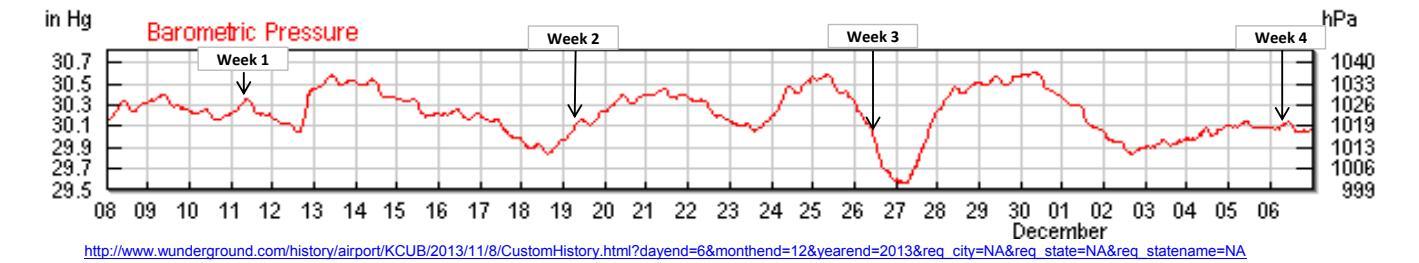
8) Barometric Pressures recorded less than 2 miles away during the 4-week monitoring period are graphed below:

Table 2 are barometric pressure readings for the monitoring period recorded at the nearest meteorological station¹ (Owens Field, KCUB) located less than two miles from the site. Atmospheric pressure may be of importance at sites where testing indicates variable or unexpected readings. A trend of rising barometric pressure tends to promote advection of air into the ground, which may negatively represent the subsurface soil gas conditions. During falling barometric pressures, methane concentrations tend to be higher as the methane dissipates from the subsurface.

Barometric pressure data was reviewed for the days prior to and on the day of monitoring. The pressure results recorded for Weeks 1 and 4 indicated relative steady readings prior to sampling. Week 2 was monitored during a *rising* barometric condition. No methane was detected in the temporary wells for these three weeks after the wells were vented. Conversely, Week 3 readings were recorded during a *falling* barometric condition, and elevated methane concentrations were recorded. This data can be used to help prepare future sampling protocols for long-term monitoring at the facilities.

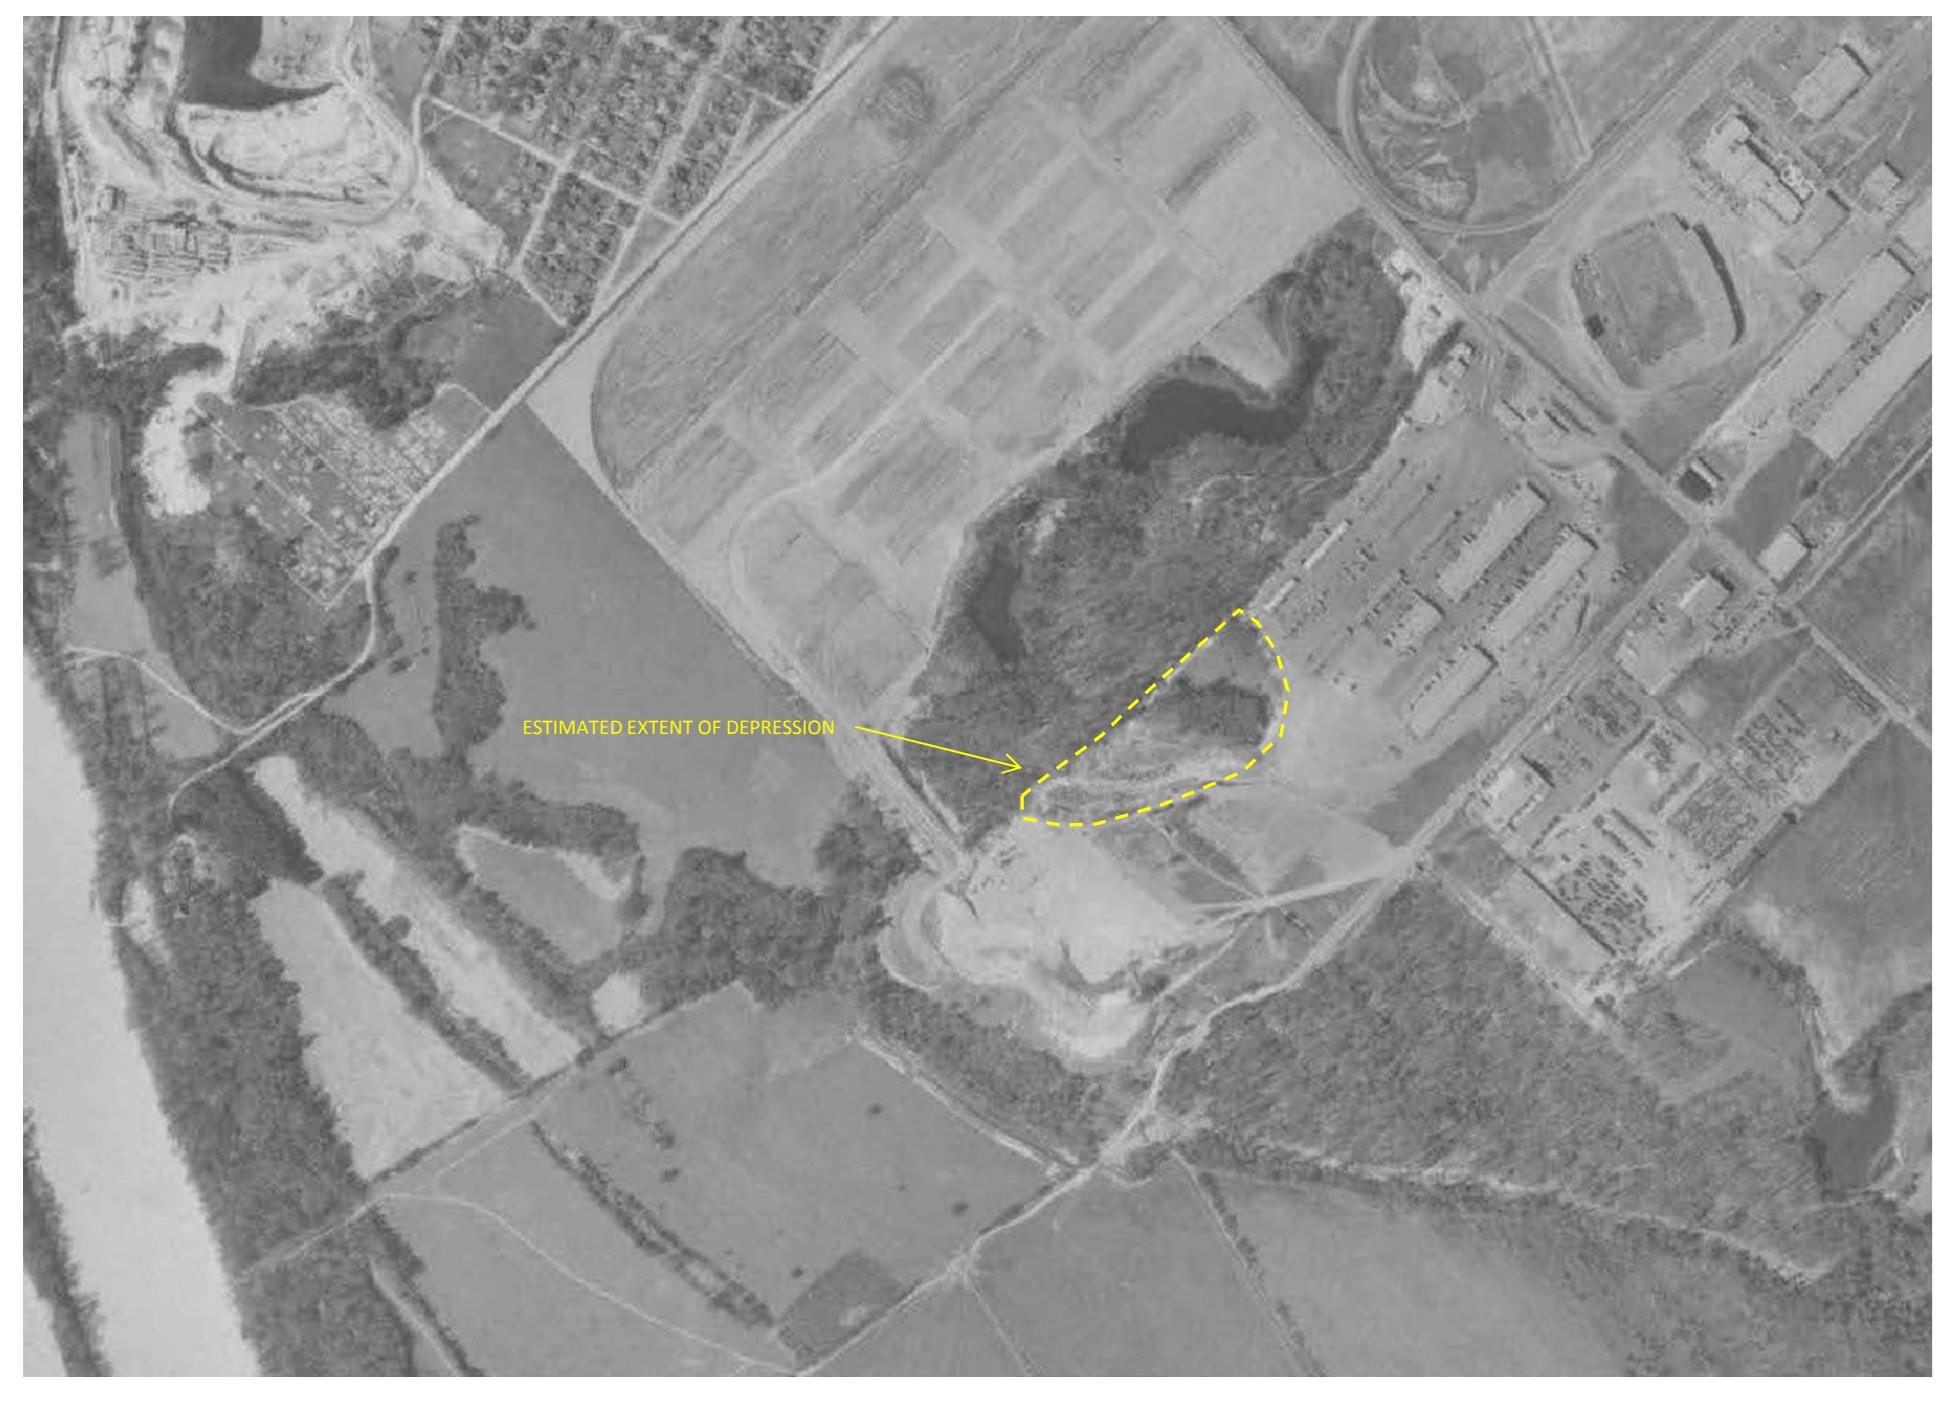
FARMER'S MARKET AERIAL PHOTO 1955

Aerial photographs of the site were reviewed to evaluate the former site use. The 1955 aerial photo shows an apparent depression adjacent to the Farmer's Market. Further, an unpublished map showing a hatched area, labeled as 'Columbia Landfill Boundary' was reviewed with respect to the proposed development. The inspection of the above historical items indicate the proposed practice fields are located in the area of the depression and mapped landfill, as shown on Figure 2. Copies of these documents are included in Appendix E.
