Mepkin Wreck Project Continues: Is Vessel Henry Lauren's Plantation Boat *Baker*

By Lynn Harris

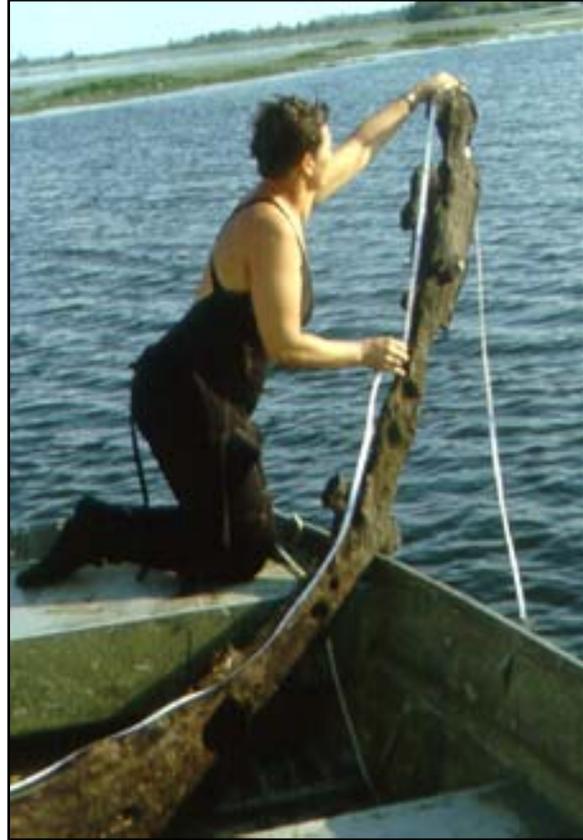
Figure 1: Sue Vezeau measures fasteners of vessel's stempost (SCIAA photo).

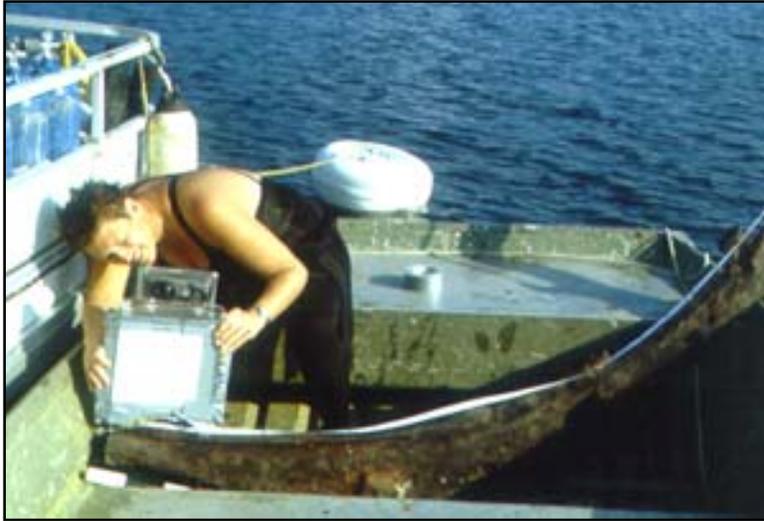
Figure 2: Sue Vezeau uses goniometer to record curvatures of loose timbers from the wreck (SCIAA photo).

With the donation of threaded fiberglass rods from Strongwell Corporation in Bristol, Virginia, the separate rudder components recovered in the 1980s have been successfully united and can be viewed on site when the trail reopens in the spring next year. We were also fortunate to have the assistance of our former intern and current graduate student, Sue Vezeau, who joined us from Texas A & M Nautical Archaeology Program along with her goniometer to take hull lines as a reconstruction project for a term paper. We look forward to the results.
