**THE MEPKIN ABBEY SHIPWRECK:
DIVING INTO MEPKIN PLANTATION'S PAST**

A Thesis

Major Subject: Anthropology

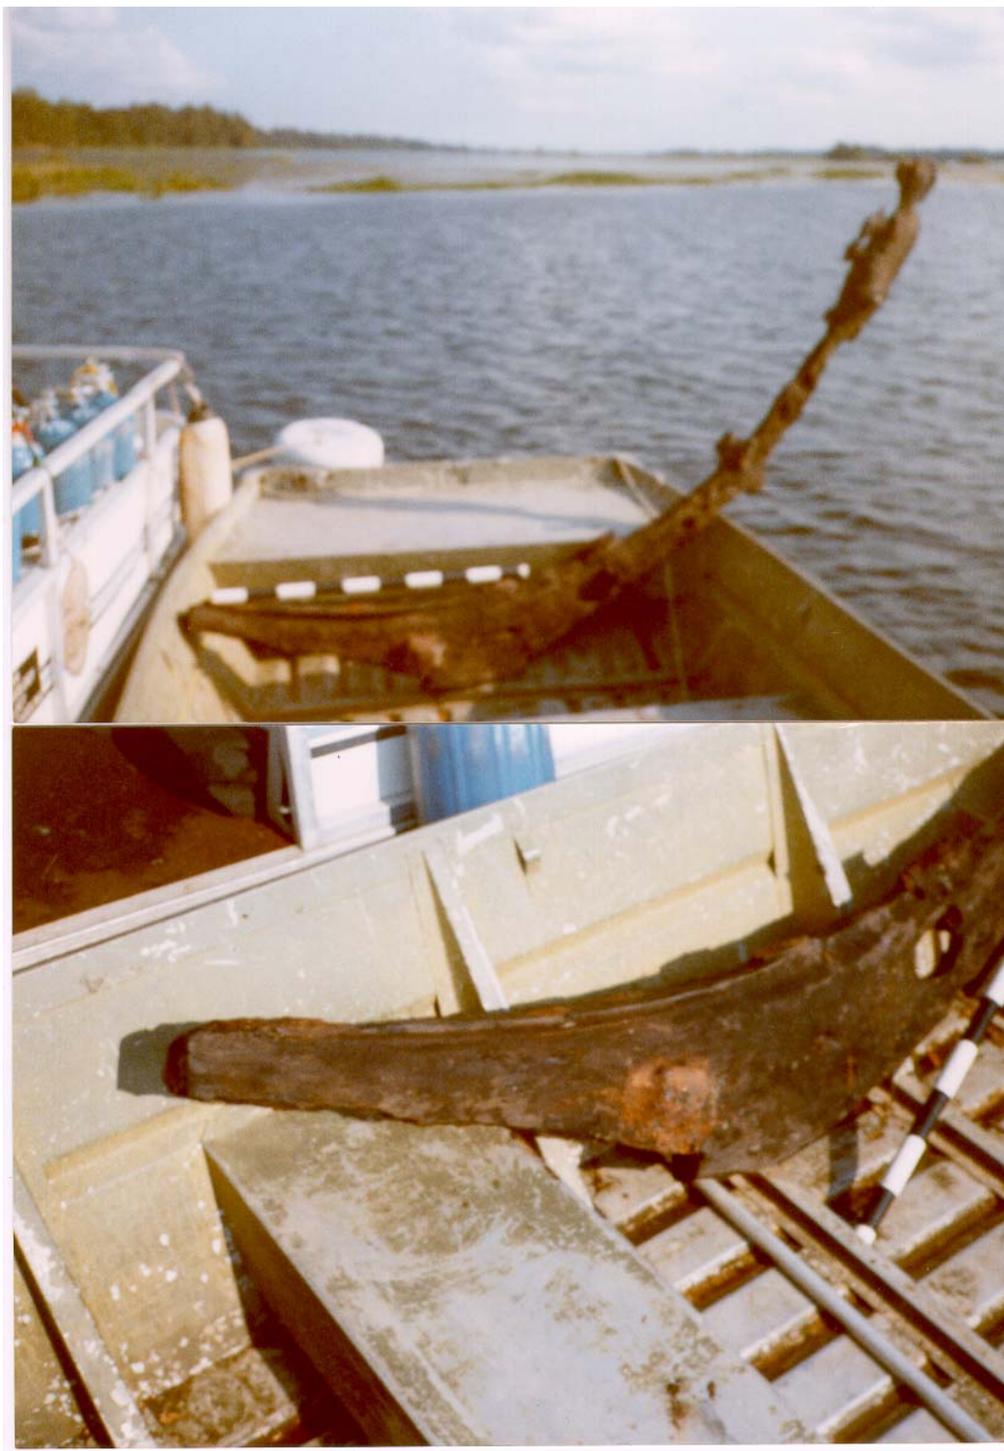
Figure 9. Two Views of the Stem (photographs taken October 2000 by Sue Vezeau). The complete stem is shown at top and a detail of the base and the keel scarf is shown in the lower photo.

We elected to bring up the stem (Figure 9) and the mast step (Figure 10) to photograph and record on board our dive boat then return them to their original locations. The stern assembly, in storage at a nearby plantation, was also re-recorded and photographed (Figure 11). I made copies of all field notes and upon my return to Texas A&M University, began an analysis and interpretation of the hull. This included preparation of ship's lines based on the wreck plan (Figure 12), frame curvatures, historical data, development of a scantling list in both imperial and metric measurements (Appendices A and B), and the creation of construction drawings (Figure 13) that included an interior profile, a deck plan, and a section drawing specifically chosen to highlight the saddle mast step. The reconstruction of the ship was based not only on the wreck plan, frame sections, and related research conducted in 2000, but also on the preliminary report written in 1981 from the 1980 field work.

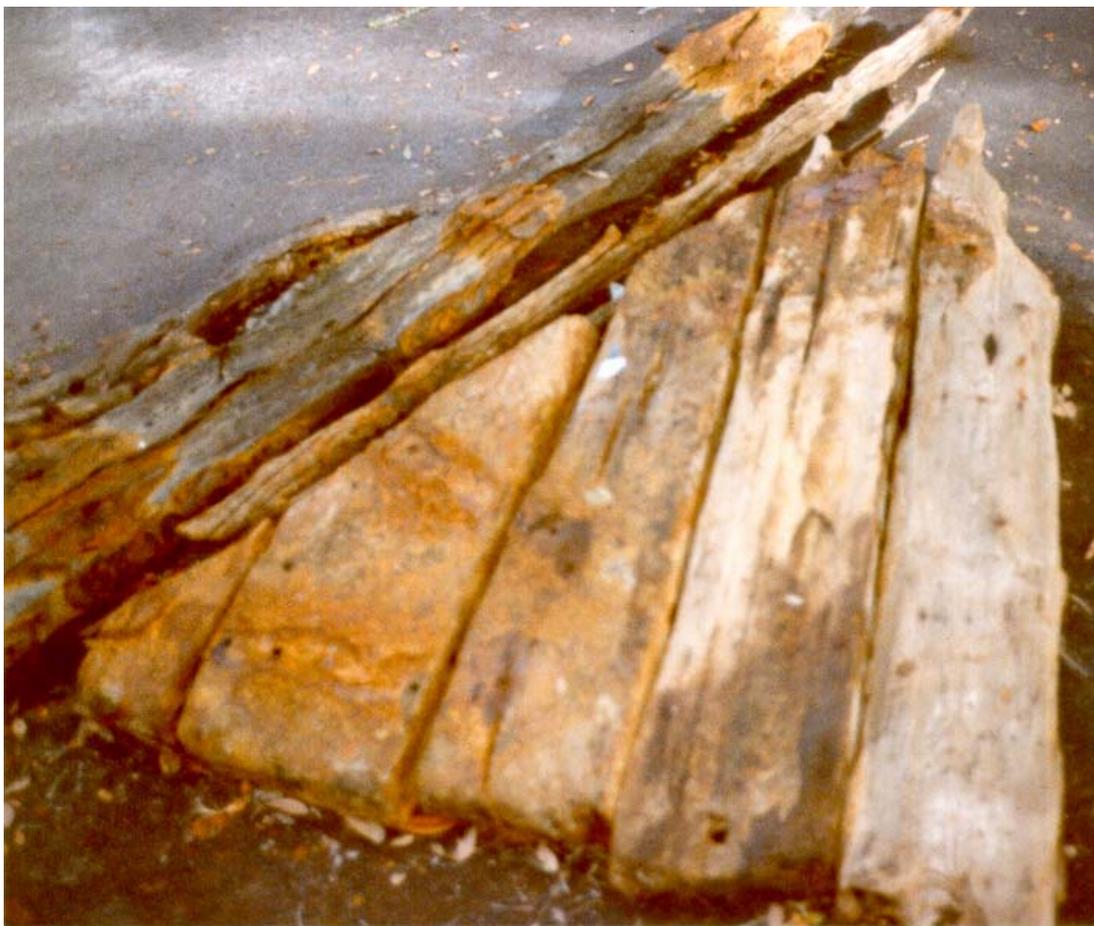
Figure 11. The Rudder Assembly (photograph taken October 2000 by Sue Vezeau).

The rudder stock was constructed from two pieces of wood. These timbers are highly eroded but were connected with .4 inch (1.02 cm) square-headed iron bolts or spikes, and treenails. Iron-stained notches show where the two iron straps were used to hold the rudder blade and stock together. There are also iron stains remaining from the pintle straps. The rudder, rudder stock, stern knee, and stern post were all recovered in 1980 and conserved by the SCIAA team. Another piece, also labeled as rudder stock, was recovered as well but was not with the rest of the assemblage in 2000. It could possibly have fit between the two remaining pieces of stock, together making up the rudder post and securing the blade to the stern post. The resulting post would probably have been 8 feet, 3 inches (2.52 m) in height, 1 inch (2.54 cm) thick, and 6 inches (15.24 cm) wide. The 1980 report also mentions a small piece of wood concreted to the rudder that could have been a rudder stop, but it no longer exists; a rudder stop is used to keep the rudder from floating out of the gudgeons.

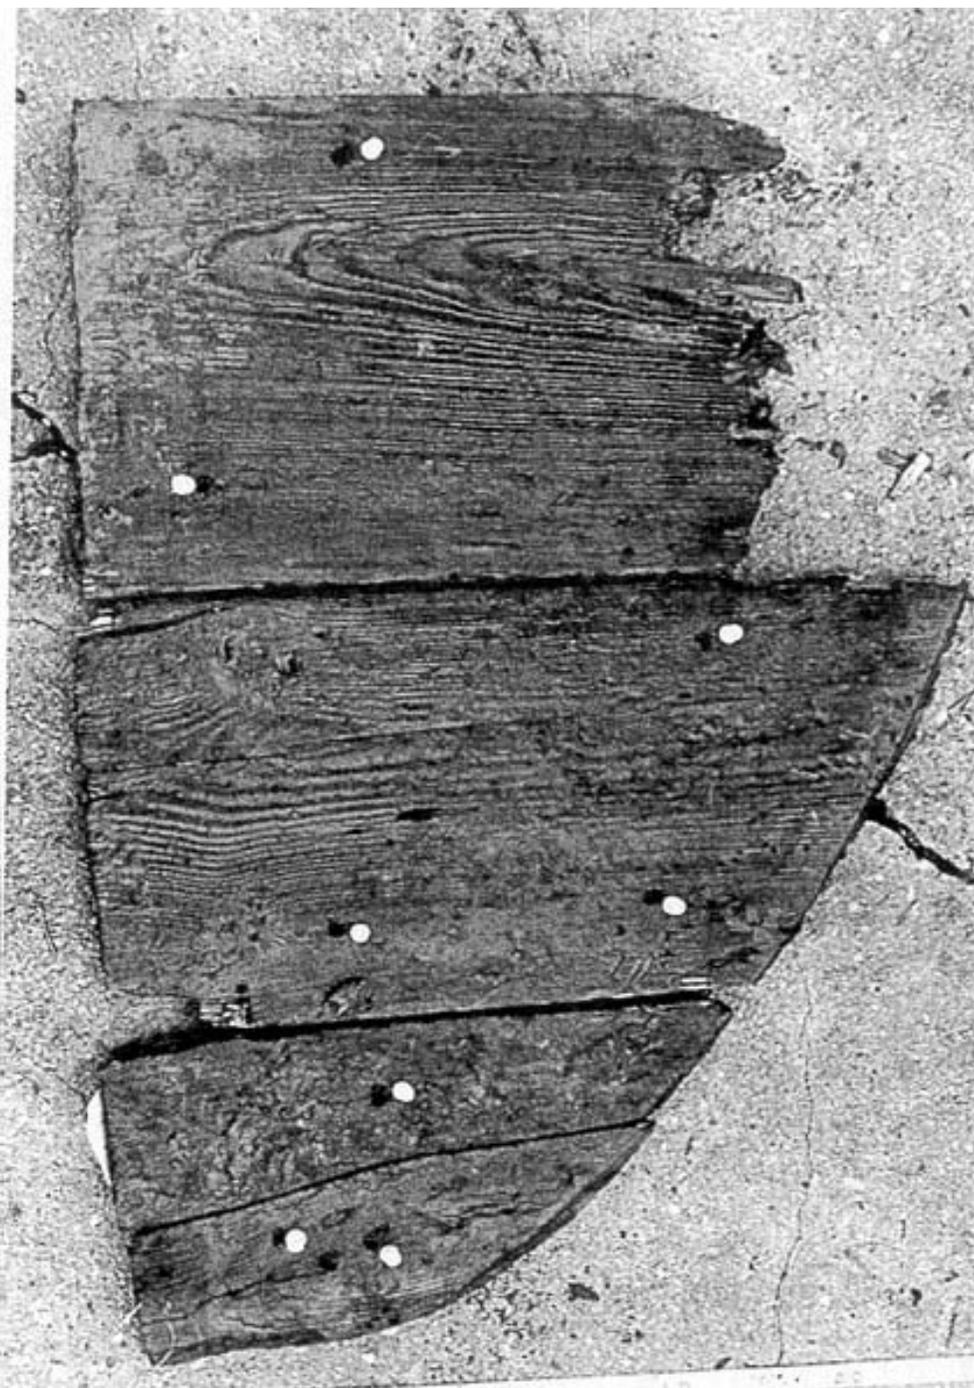
Figure 37. Malcolm Boat's Surviving Transom Planking (nail holes are highlighted by white pins but the scale shown at the bottom of the photo is unreadable in the originally published photograph). One of the three planks was located wedged tightly against the stern post, the other two planks were excavated aft of the stern (Amer and Hocker 1995: 48) (photo courtesy of SCIAA).

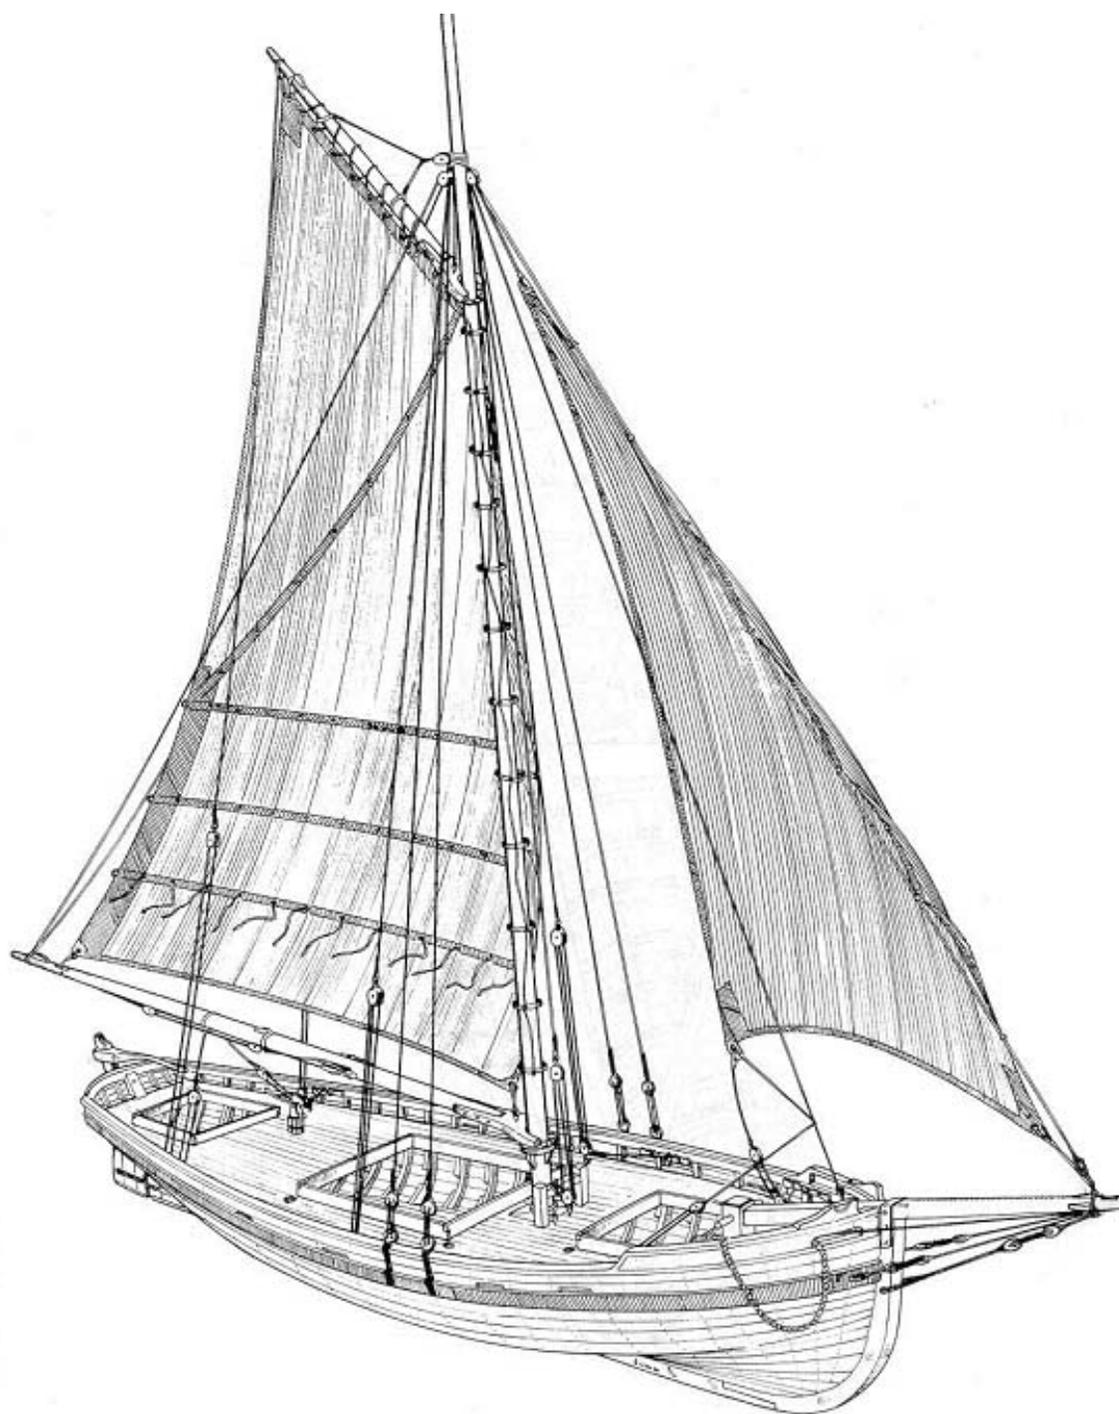
Figure 38. Reconstruction of the Malcolm Boat with a Gaff Rig (drawing by William R. Judd, courtesy of SCIAA).

Two rectangular mast steps were carved into the keelson: one located above the midship frame (approximately one third of the vessel's length abaft the stem) and the other step, which was partially plugged, was set further aft, yet still in the forward half of the ship (Figure 36). Amer and Hocker describe the boat as being 'designed for strength and with the ability to carry heavy loads' (1995: 300). They also felt that 'the transom stern would have enhanced the vessel's cargo-carrying capacity and seaworthiness for offshore voyages' (Figure 37). The Malcolm boat would have been suited to both offshore and riverine usage, and the reconstruction drawings by William Judd show a fine craft that was well made, functional, and aesthetically pleasing (Figure 38).
